Inspection Photos

Location Name: TEP ROCKY MOUNTAIN LLC LANGSTAFF 1 Pad

Location ID: 335194

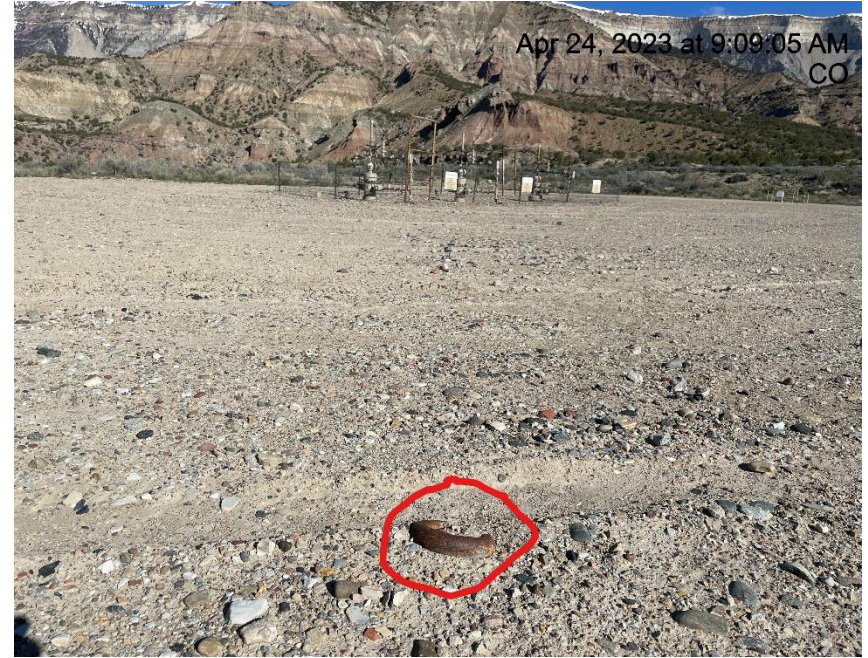
Photo # 6072 Unmarked deadman

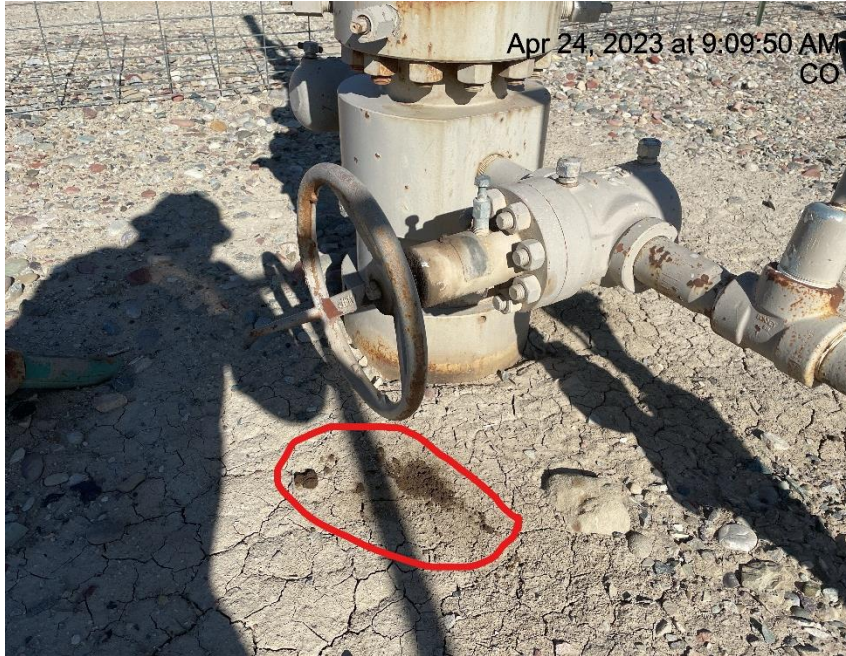
Photo # 6074 Stained soils

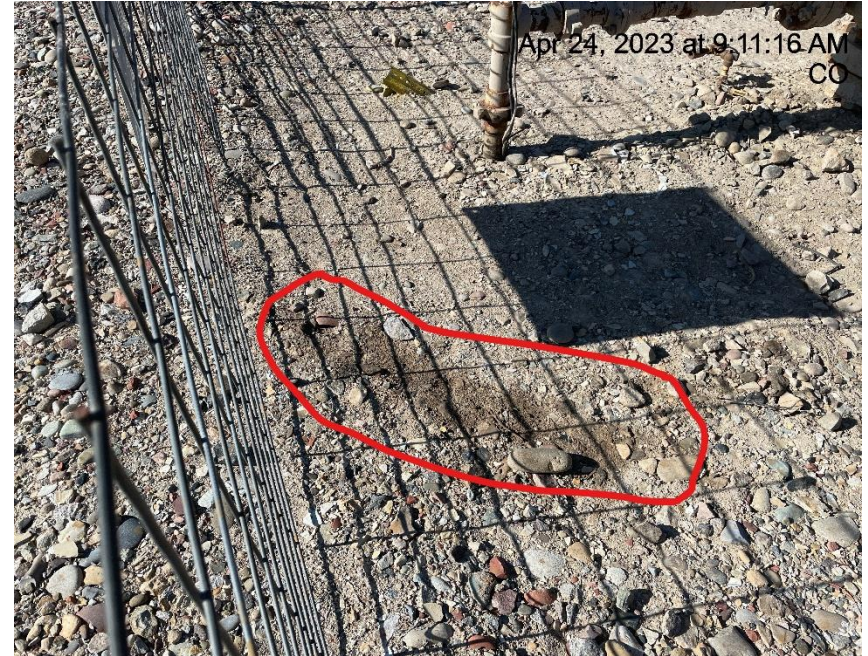
Photo # 6075 Stained soils & gravel

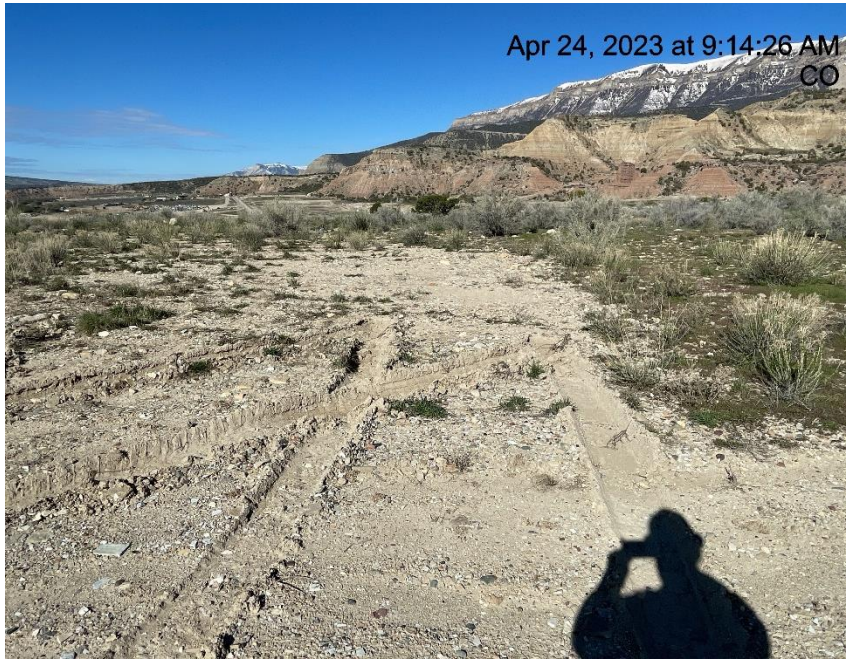
Photo # 6080 Failure to minimize surface disturbance

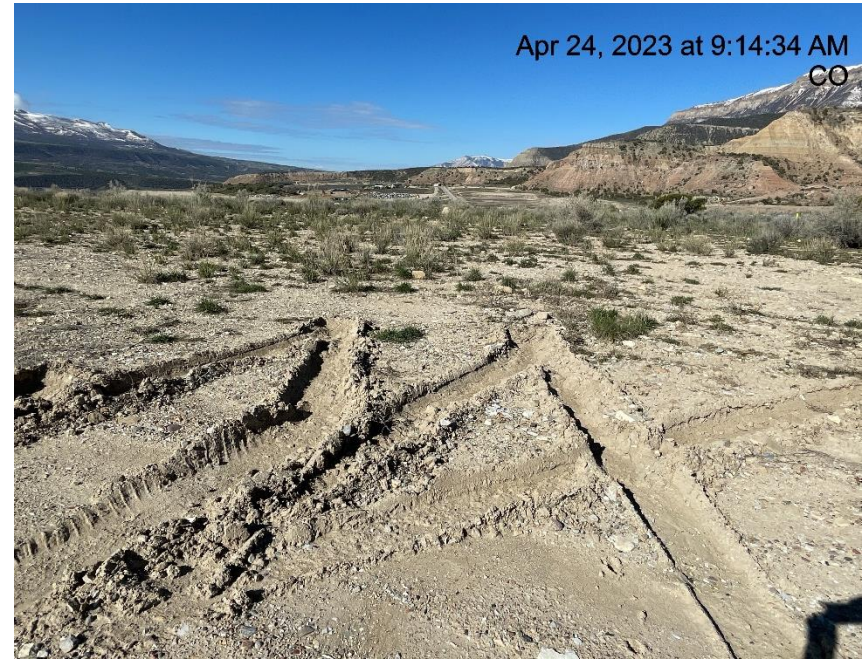
Photo # 6081 Failure to minimize surface disturbance

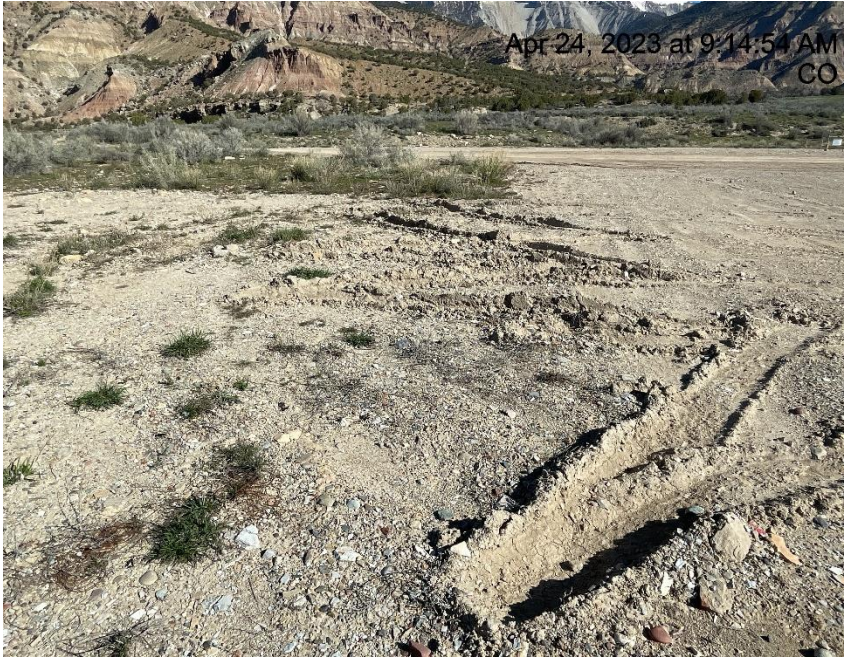
Photo # 6083 Failure to minimize surface disturbance

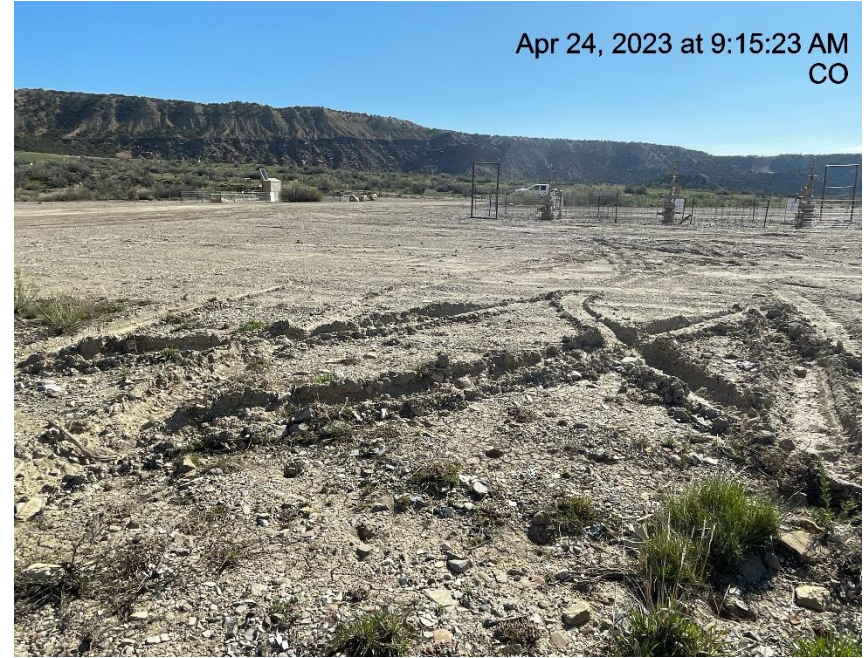
Photo # 6086 Failure to minimize surface disturbance

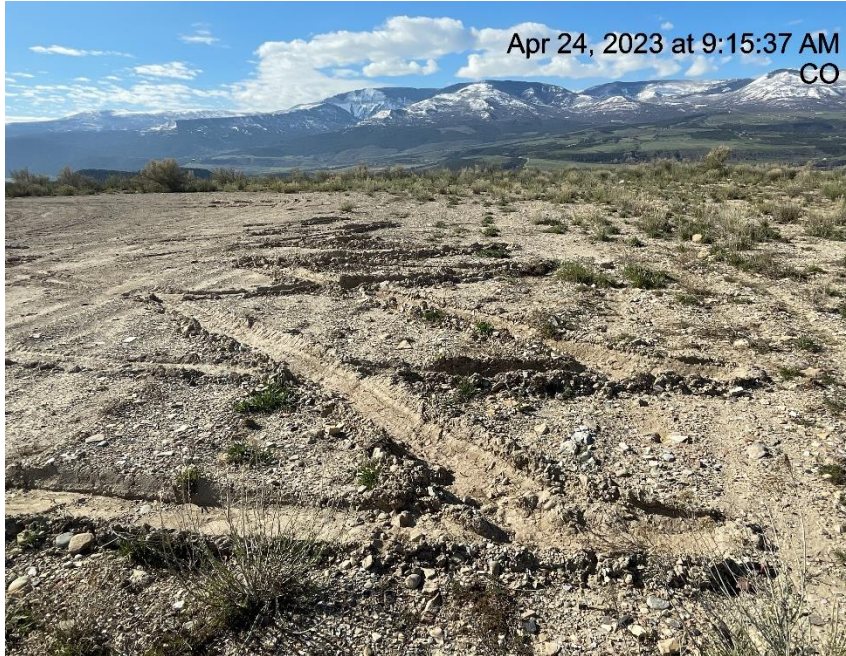
Photo # 6087 Failure to minimize surface disturbance

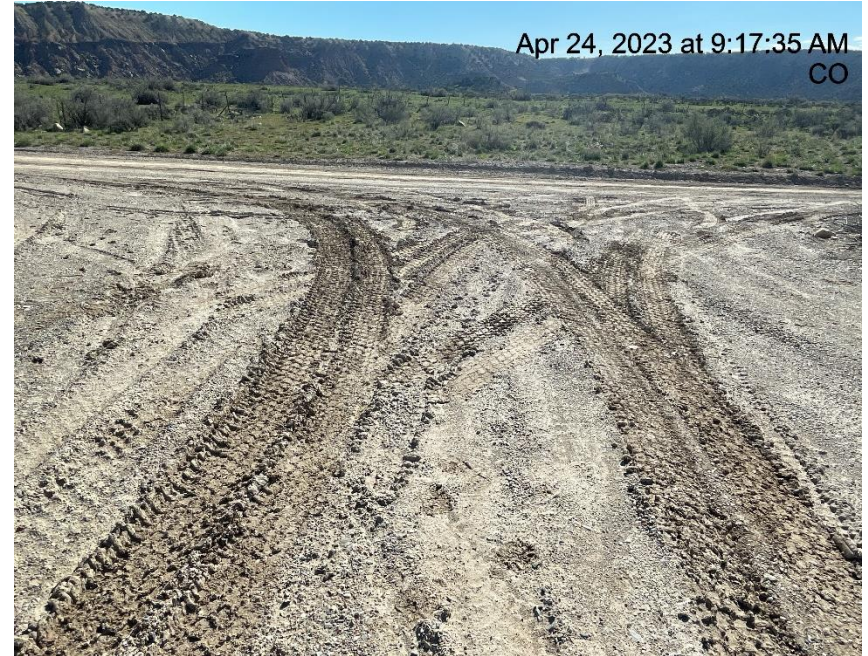
Photo # 6088 Lack of stabilization/Compaction/Insufficient tracking BMP's

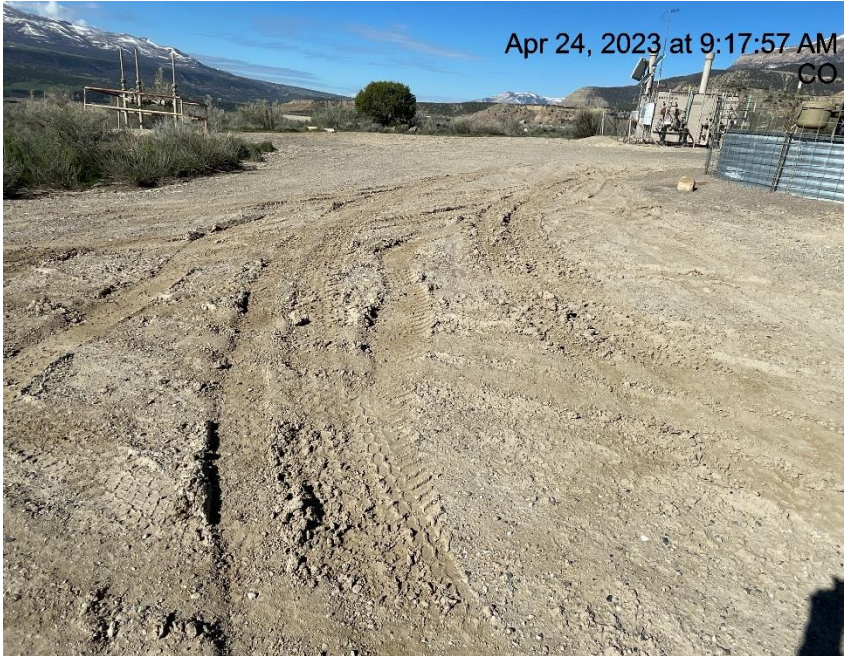
Photo # 6089 Lack of stabilization/Compaction/Insufficient tracking BMP's

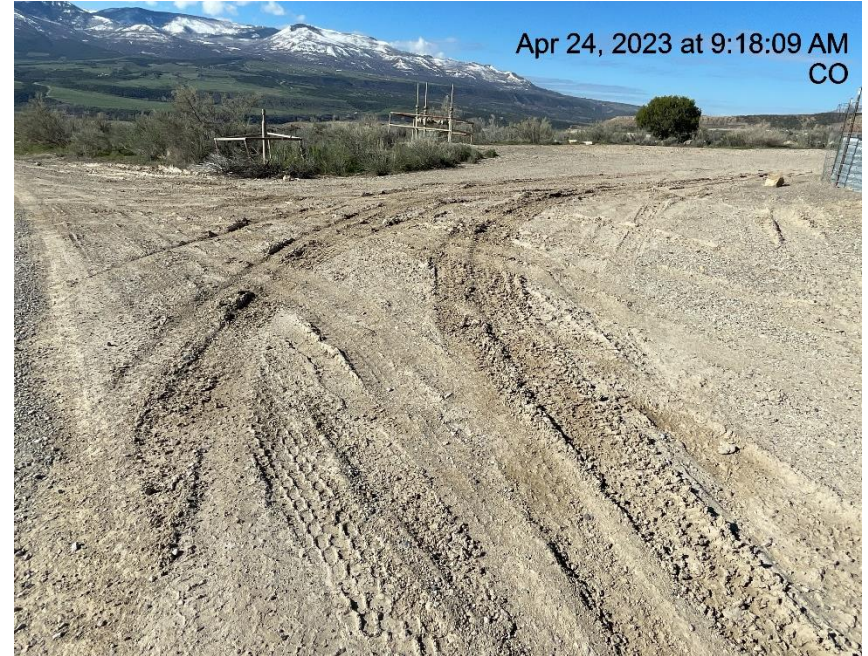
Photo # 6090 Lack of stabilization/Compaction/Insufficient tracking BMP's

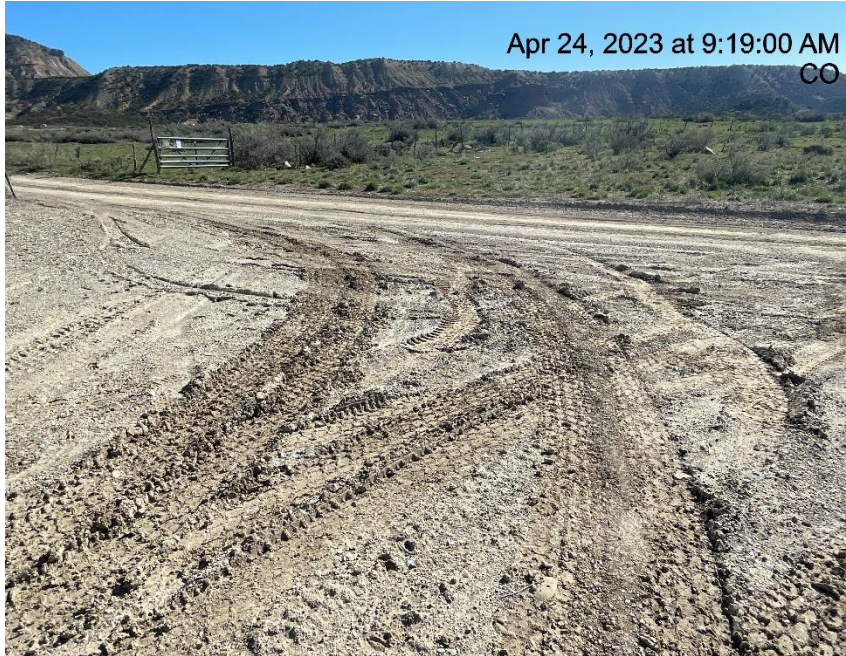
Photo # 6094 Lack of stabilization/Compaction/Insufficient tracking BMP's

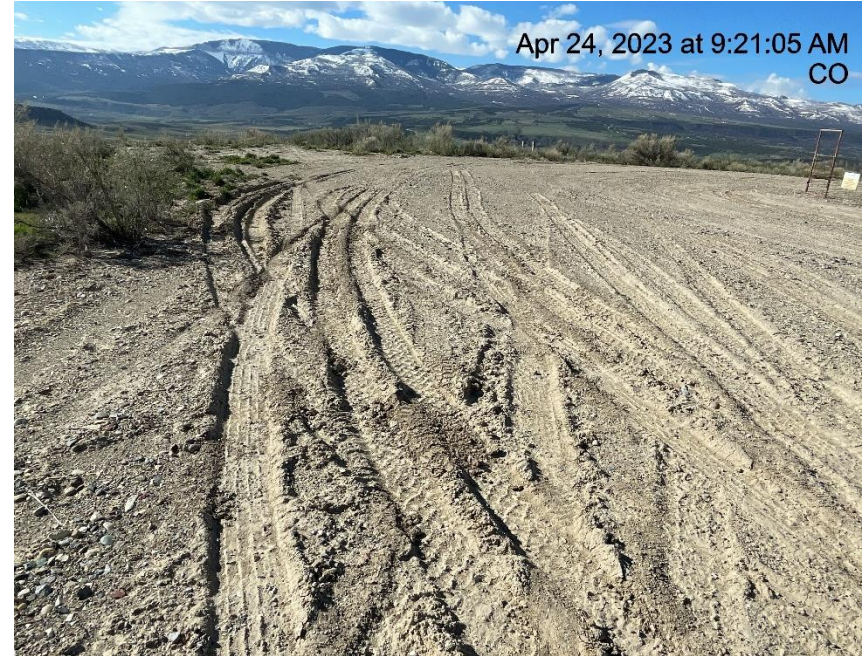
Photo # 6097 Lack of stabilization/Compaction on location

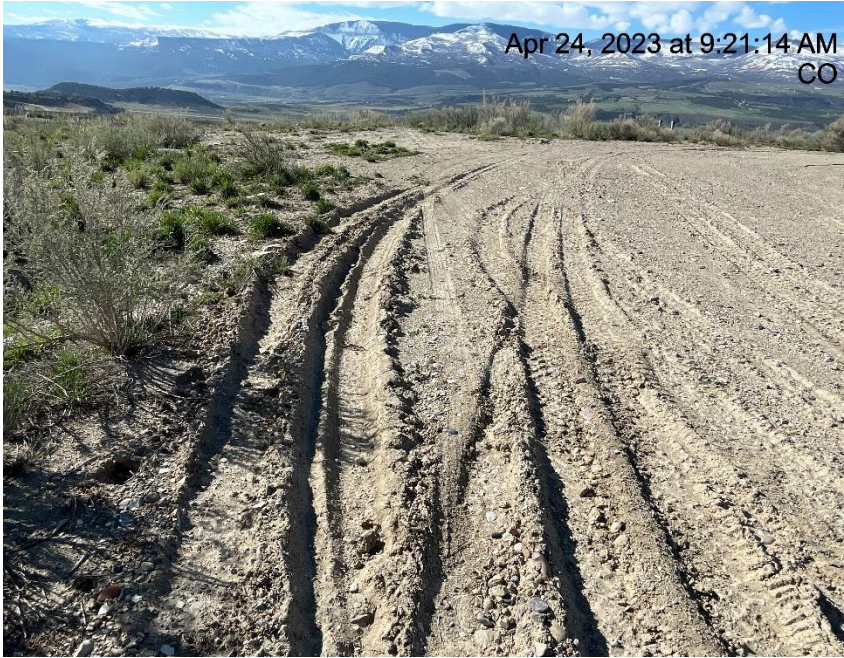
Photo # 6098 Lack of stabilization/Compaction on location

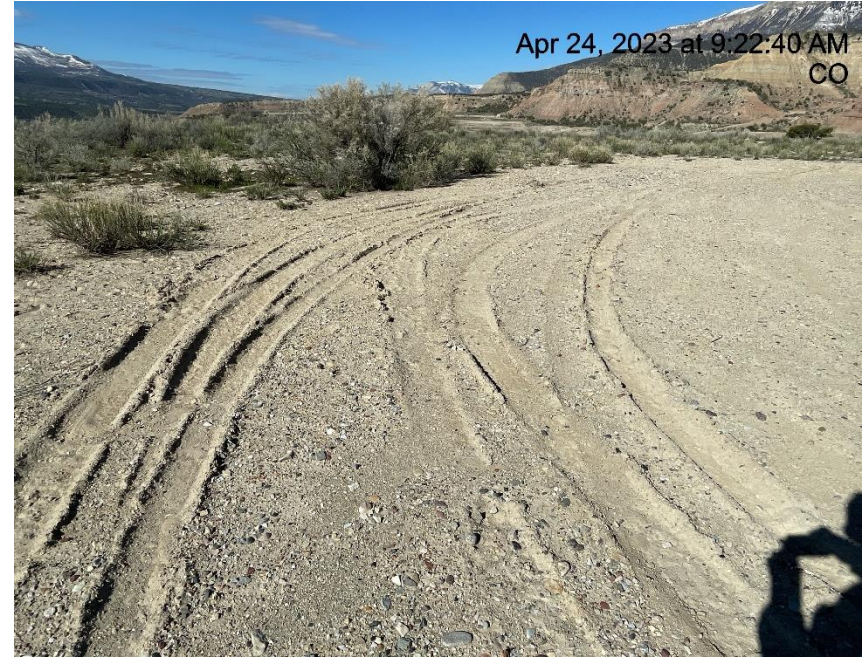
Photo # 6102 Lack of stabilization/Compaction on location

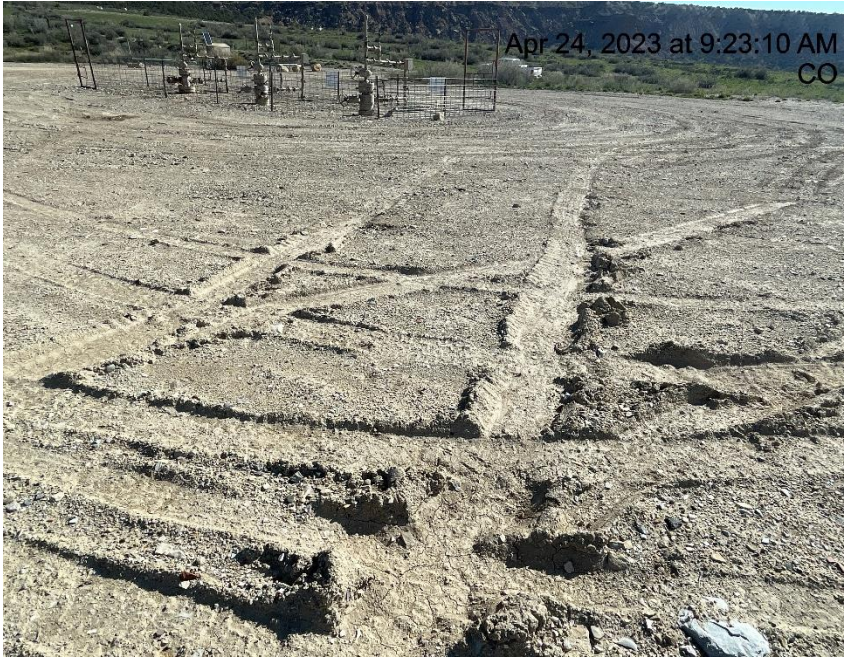
Photo # 6103 Lack of stabilization/Compaction on location

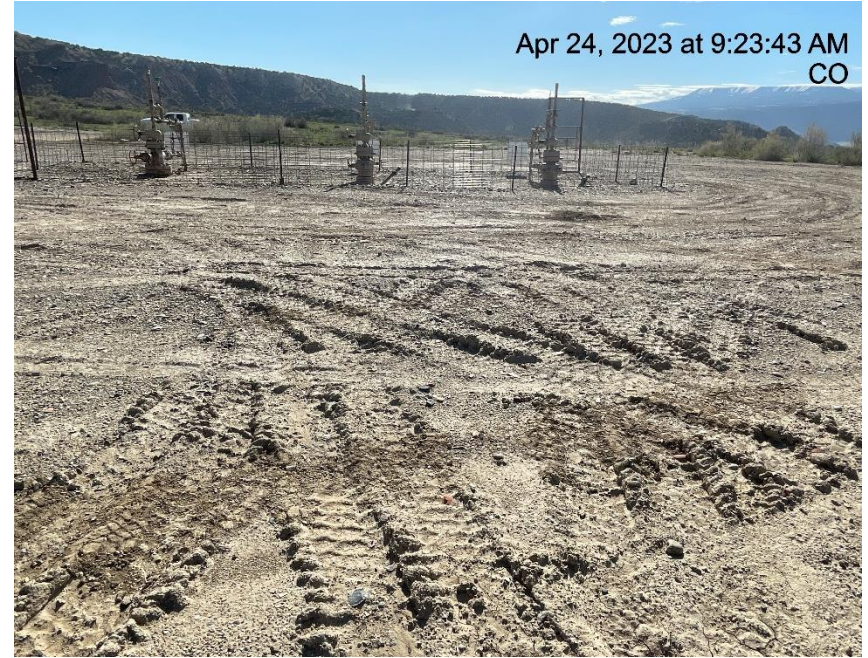
Photo # 6104 Lack of stabilization/Compaction on location

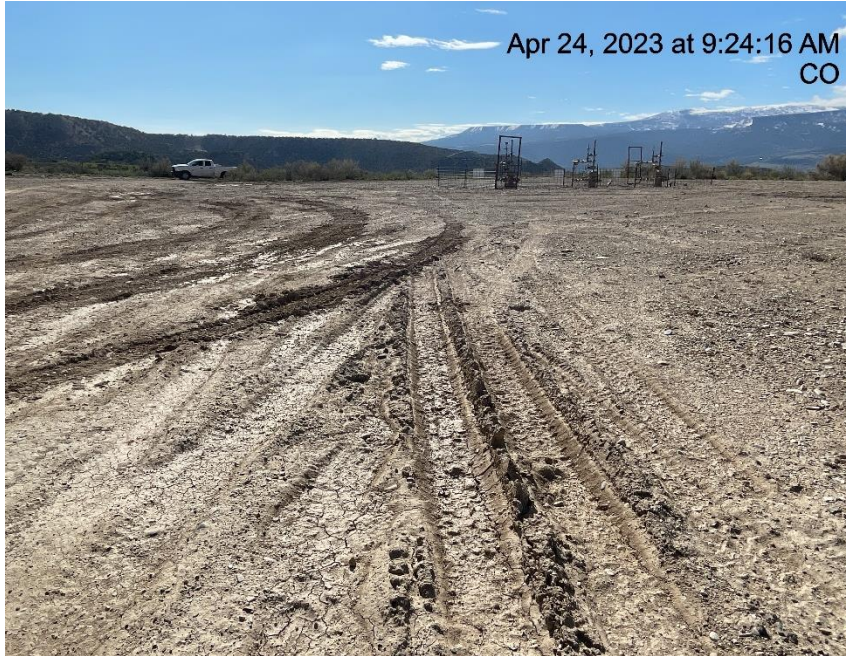
Photo # 6105 Lack of stabilization/Compaction on location

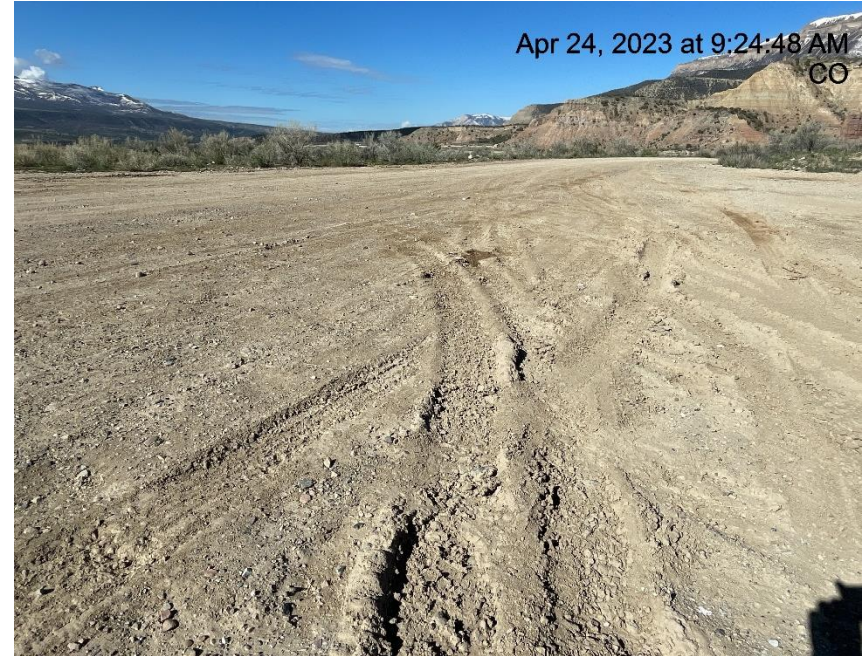
Photo # 6107 Lack of stabilization/Compaction on location

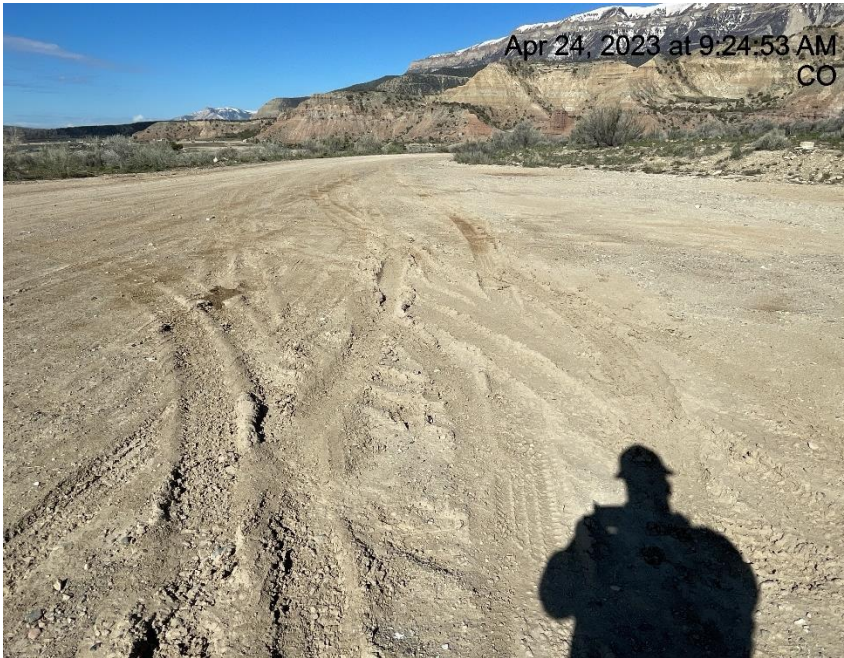
Photo # 6108 Lack of stabilization/Compaction on location

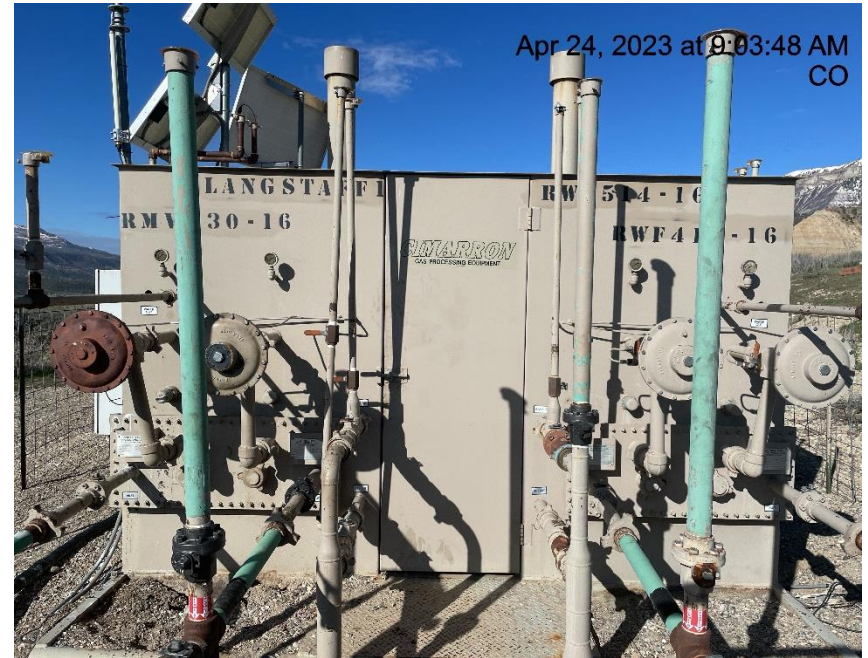
Photo # 6067 Meter calibration info not conspicuously posted
