Inspection Photos

Loc: 393275

Operator: FOUR CORNERS ENERGY LLC

Inspection Date: 4/19/2023

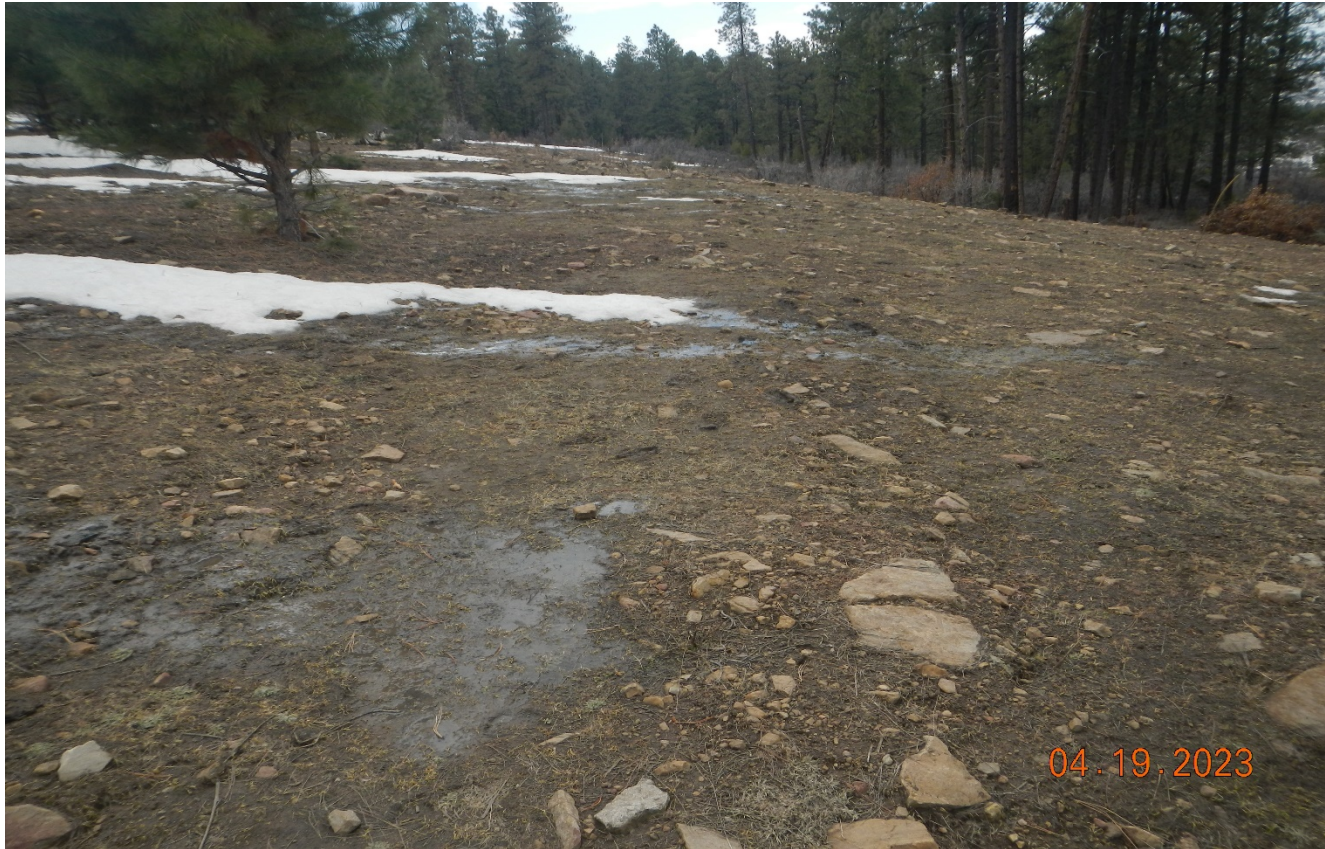
Photo 1. Facing southwest at the location which was recontoured however there are areas that have not re-established a perennial vegetation cover.

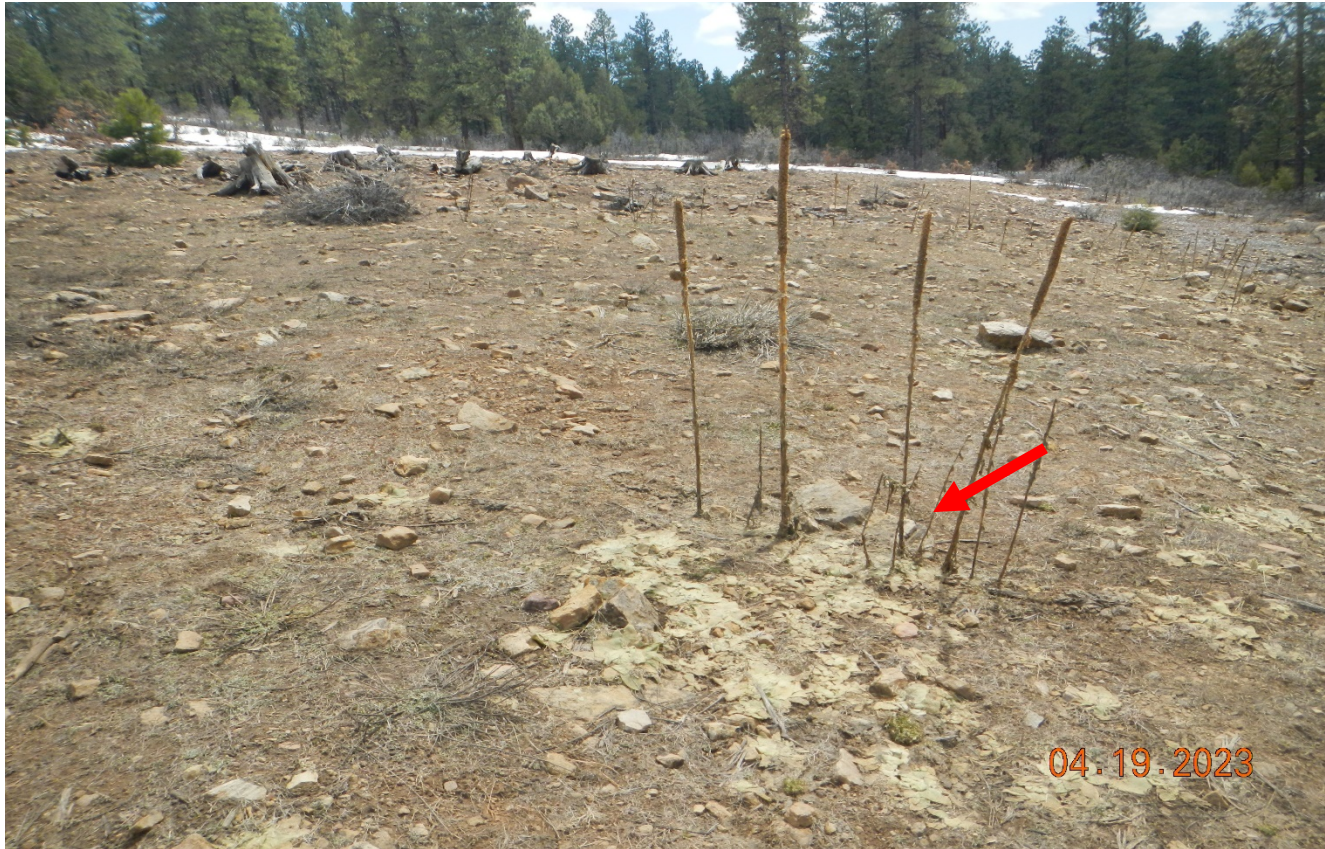
Photo 2. Facing south at the location. There are areas of noxious weeds that need to be controlled. Red arrow points to Mullein and thistle.

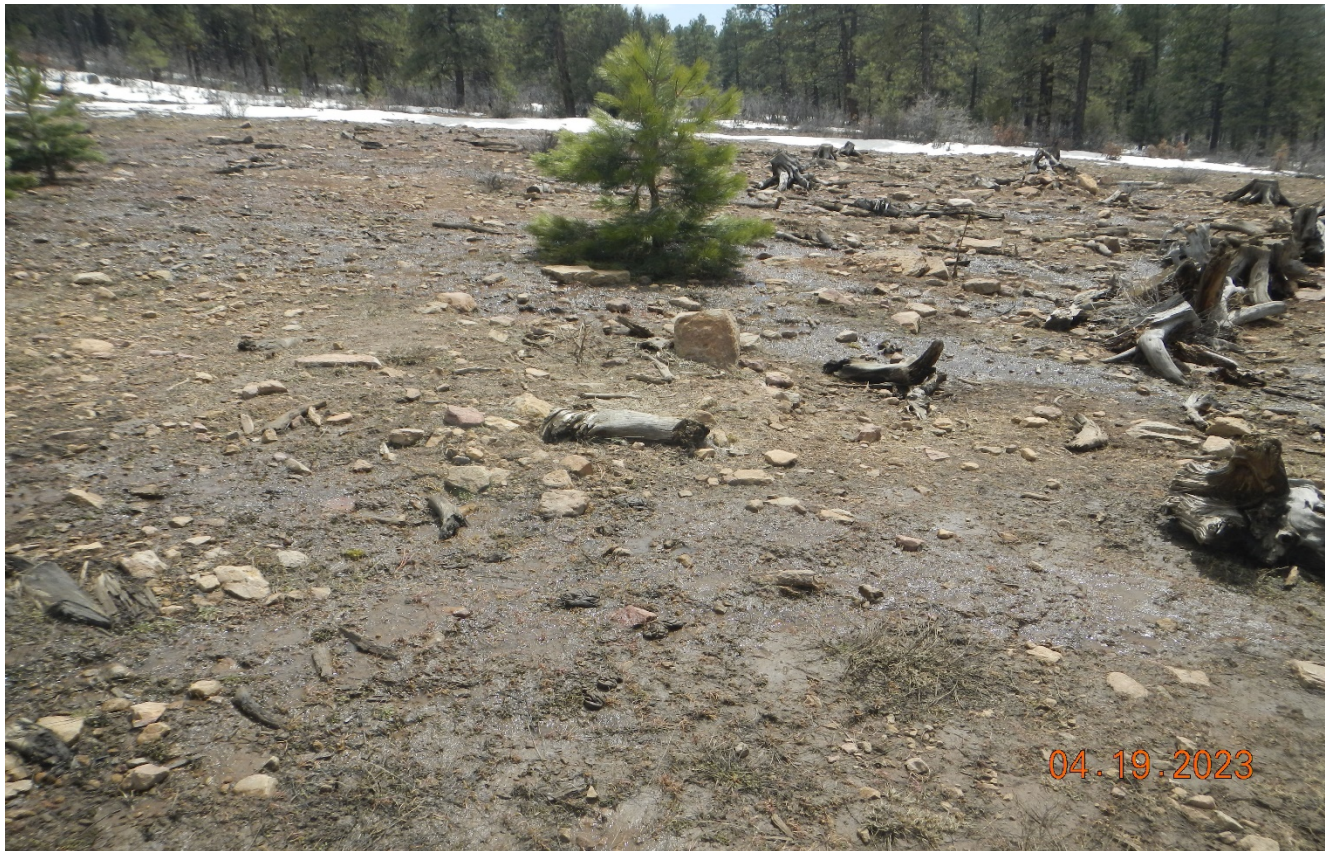
Photo 3. Facing south at the location. Numerous pine trees are growing back throughout the location.

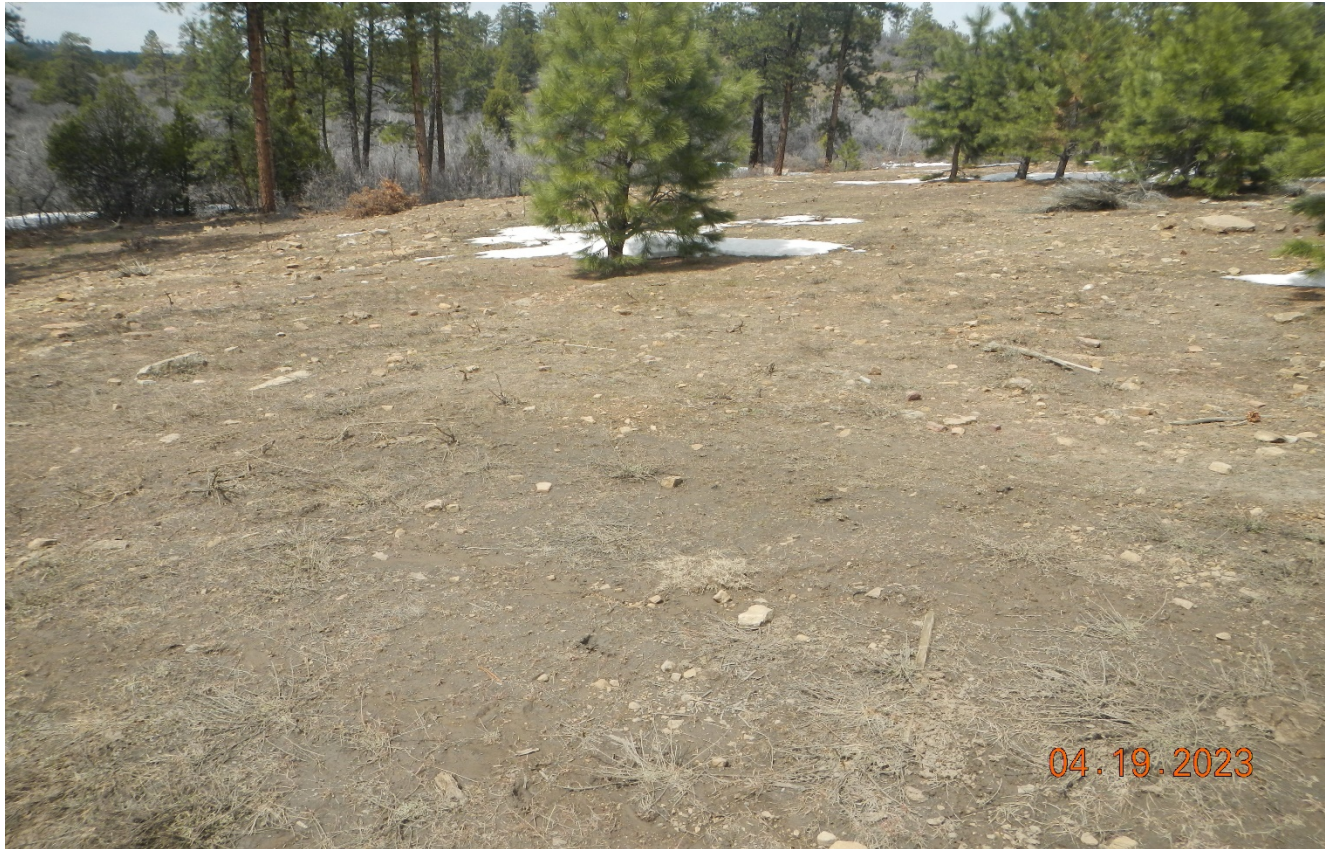
Photo 4. Facing back to the north. There are areas that have not re-established a perennial vegetation cover.
