Inspection Photos
Simcoe LLC. Albright-Trimble 2
API 067-08882

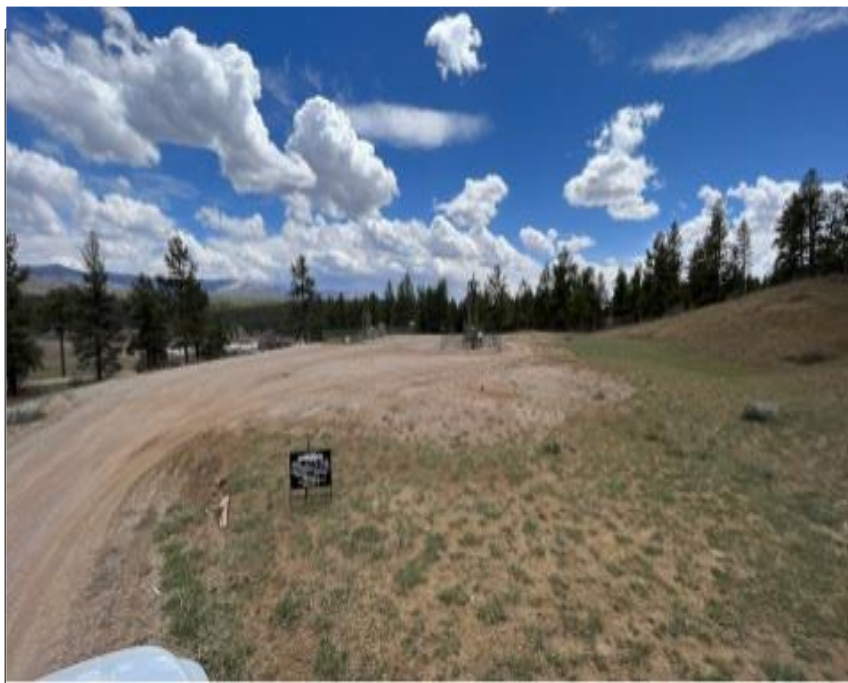
Photo #1. Overview of well location.

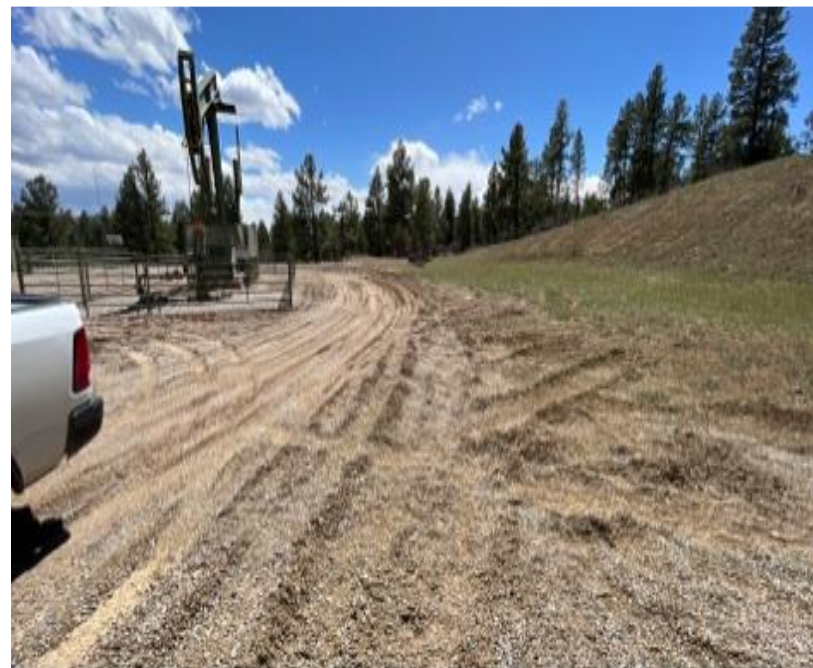
Photo #2. View of rutting on well location..
