Inspection Photos

4/24/2023

Operator: SCOUT ENERGY MANAGEMENT LLC
- 10779

Location #398964
Rio Blanco County, CO

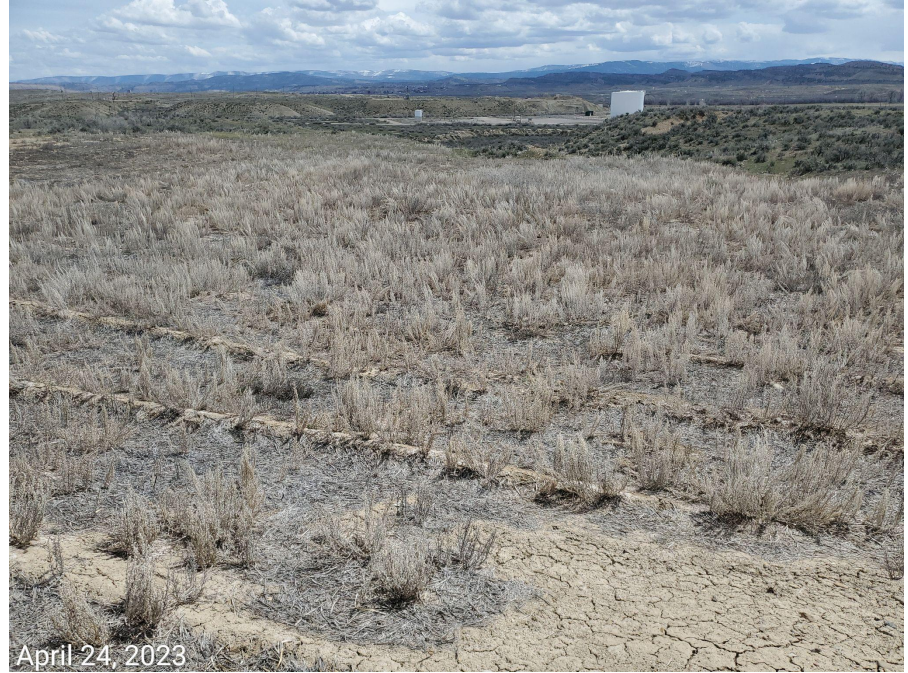
Photo 1: Photos 1-2 taken from the north end of the reclamation area (reclamation work includes both the McLaughlin 67 and 68 Locations). Photos provide an overview of the Location(s) from east, southeast, southwest to west. Vegetation observed in the photos are predominantly Undesirable Plant Species (Halogeton). Desirable plant germination/establishment not apparent.

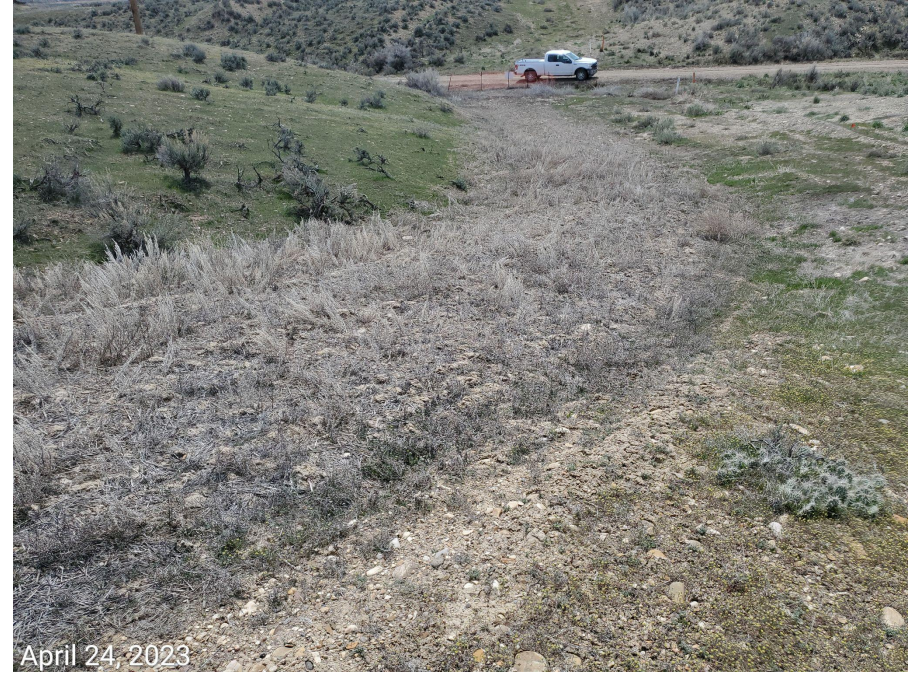
Photo 3: Photos show reclamation areas of the former access road. Vegetation observed in the photos are predominantly Undesirable Plant Species (Halogeton). Desirable plant germination/establishment not apparent.
