# Inspection Photos

4/24/2023

Operator: SCOUT ENERGY MANAGEMENT LLC  
- 10779

Location #398959  
Rio Blanco County, CO

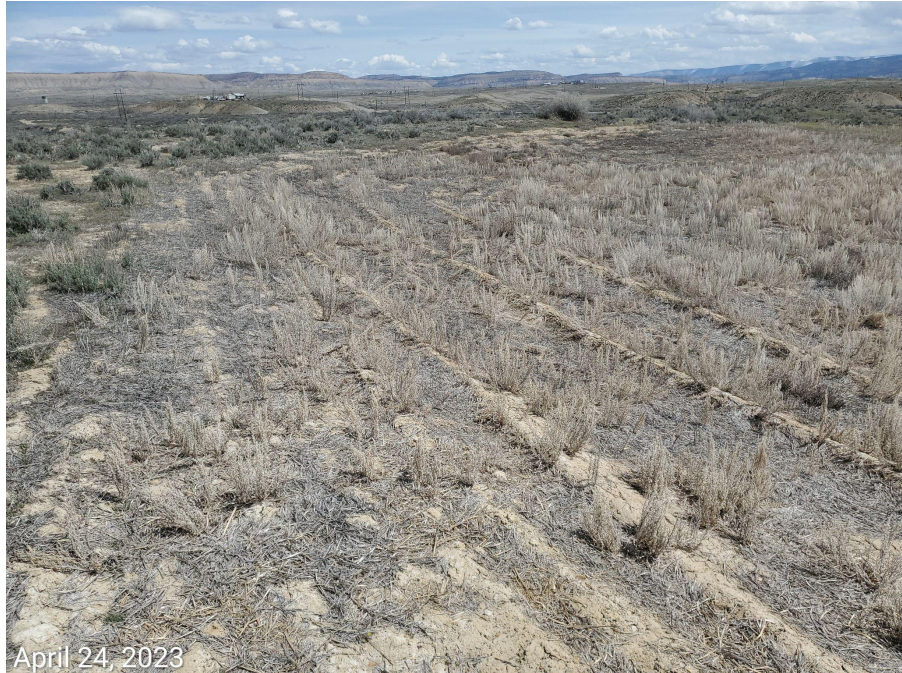
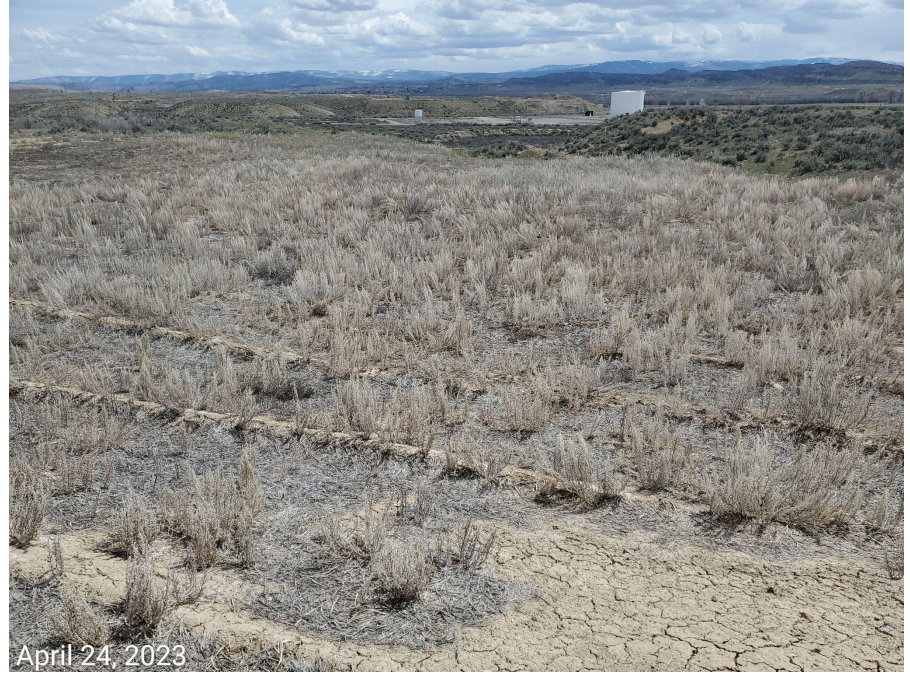
**Photo 1:** Photos 1-2 taken from the north end of the reclamation area (reclamation work includes both the McLaughlin 67 and 68 Locations). Photos provide an overview of the Location(s) from east, southeast, southwest to west. Vegetation observed in the photos are predominantly Undesirable Plant Species (Halogeton). Desirable plant germination/establishment not apparent.

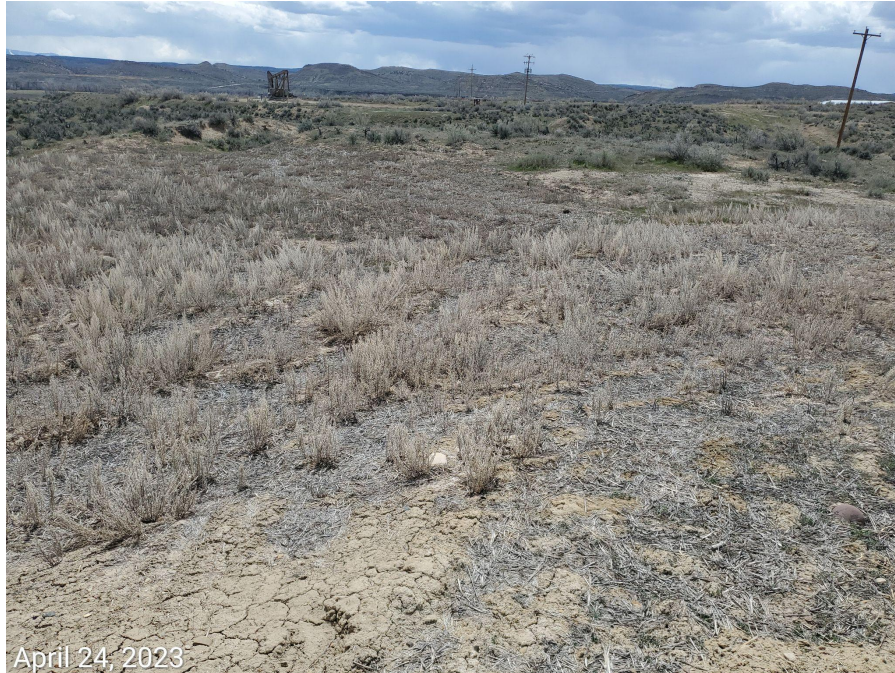
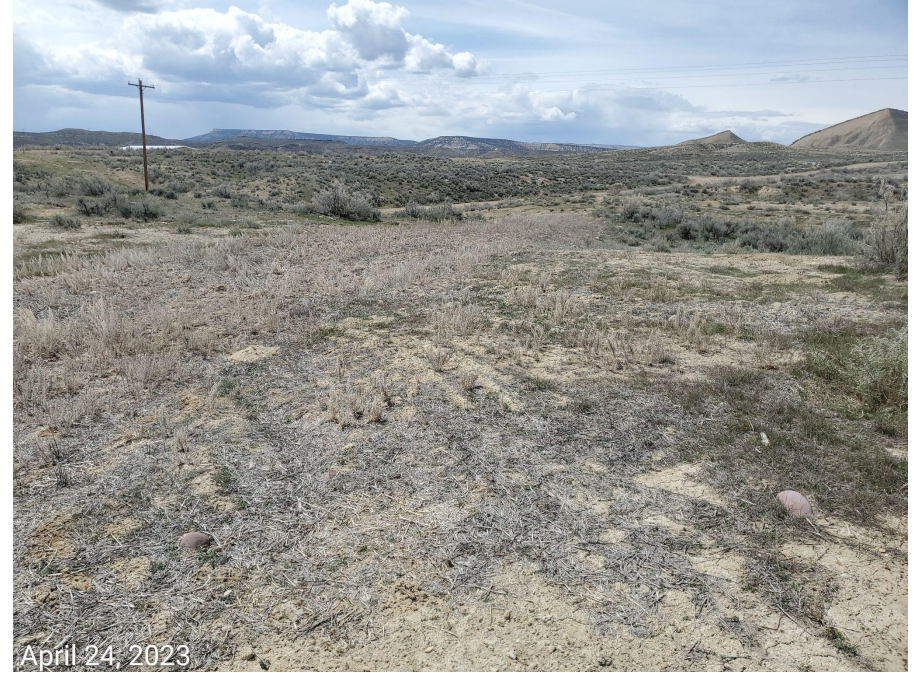
**Photo 2:** See comments under photo 1.

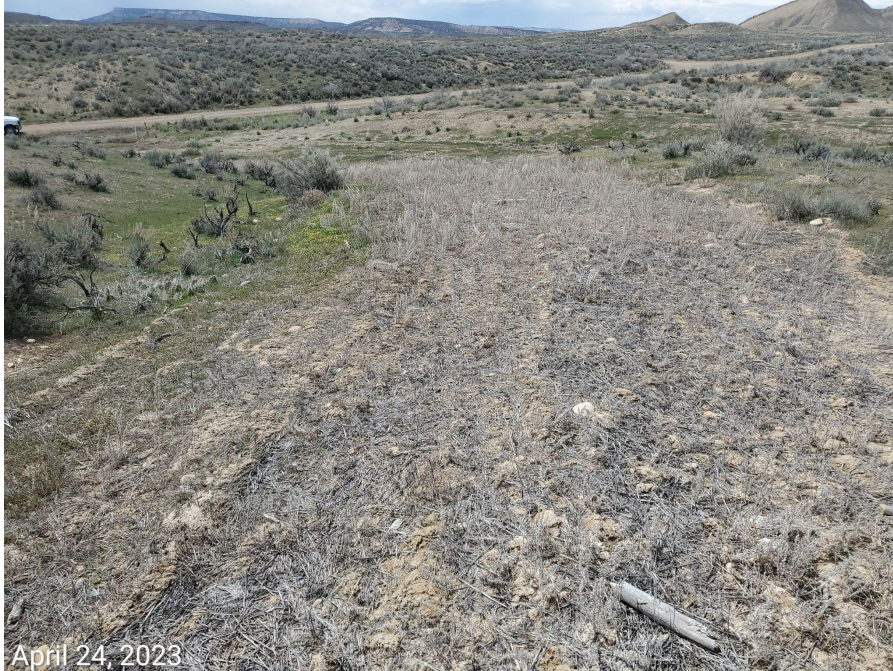
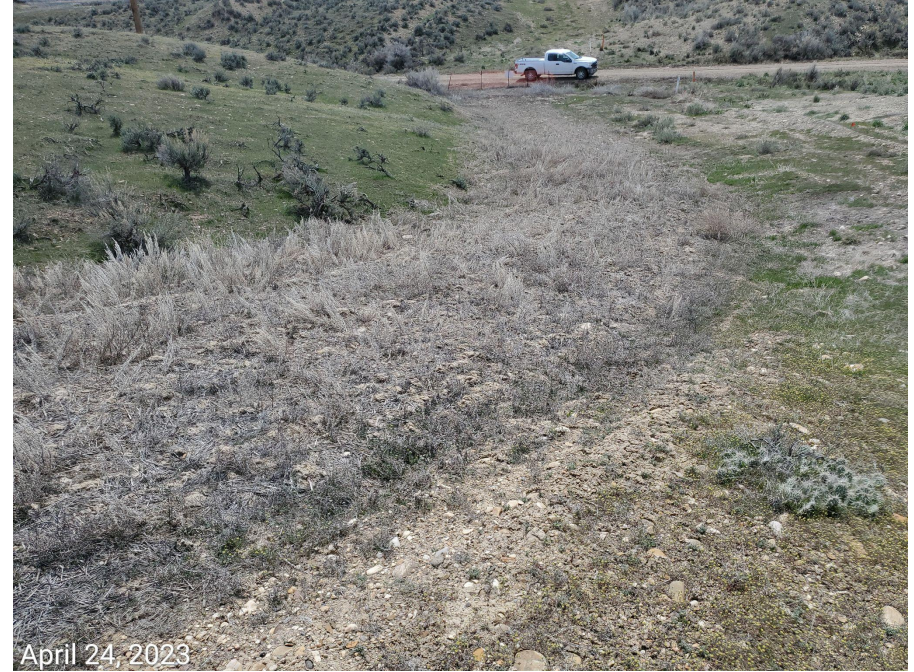
**Photo 3:** Photos show reclamation areas of the former access road. Vegetation observed in the photos are predominantly Undesirable Plant Species (Halogeton). Desirable plant germination/establishment not apparent.

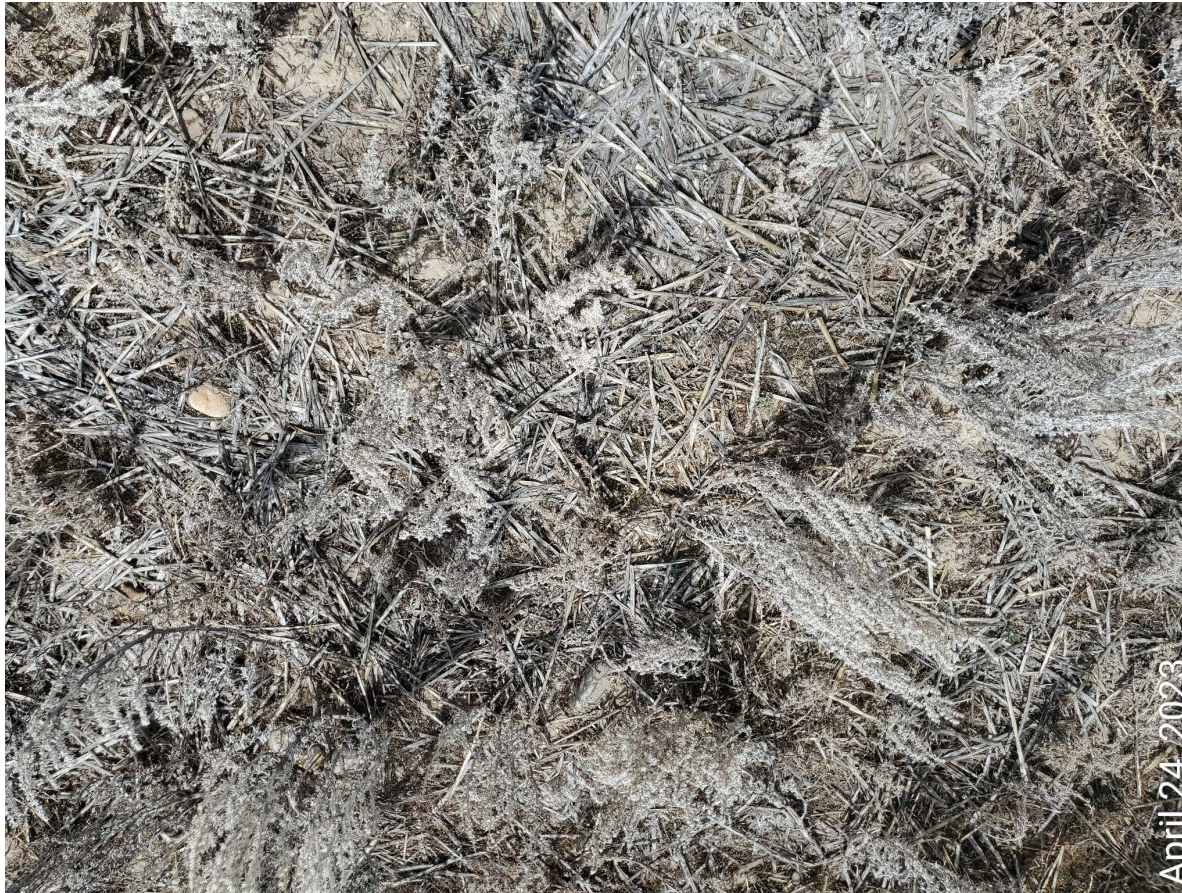
**Photo 4:** Reclaimed Location surface. Vegetation observed in the are predominantly Undesirable Plant Species (Halogeton). Desirable plant germination/establishment not apparent.
