Inspection Photos

Location Name: TEP ROCKY MOUNTAIN LLC CLOUGH 135 Pad

Location ID: 322438

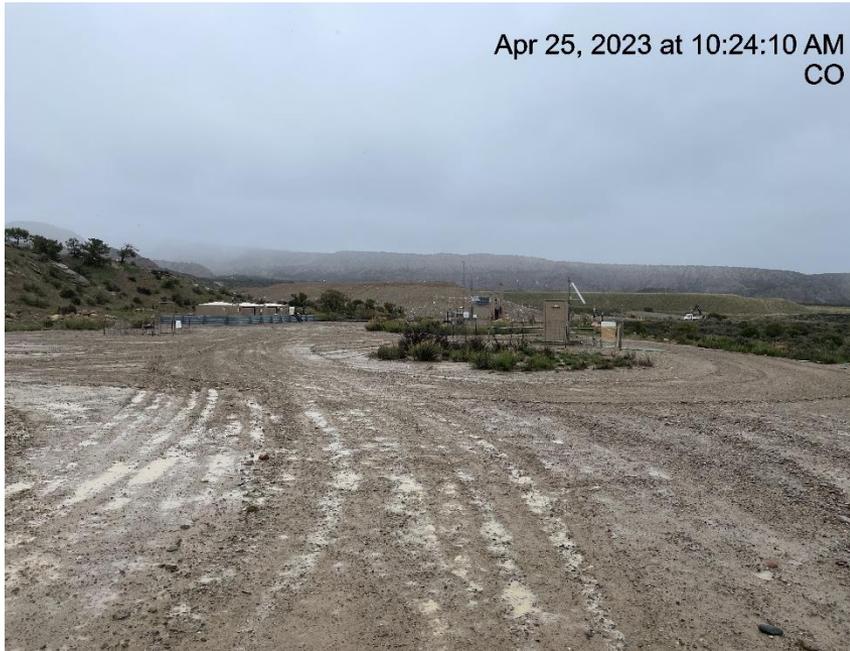
Photo # 6301 From entrance to location

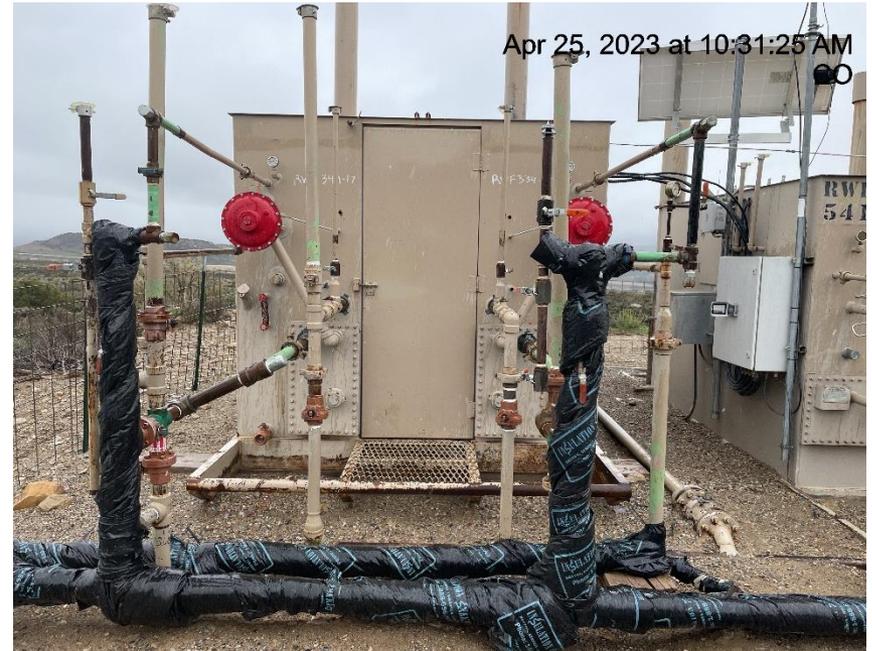
Photo # 6310 Meter calibration info not conspicuously posted

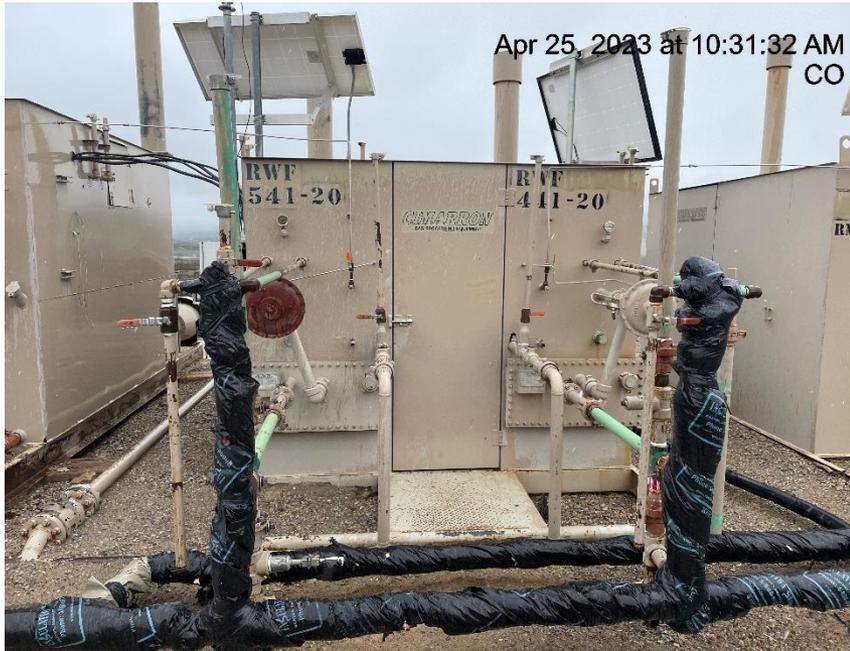
Photo # 6311 Meter calibration info not conspicuously posted

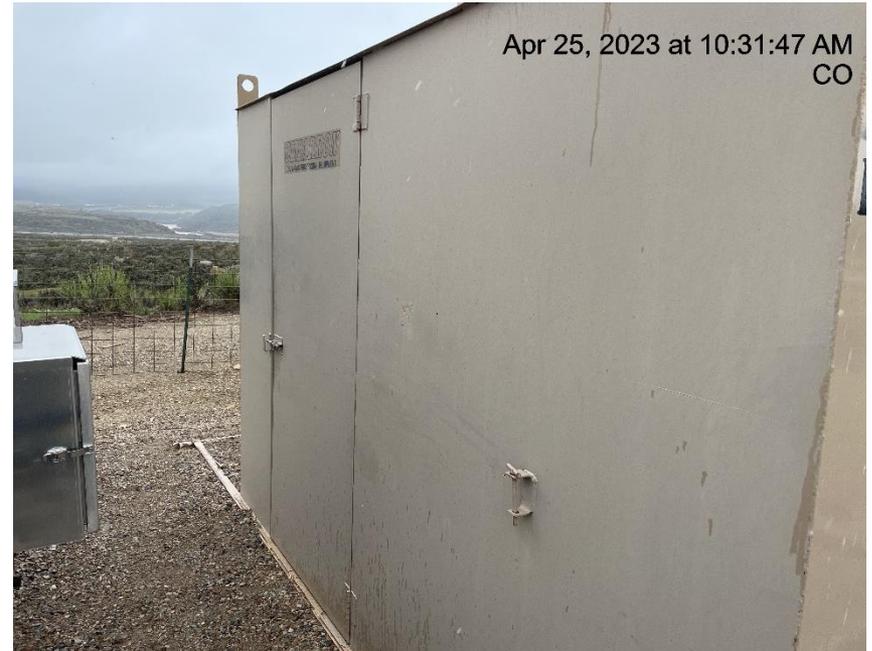
Photo # 6312 Meter calibration info not conspicuously posted

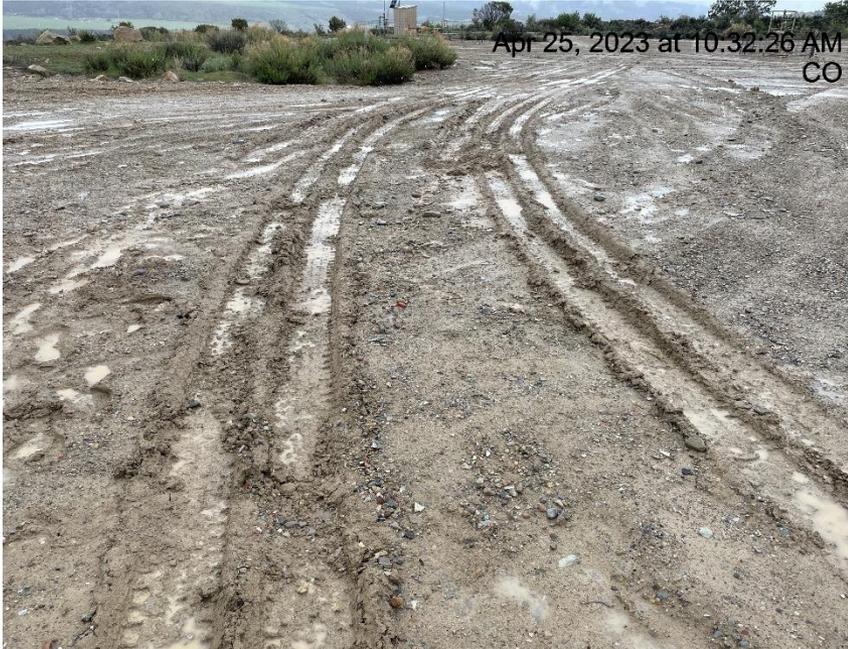
Photo # 6313 Lack of stabilization/compaction

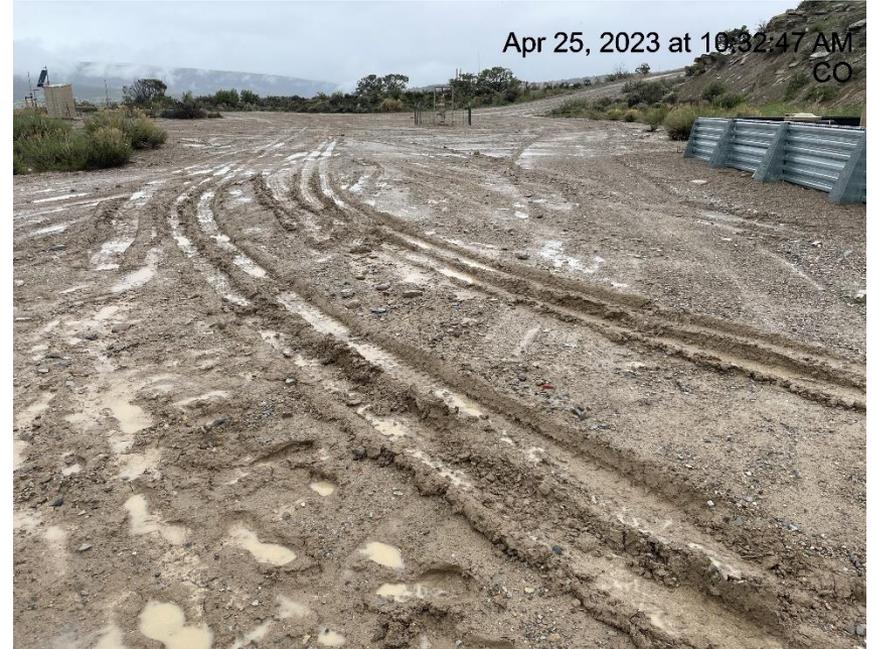
Photo # 6314 Lack of stabilization/compaction

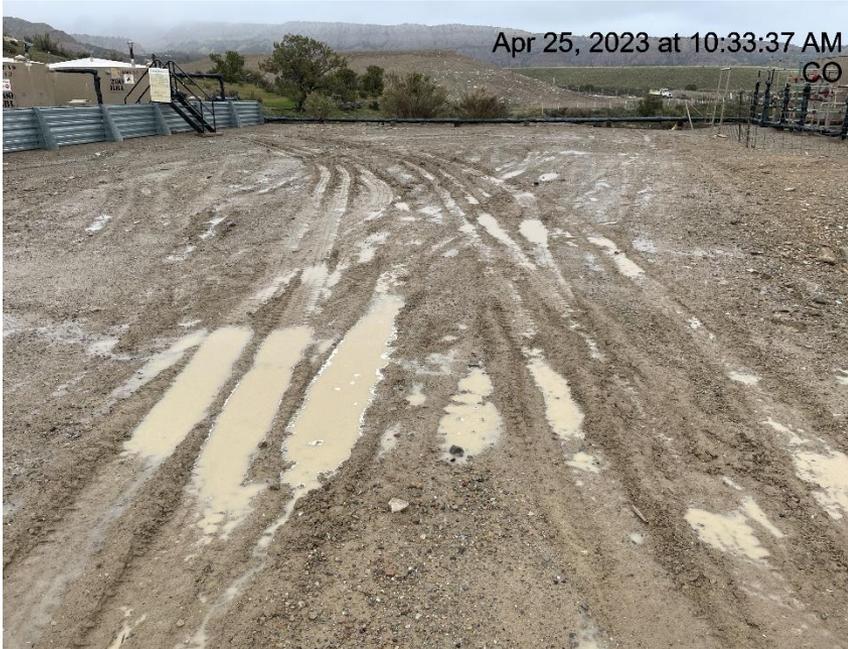
Photo # 6316 Lack of stabilization/compaction

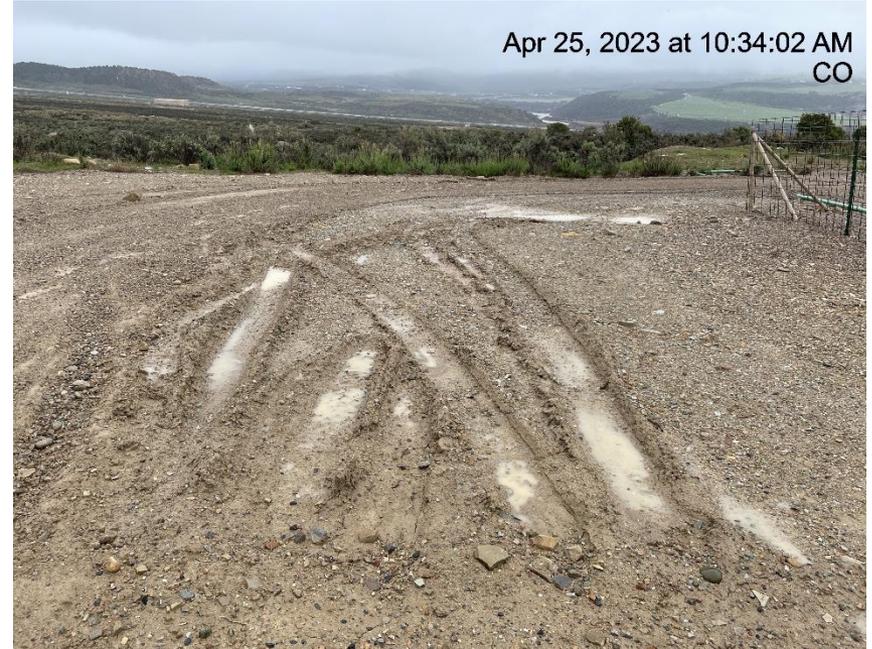
Photo # 6317 Lack of stabilization/compaction

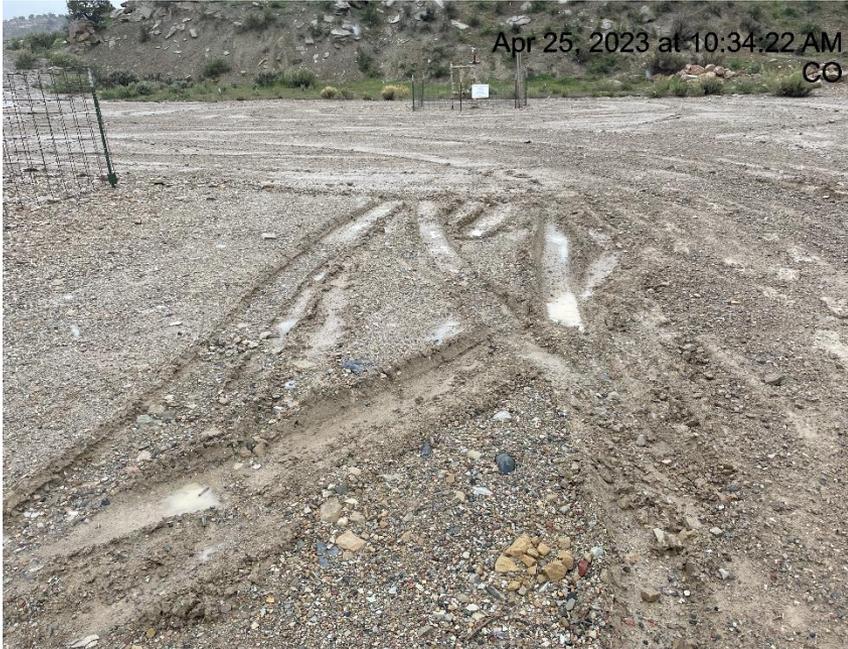
Photo # 6318 Lack of stabilization/compaction

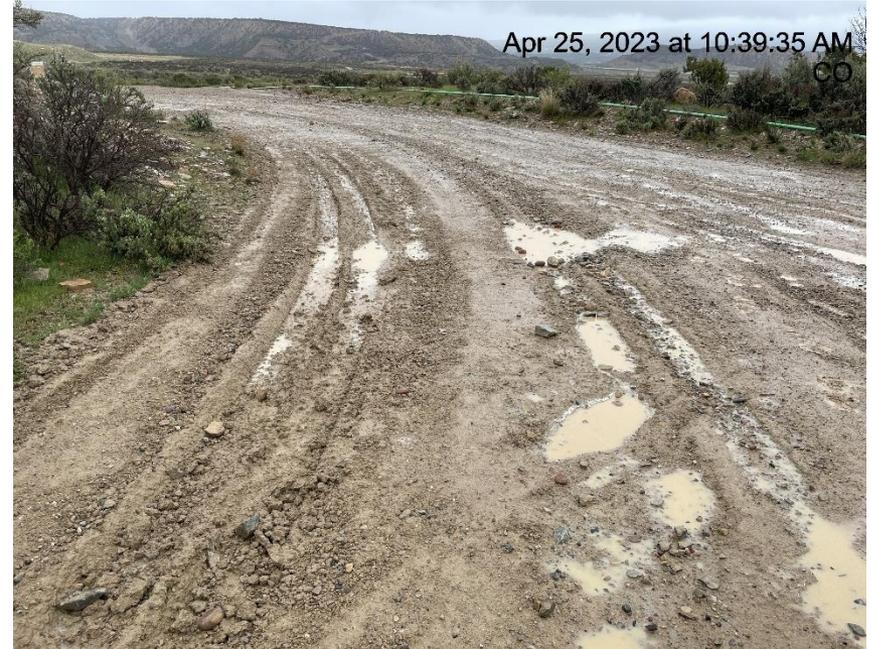
Photo # 6333 Lack of stabilization/compaction

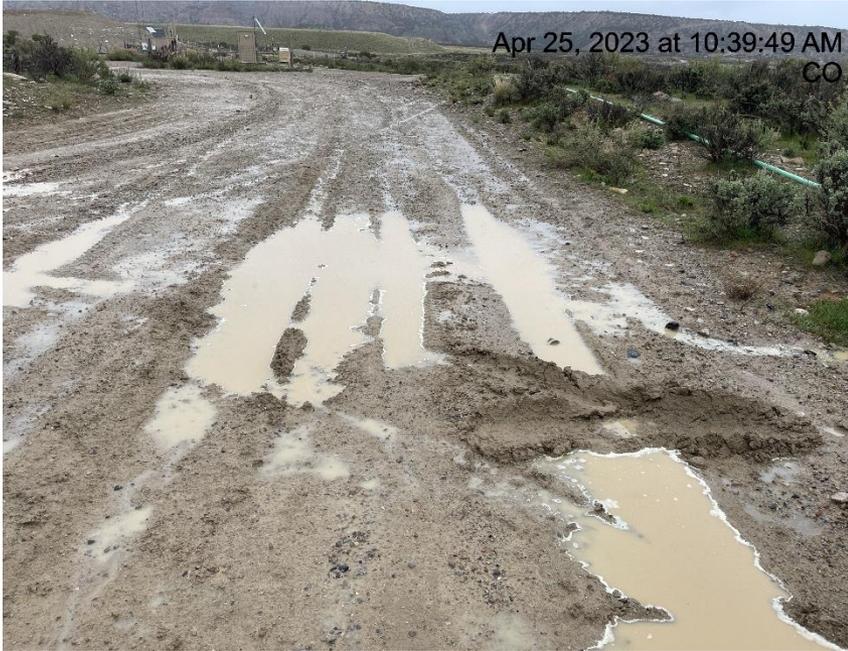
Photo # 6334 Lack of stabilization/compaction

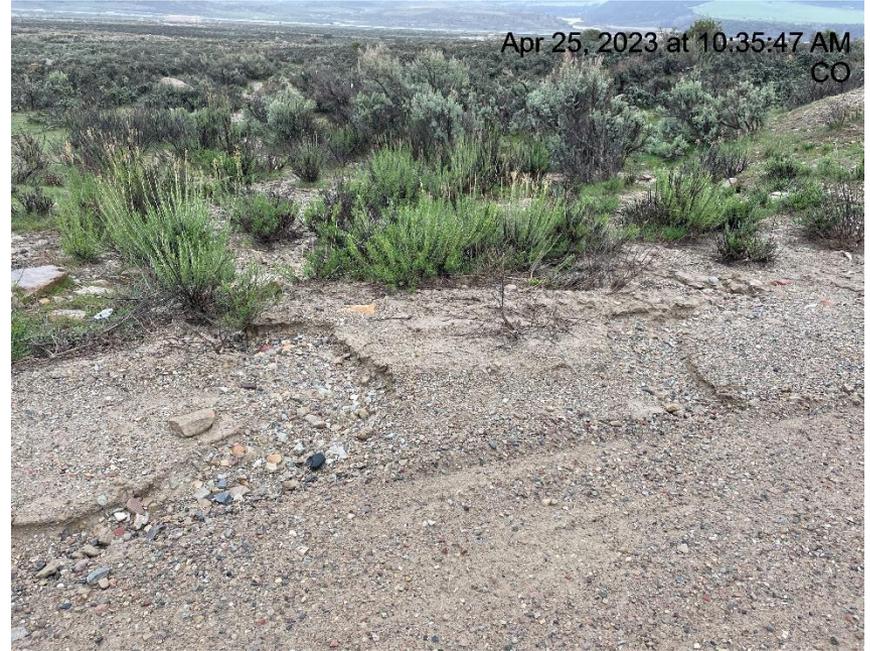
Photo # 6321 Erosion & transport of sediment off location

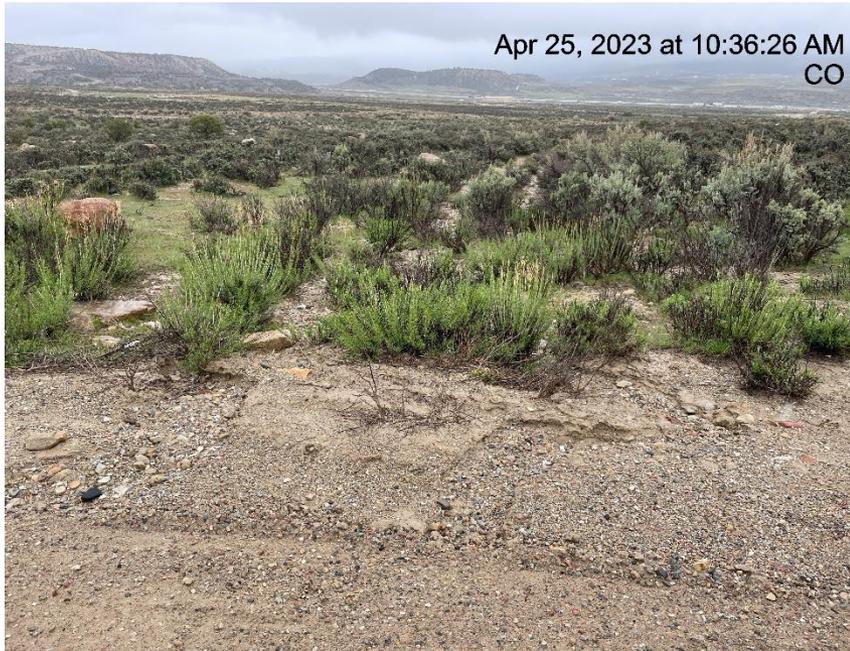
Photo # 6323 Erosion & transport of sediment off location

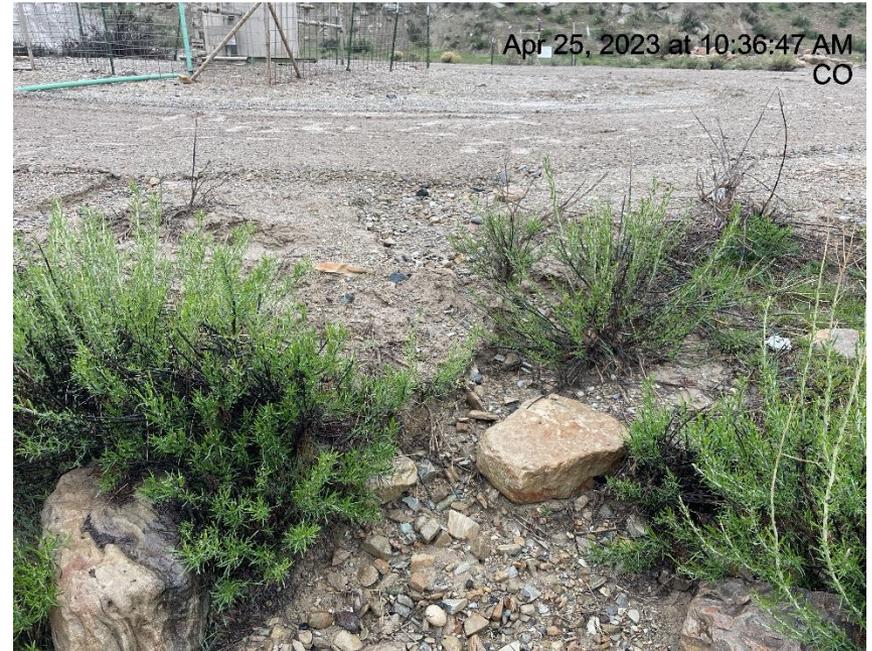
Photo # 6324 Erosion & transport of sediment off location

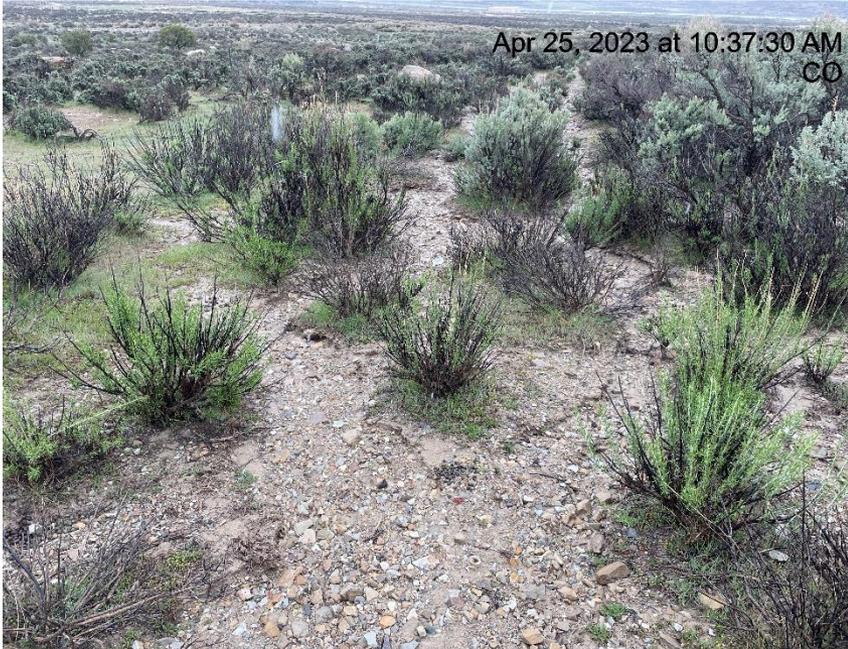
Photo # 6327 Erosion & transport of sediment off location

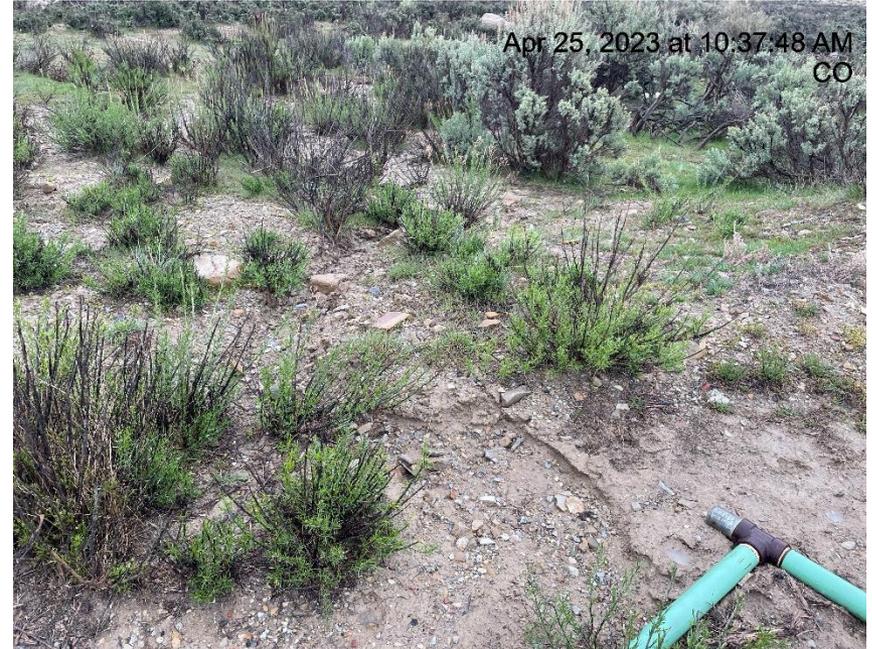
Photo # 6328 Erosion & transport of sediment off location

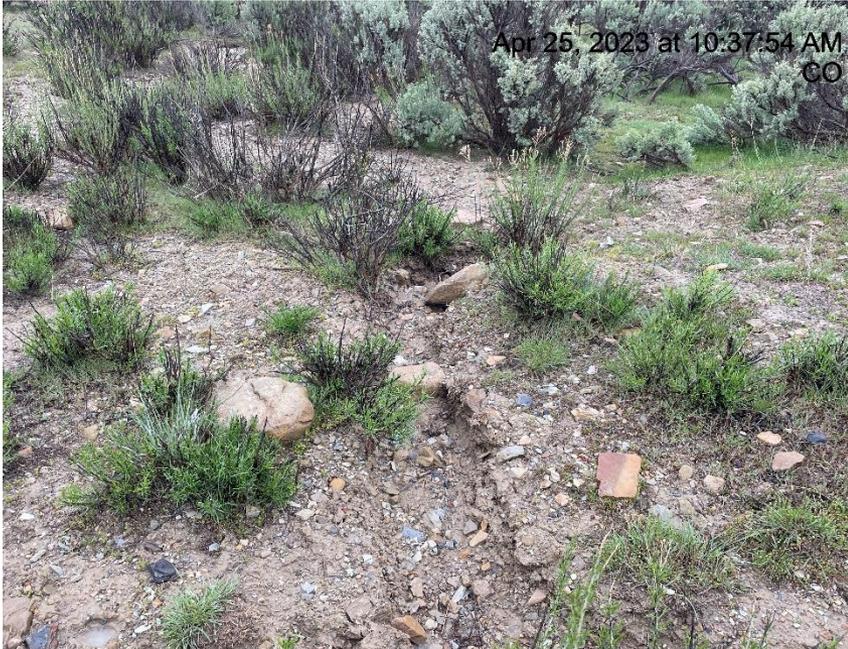
Photo # 6329 Erosion & transport of sediment off location

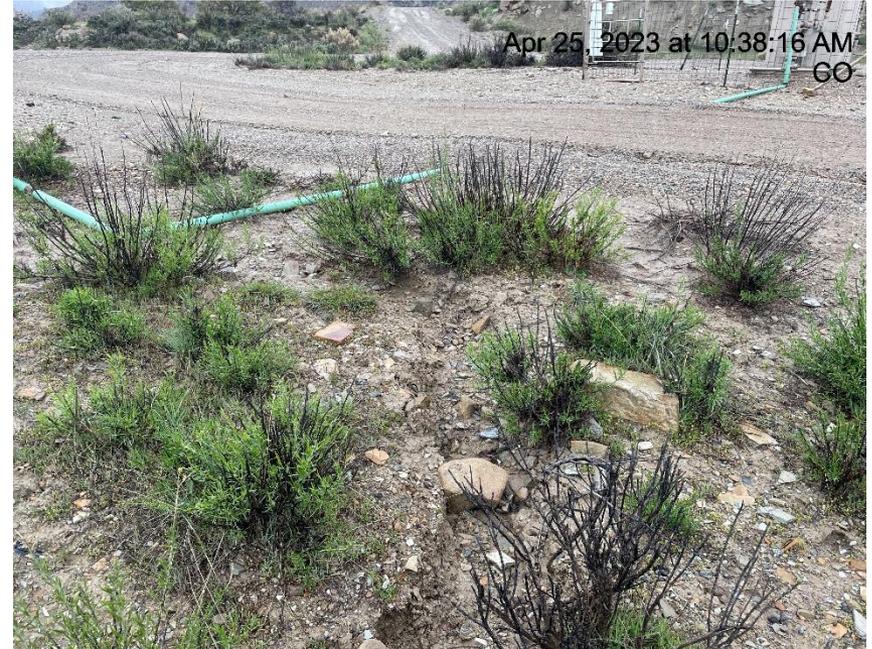
Photo # 6330 Erosion & transport of sediment off location

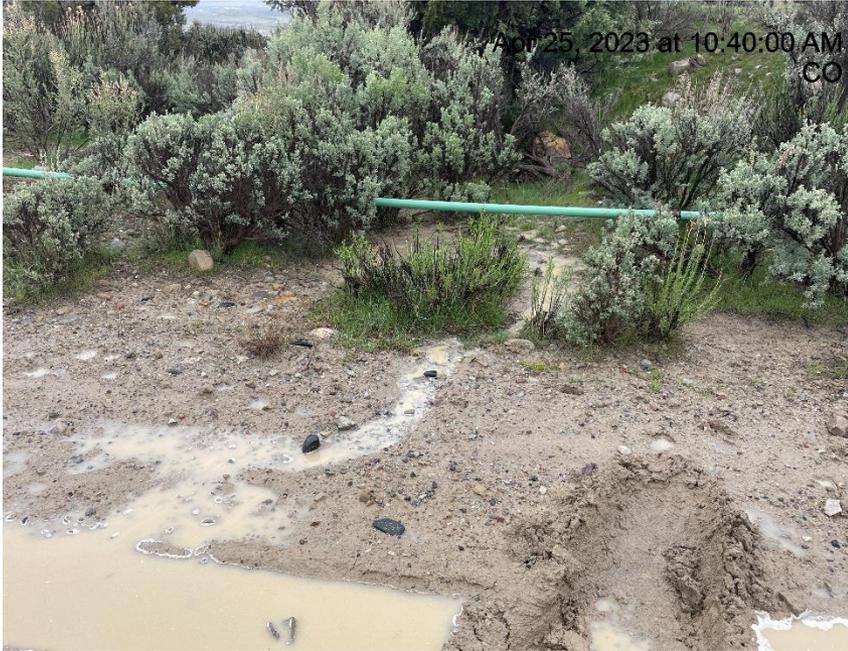
Photo # 6335 Erosion & transport of sediment off location

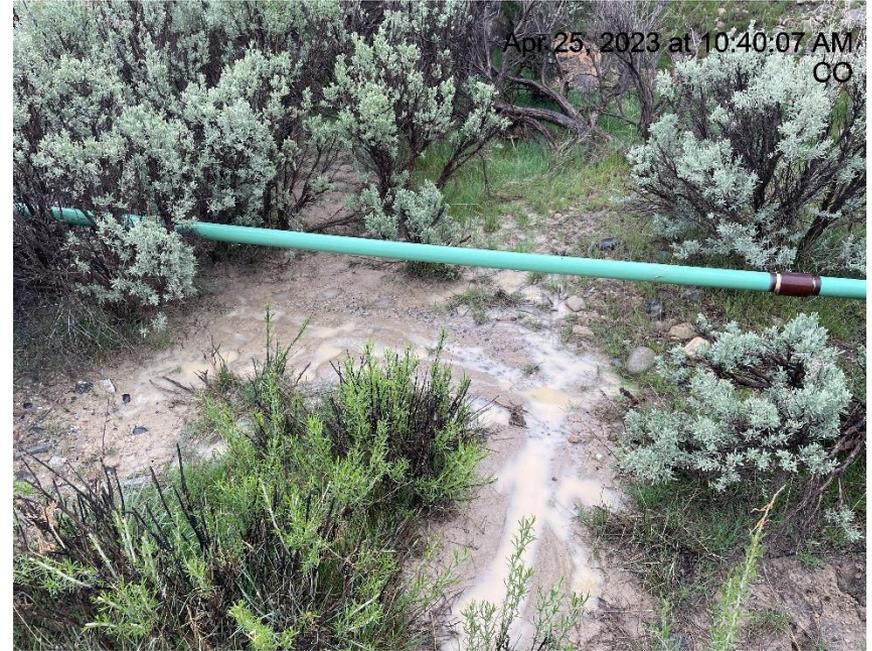
Photo # 6336 Erosion & transport of sediment off location
