Inspection Photos
Petrox Candelaria 33-5 #10-1
API 007-06278

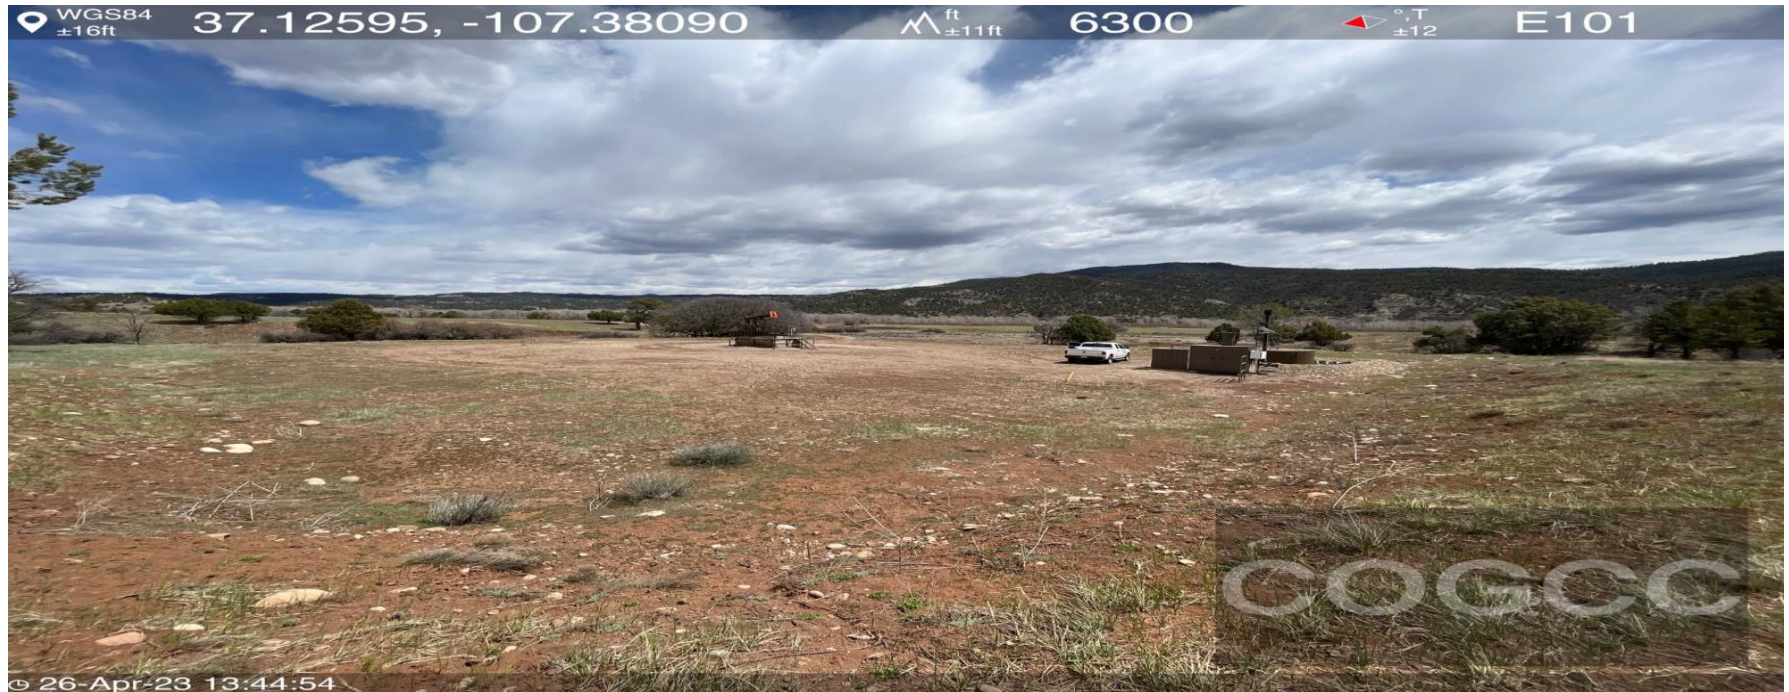
Photo #1. Overview of well location.

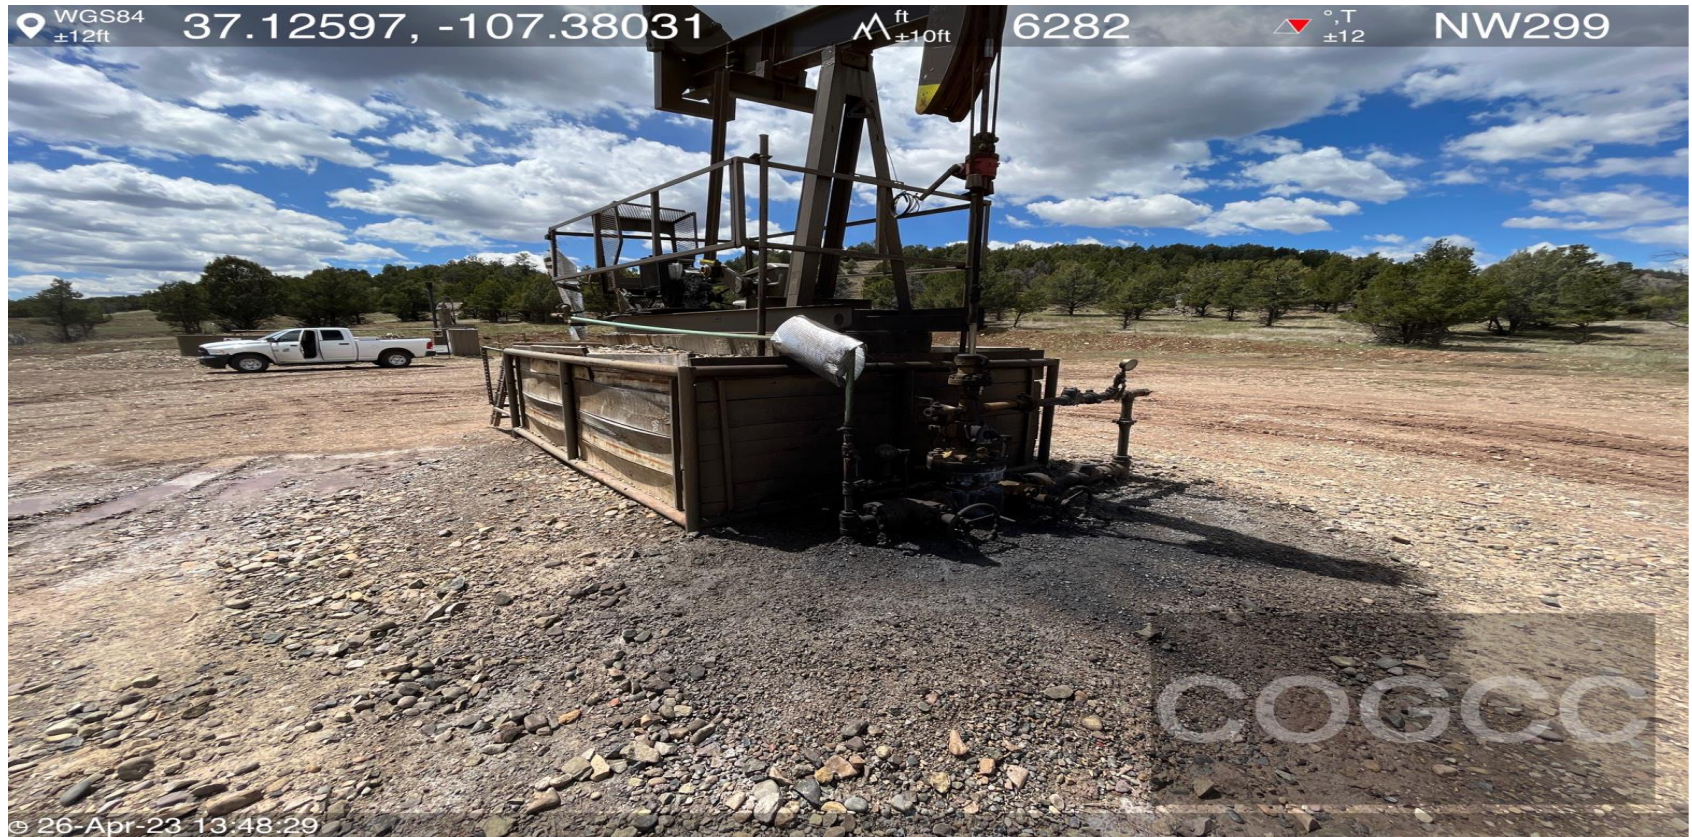
Photo #2. Wellhead spill and impacted material.

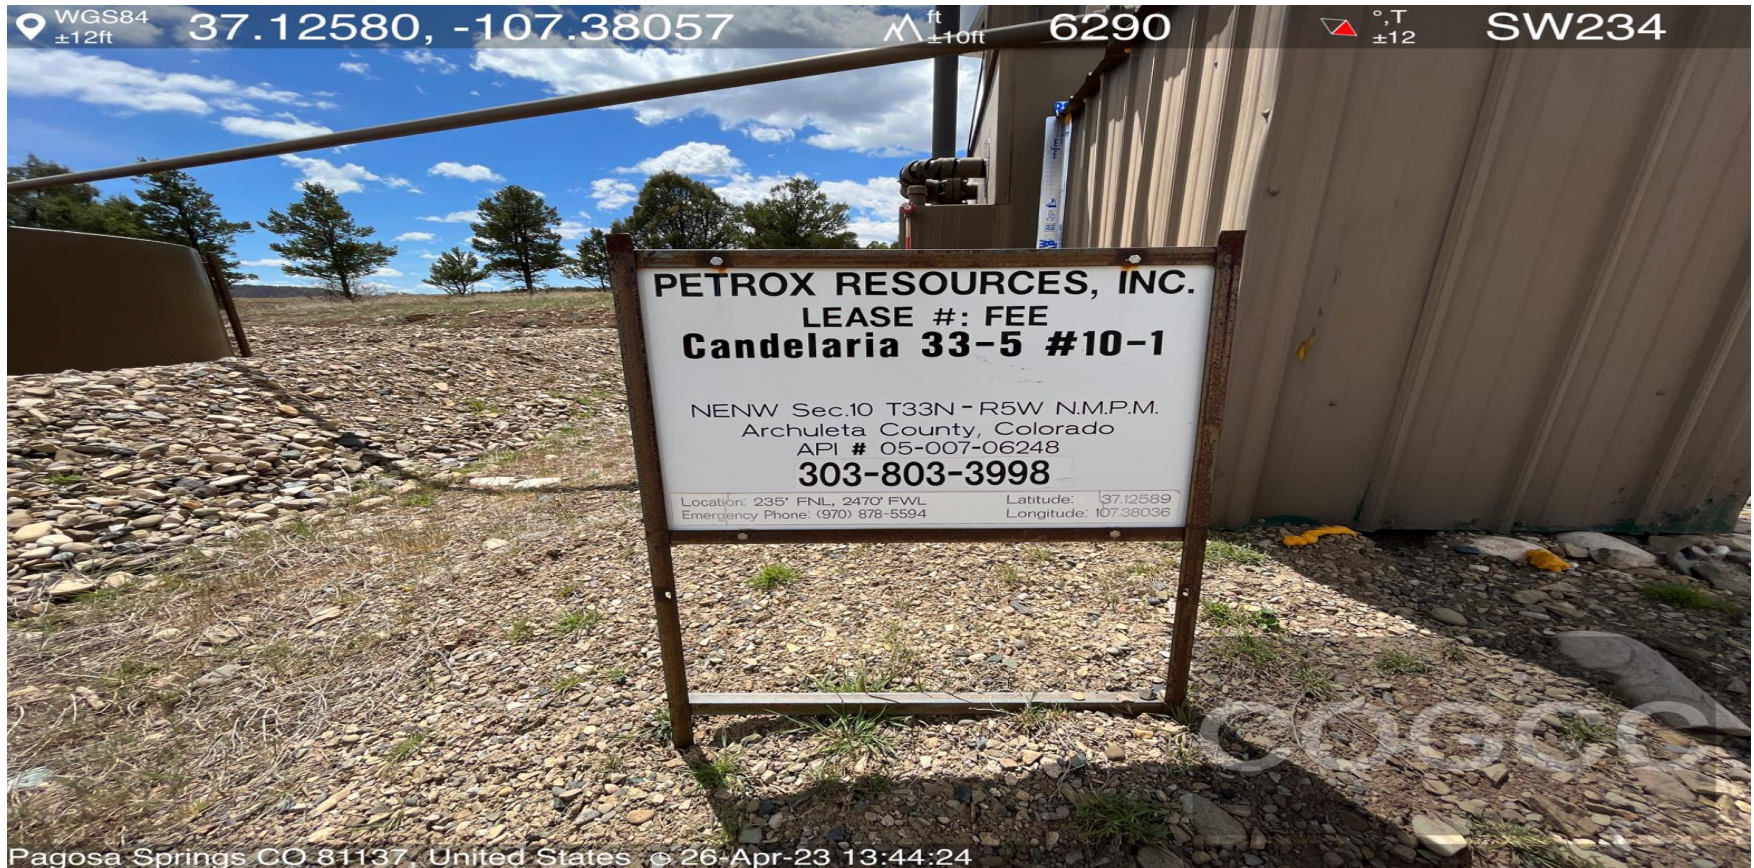
Photo #4. Wellhead sign with incorrect API number.
