Inspection Photos
Location Name: Raindance FC 20-362HNX
API #: 05-123-44987

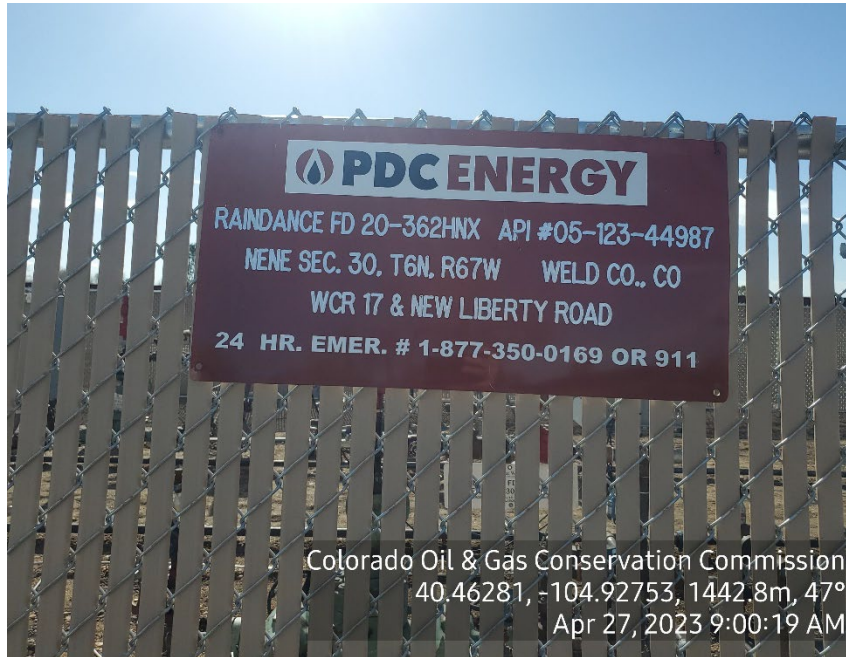
Photo 1: Wellhead Sign

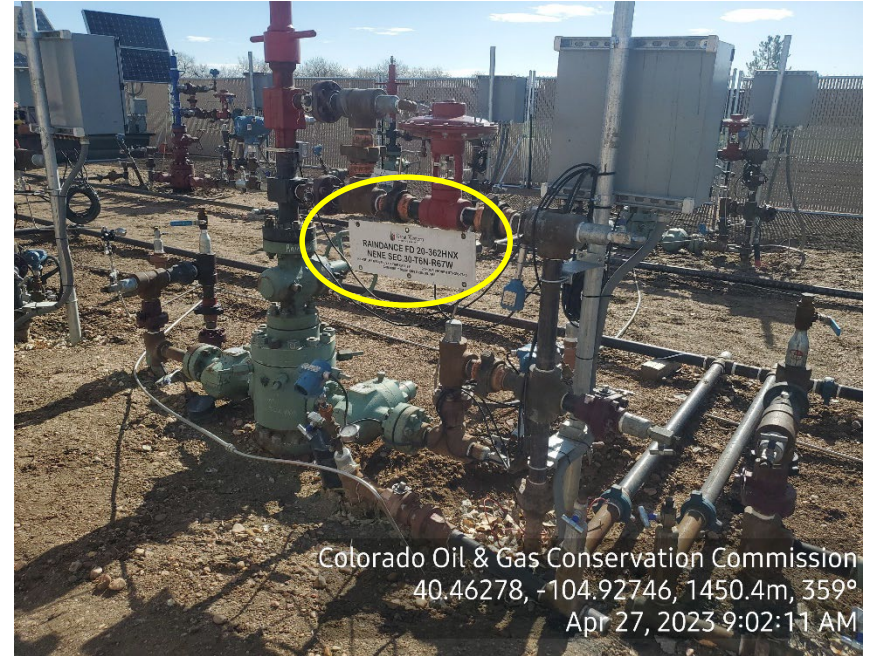
Photo 2: Wellhead, previous operator signage

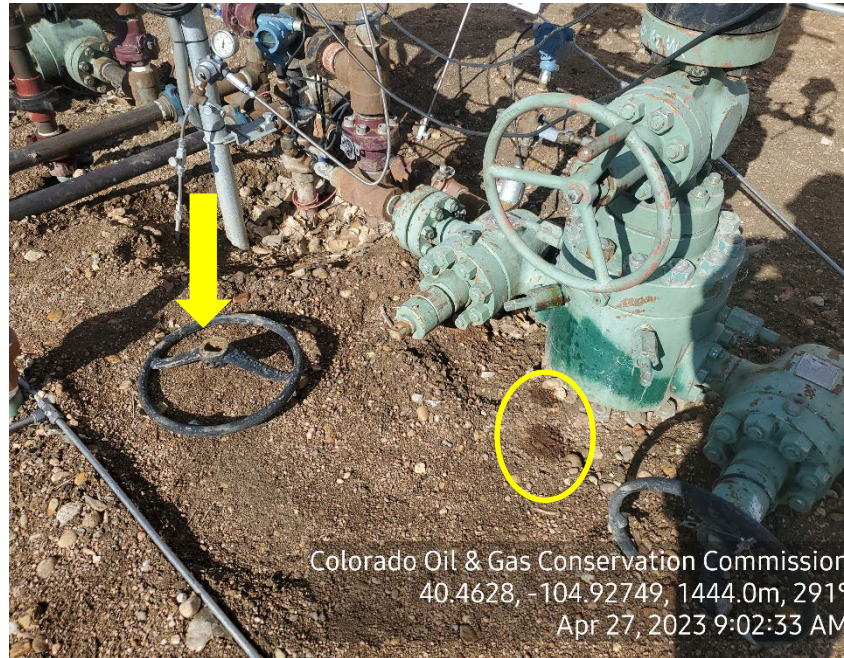
Photo 3: Stained soil, unused/disconnected equipment
