Inspection Photos

Location Name: Raindance FD 20-319 HNX

API #: 05-123-44990

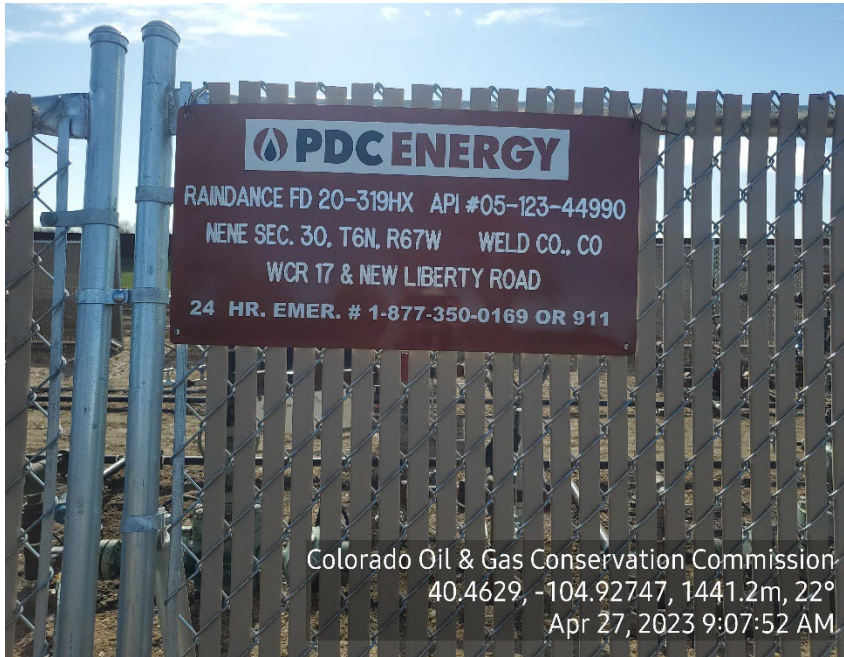
Photo 1: Wellhead Sign

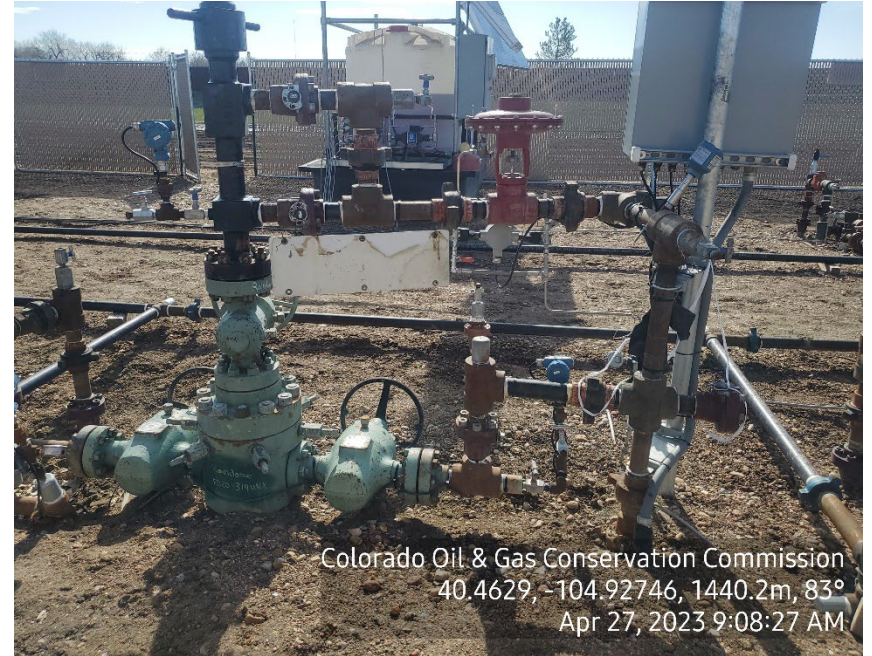
Photo 2: Wellhead

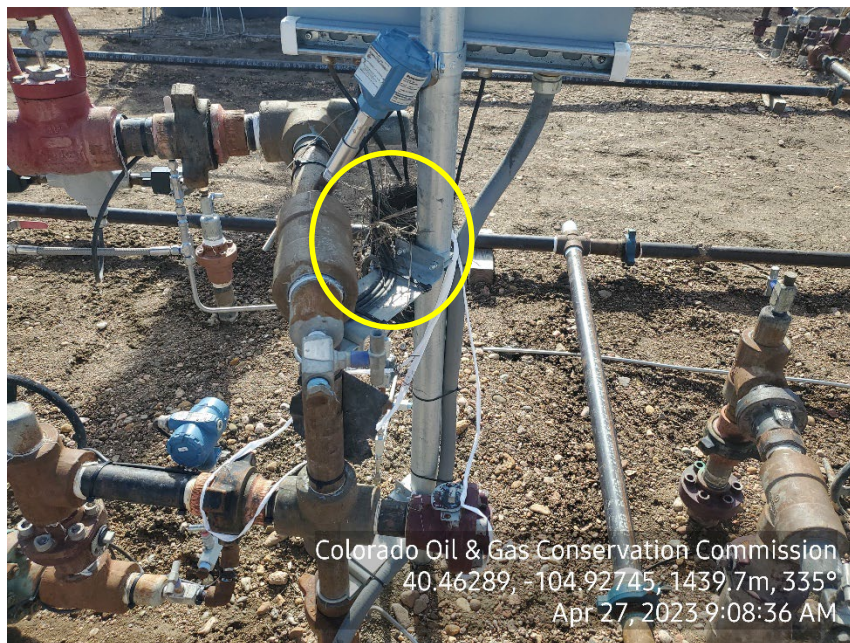
Photo 3: Debris (birds nest)

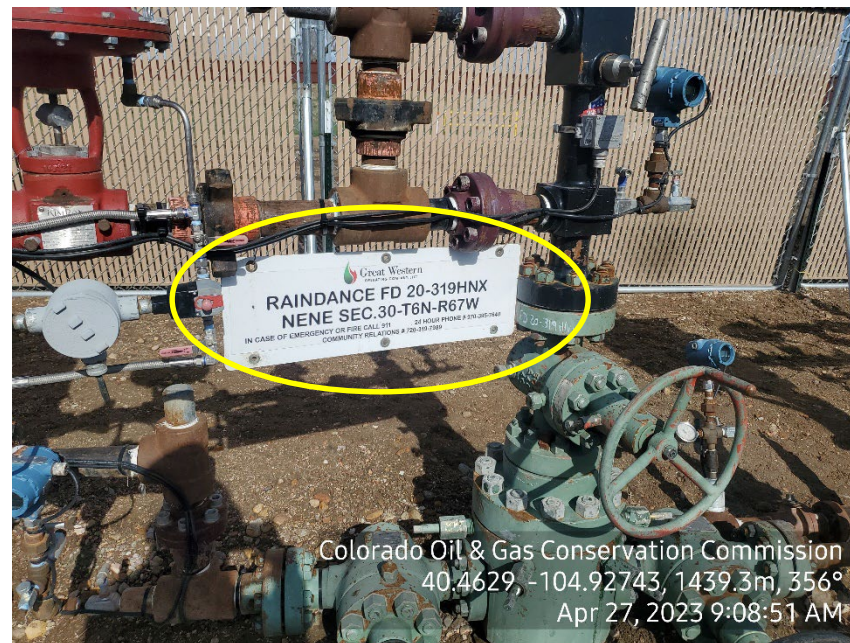
Photo 4: Previous operator signage
