Inspection Photos

Loc: 322108

Operator: FOUR CORNERS ENERGY LLC

Inspection Date: 4/19/2023

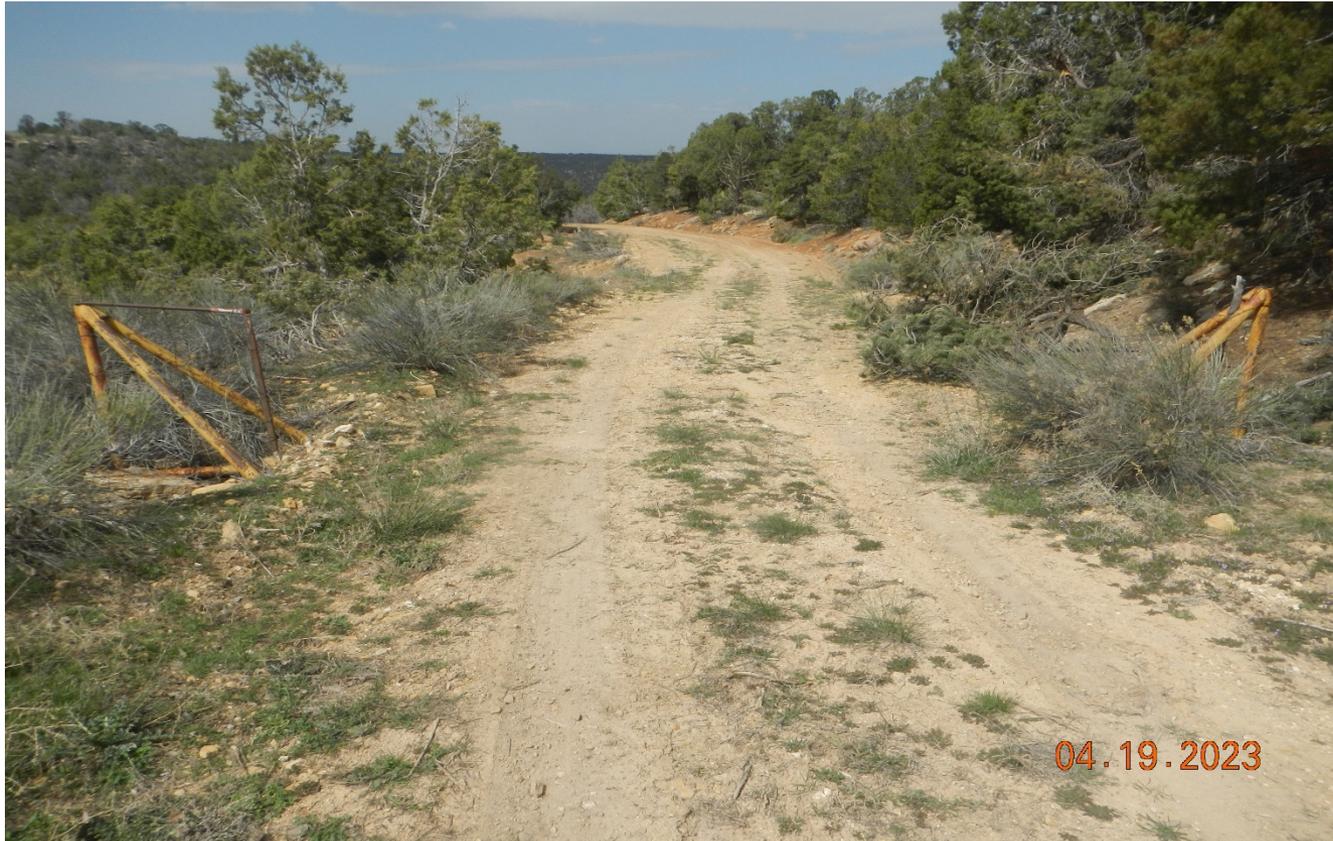
Photo 1. Facing west along the access road. There is a cattleguard that is filled in with sediment and has not been removed. There is also another cattleguard further down the road that remains.

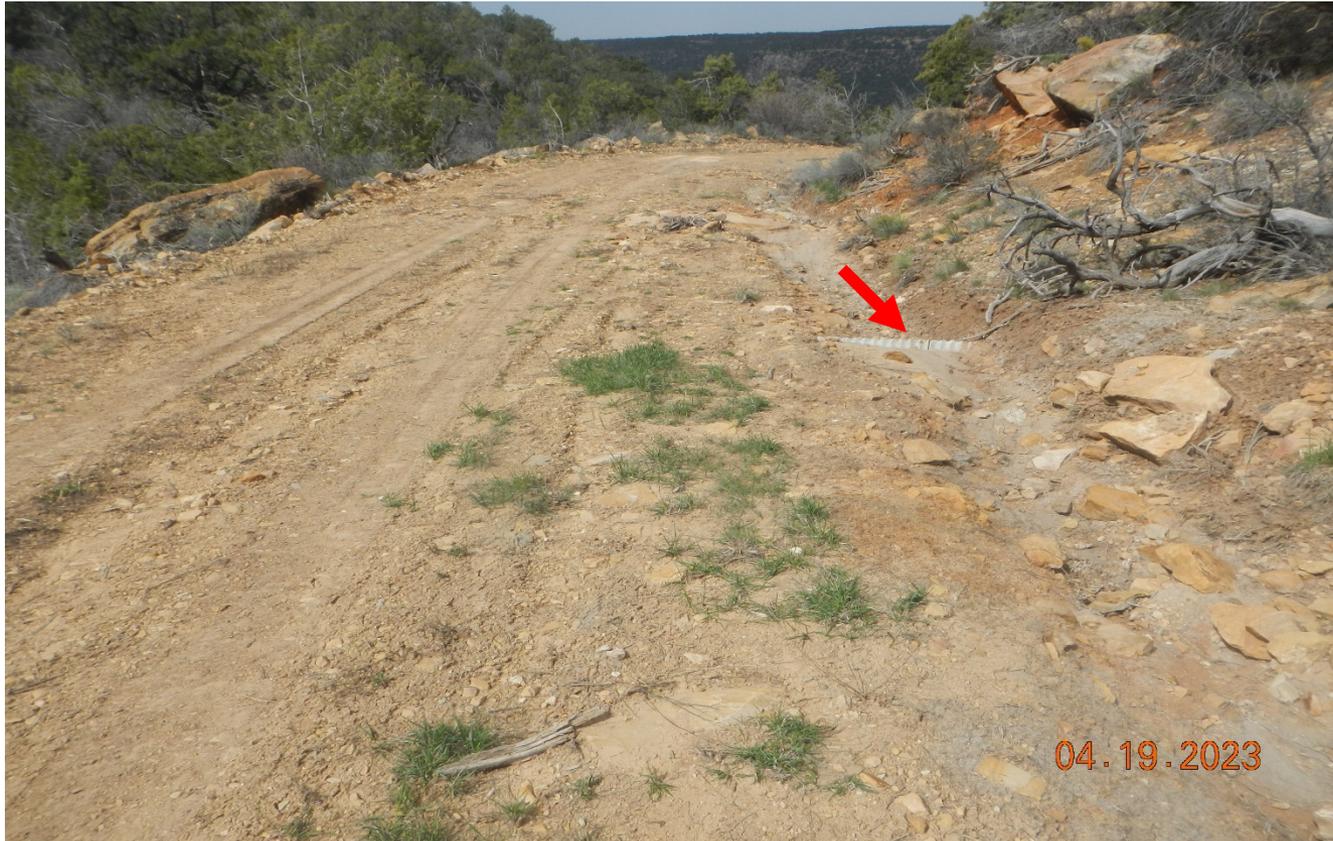
Photo 2. Facing west along the access road. There are culverts along the road that are filled in with sediment. Red arrow shows culvert filled in with sediment.

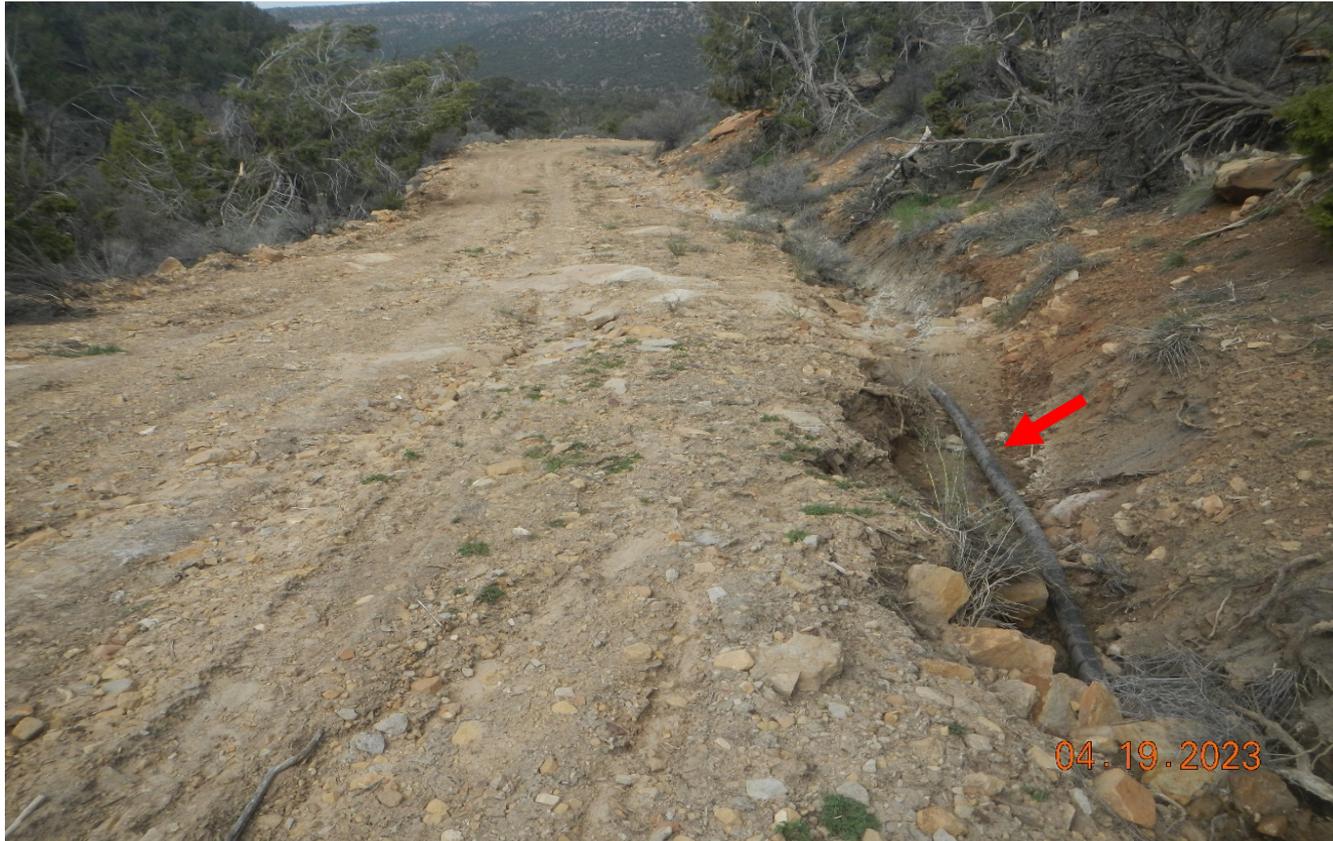
Photo 3. Further west down the road there is exposed flowline shown at red arrow from erosion cutting a deep channel into the road side.

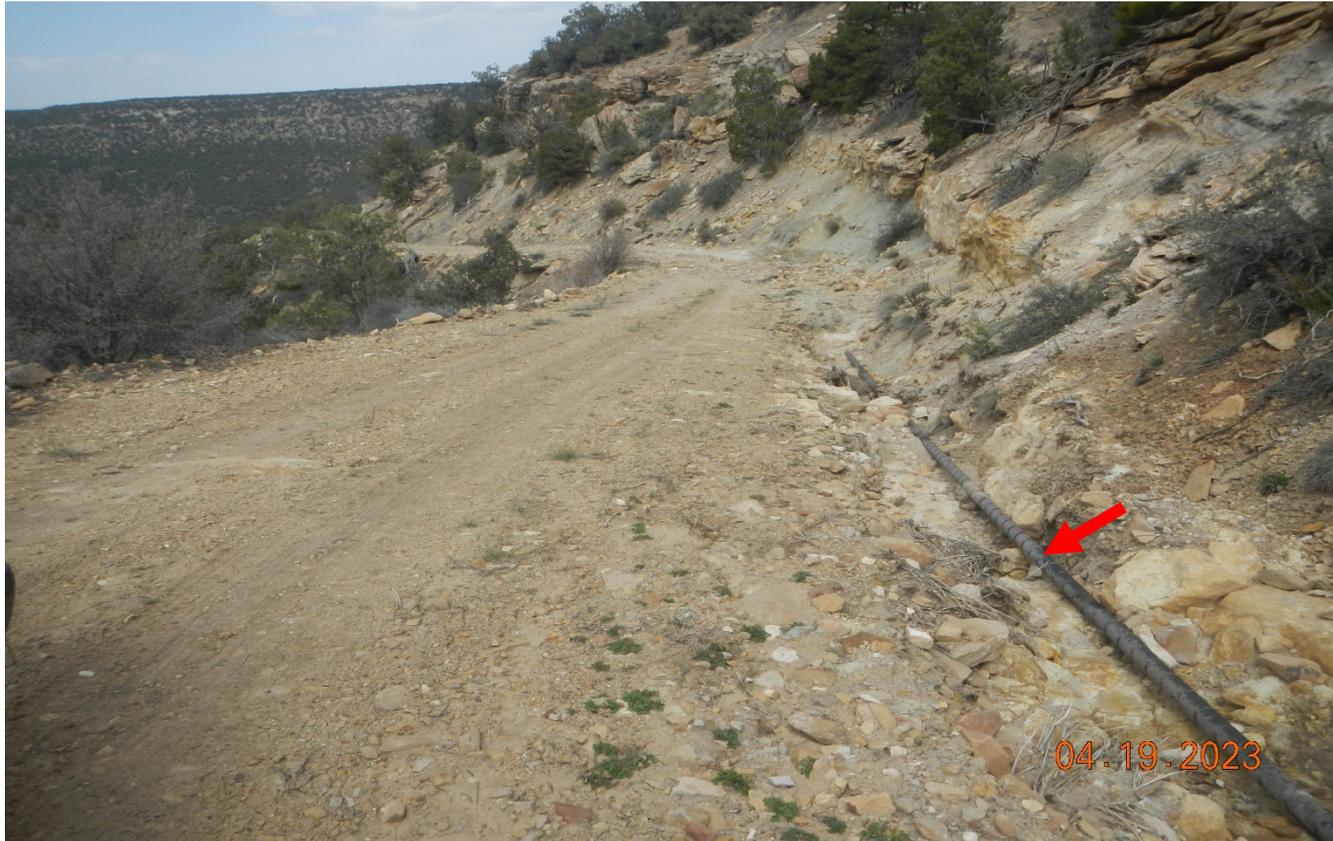
Photo 4. Further west down the road there is exposed flowline shown at red arrow from erosion cutting a deep channel into the road side.

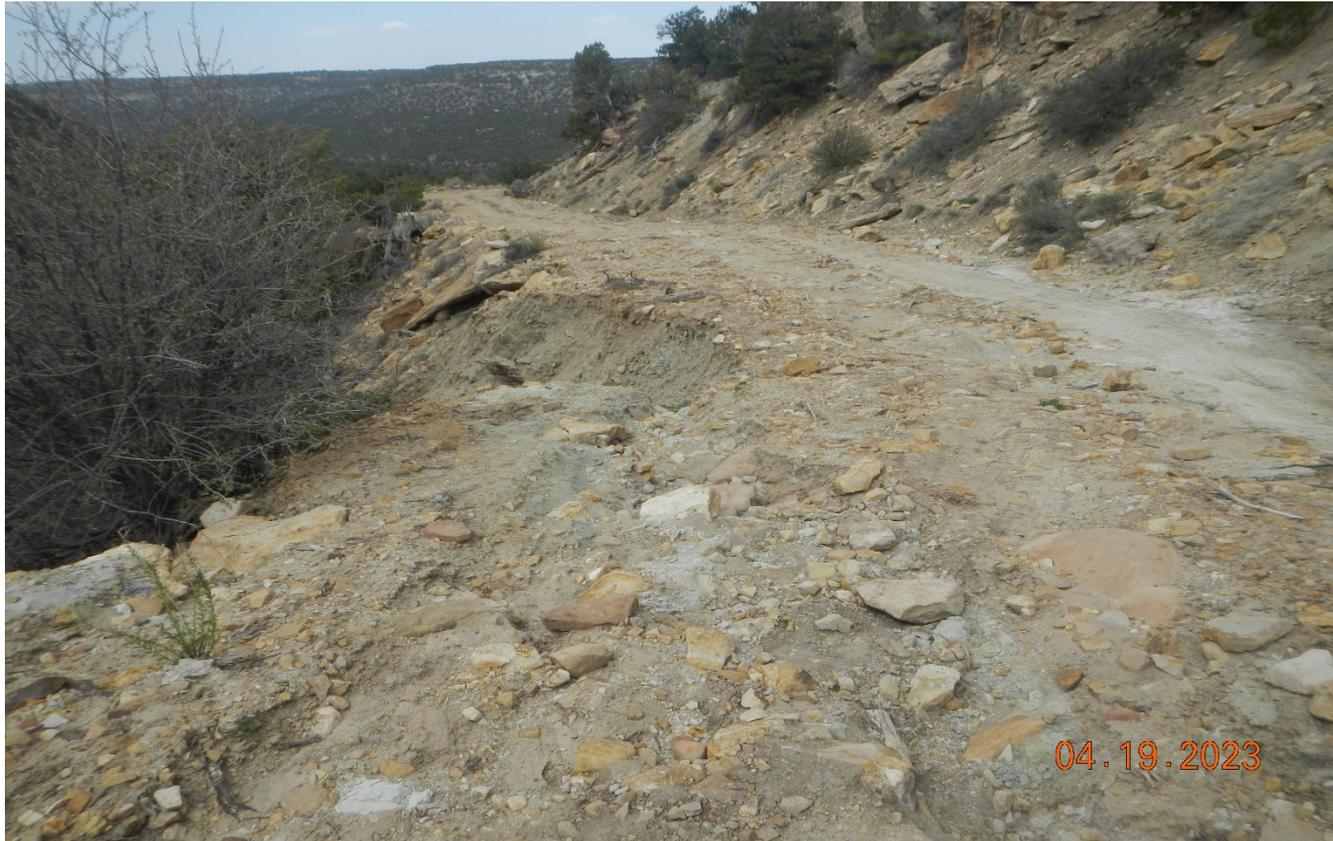
Photo 5. Facing west along the road. The road side is being washed out in this area.

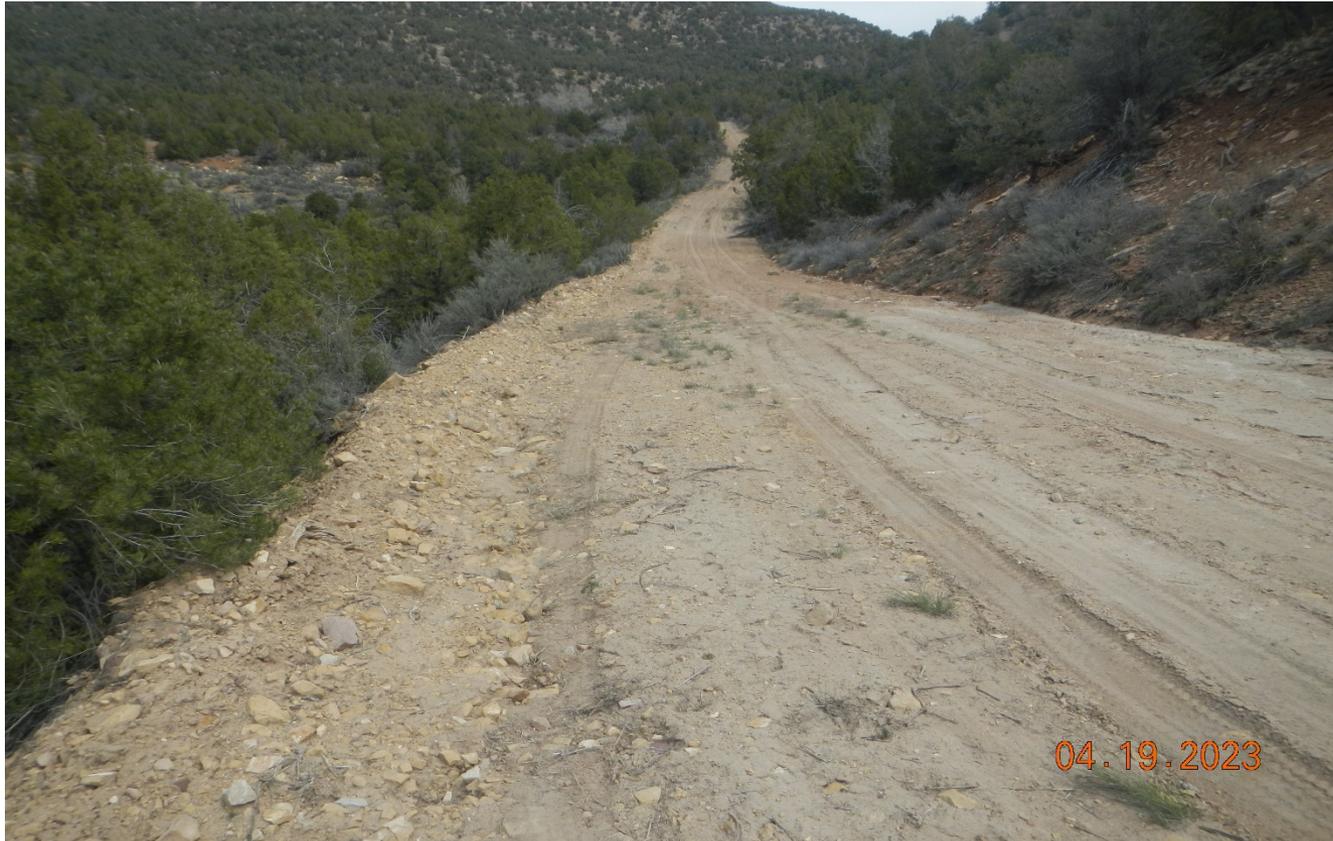
Photo 6. Facing northeast along the access road which goes into the canyon towards the wellsite location.

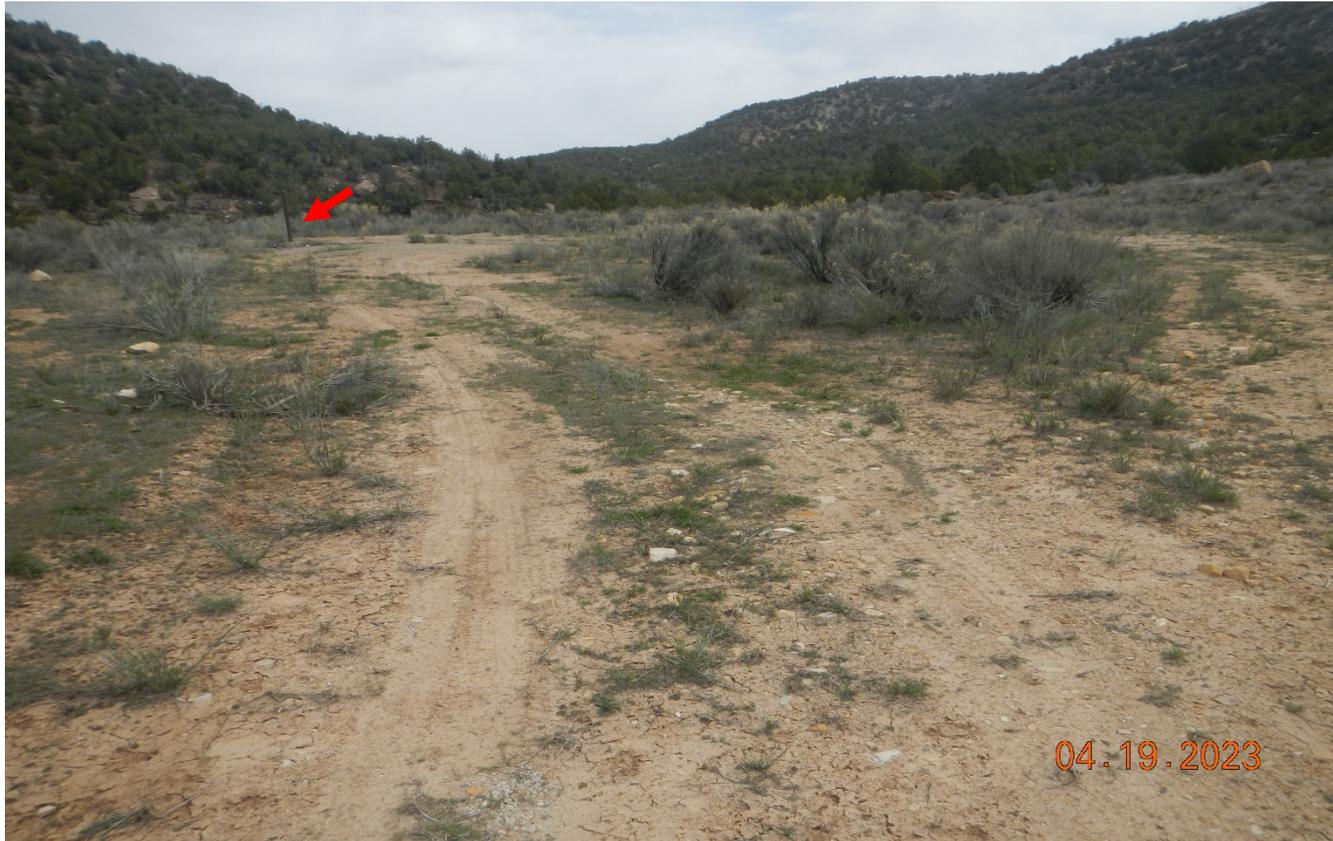
Photo 7. Facing northeast toward the wellsite. PA marker is shown at red arrow. The location has not been recontoured and reclaimed.

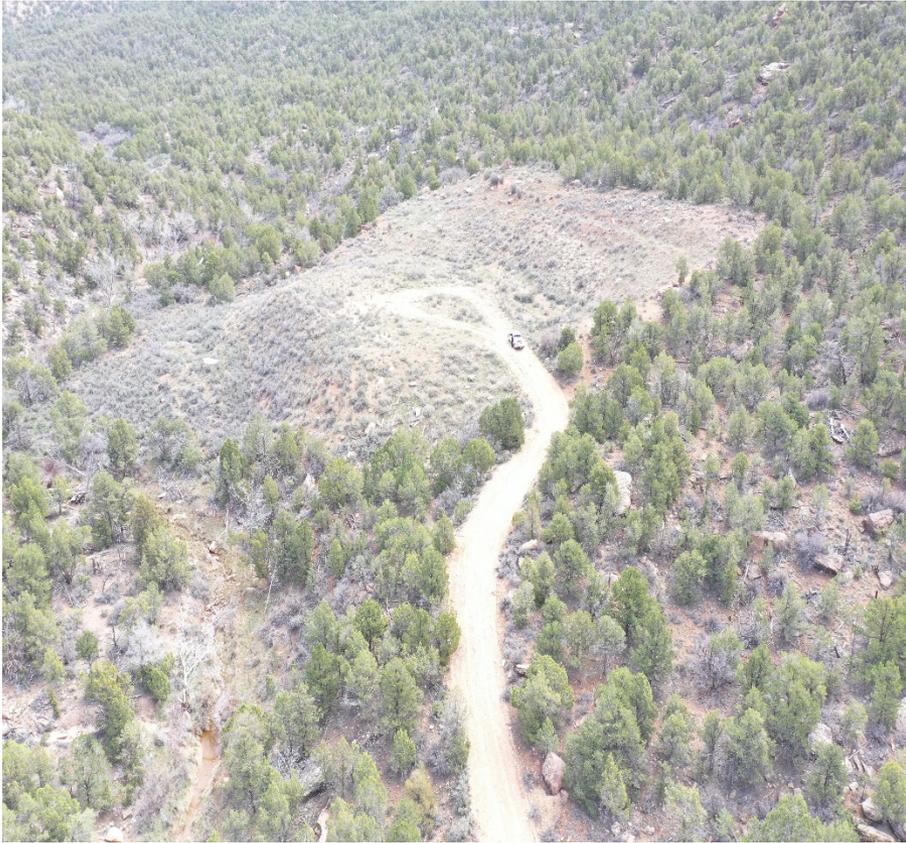
Photo 8. Drone aerial photo facing northeast toward the wellsite location.

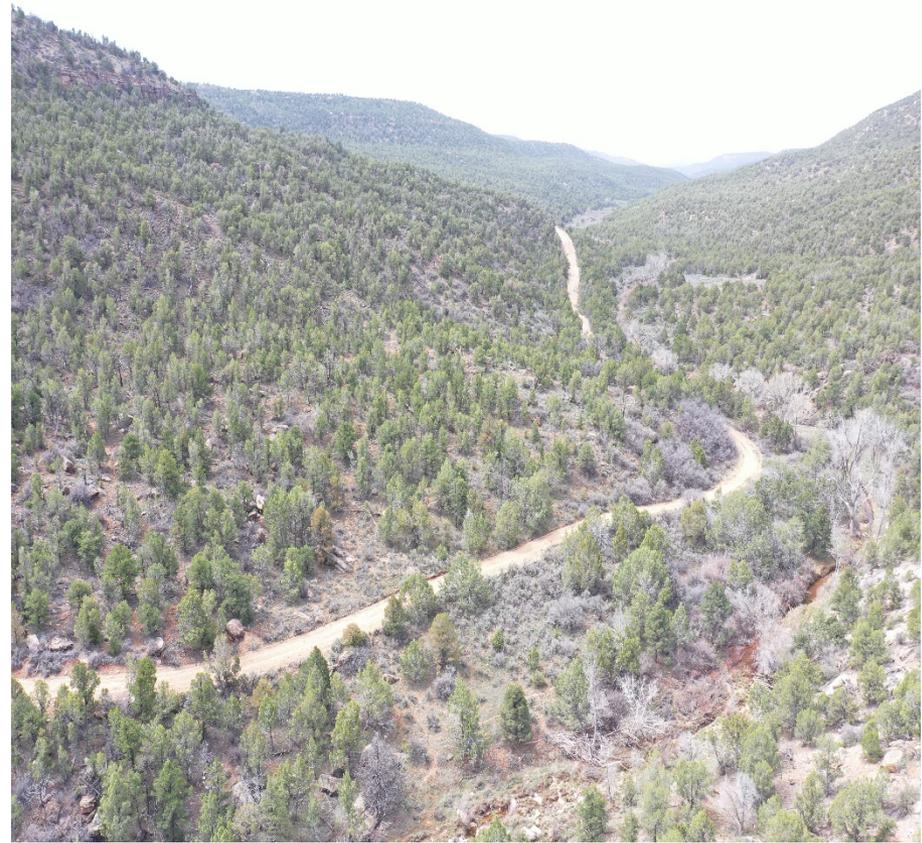
Photo 9. Drone aerial photo facing southwest showing the access road which leads and ends at the wellsite.

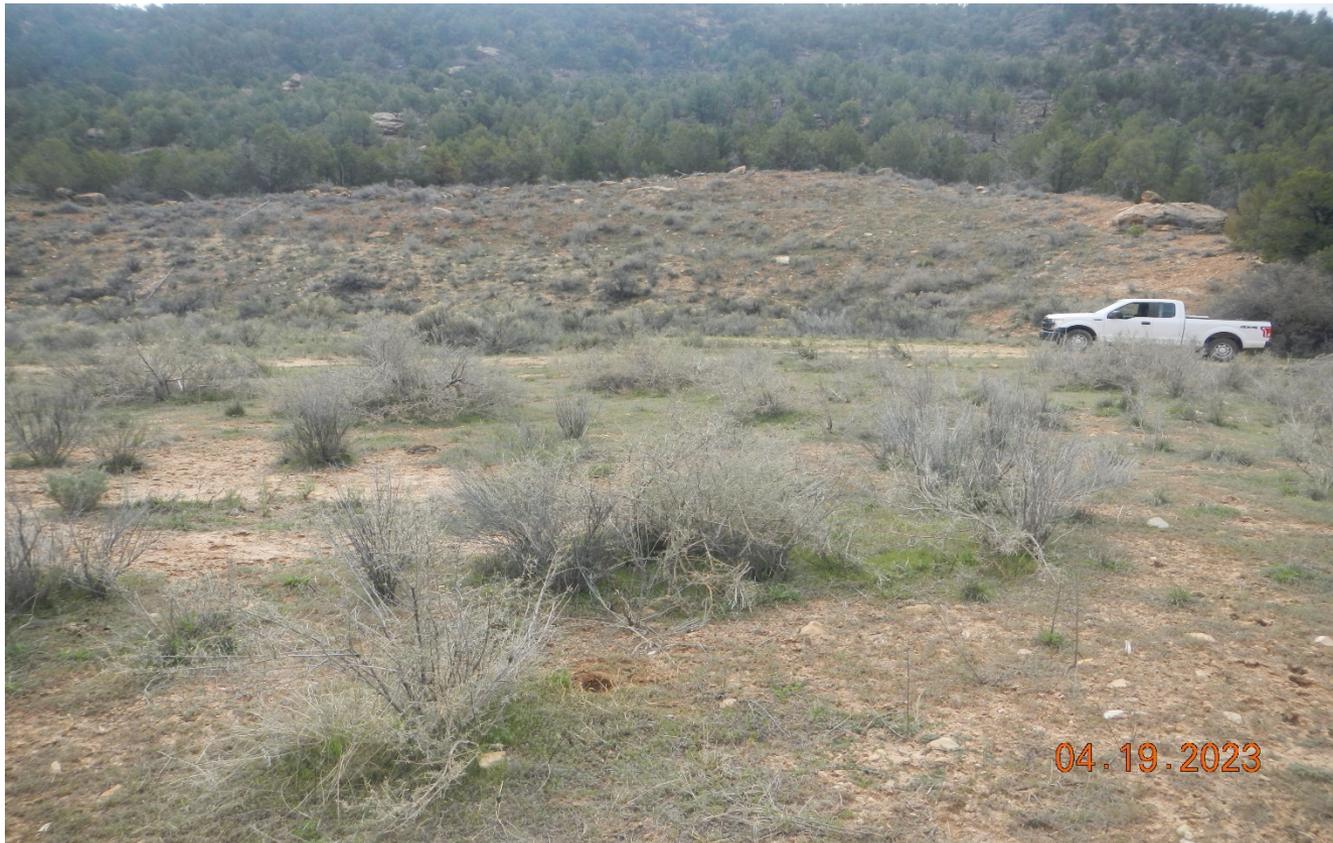
Photo 10. West side of the location facing southeast.

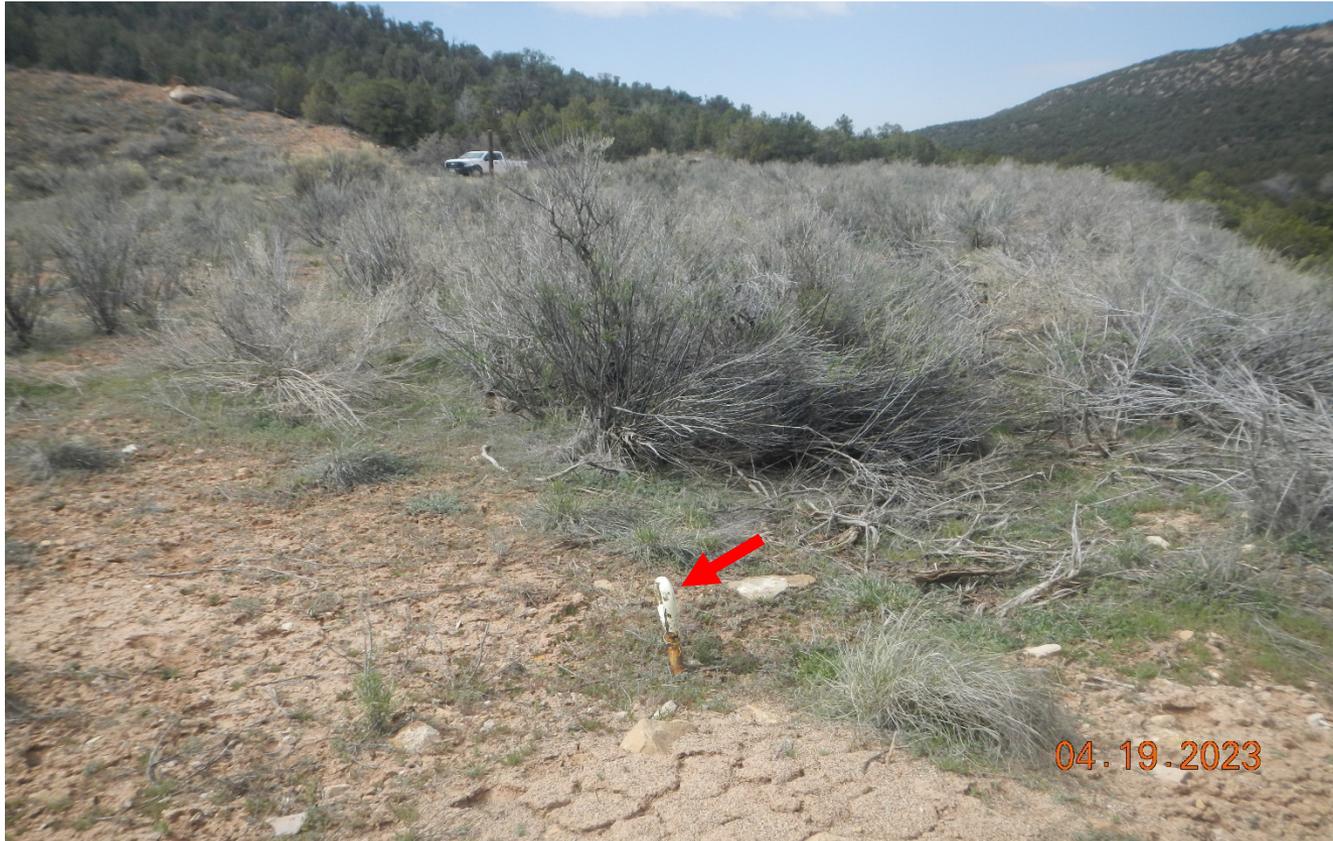
Photo 11. North corner of the location facing southwest. There are four guyline anchors that remain at the location.

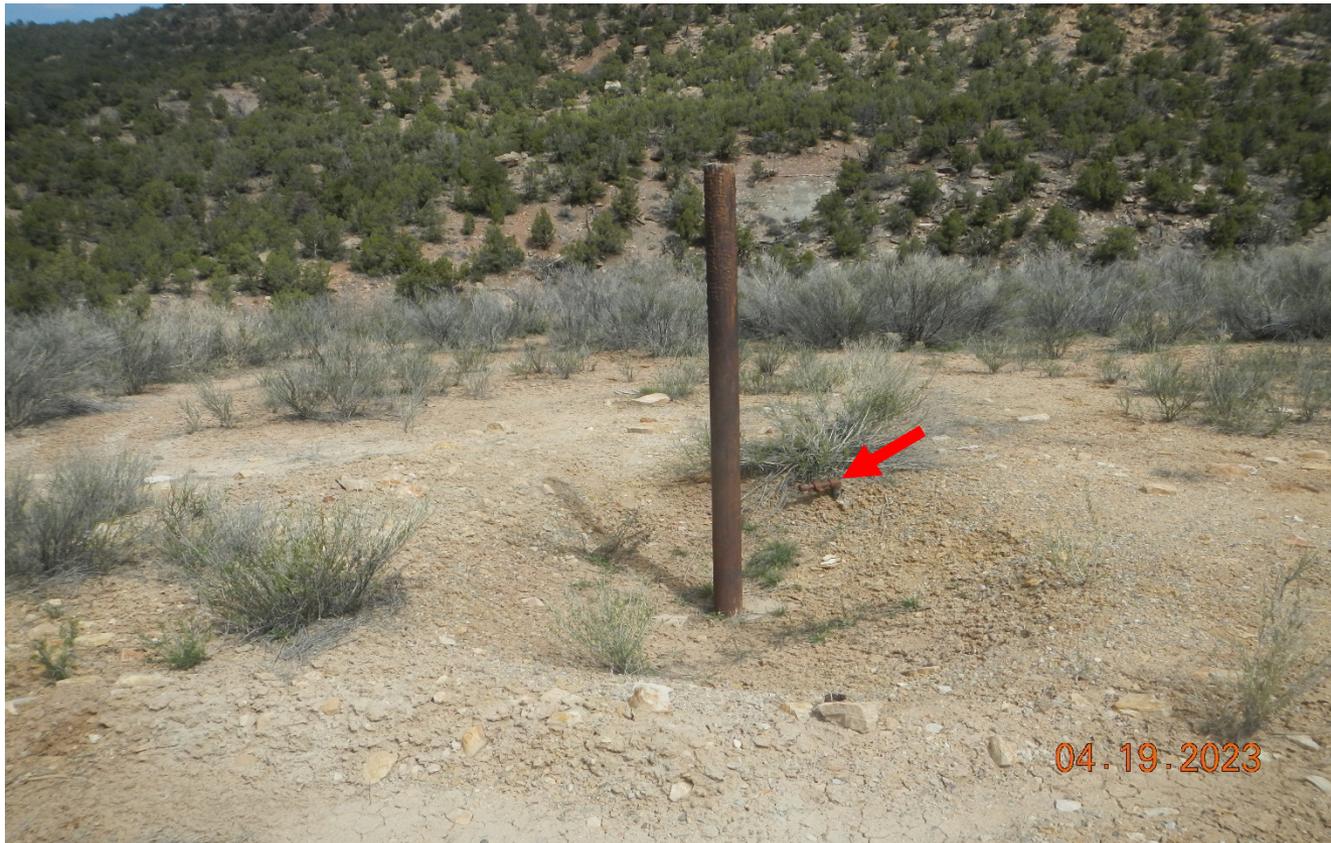
Photo 12. There is an above ground PA marker at the location. There is a small 2" pipe shown at red arrow.

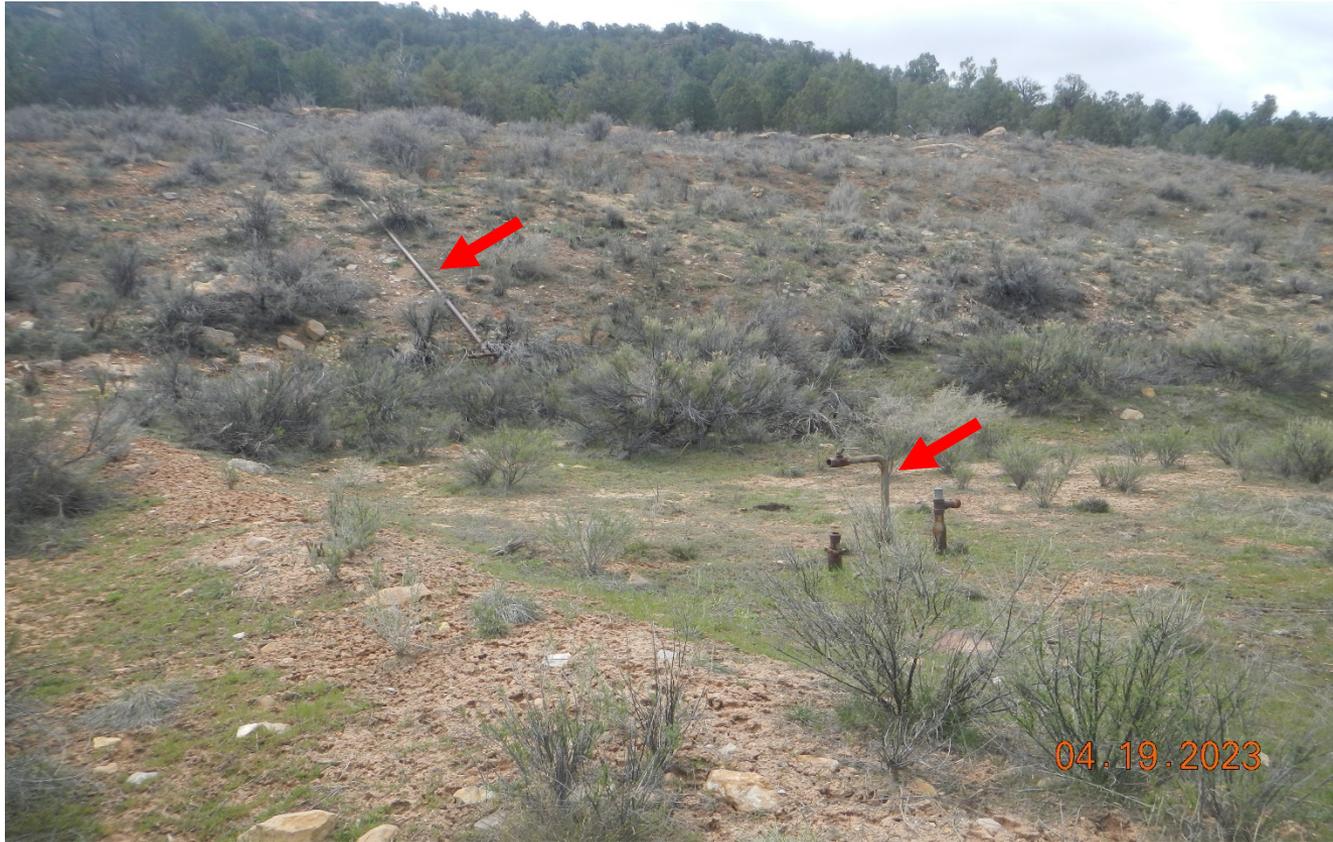
Photo 13. Facing toward the southeast cut slope. There is a bermed area where tanks were location and pipe risers flowline still remain.

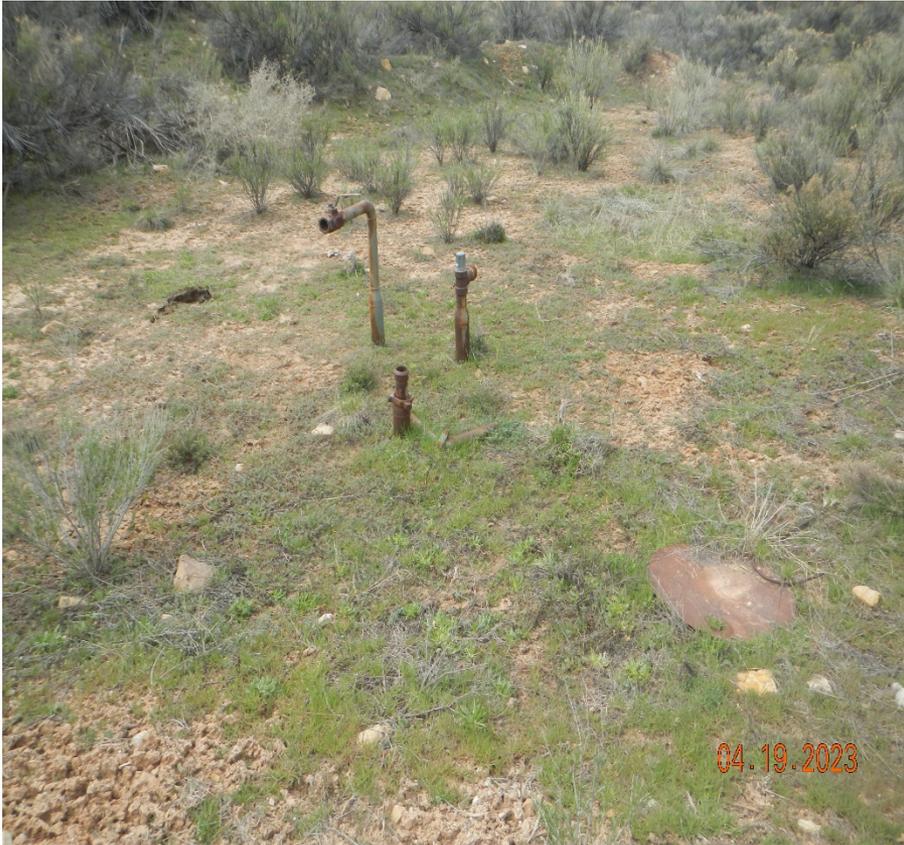
Photo 14. View of 3 pipe risers and 12' plate.

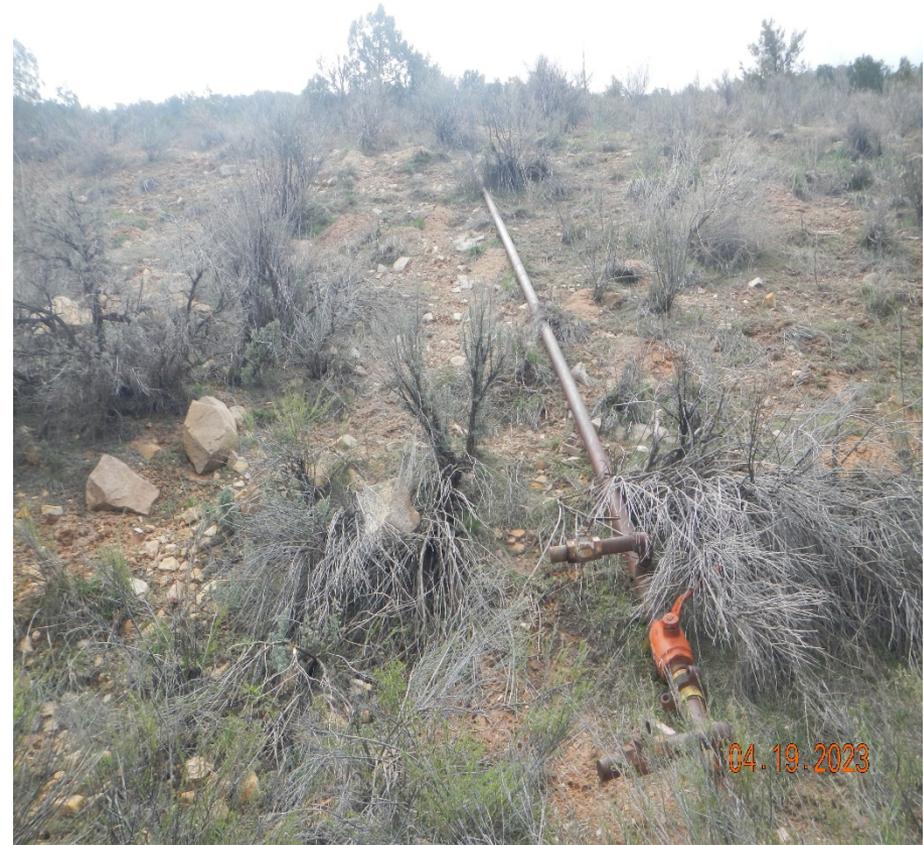
Photo 15. View of above ground flow line which goes up the hill towards the Federal 2-19 wellsite.

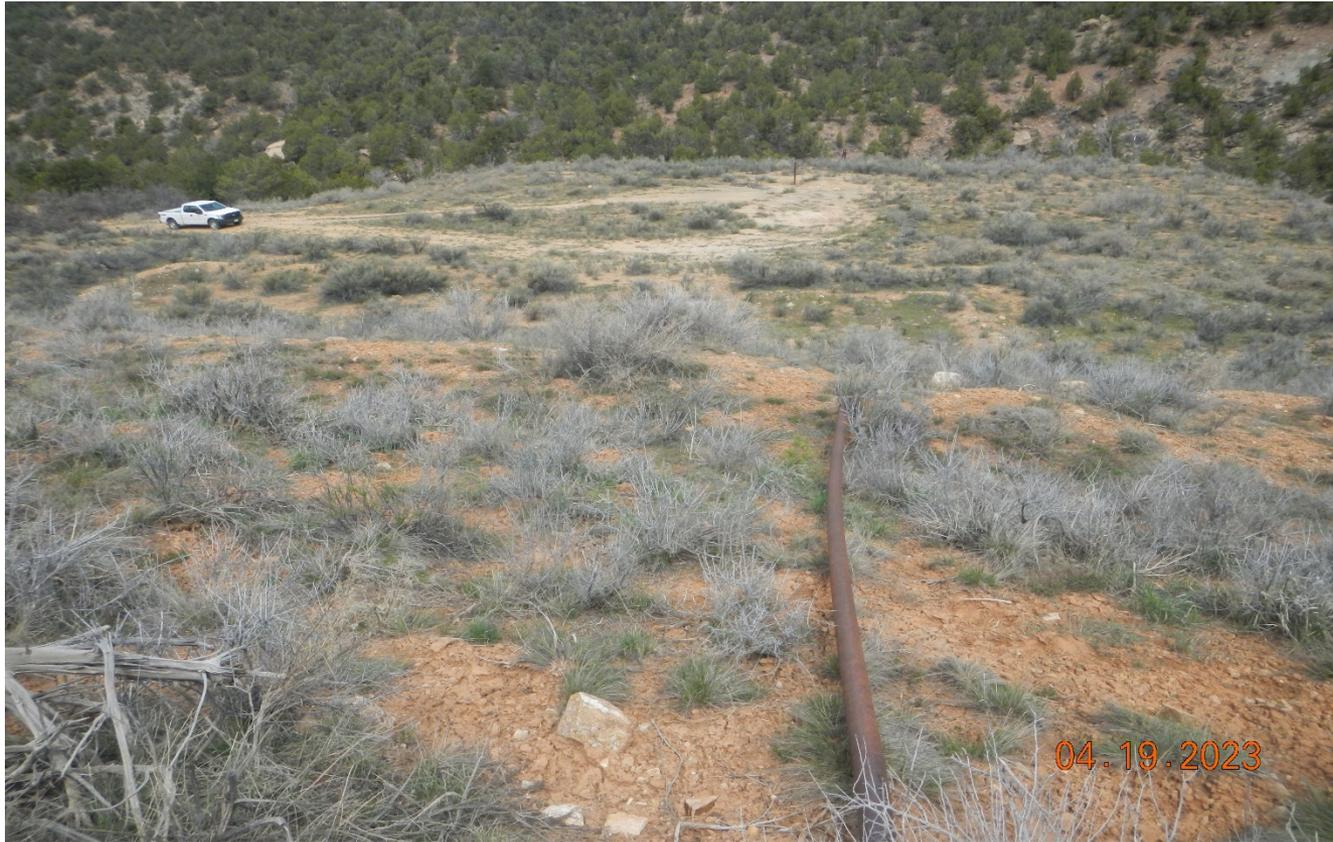
Photo 16. Standing at the top of the cut slope facing northwest.

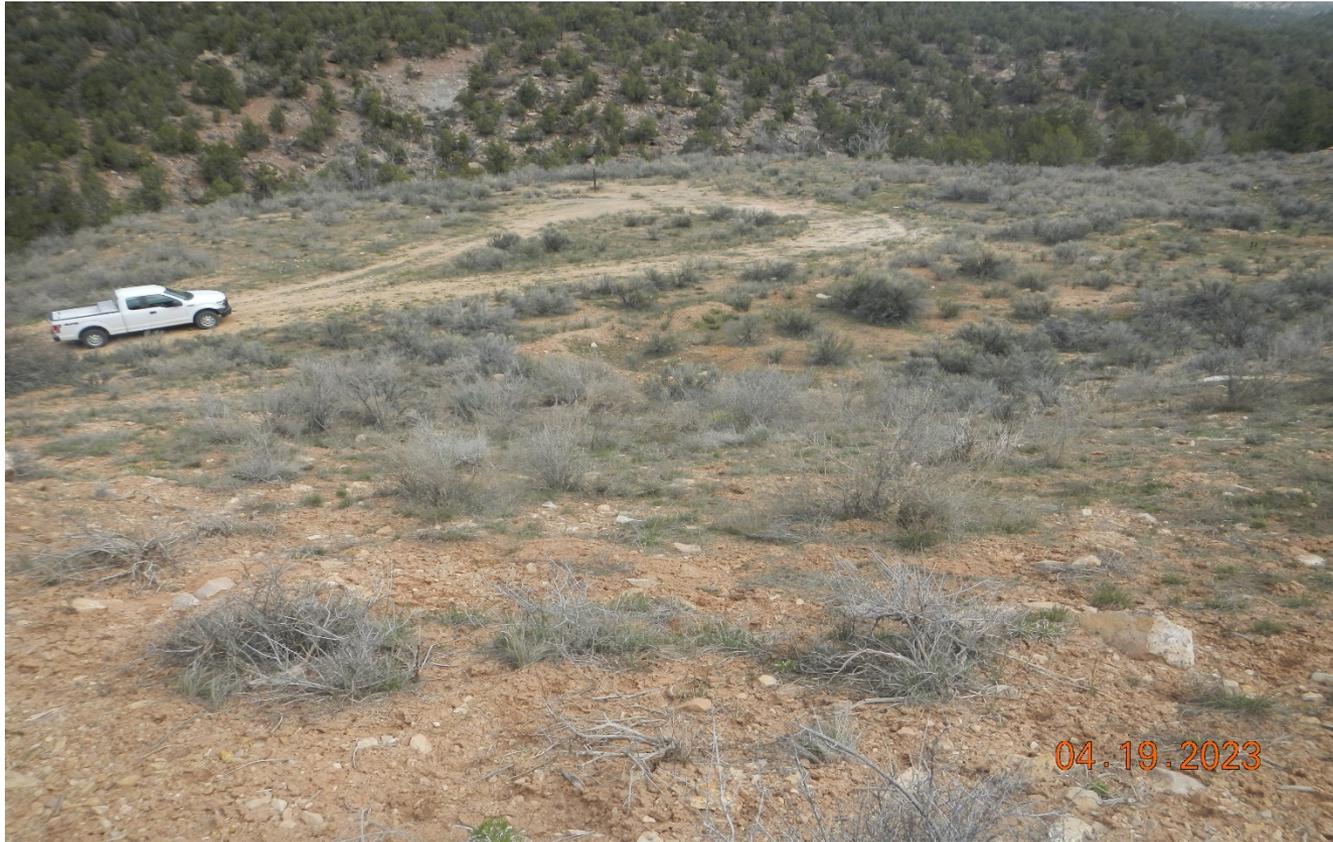
Photo 17. South side of the cut slope facing north.
