# Inspection Photos

Loc: 381617

Operator: FOUR CORNERS ENERGY LLC

Inspection Date: 4/19/2023

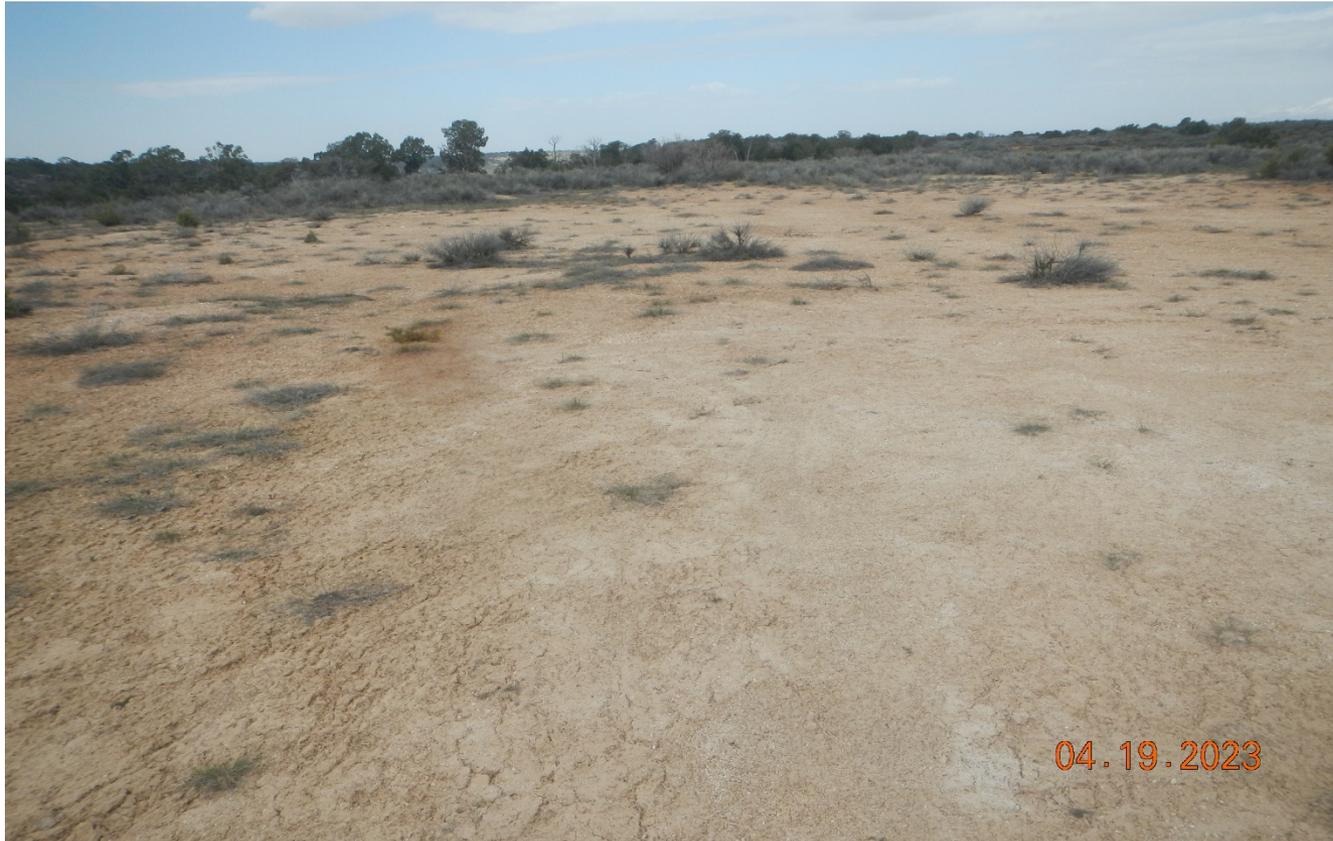
**Photo 1.** Facing west at the location. The vegetation has not re-established in this area approx. 1560'x150'.

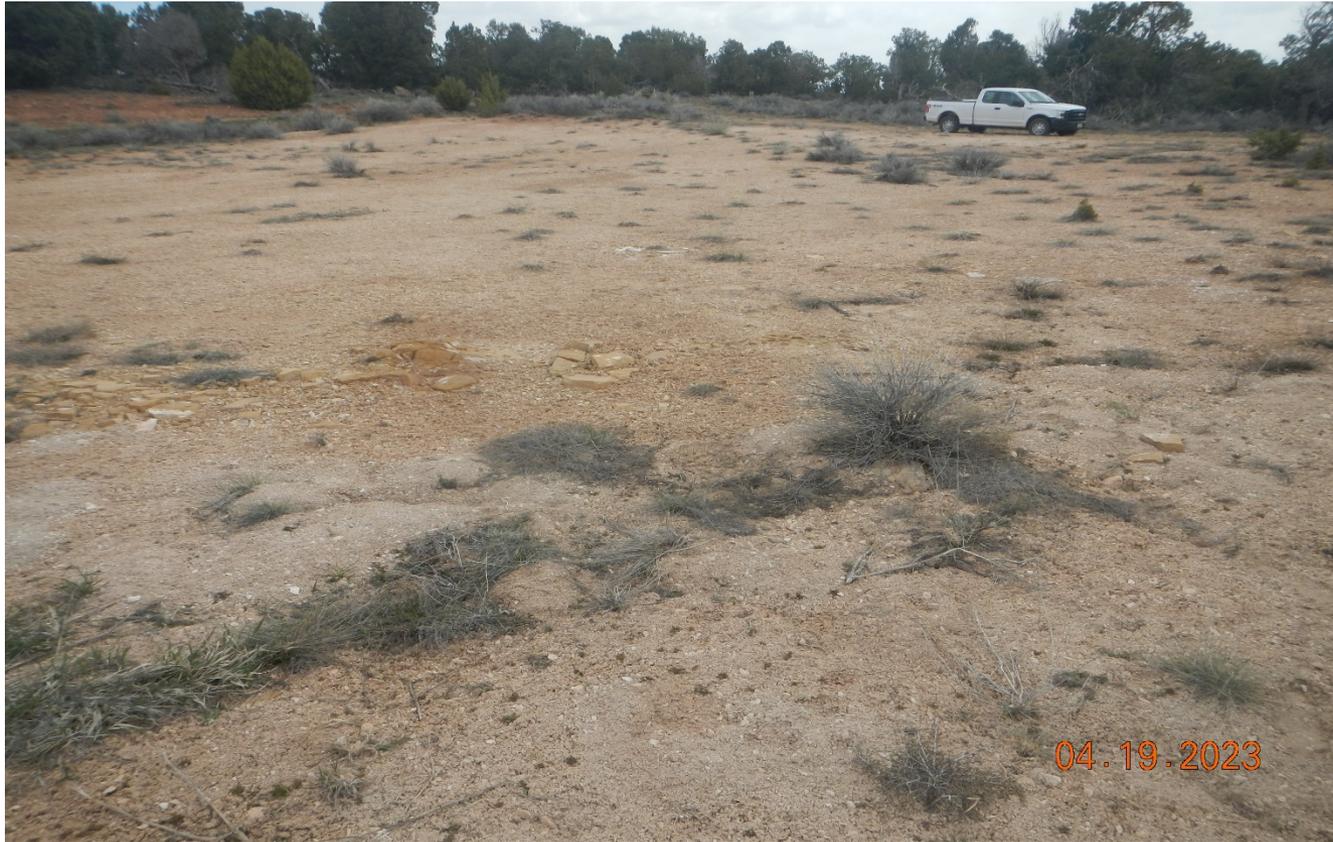
**Photo 2.** Facing northeast at the location. The vegetation has not re-established in this area approx. 1560'x150'.

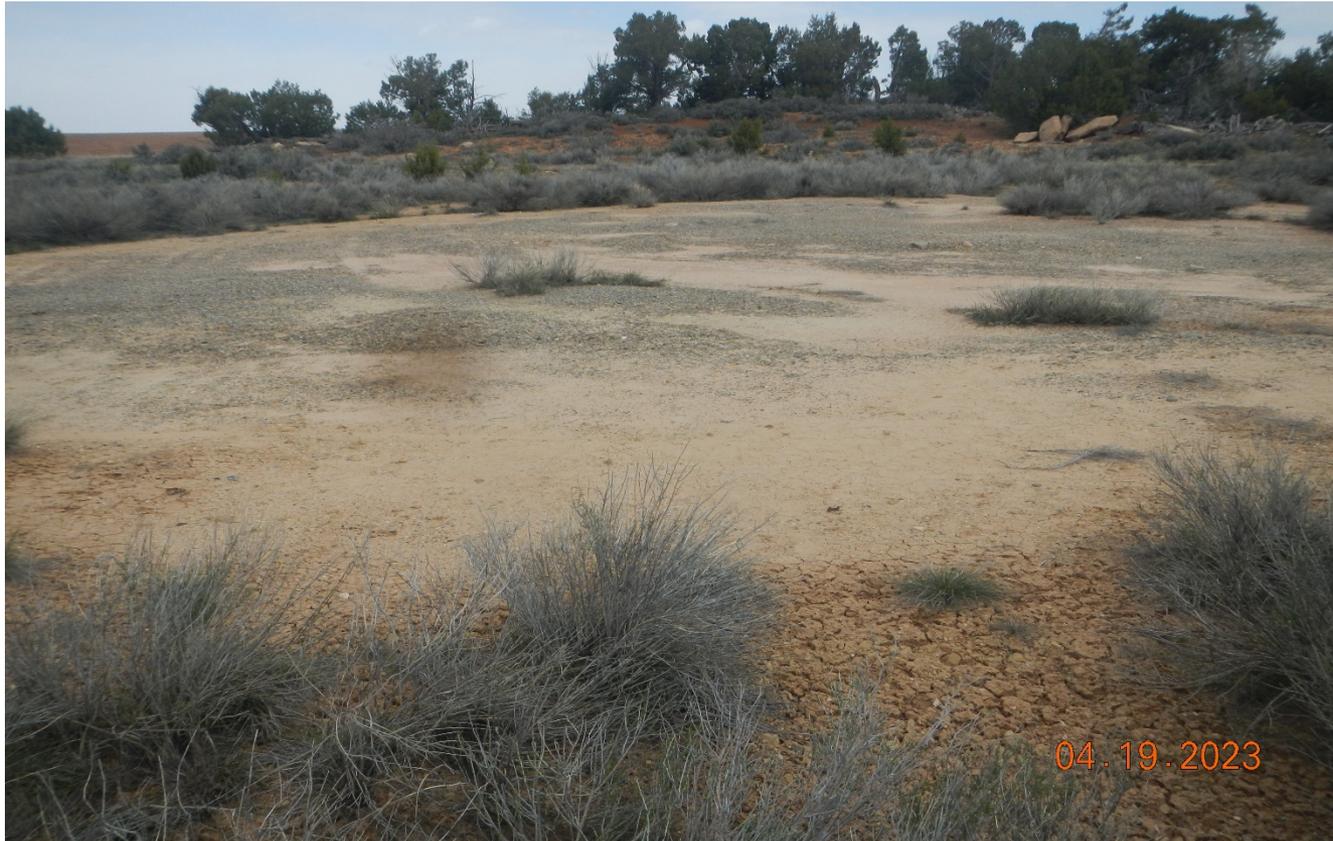
**Photo 3.** Facing northwest at the well site. There is some remnant gravel that remains in this area and there is no vegetation growth approx. 70'x70'.

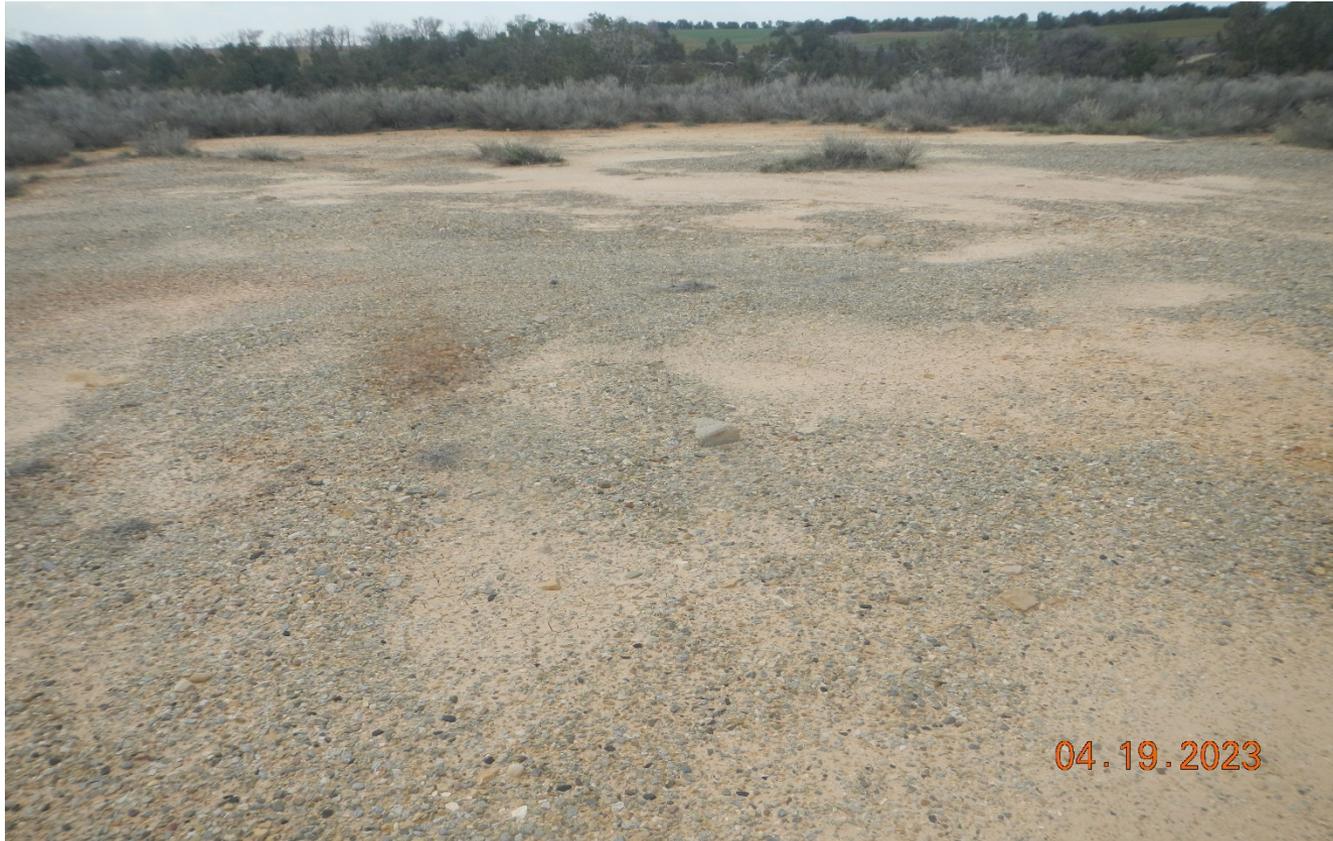
**Photo 4.** Facing southeast at the well site. There is some remnant gravel that remains in this area and there is no vegetation growth approx. 70'x70'.

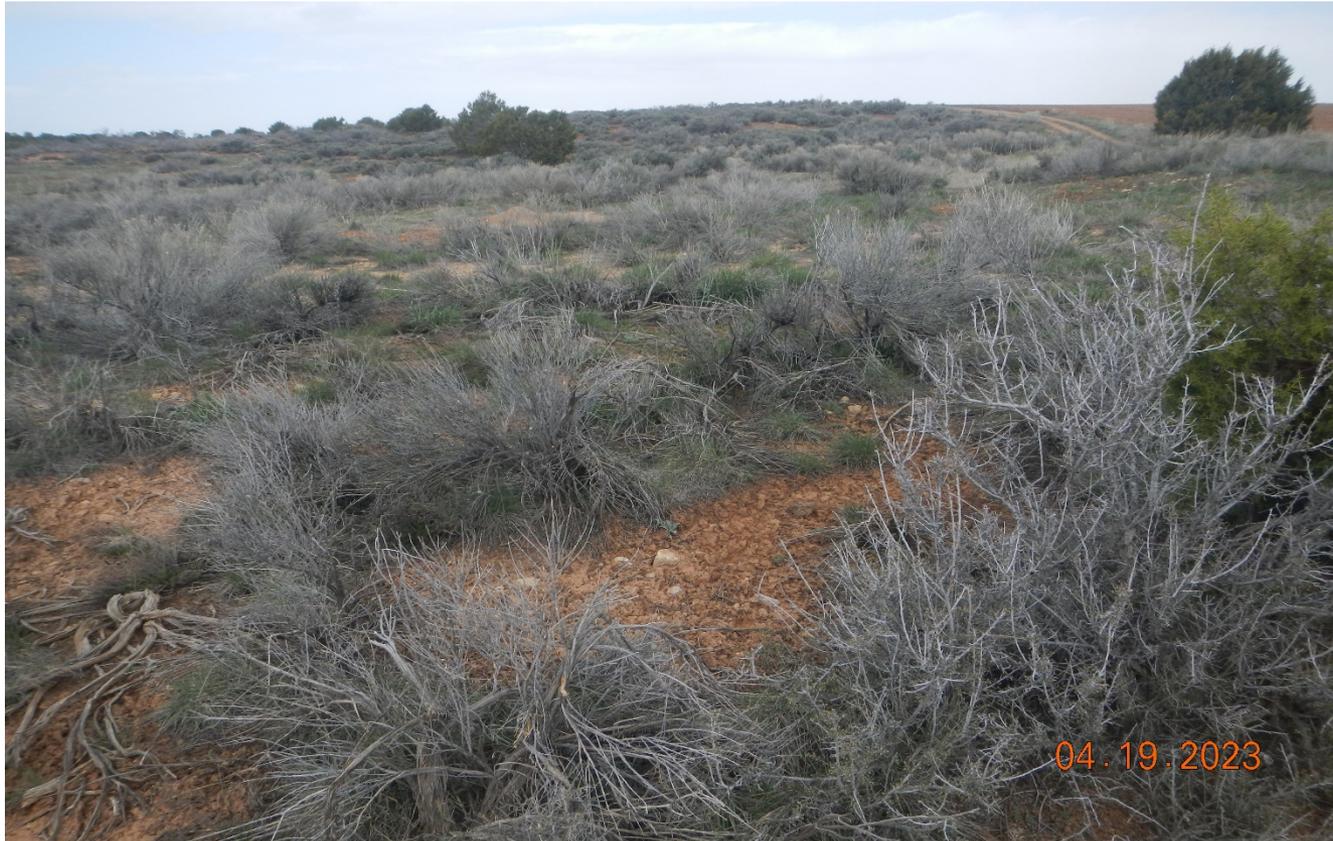
**Photo 5.** Facing northwest toward the surrounding pinyon/juniper/sage shrubland
