Construction and Stormwater Inspection

Operator: DENOVA SEQUESTRATION LLC - 10790

Location ID: 483817

Inspection Document #: 708200178

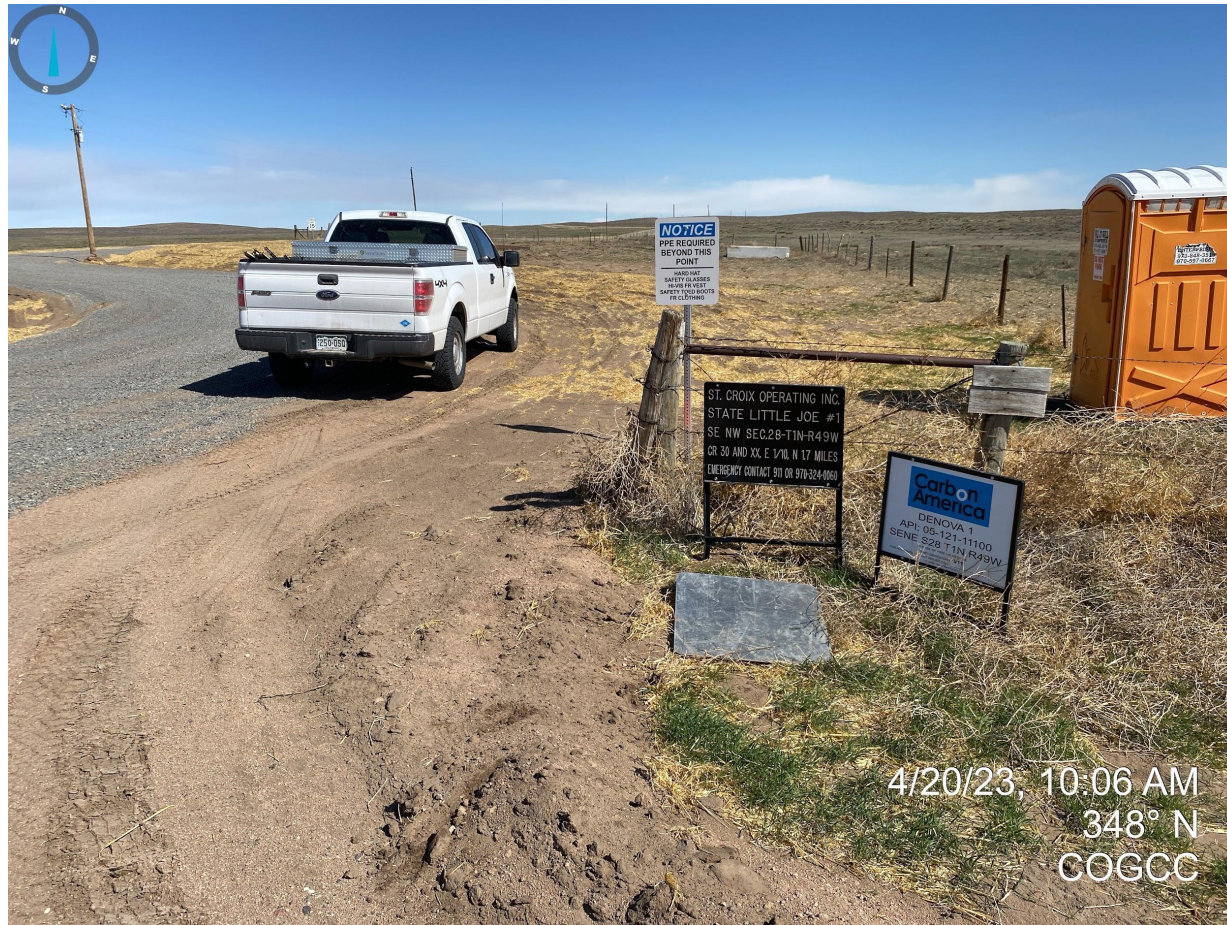
Photo 1. Location sign has been installed at the intersection of the lease road and public road, as required by Rule 406.d.

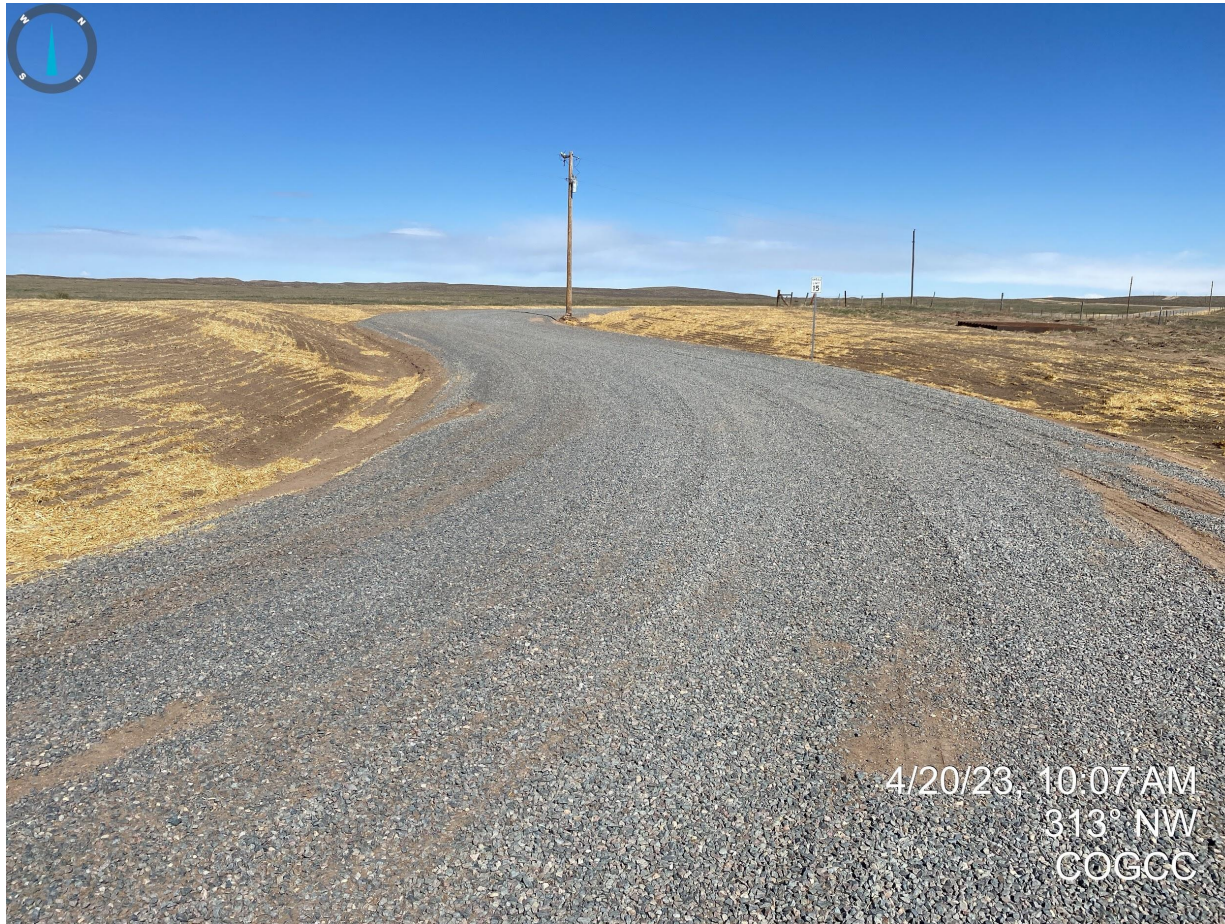
Photo 2. View from access road illustrating that the road has been stabilized with road base and any disturbed areas have been contoured and seeded/mulched for long term stabilization.

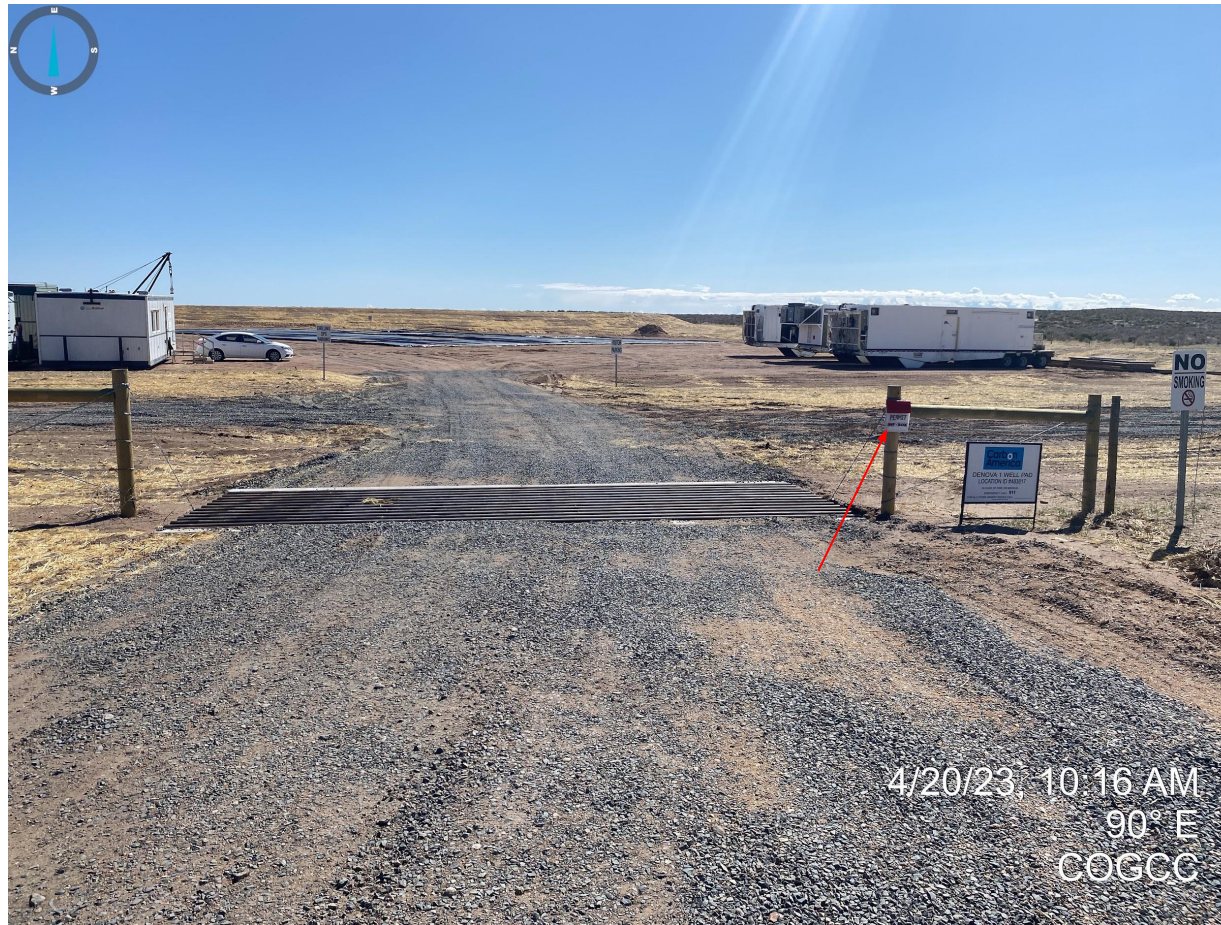
Photo 3. View from the location entrance illustrating that the approved Form 2A has been posted in a conspicuous location, as required by Rule 406.c.

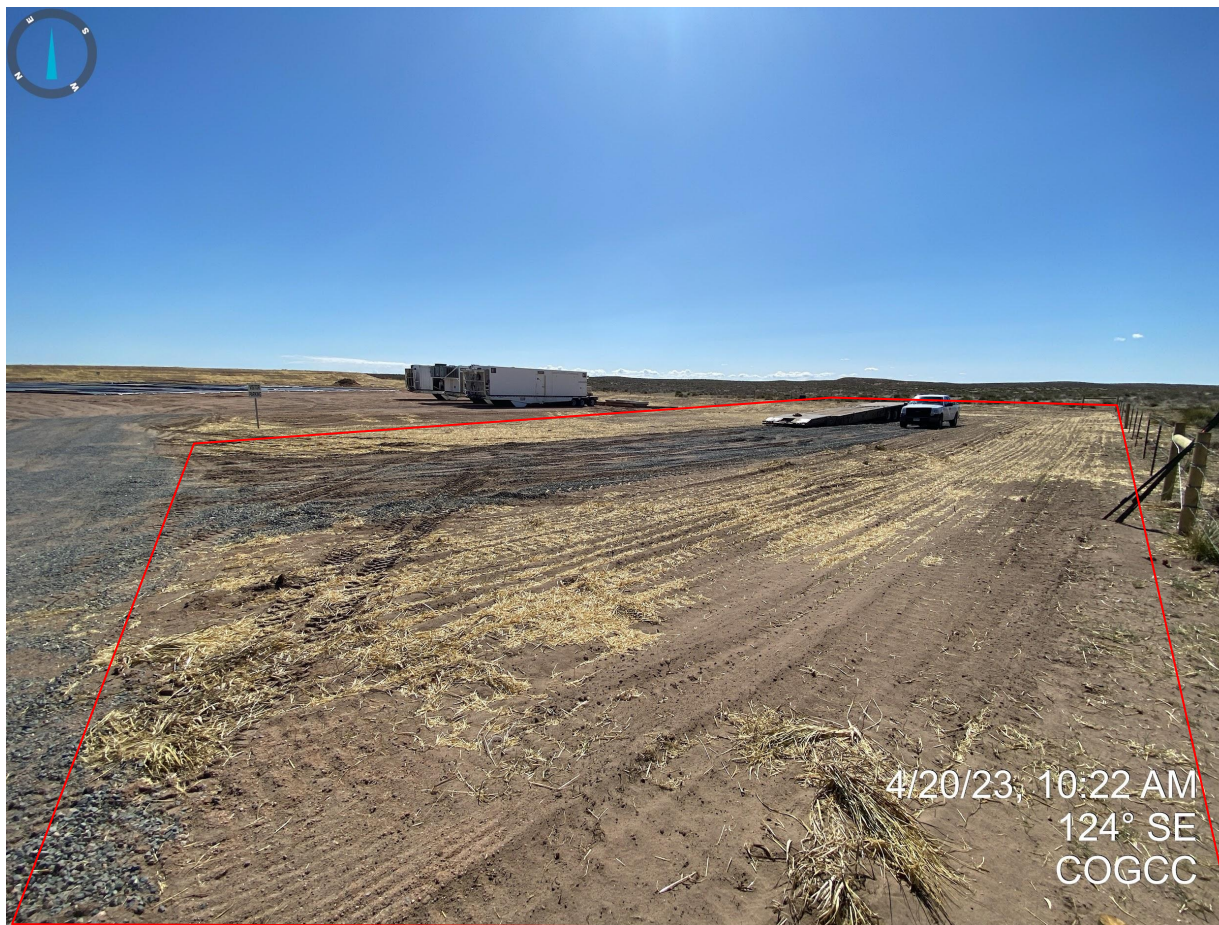
Photo 4. Facing southeast from the location entrance. It does not appear that topsoil have been salvaged from the two “parking areas”; this location is not in compliance with Rule 1002.b. Additionally, no stormwater control BMPs were identified at this portion of the location.

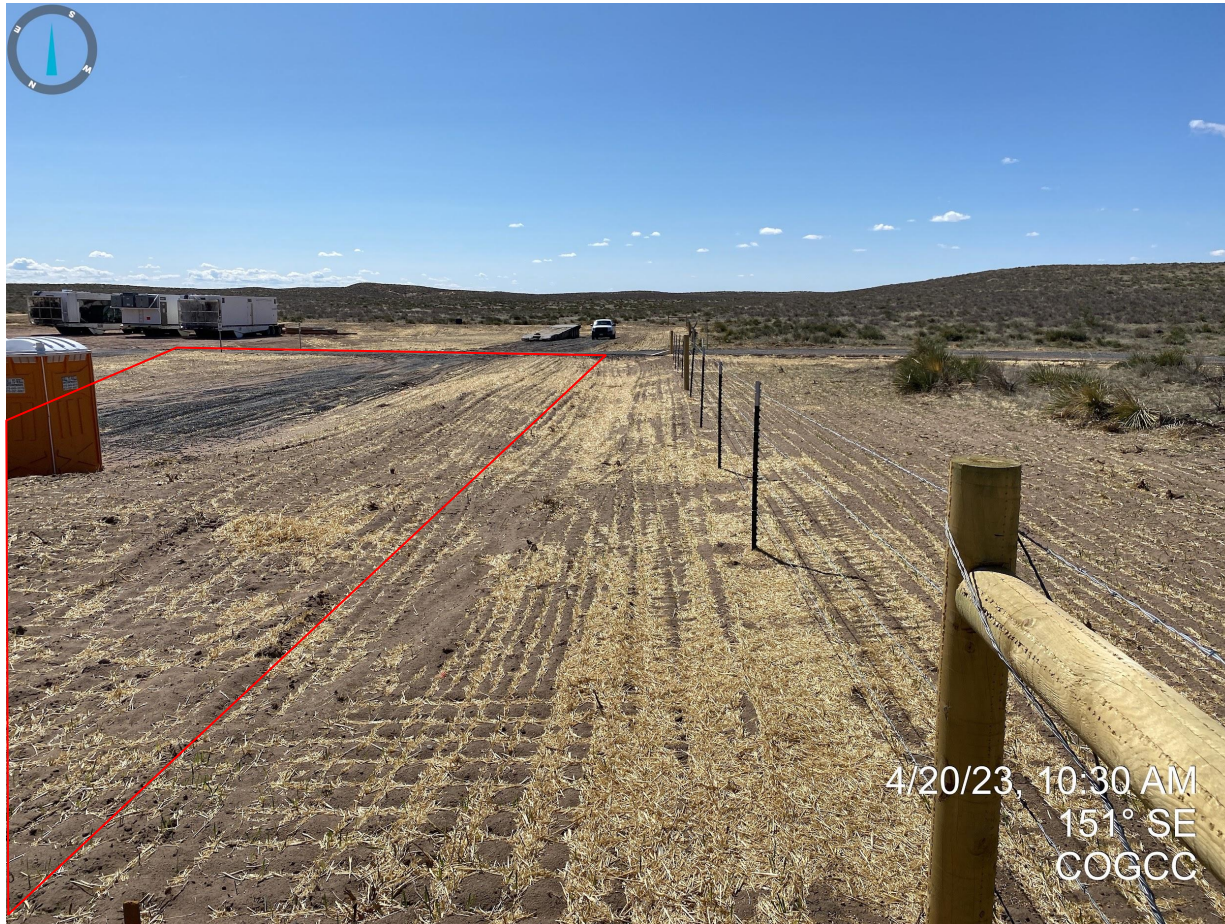
Photo 5. Facing southeast from the northwest corner. See comments in Photo 4.

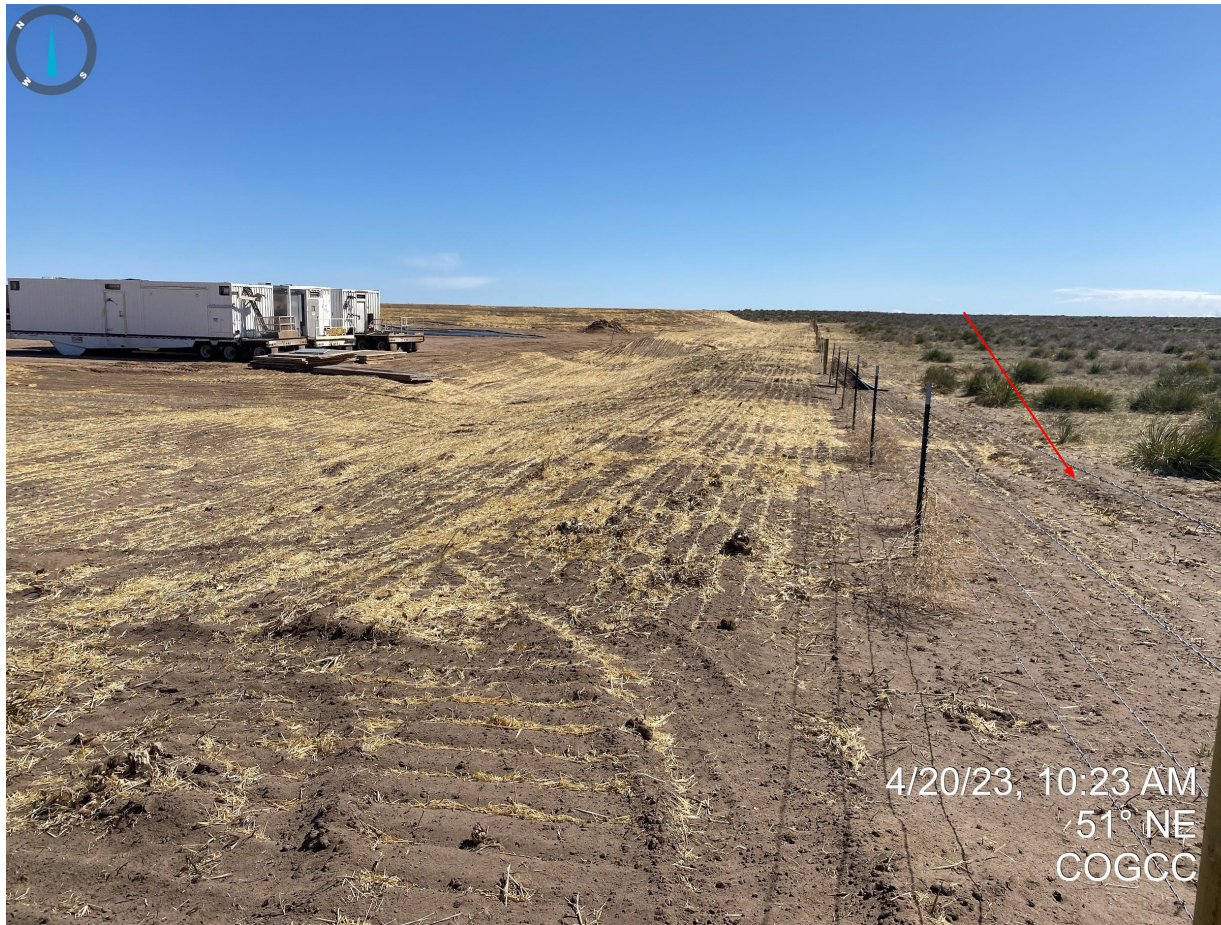
Photo 6. Facing northeast from the southwest corner of the location. Photo illustrates the absence of stormwater control BMPs around the perimeter of the location and additional disturbance outside of the fence line.

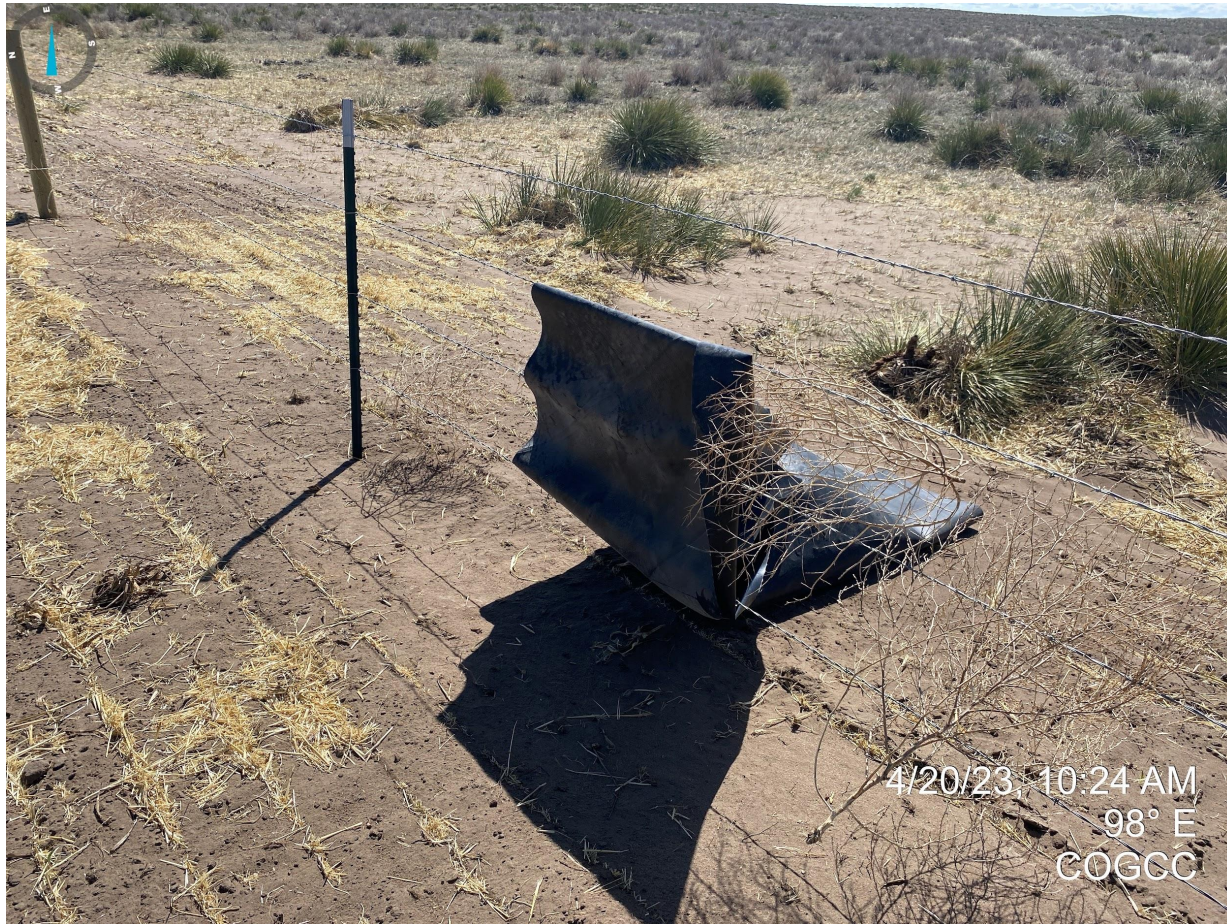
Photo 7. Trash observed on the fence line that will need to be removed. The operator shall ensure that the entire location is kept free from all trash, at all times.

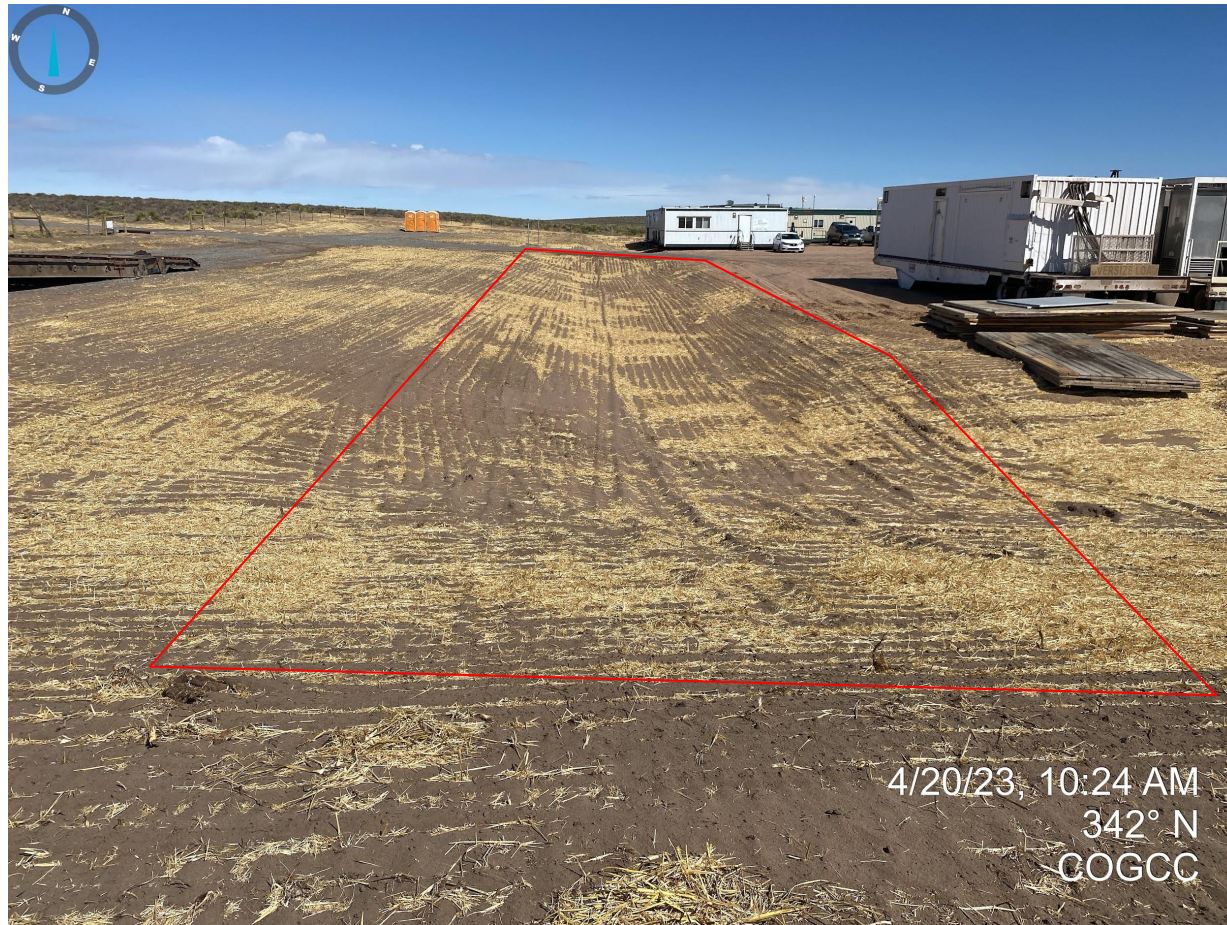
Photo 8. Sediment trap installed on the southwest portion of the production pad.

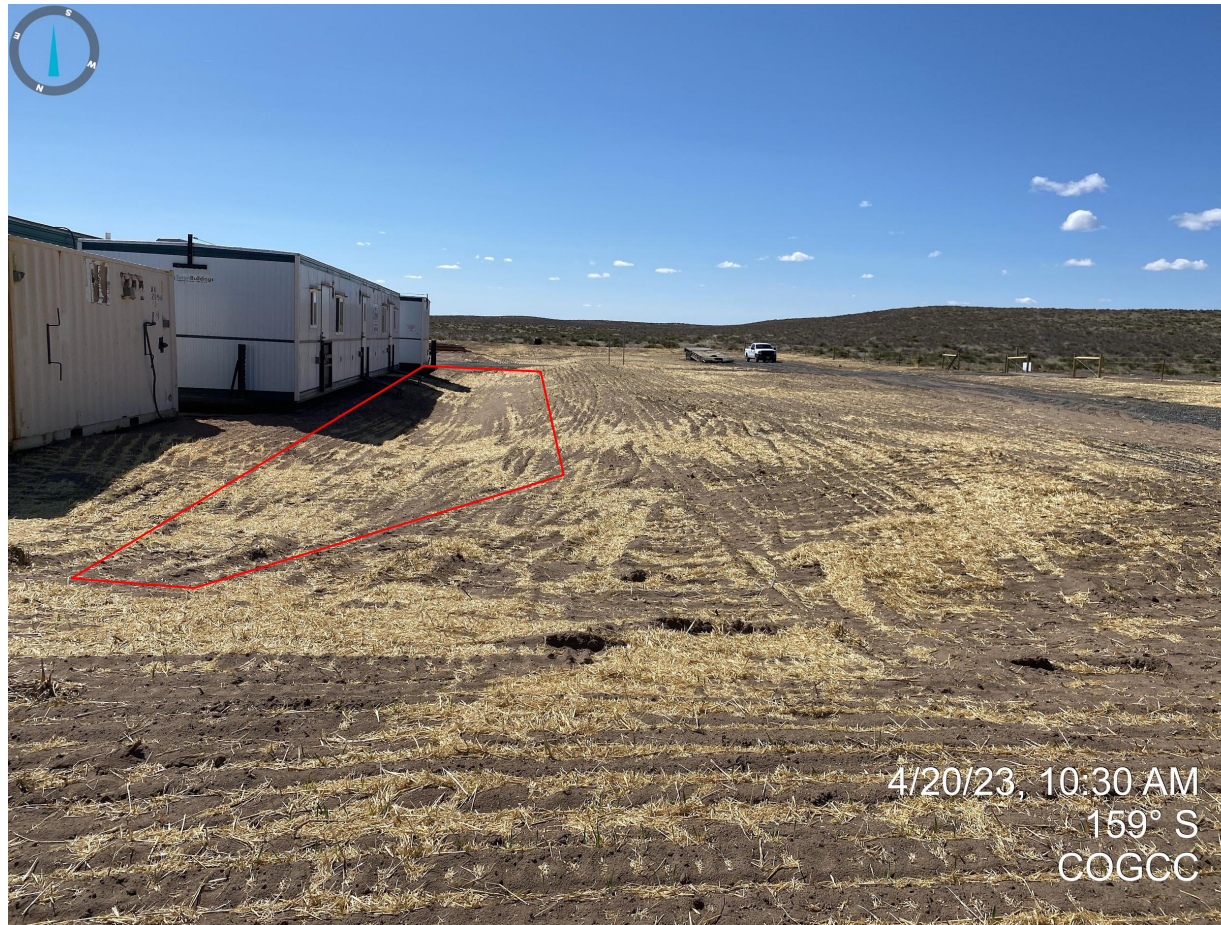
Photo 9. Additional sediment trap installed on the northwest corner of the production area.

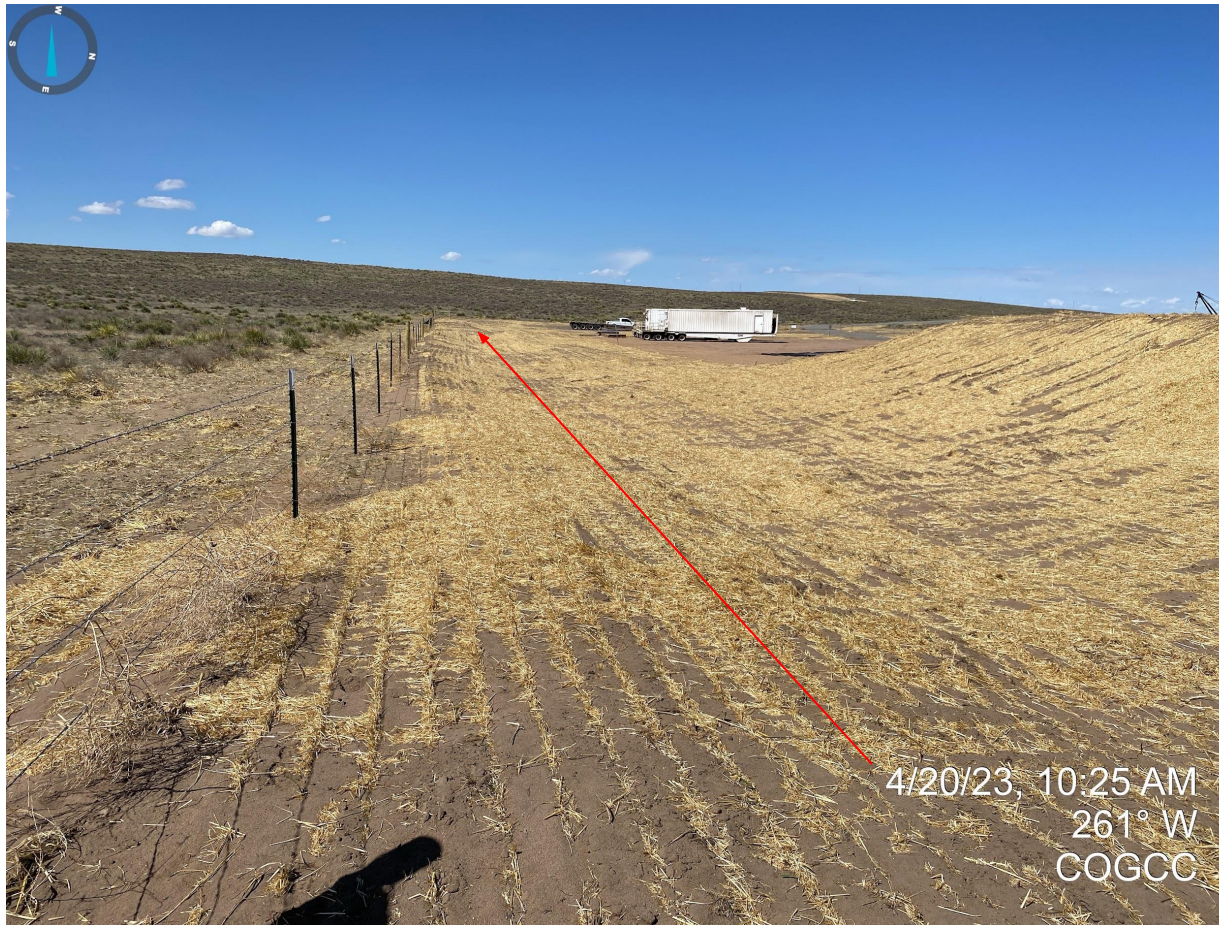
Photo 10. Facing west from the southeastern corner of the location. Topsoil stockpile pictured in the background has been seeded/mulched for long term stabilization. Stormwater BMPs appear to be inadequate along the southern portion of the location.

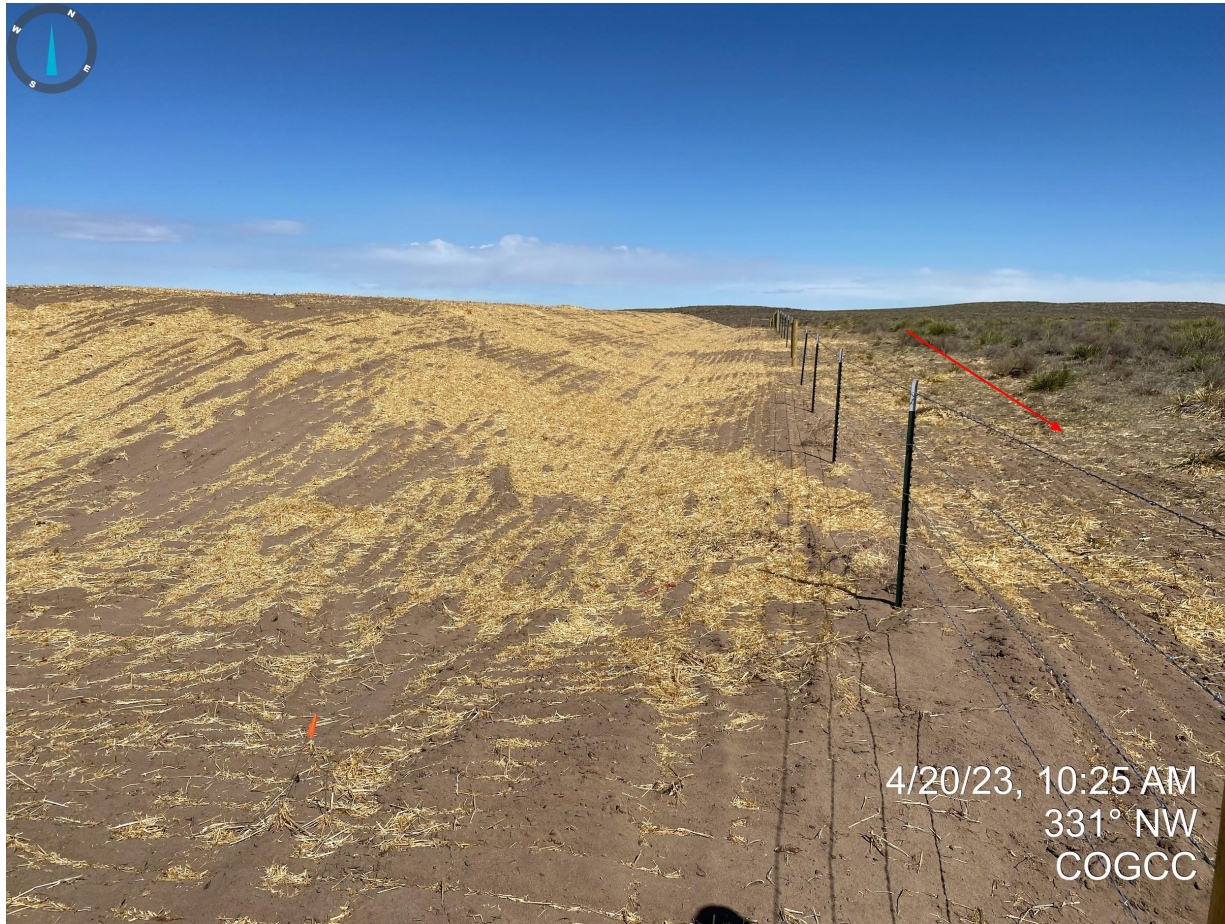
Photo 11. Facing northwest; see comments in Photo 10. Also pictured, additional disturbance was identified on the outside of the location's perimeter fence.

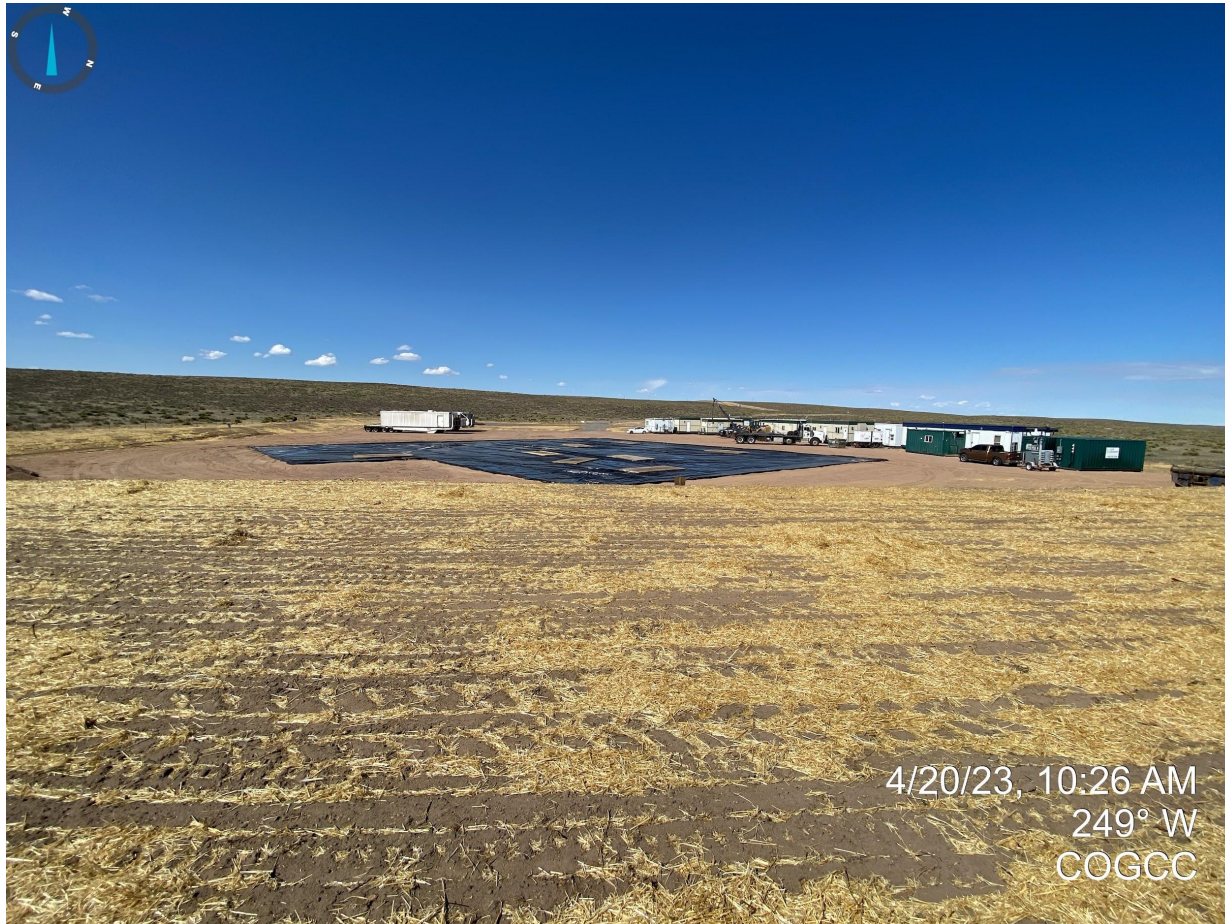
Photo 12. Seeded/mulched topsoil stockpile.

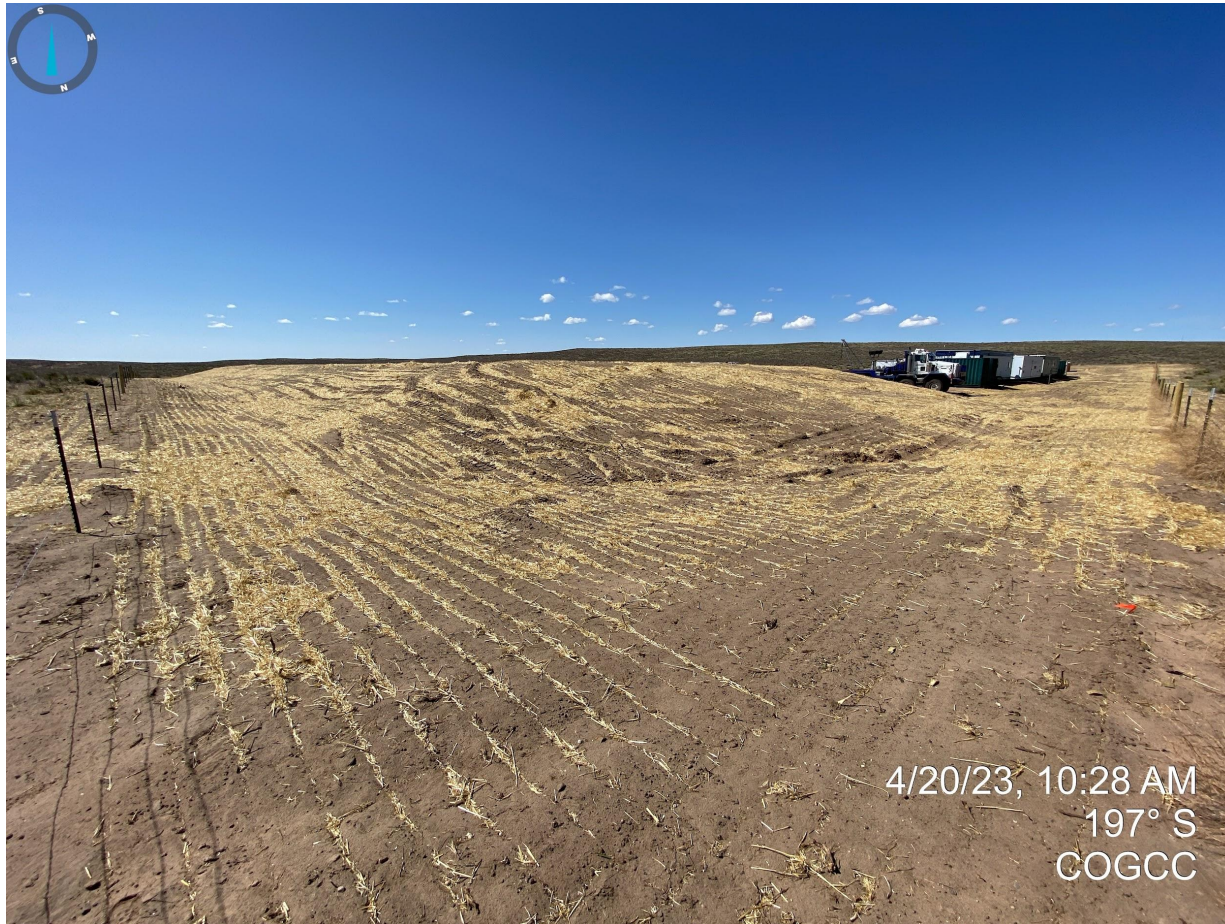
Photo 13. Facing south from the northeastern corner of the location. No evidence of stormwater BMPs identified at this portion of the location.

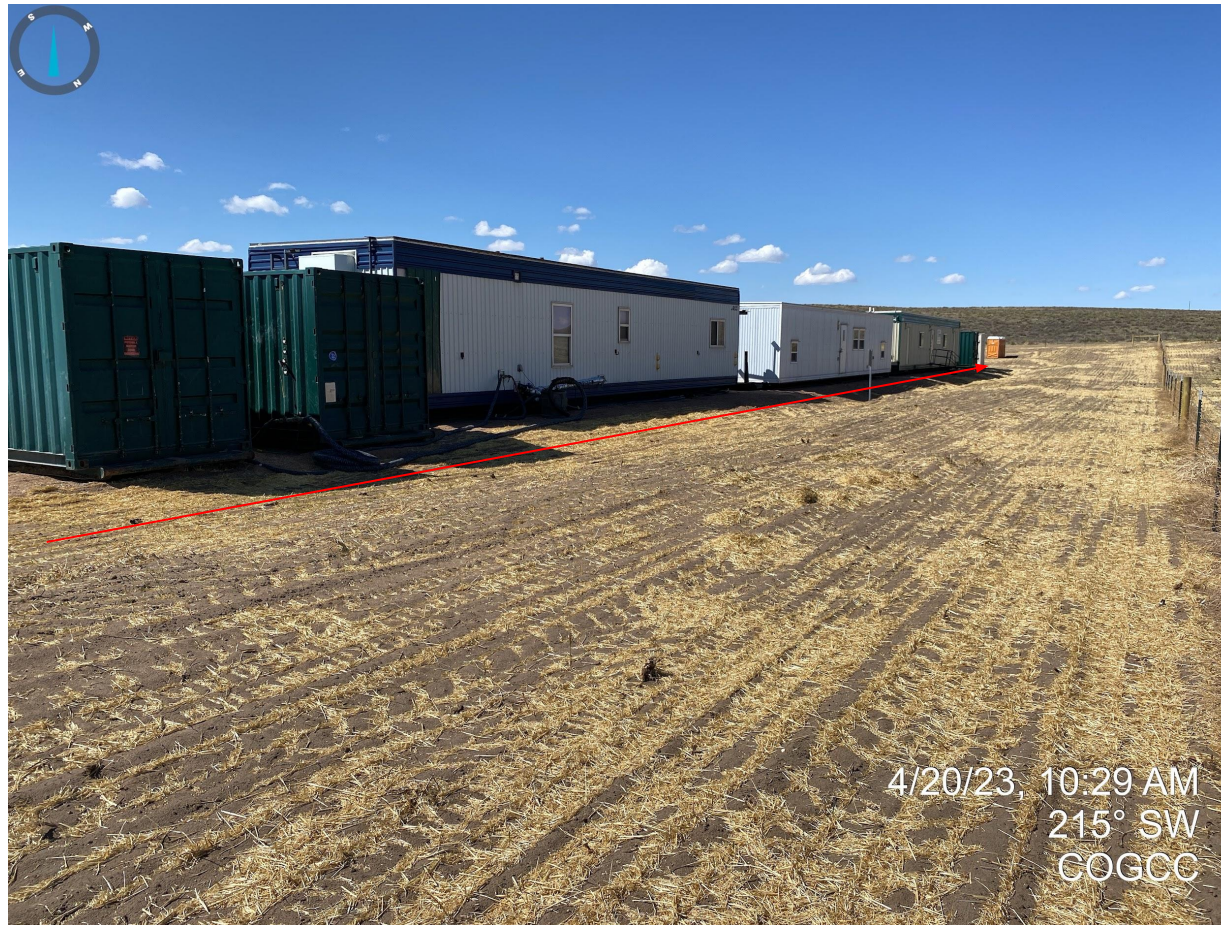
Photo 14. Facing southwest from the northern portion of the location. An interior ditch has been constructed around the production pad and no apparent stormwater BMPs located on the perimeter of the location.

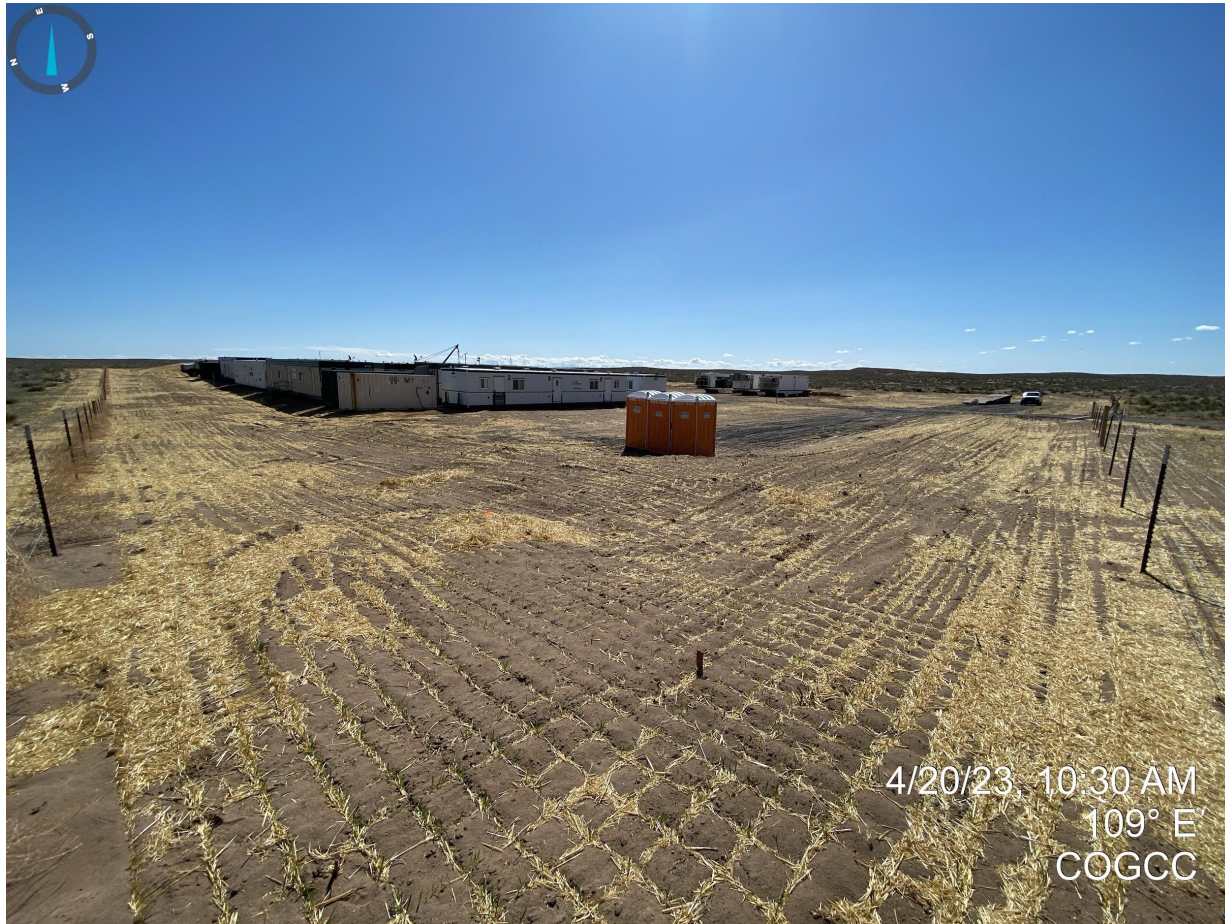
Photo 15. Facing east from the northwest corner of the location. See comments in Photo 14.

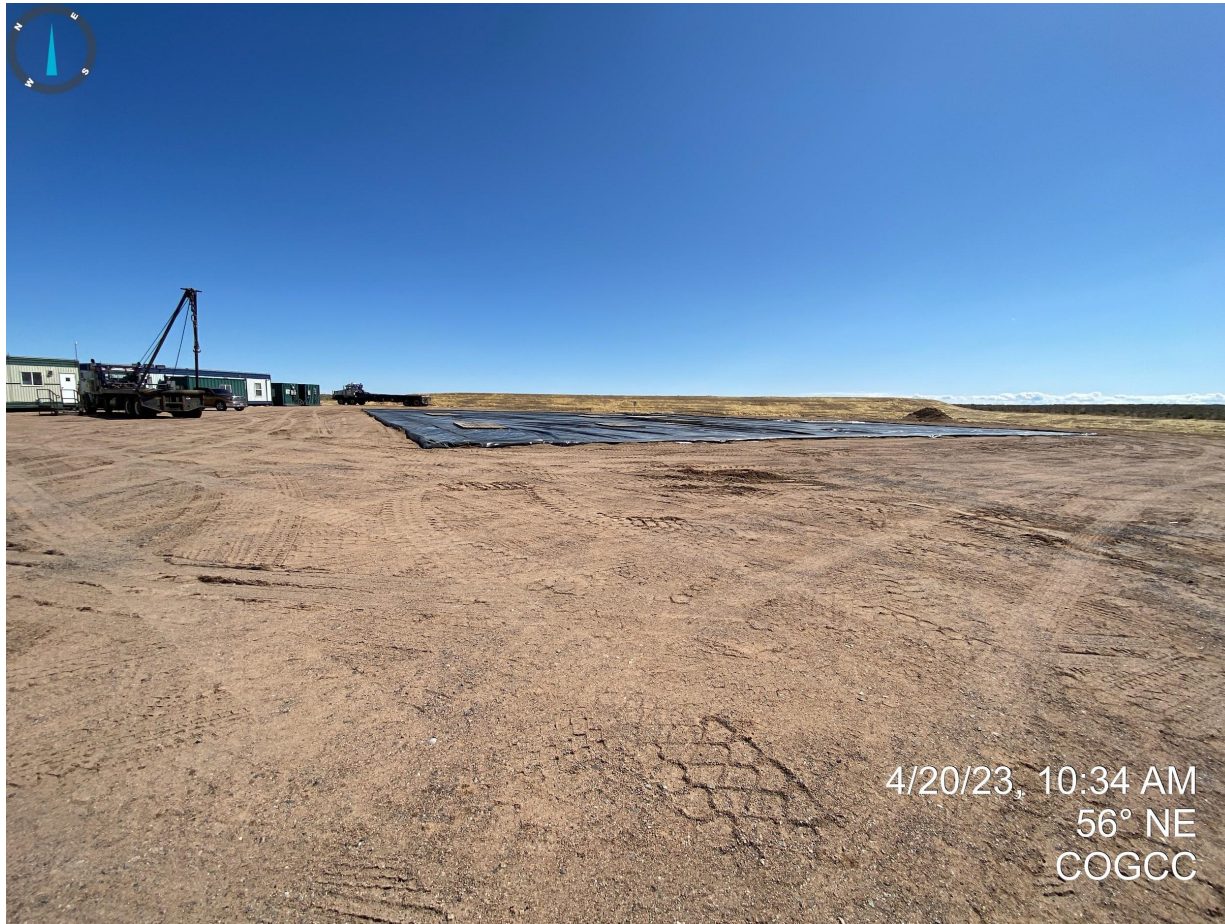
Photo 16. Overview of newly constructed production area.

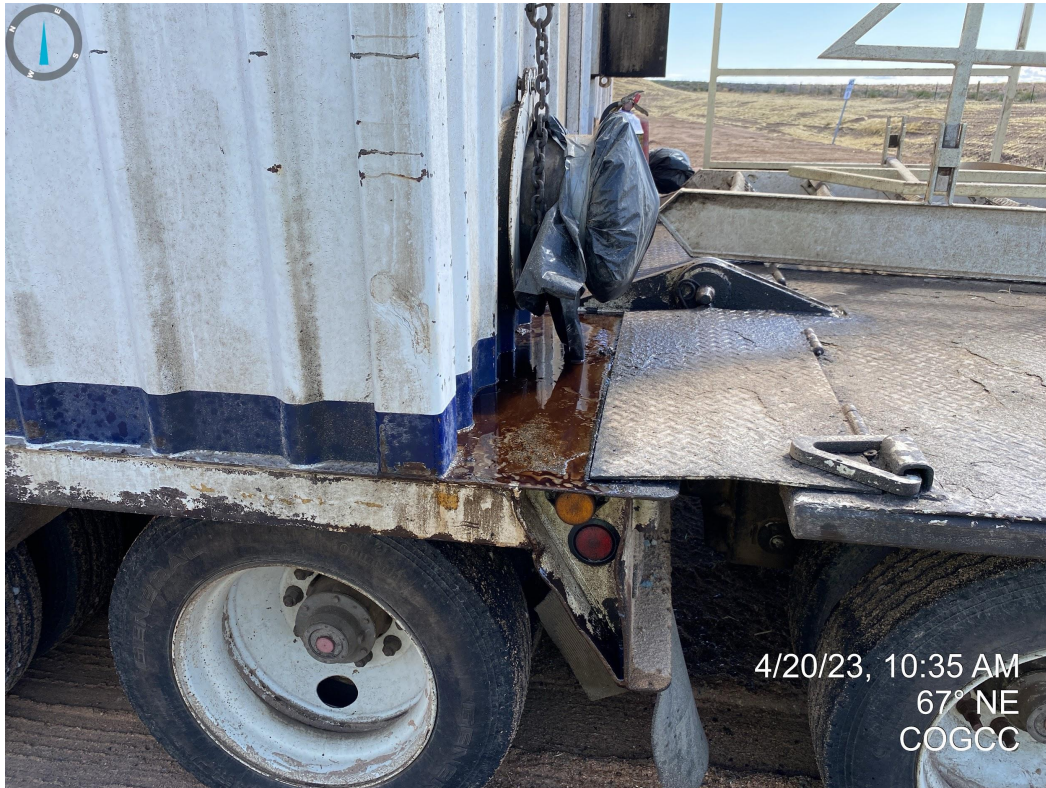
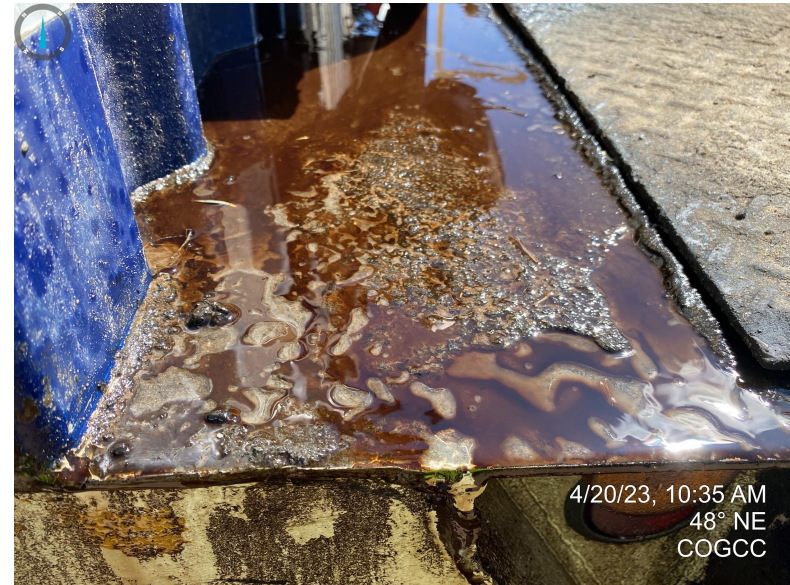
Photos 17 & 18. Close up photos of leaking equipment observed during this inspection. Unknown fluid had a chemical odor and will need to be properly disposed of in accordance with Rule 905.e.

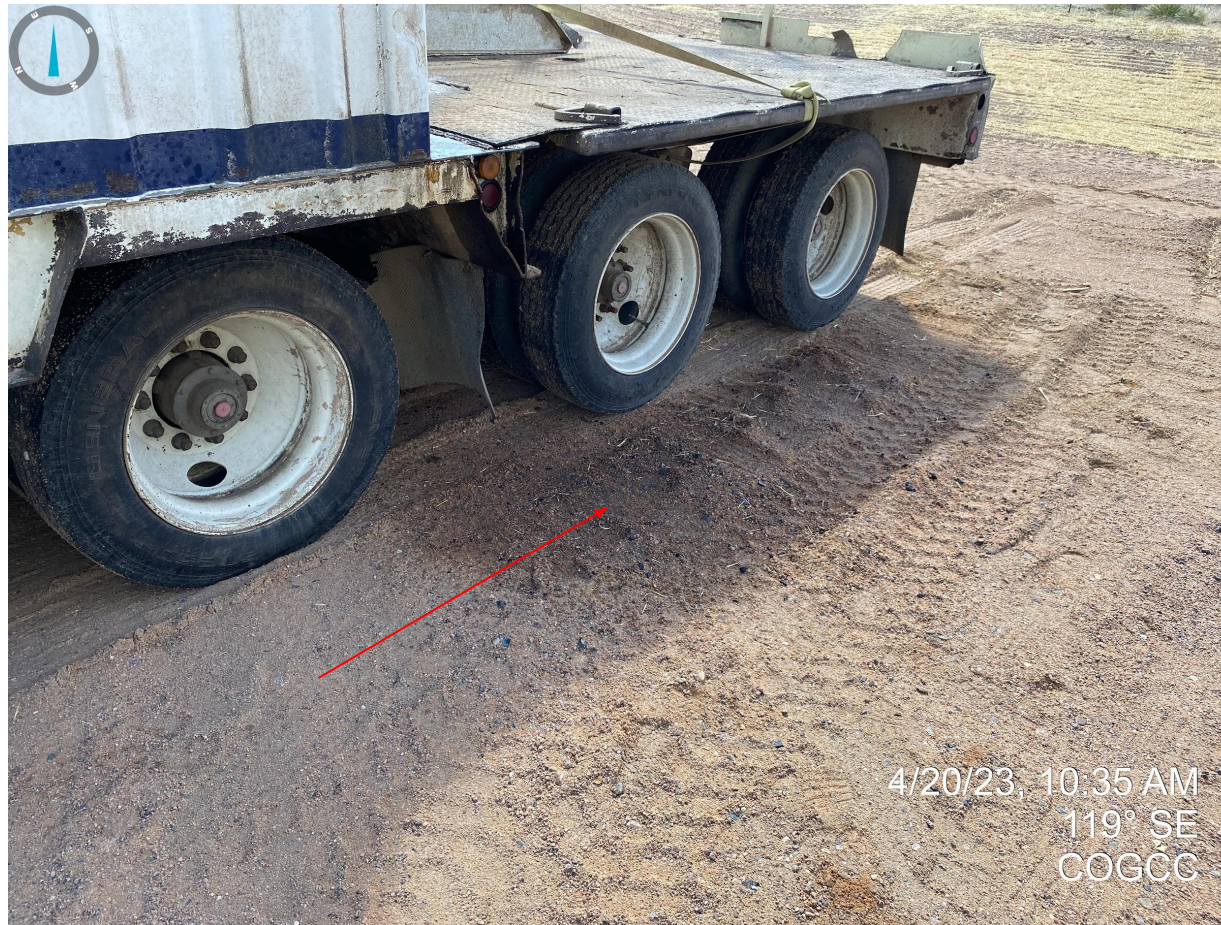
Photo 19. Stained soil from leaking equipment that will need to be properly disposed of per Rule 905.e.

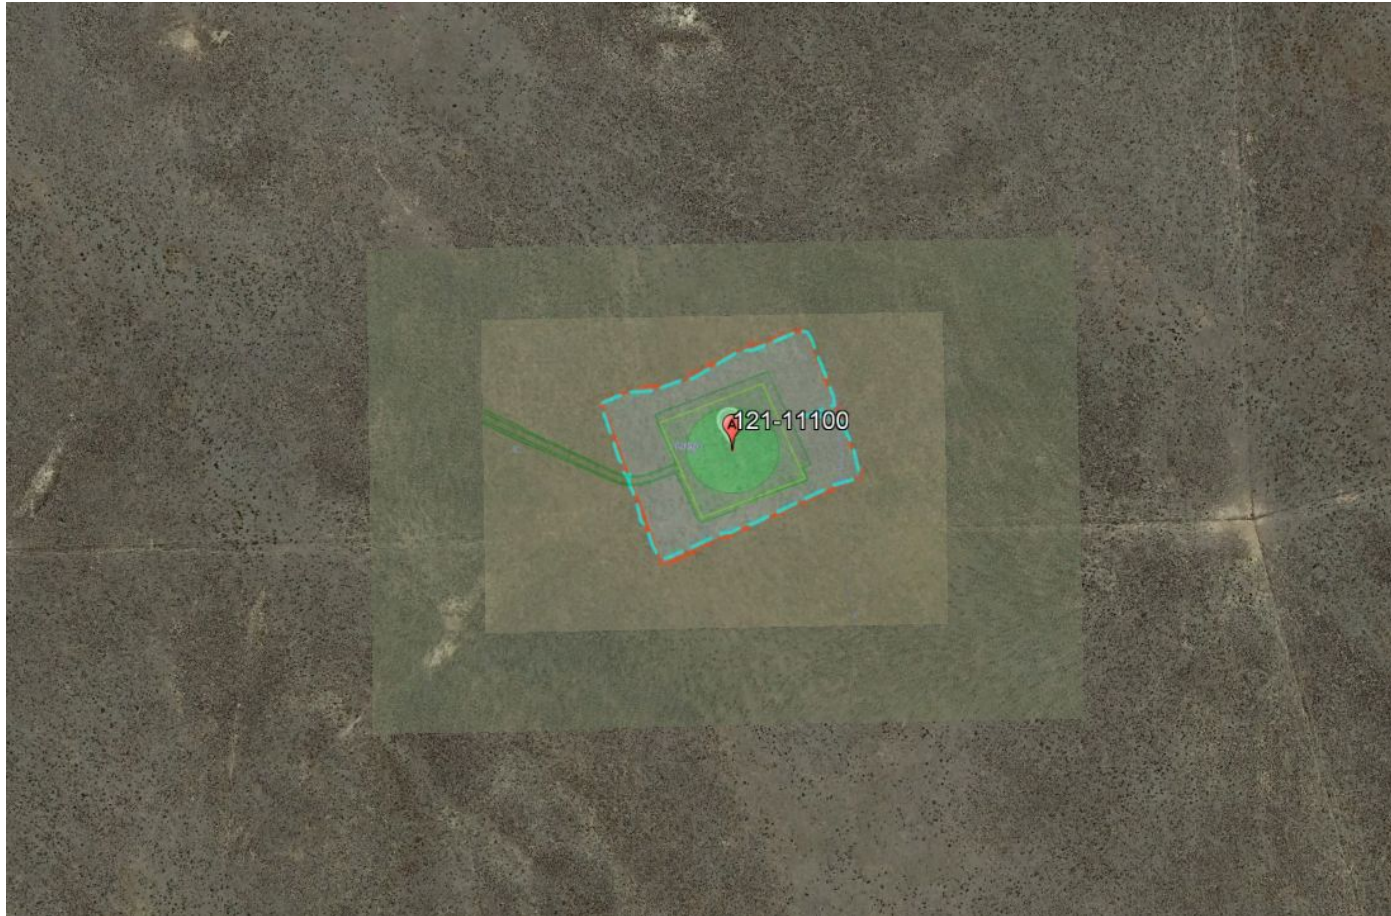
Photo 20. Google Earth aerial imagery with image overlay of permitted disturbance area of 2.57 acres (green outline; Doc #402998441) and Staff measured disturbance area of 4.64 acres (light blue/red line) See also Photo 21.
