Construction and Stormwater Inspection

Operator: DENOVA SEQUESTRATION LLC - 10790

Location ID: 483817

Inspection Document #: 708200178

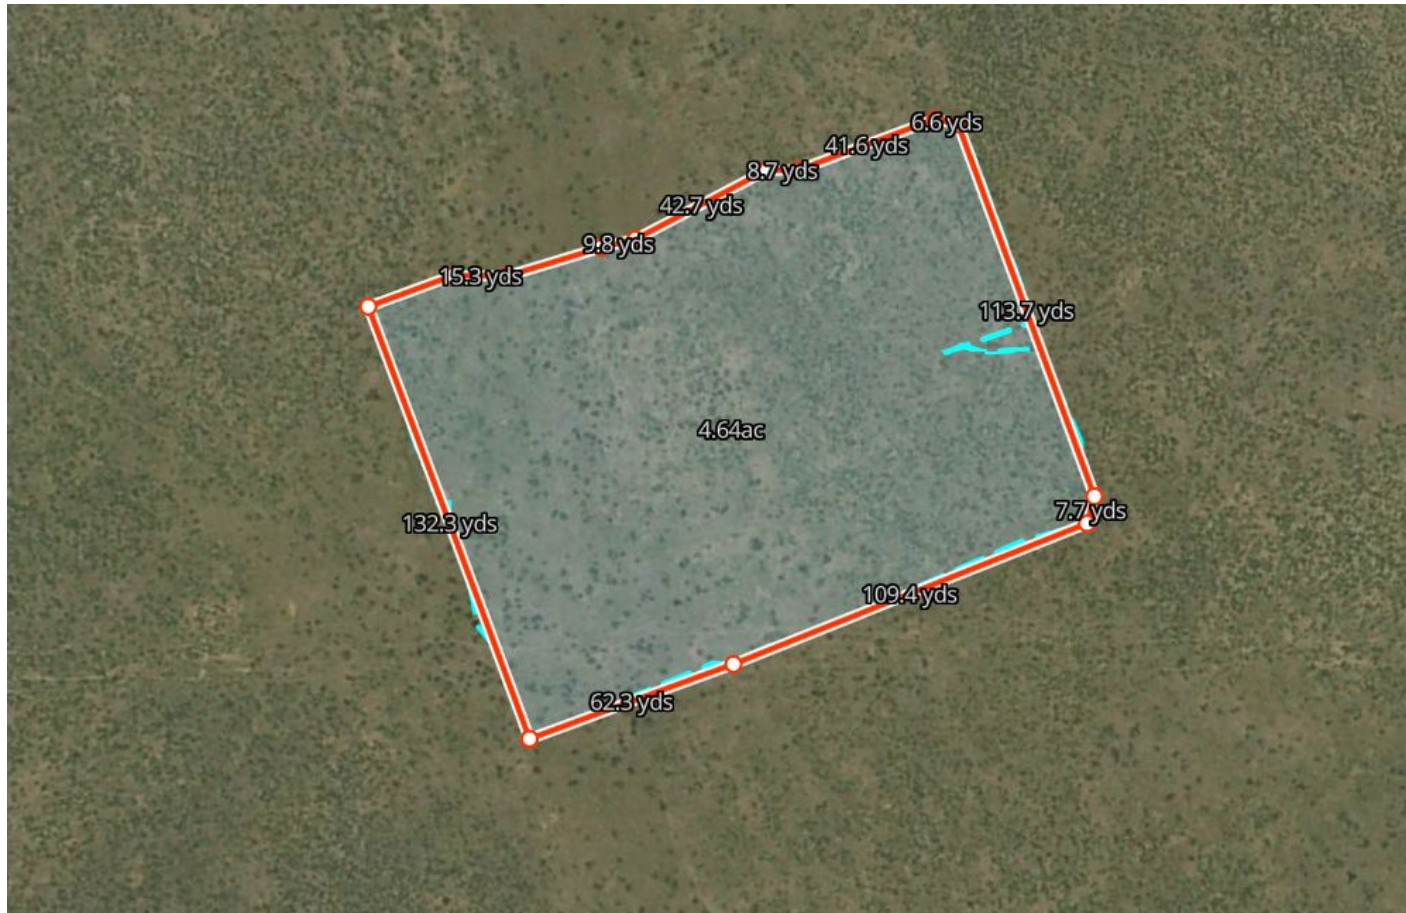
Photo 21. Staff measured 4.64 acres of disturbance area using OnX mapping software on 04/20/2023. This data was collected from inside of the perimeter fencing with additional disturbance detected exterior of the perimeter fence; see previous photos for examples.
