Inspection Photos

Location Name: TEP ROCKY MOUNTAIN LLC RMV 200-20 Pad

Location ID: 335263

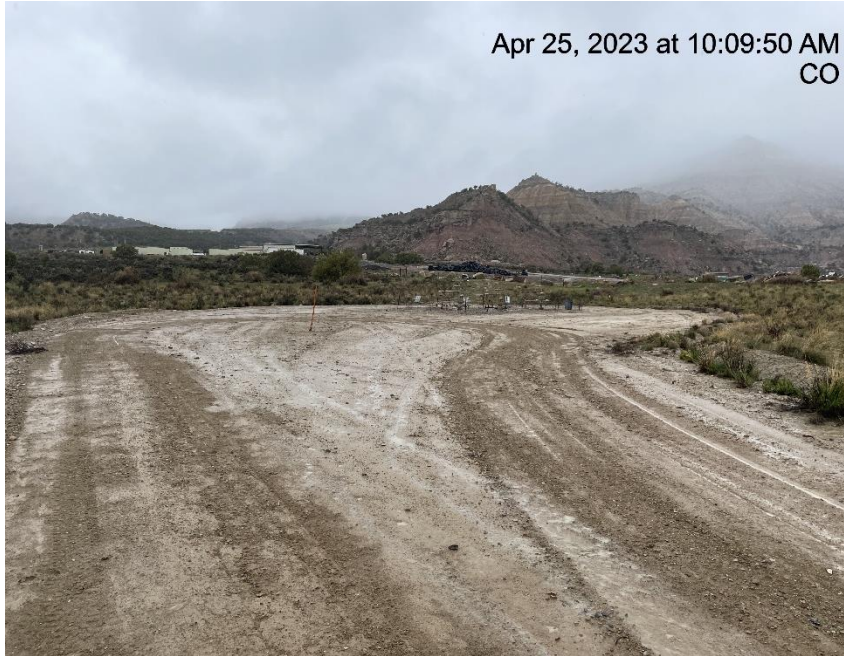
Photo # 6265 From entrance to location

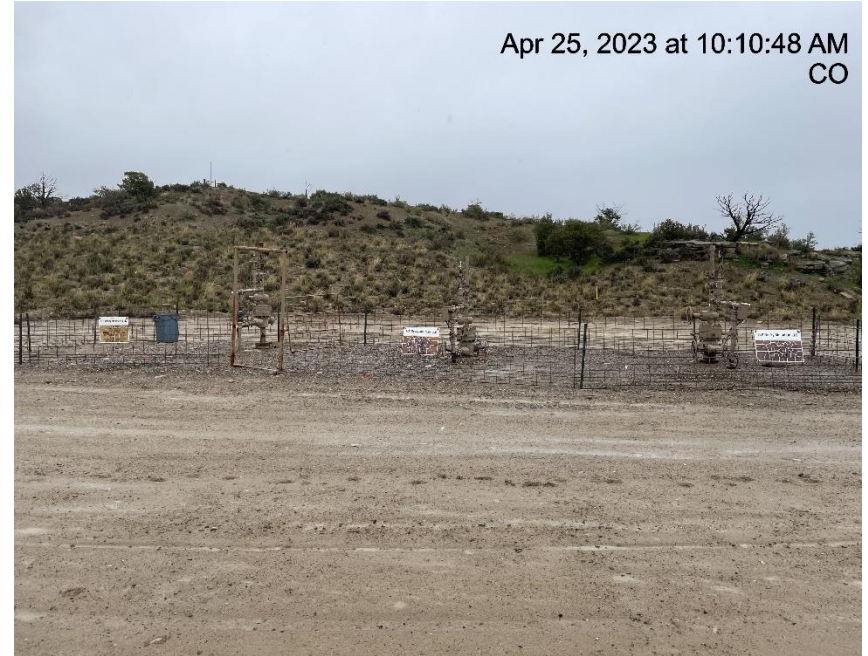
Photo # 6266 Location

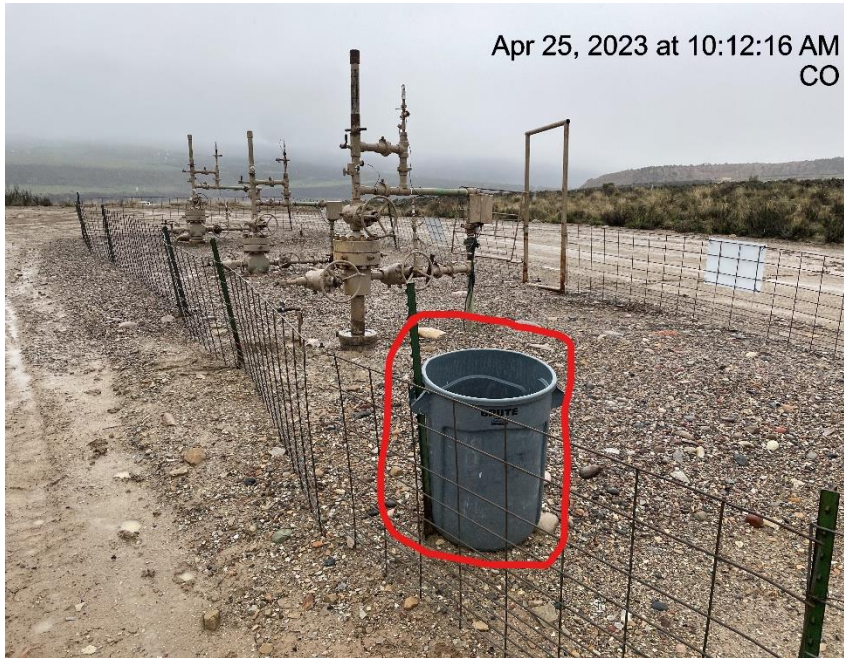
Photo # 6268 Debris

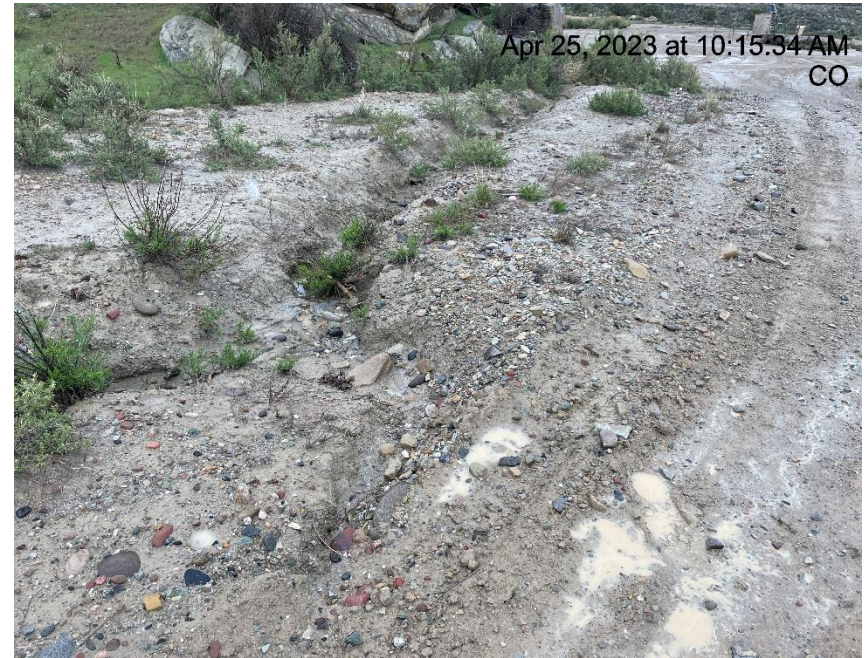
Photo # 6276 Erosion on edge of spur road near ditch

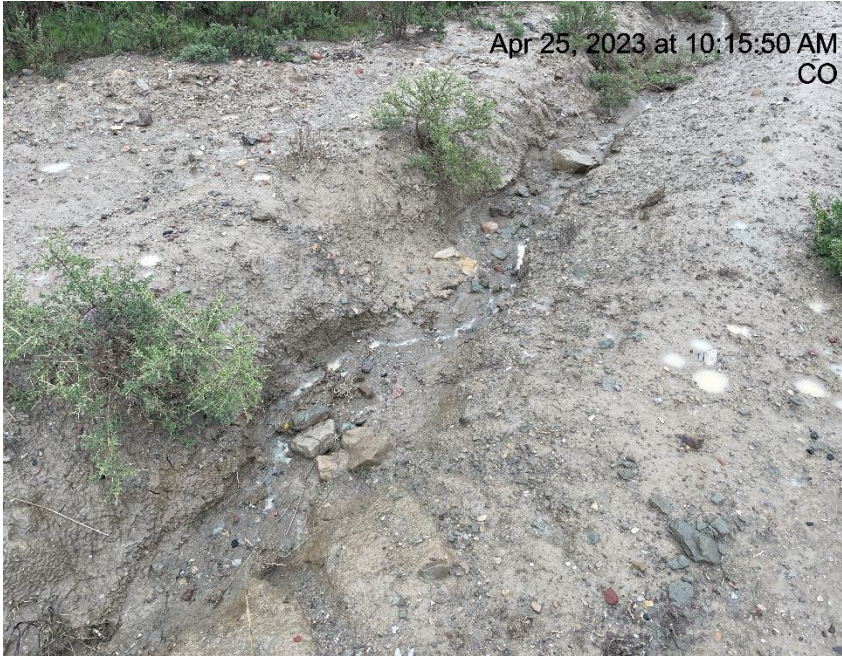
Photo # 6277 Check dam needs maintenance (in ditch along spur road)

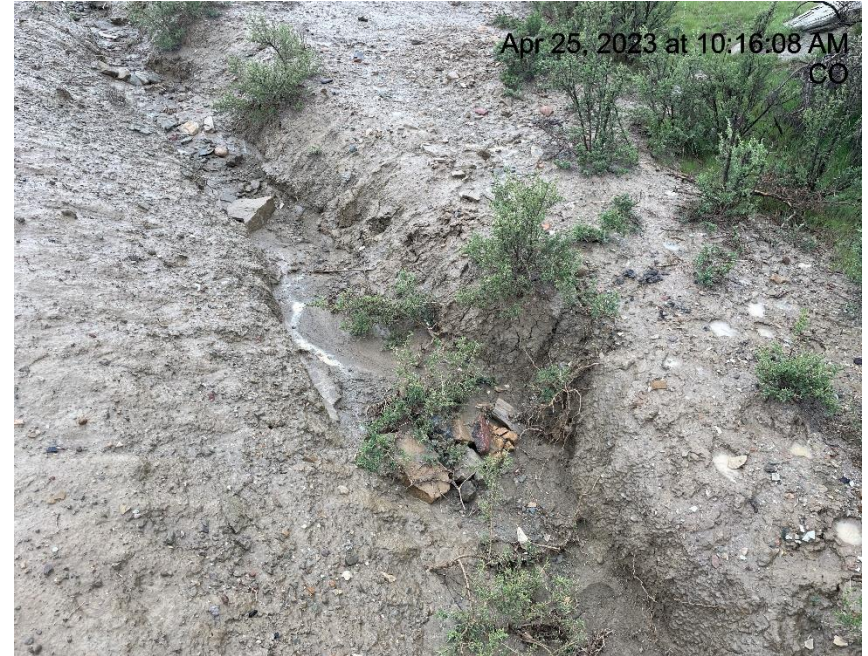
Photo # 6278 Check dam needs maintenance (in ditch along spur road)

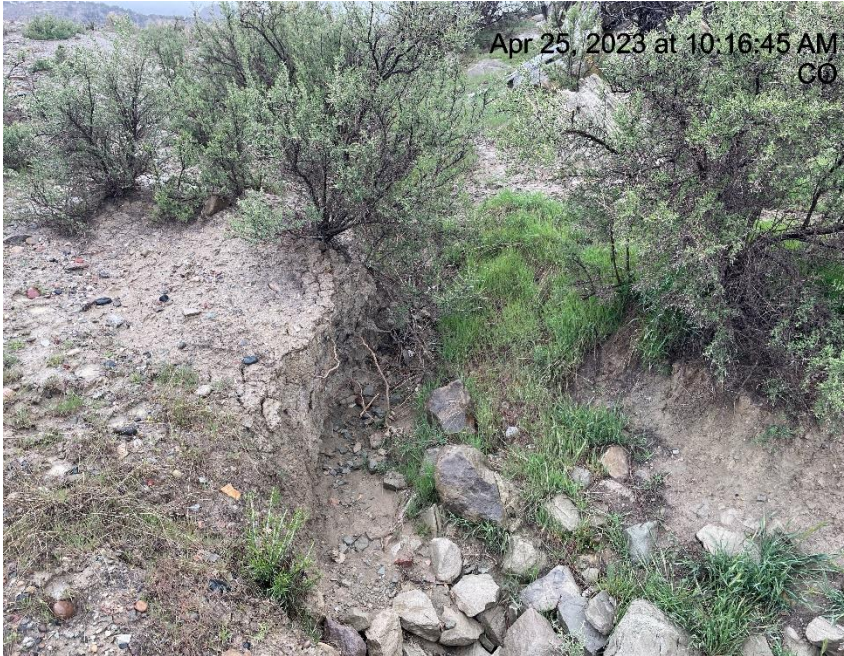
Photo # 6279 Ditch & rip rap need maintenance (along spur road)

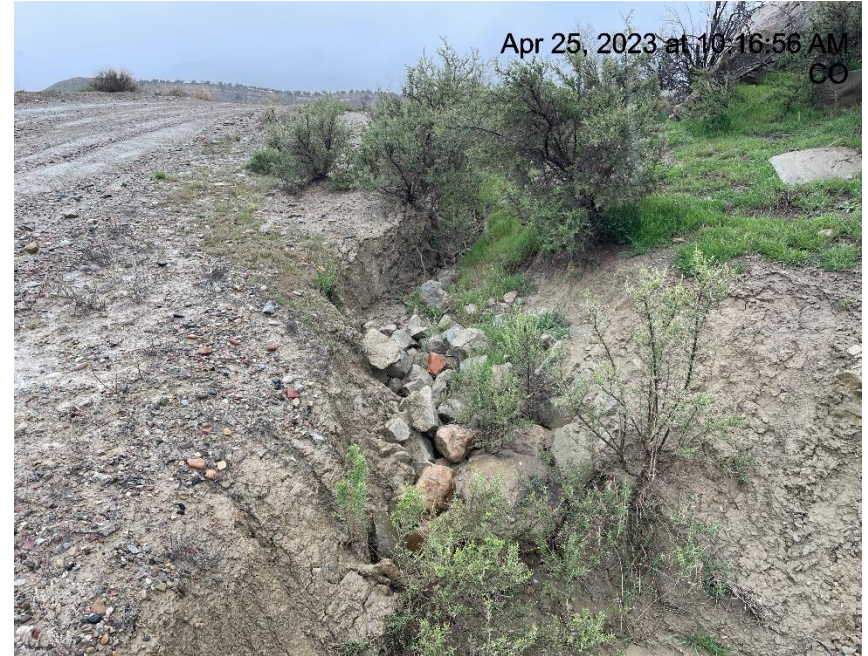
Photo # 6280 Ditch & rip rap need maintenance (along spur road)

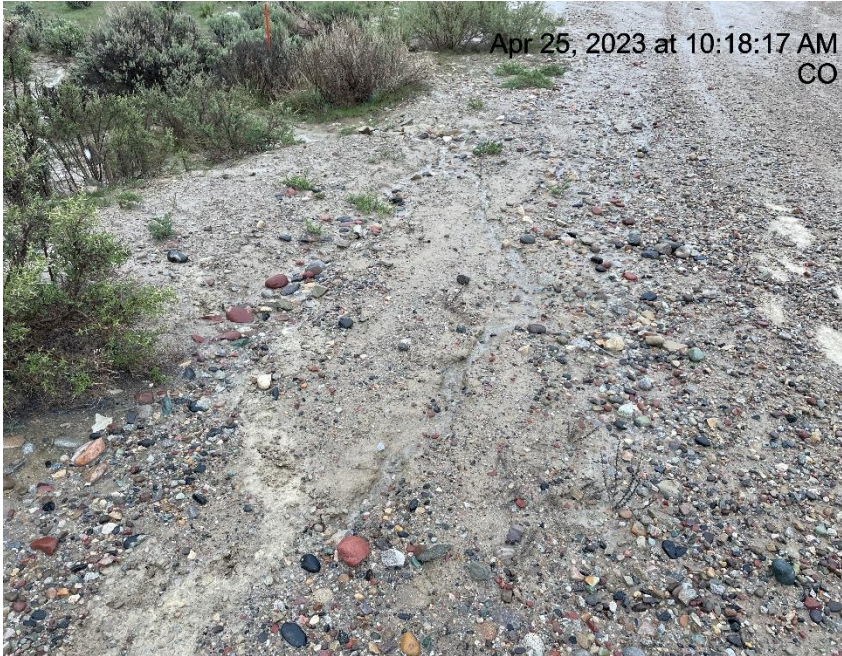
Photo # 6281 Erosion on spur road

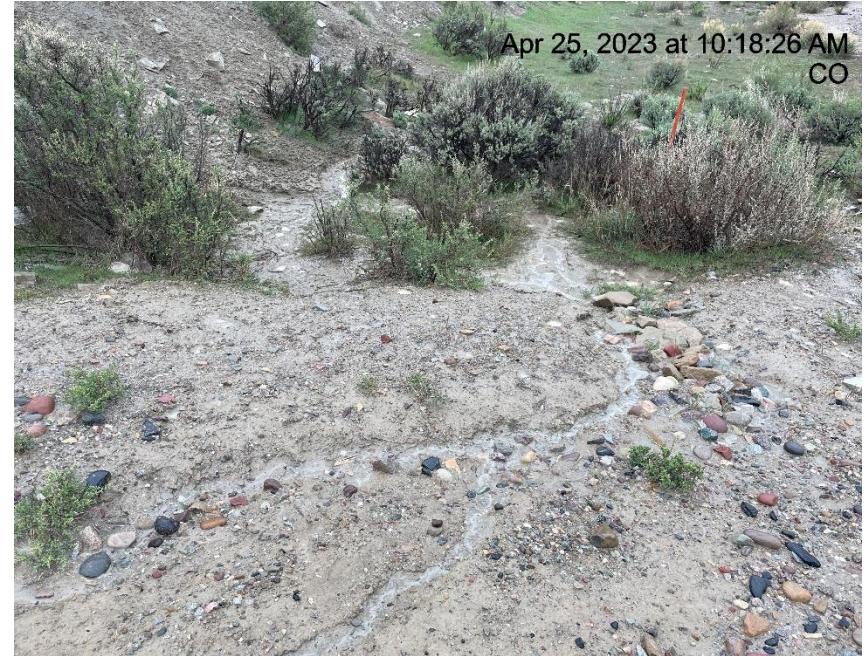
Photo # 6282 Erosion & transport of sediment off spur road & into vegetation

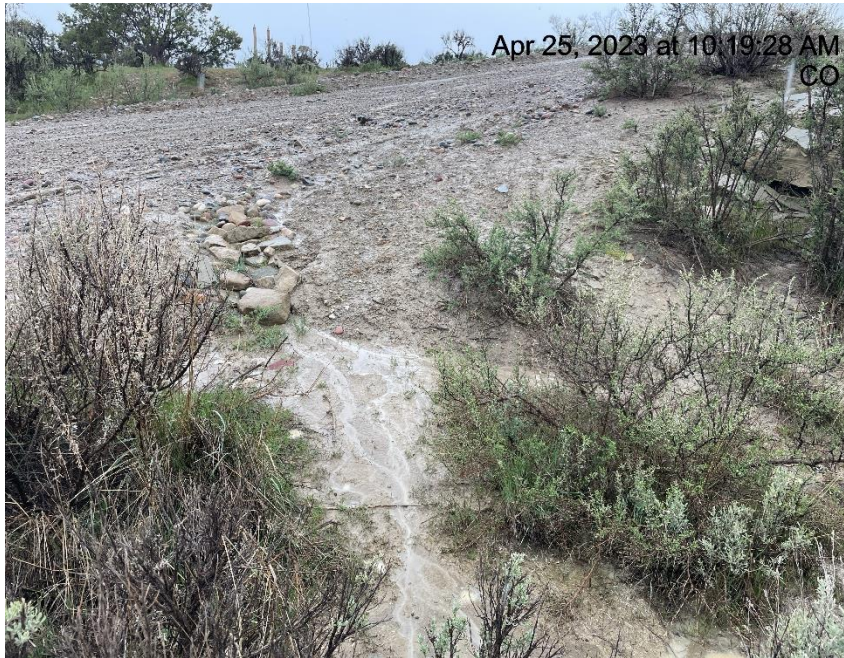
Photo # 6285 Erosion & transport of sediment off spur road into vegetation/insufficient BMP's

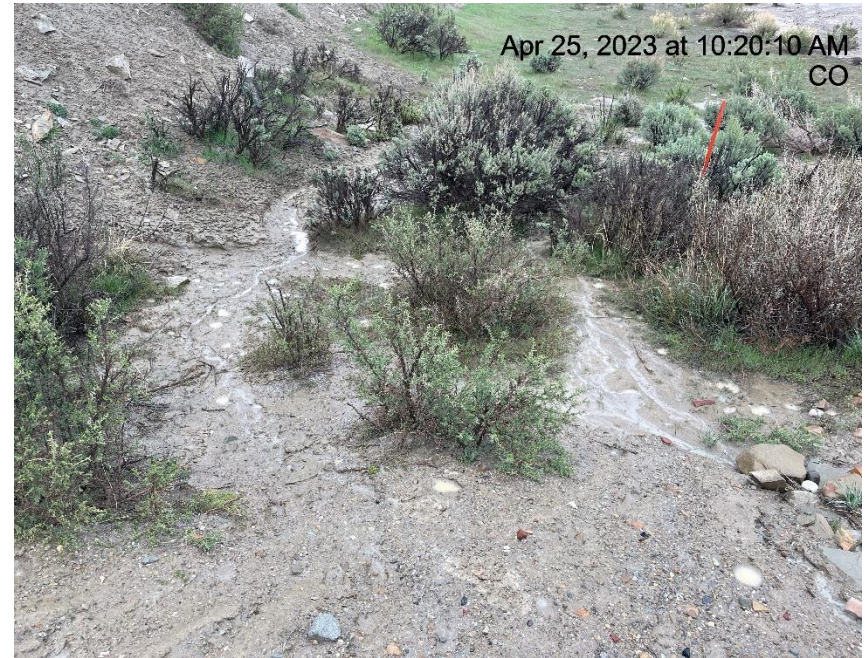
Photo # 6286 Erosion & transport of sediment off spur road into vegetation/insufficient BMP's

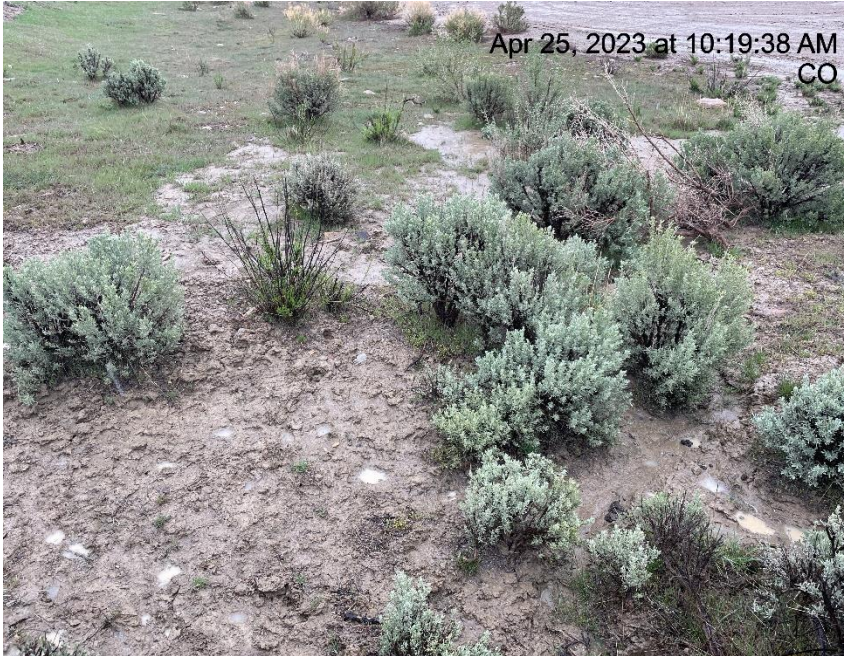
Photo # 6287 Transport of sediment off spur road into vegetation/insufficient BMP's

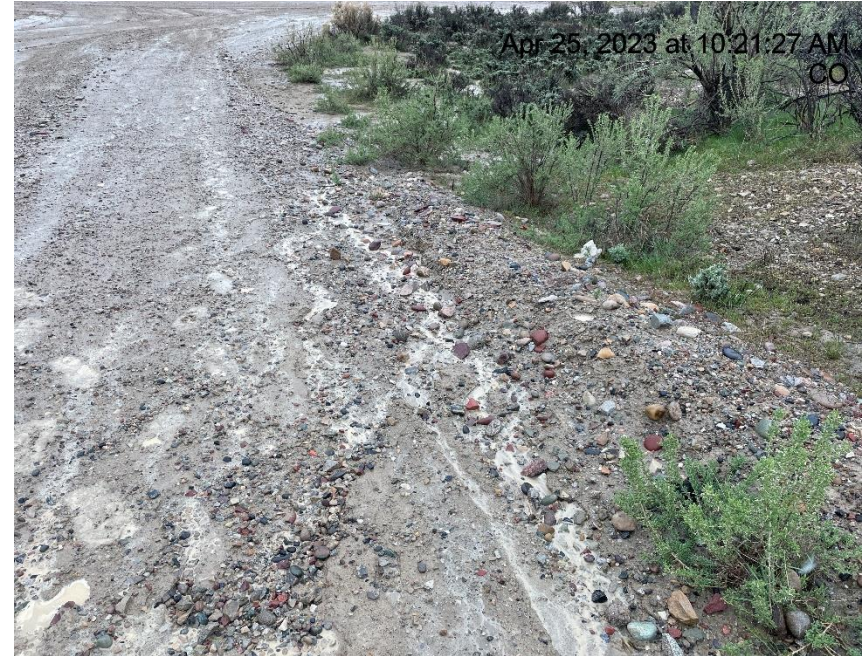
Photo # 6290 Erosion along edge of spur road

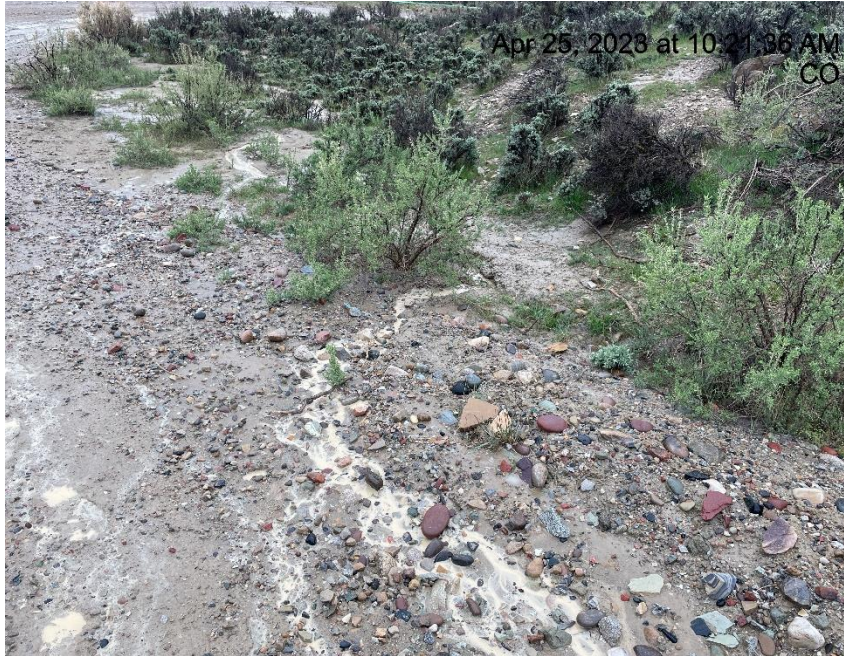
Photo # 6297 Erosion & transport of sediment off spur road into vegetation

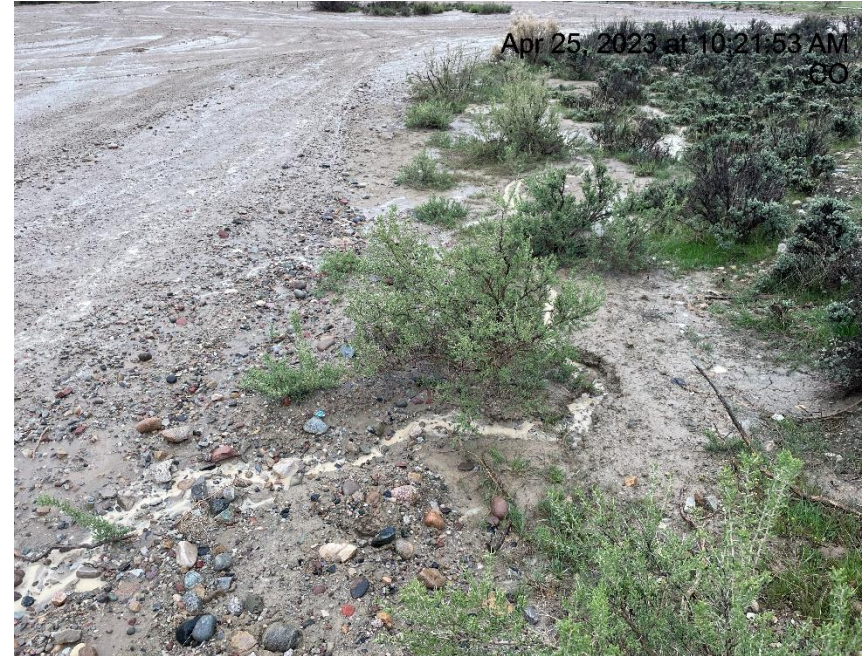
Photo # 6292 Erosion & transport of sediment off spur road into vegetation

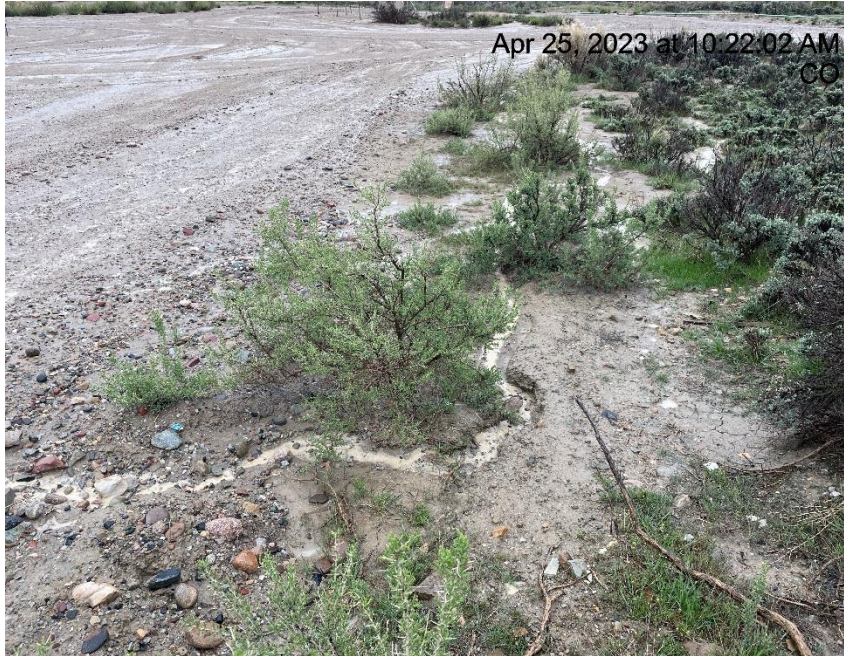
Photo # 6293 Erosion & transport of sediment off spur road into vegetation

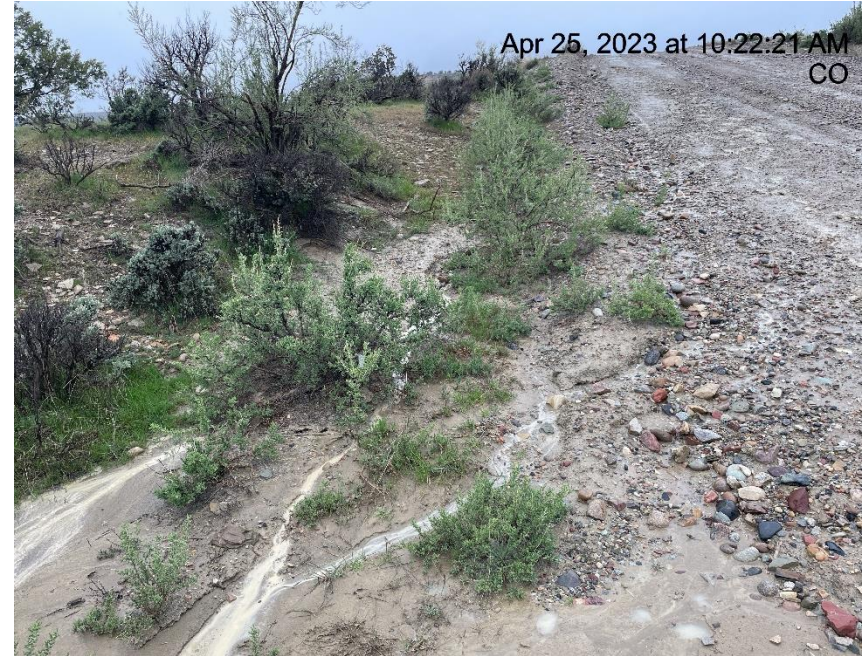
Photo # 6294 Erosion & transport of sediment off spur road into vegetation/insufficient BMP's

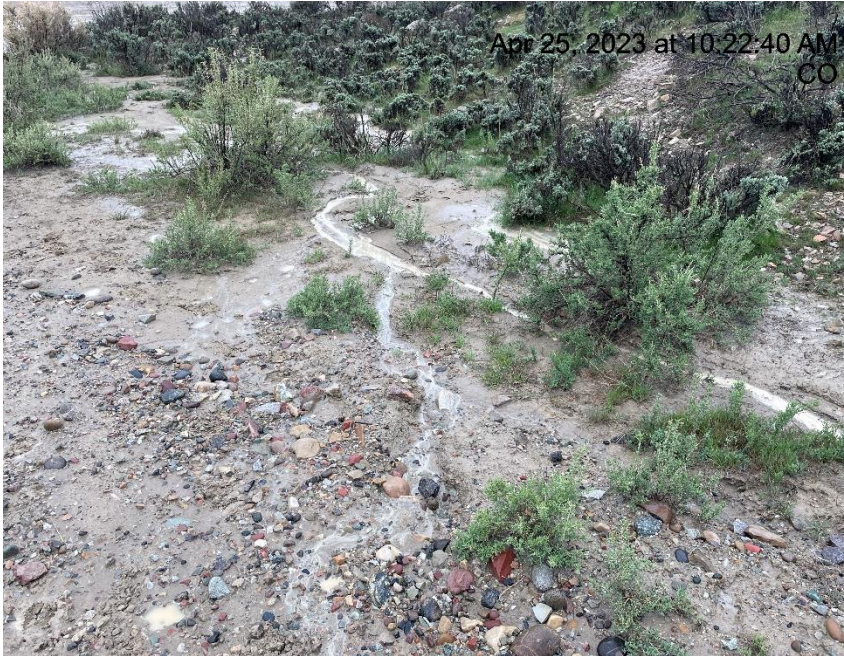
Photo # 6295 Erosion & transport of sediment off spur road into vegetation

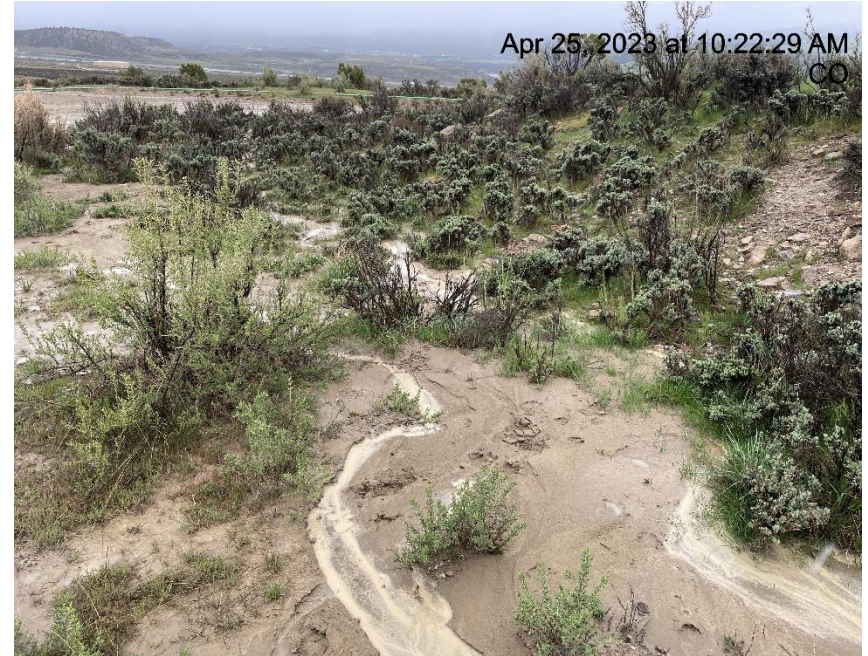
Photo # 6296 Erosion & transport of sediment off spur road into vegetation/insufficient BMP's

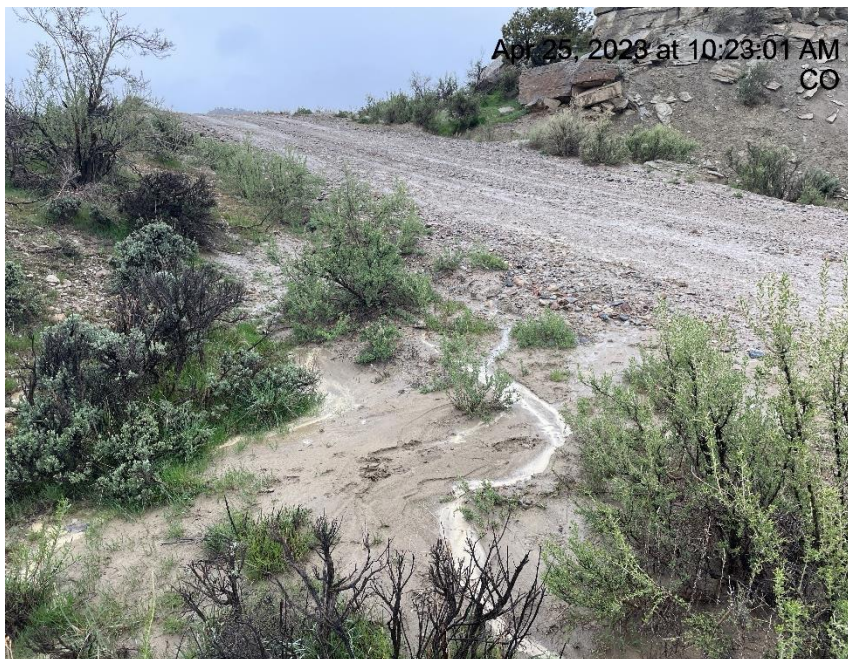
Photo # 6298 Erosion & transport of sediment off spur road into vegetation/insufficient BMP's

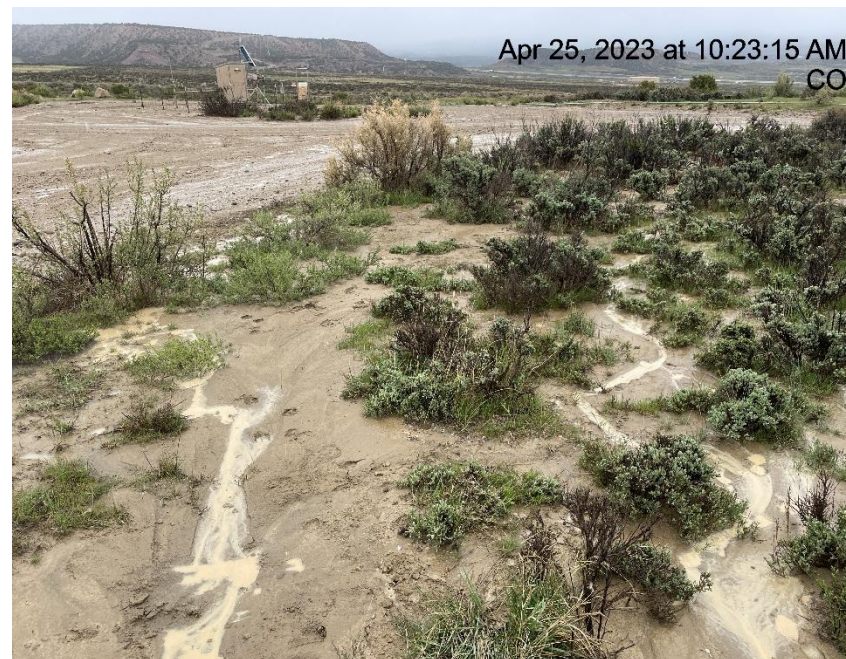
Photo # 6299 Erosion & transport of sediment off spur road into vegetation/insufficient BMP's
