Inspection Photos
Seeley Spargo 1-36
API 033-06091

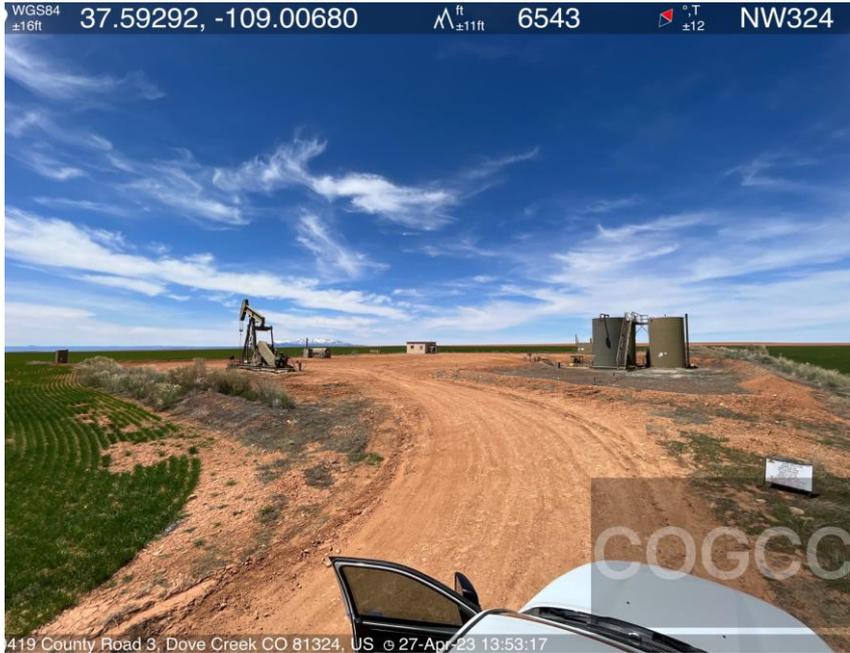
Photo #1. Overview of well location.

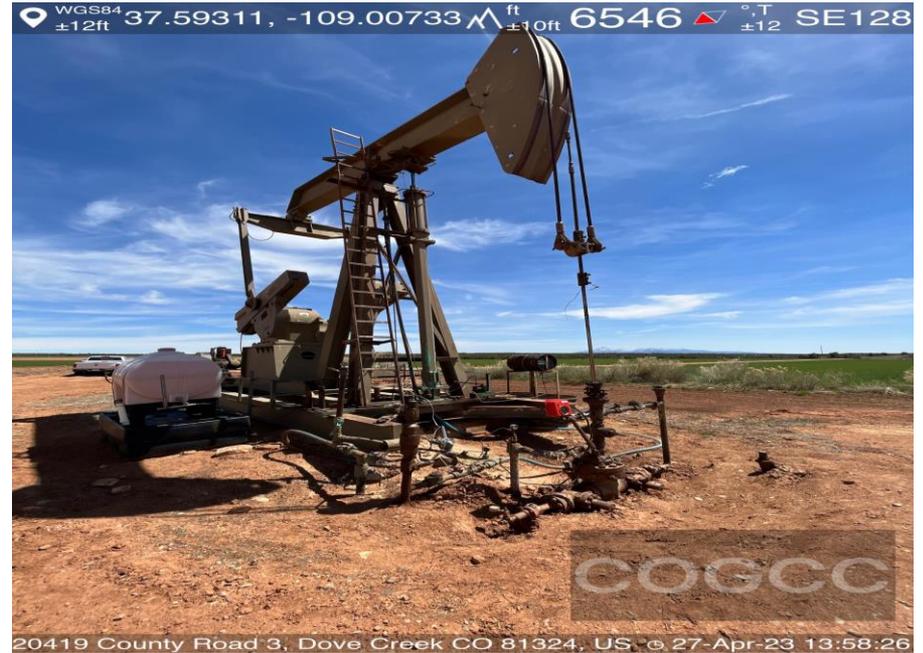
Photo #2. View of wellhead and flowline assembly.

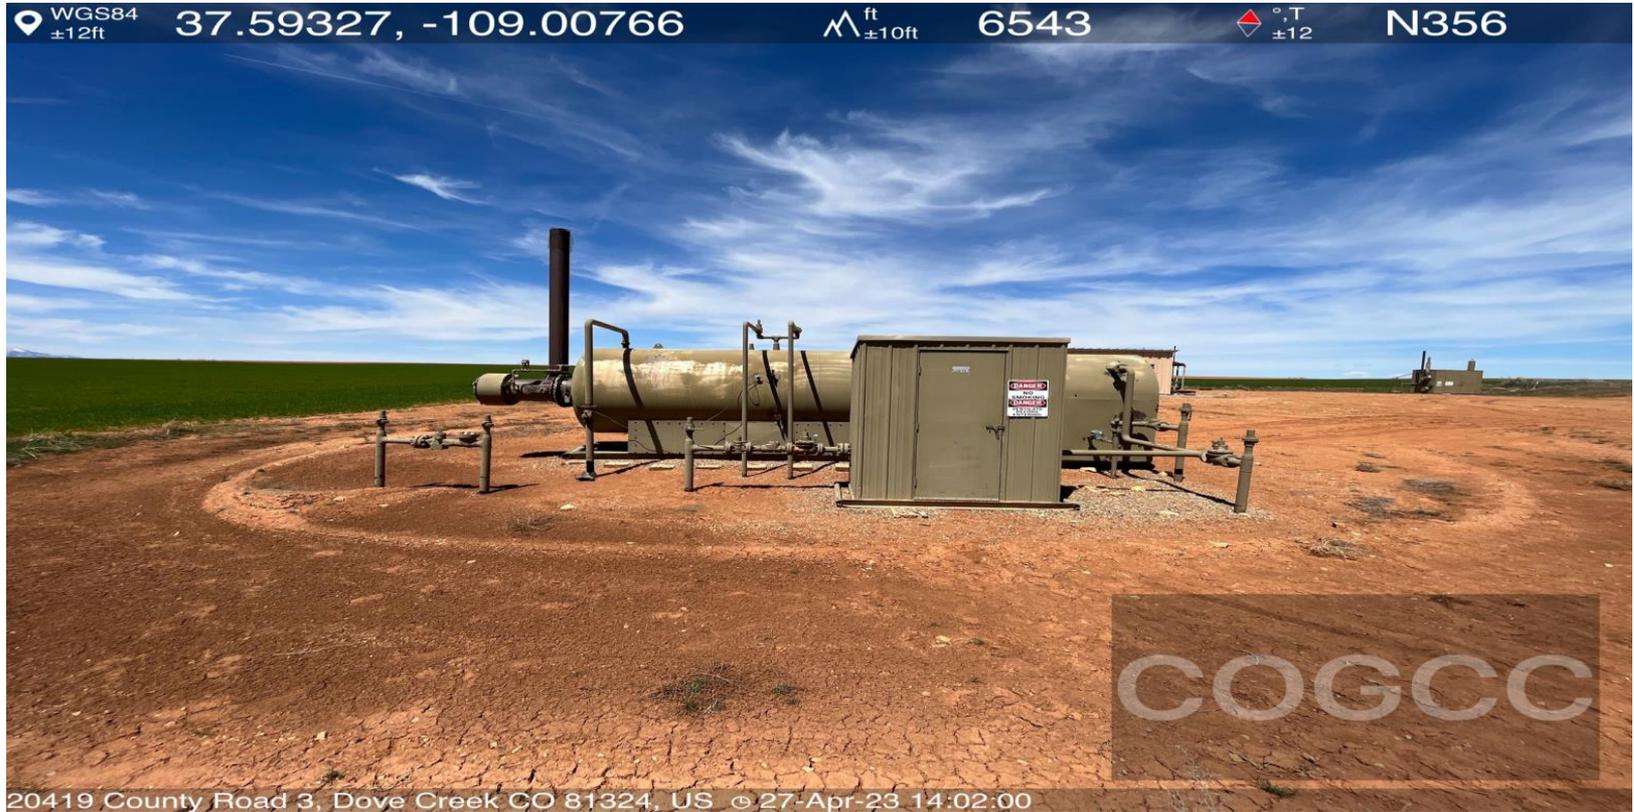
Photo #3. Horizontal separator (westside #1) eroded containment berm.

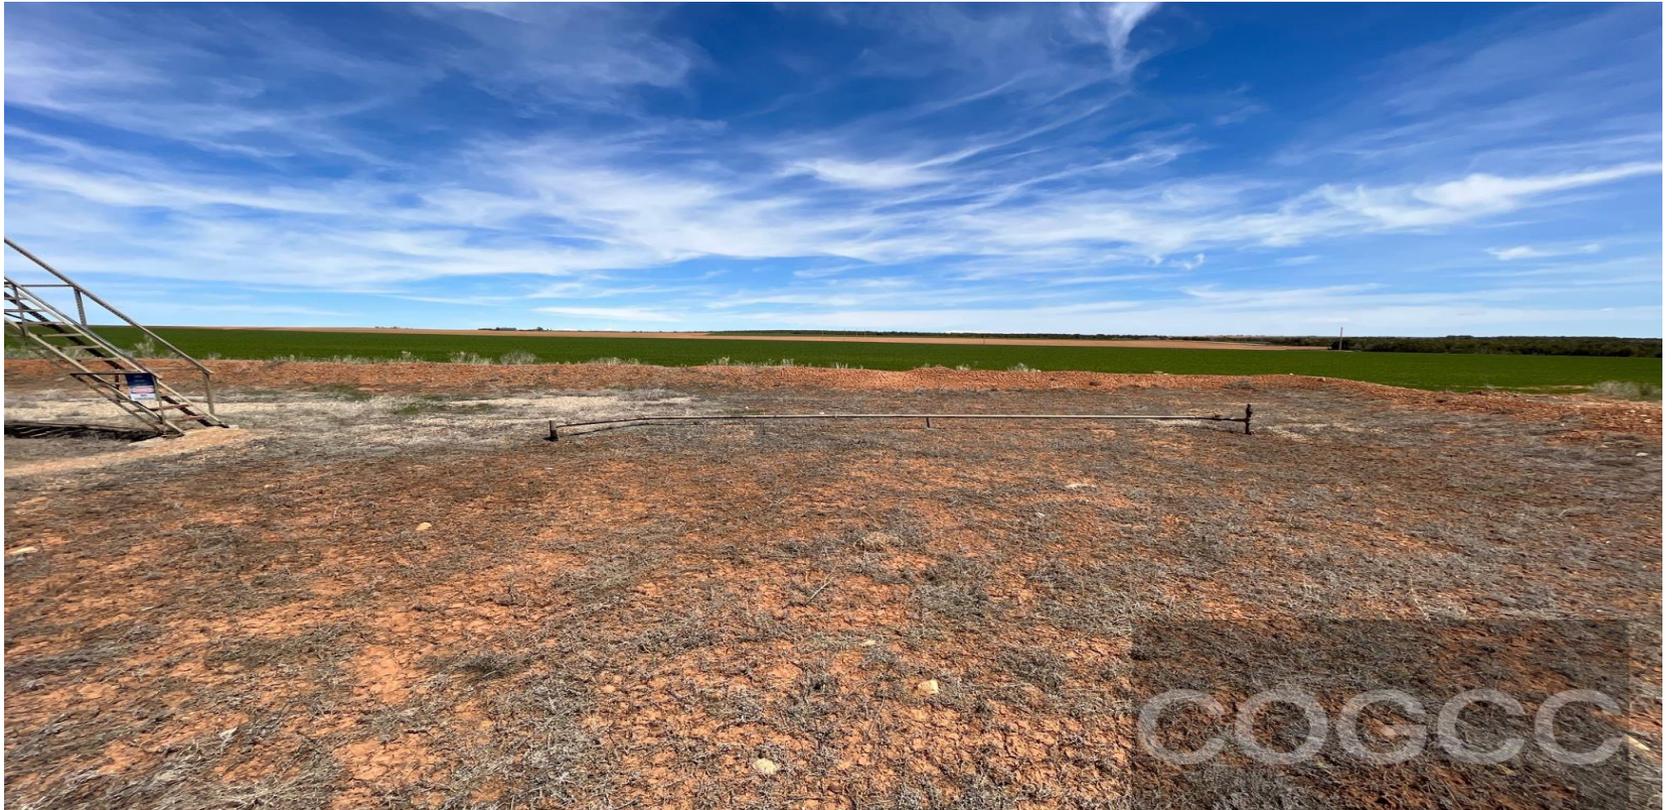
Photo #4. Abandoned flow line in tank battery.
