Storm Water Management and Erosion control

Location Name: McPherson A

Location #: 335539

COLORADO
Oil & Gas Conservation
Commission
Department of Natural Resources

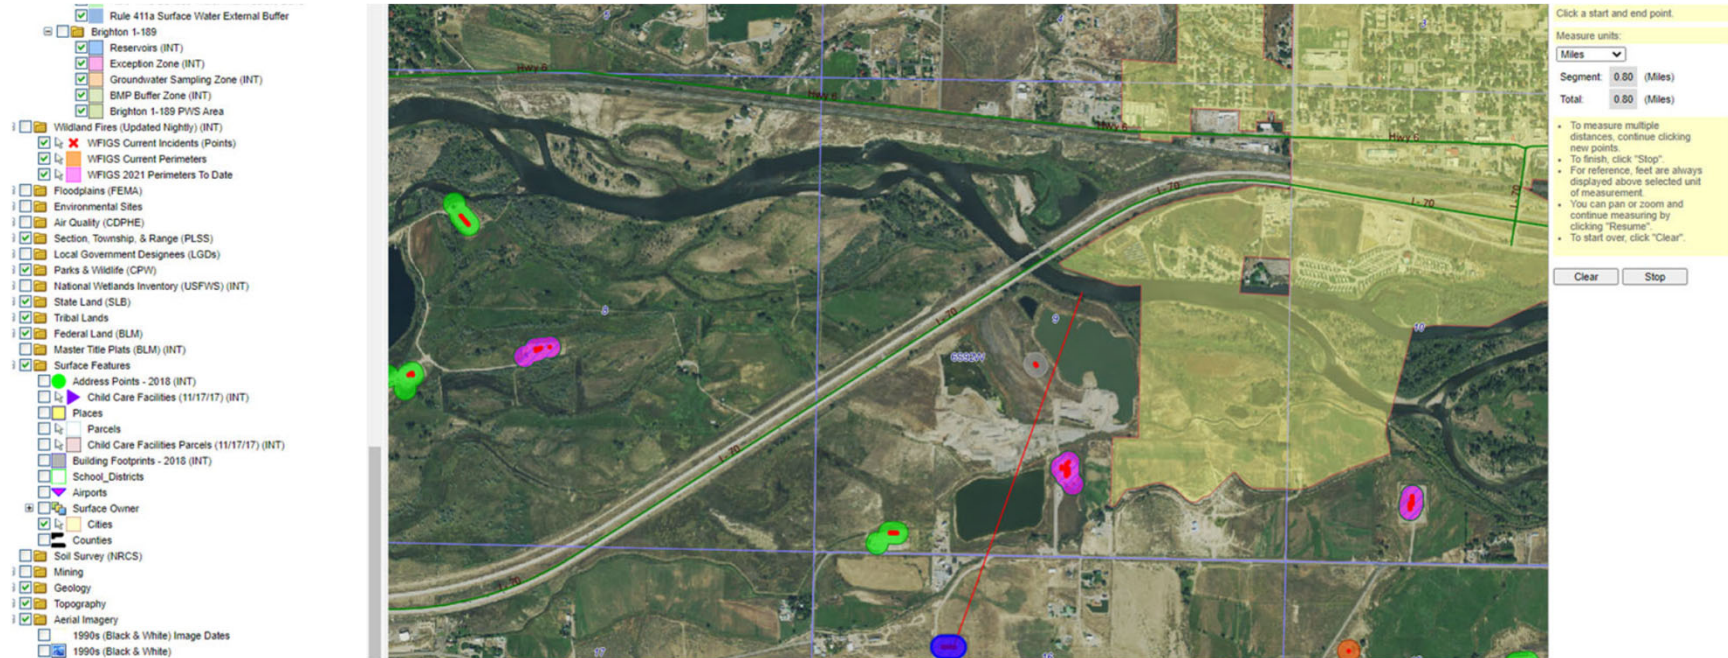
Location Overview : Location is approximately 8/10ths of a mile from the Colorado river.

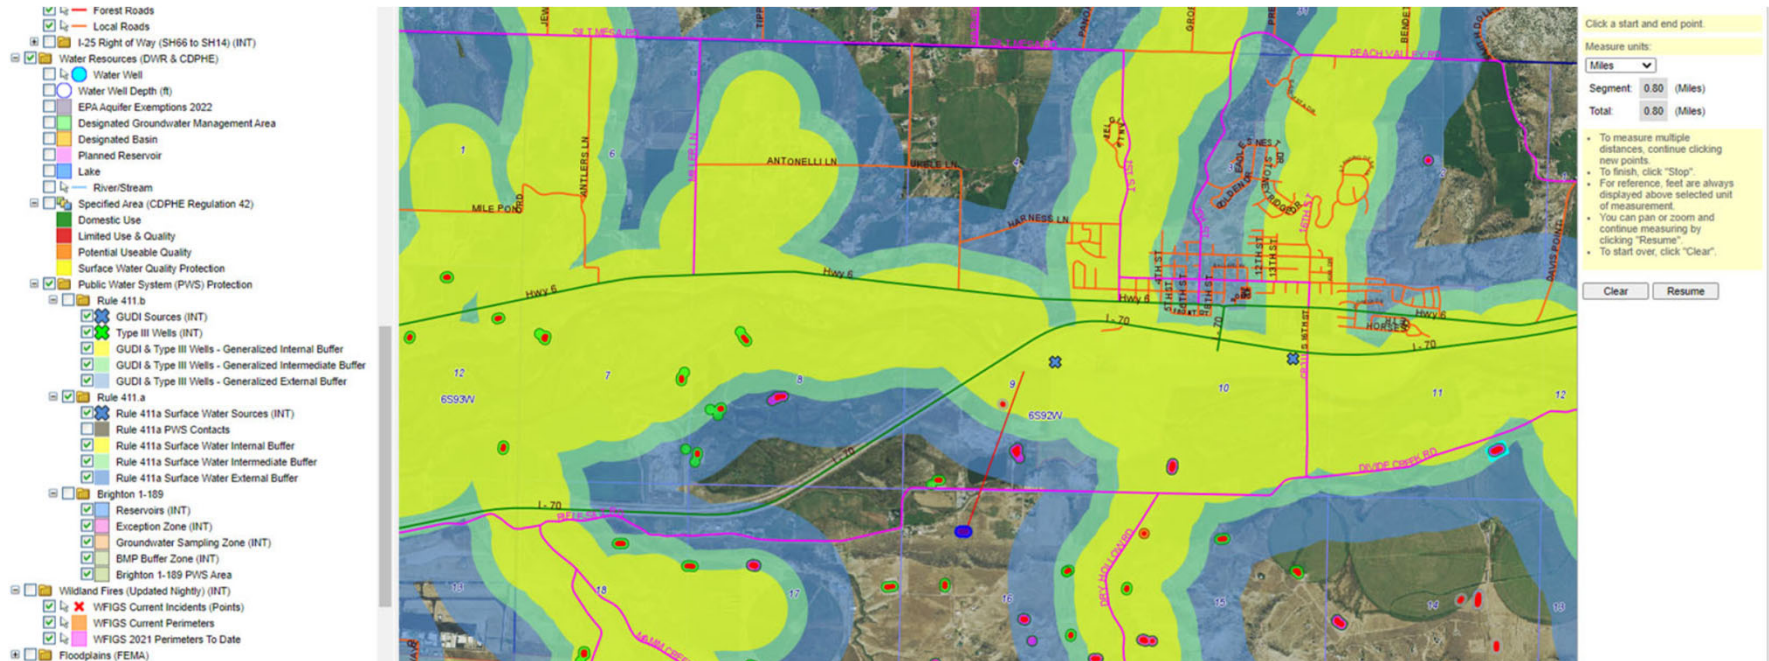
Location Overview : Location is with close proximity to the 411 Public Water System Protection

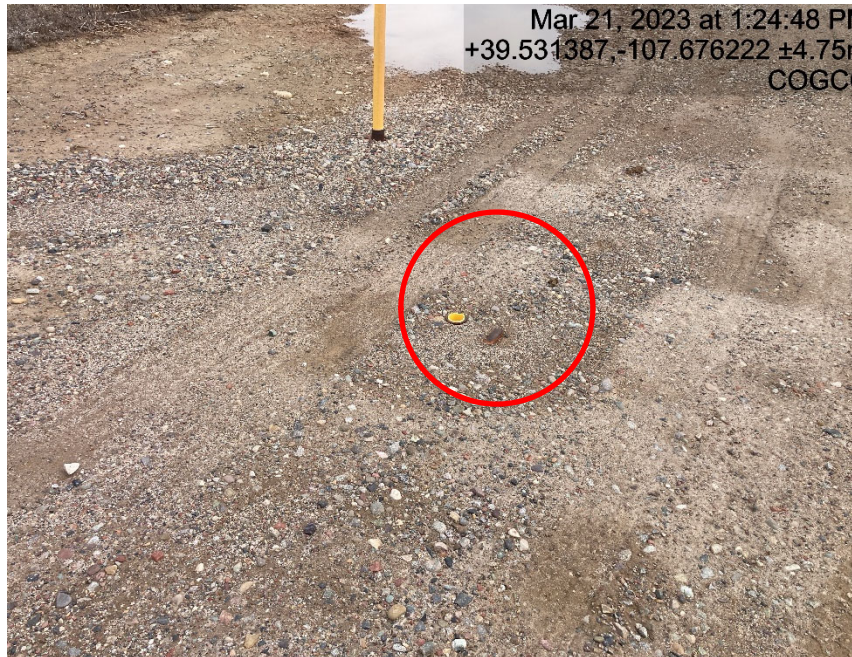
Unmarked dead man, photo from previous inspection.

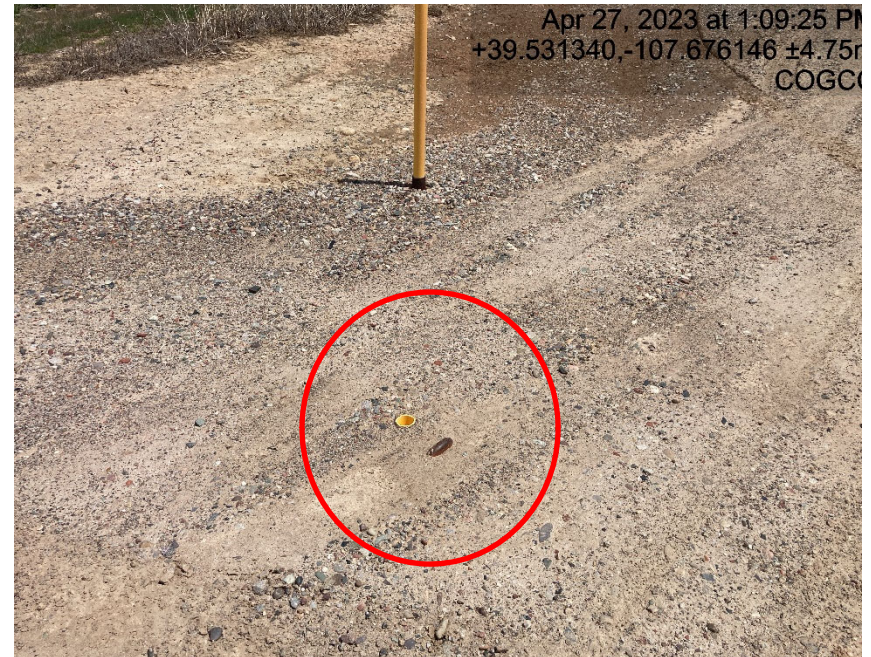
Unmarked dead man, photo from follow up inspection.

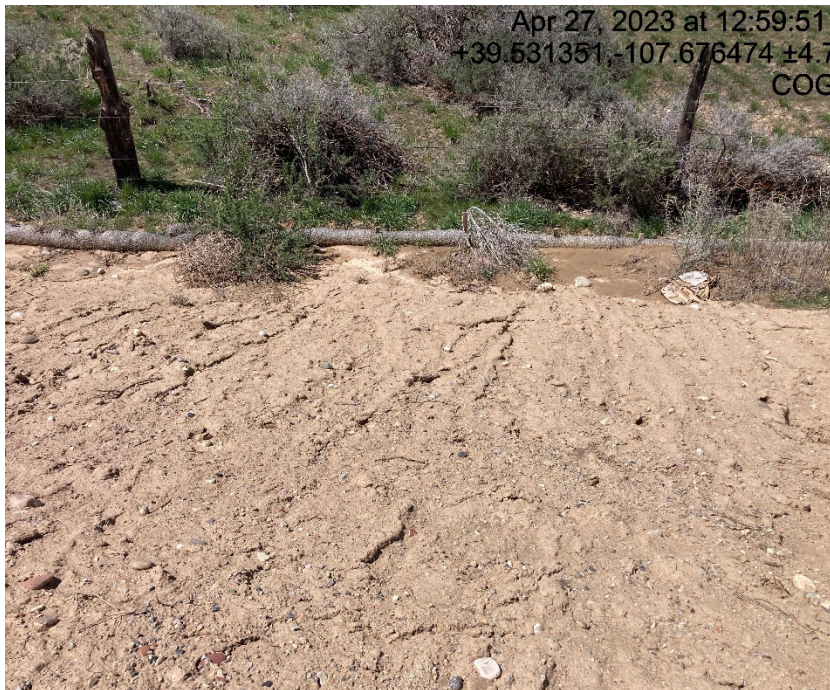
Fill slope shows lack of stabilization, Photo from
Follow up inspection

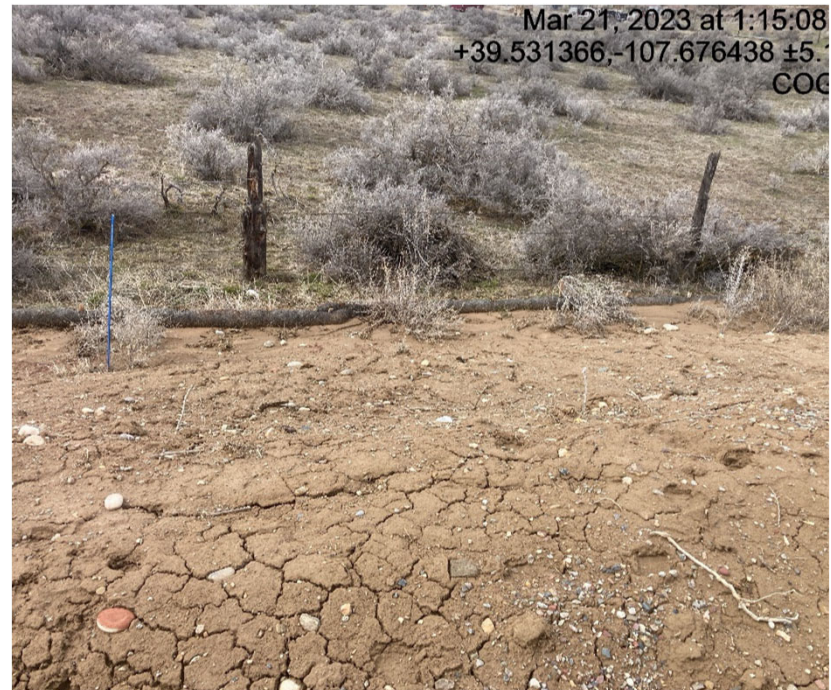
Fill slope shows lack of stabilization, Photo from
previous inspection

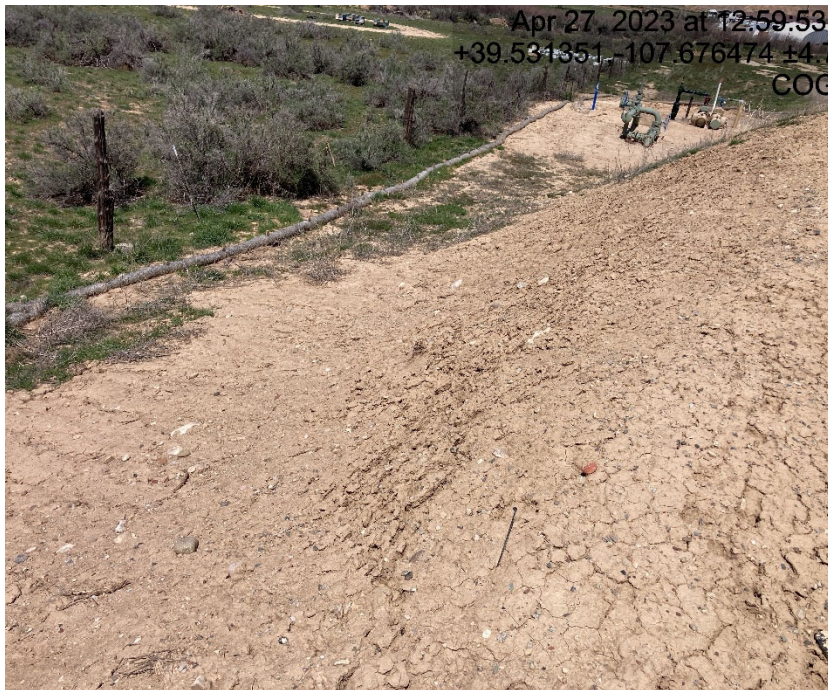
Fill slope shows lack of stabilization, Photo from
Follow up inspection

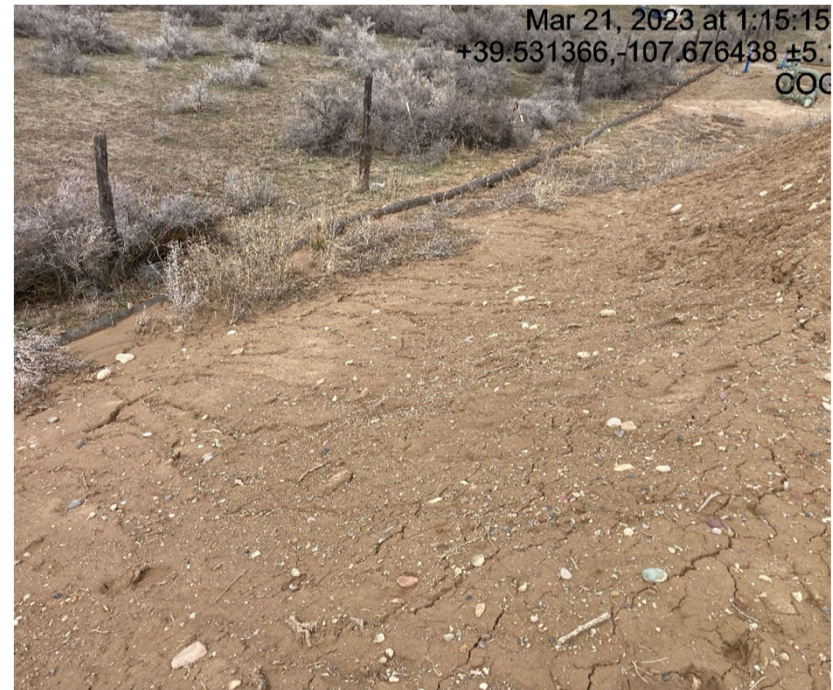
Fill slope shows lack of stabilization, Photo from
previous inspection

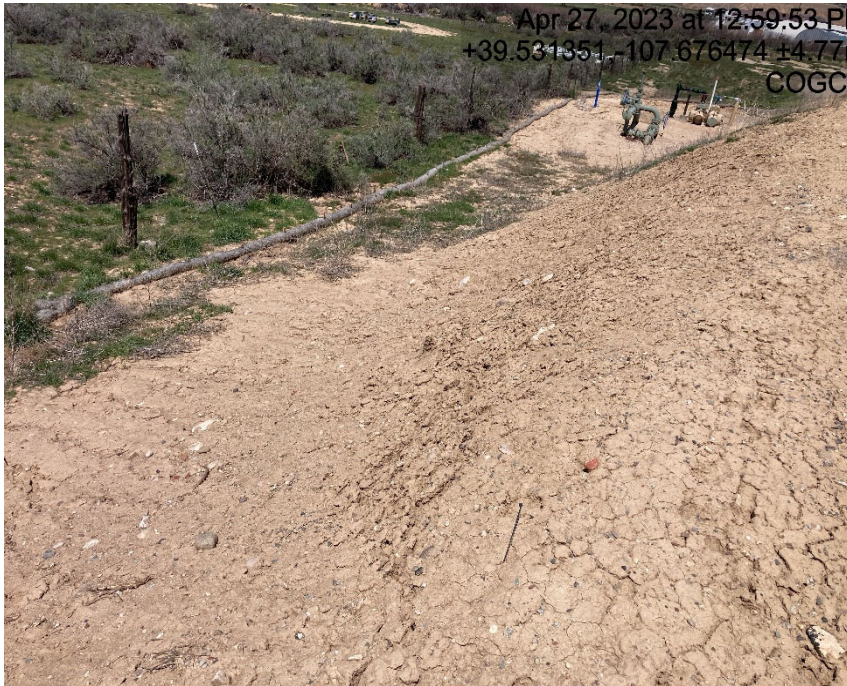
Fill slope shows lack of stabilization, Photo from
Follow up inspection

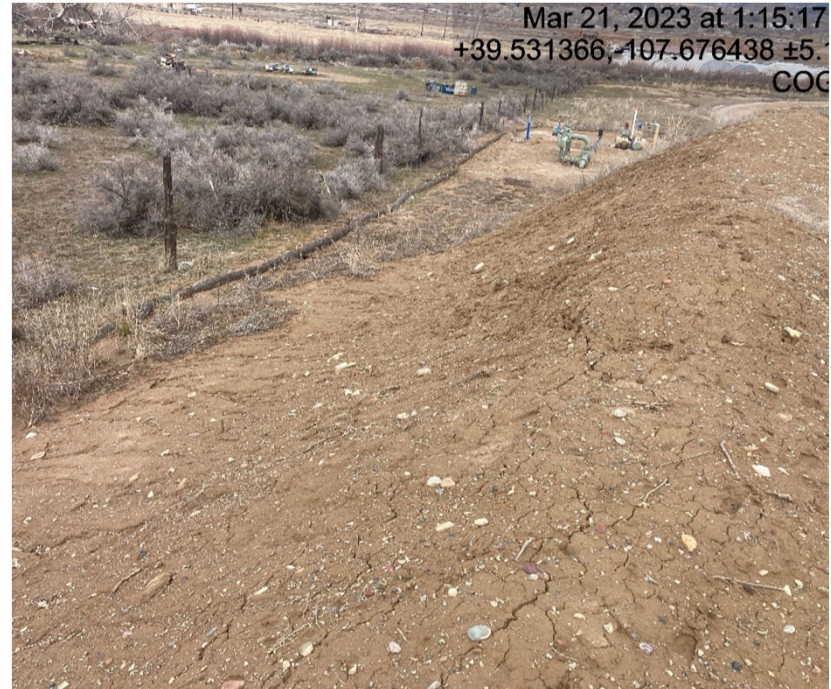
Fill slope shows lack of stabilization, Photo from
previous inspection

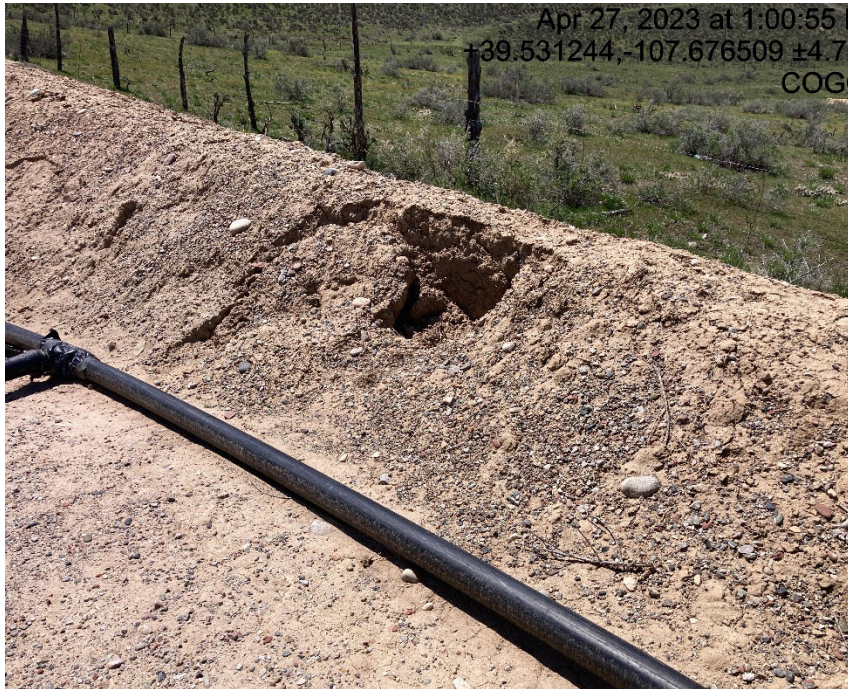
Erosion is undermining location berm coming out of fill slope. Photo from follow up inspection

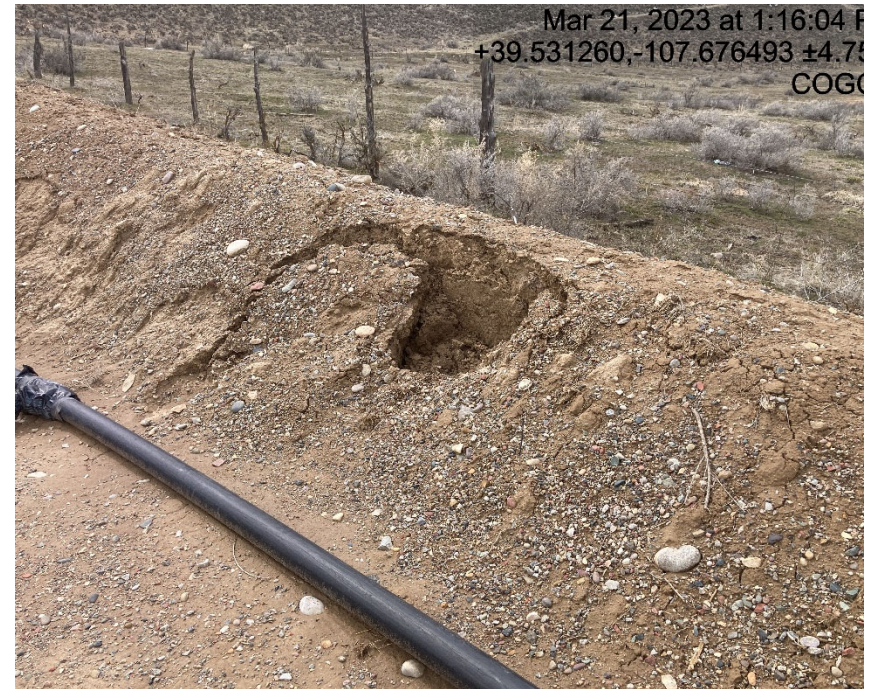
Erosion is undermining location berm coming out of fill slope. Photo from previous inspection

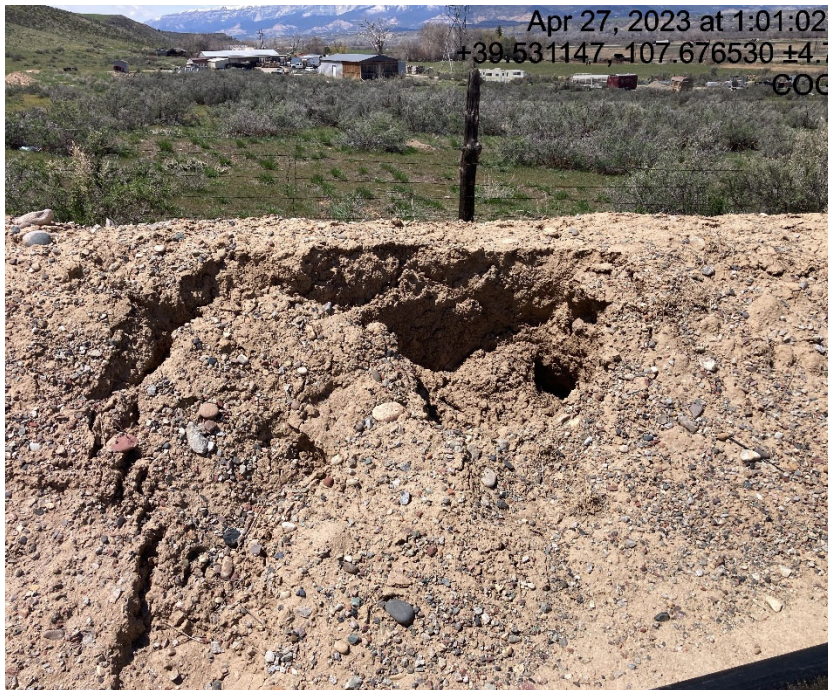
Erosion is undermining location berm coming out of fill slope. Photo from follow up inspection

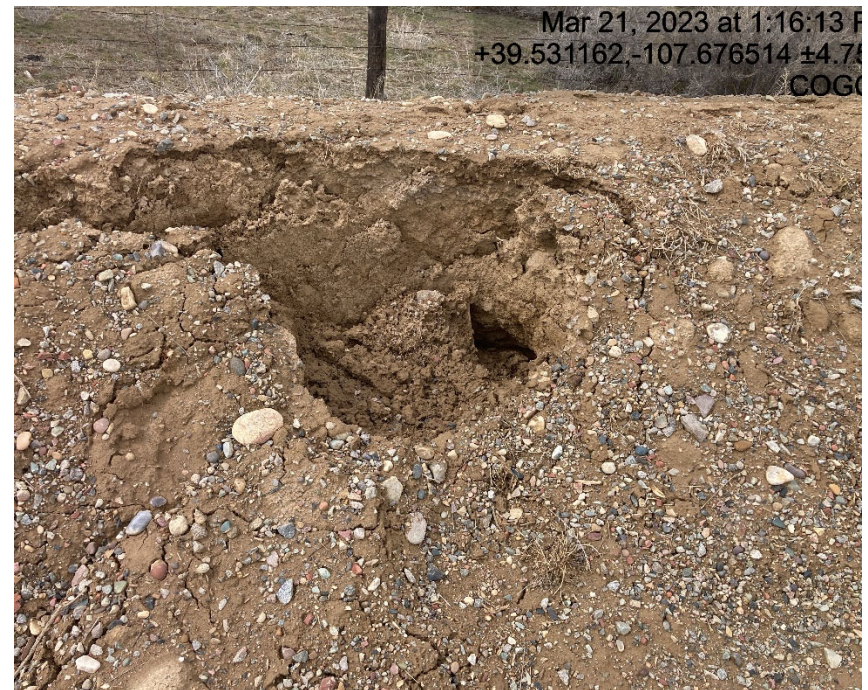
Erosion is undermining location berm coming out of fill slope. Photo from previous inspection

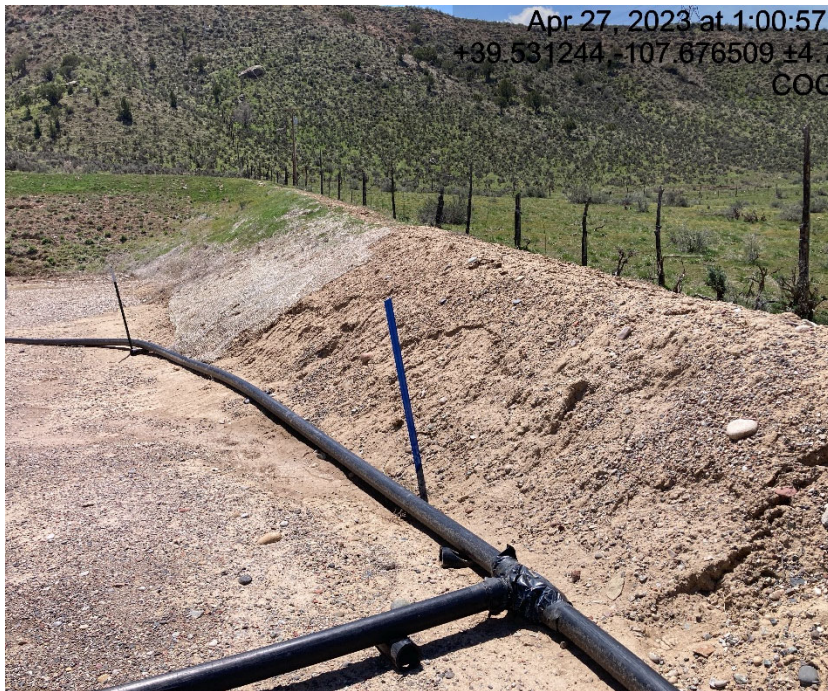
Berm shows signs of erosion. Photo from follow up inspection

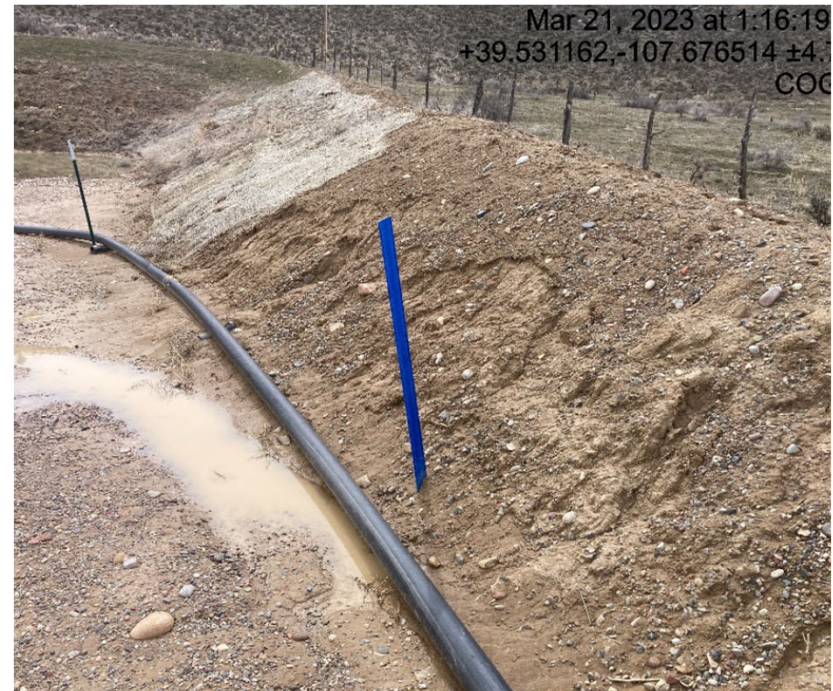
Berm shows signs of erosion. Photo from Previous inspection. Blankets have been installed in areas.

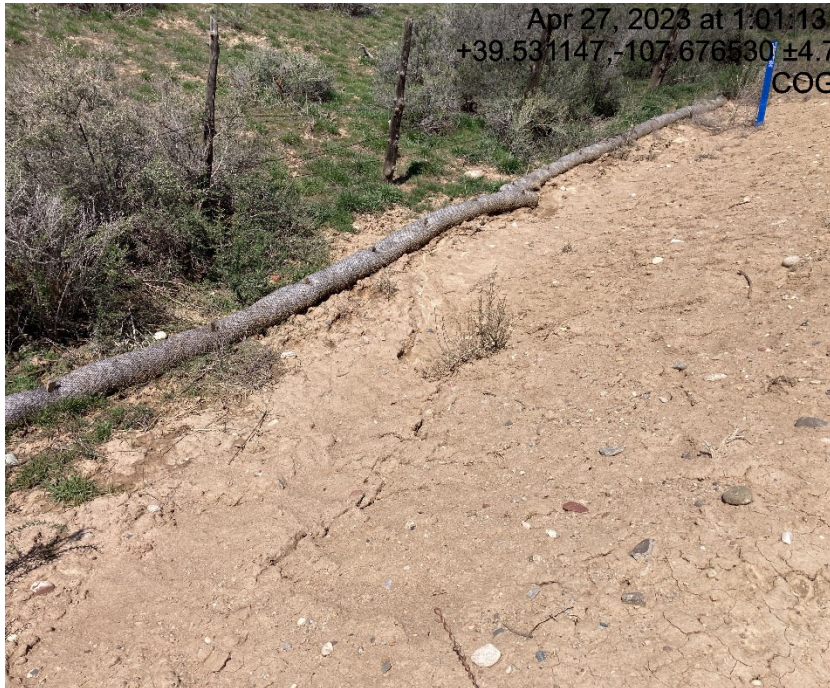
Fill slope shows lack of stabilization, Photo from
Follow up inspection

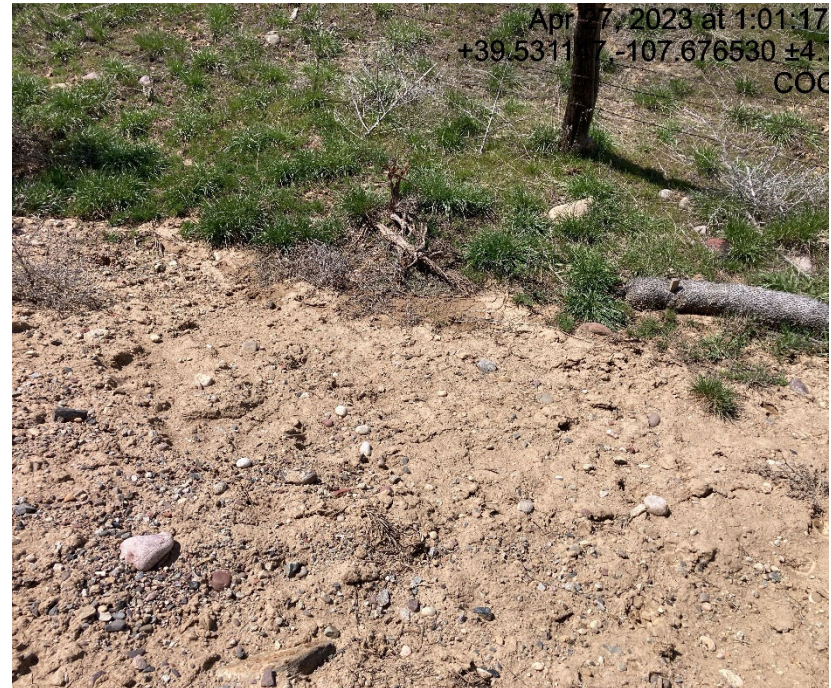
Fill slope shows lack of stabilization, Photo from
previous inspection

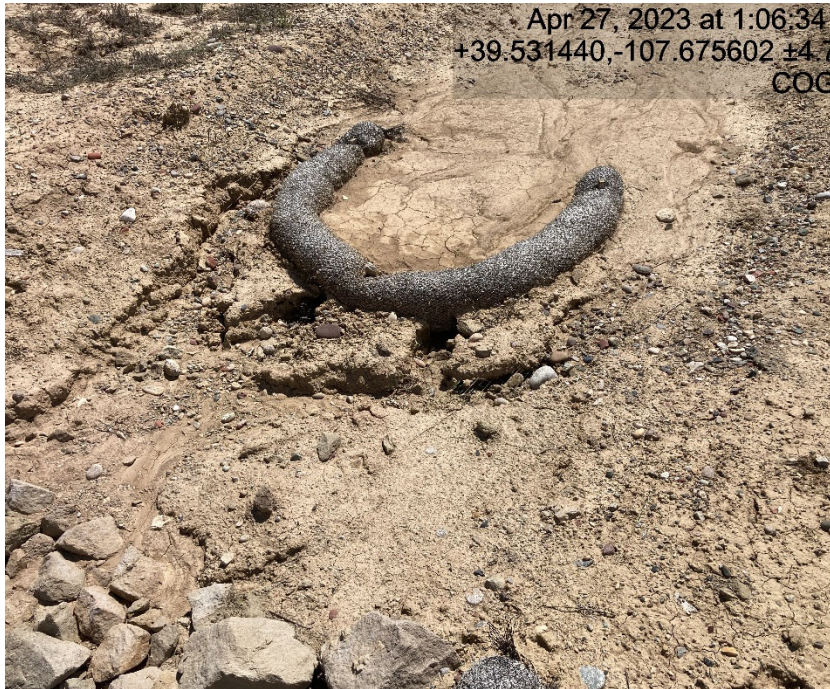
Erosion under waddles. Photo from follow up inspection

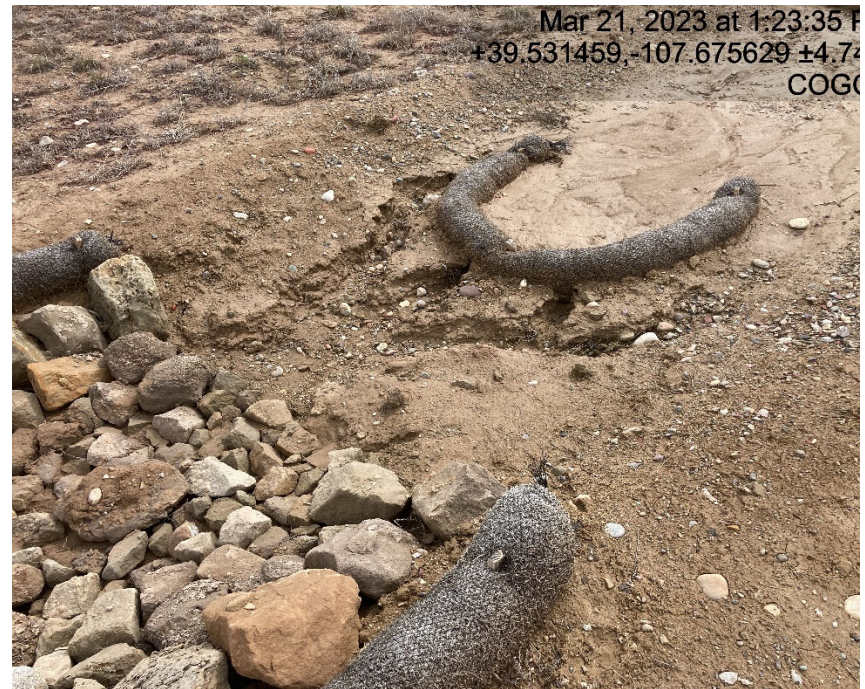
Erosion under waddles. Photo from previous inspection

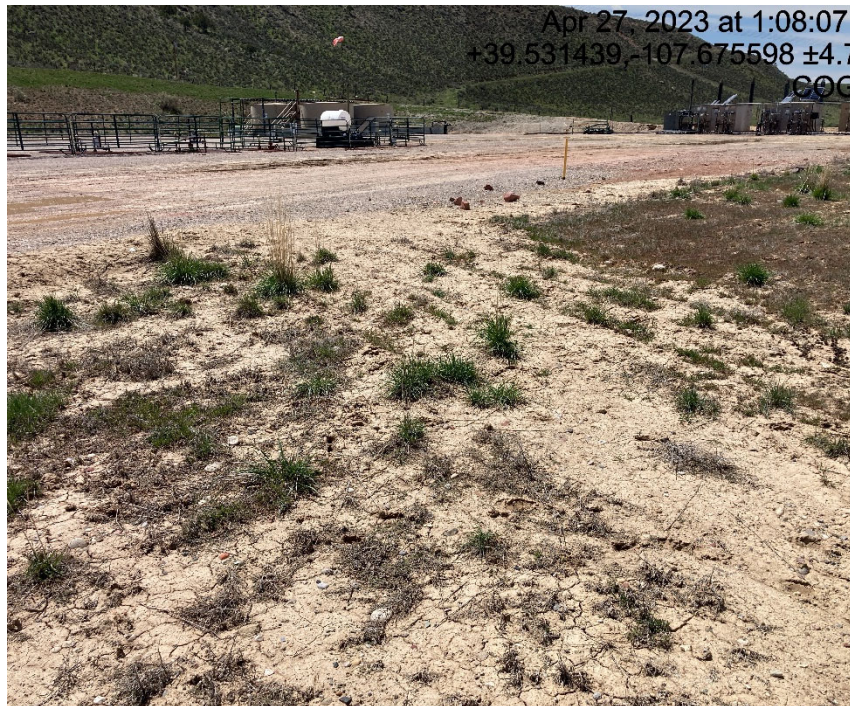
Sediment migration from location. Photo from follow up inspection

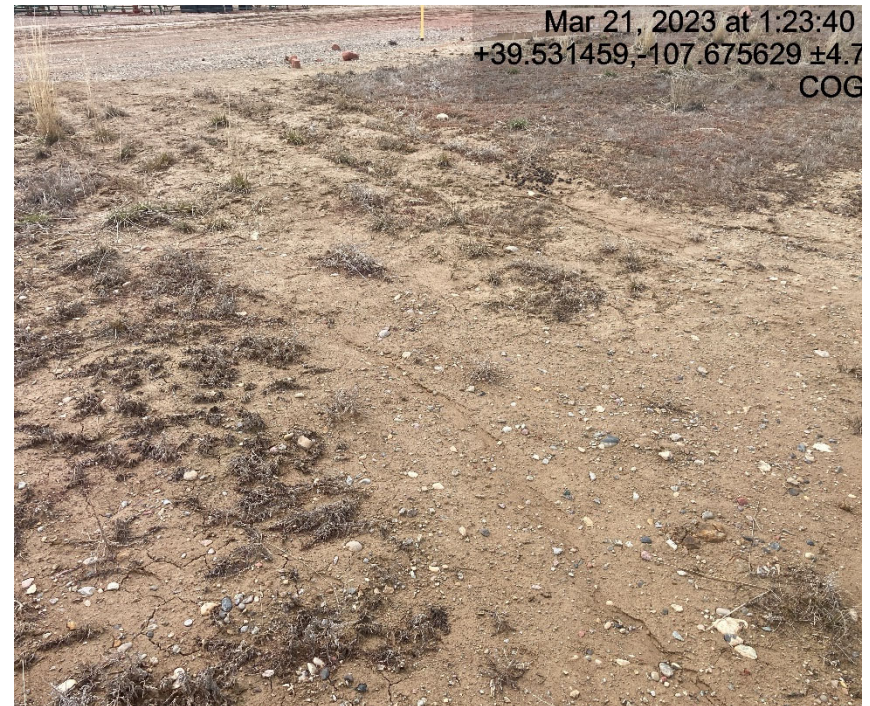
Sediment migration from location. Photo from previous inspection

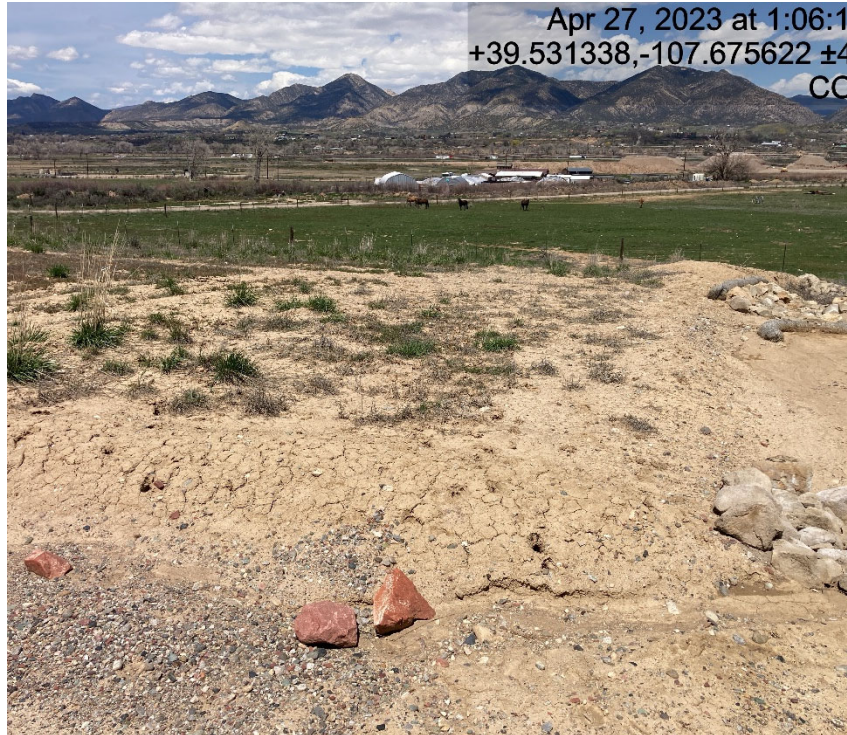
Sediment migration from location. Photo from follow up inspection

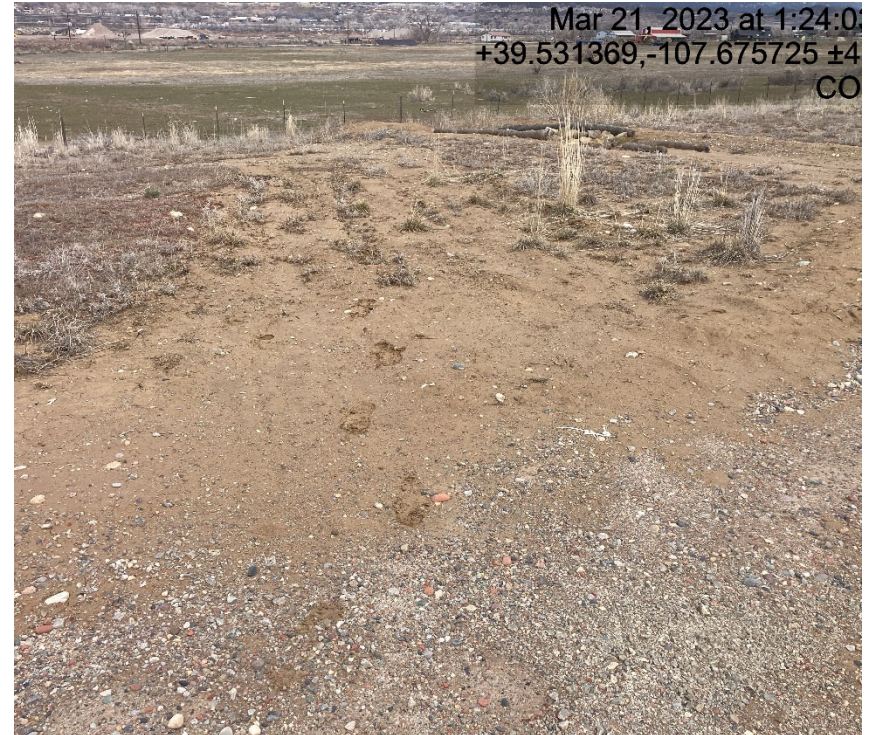
Sediment migration from location. Photo from previous inspection

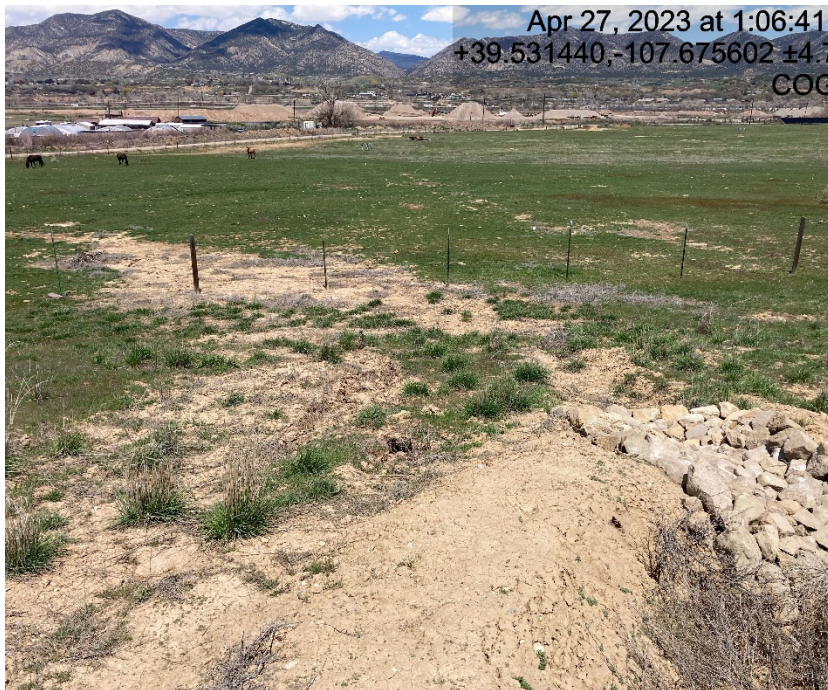
Sediment migration choking out vegetation
continues on to neighboring property.

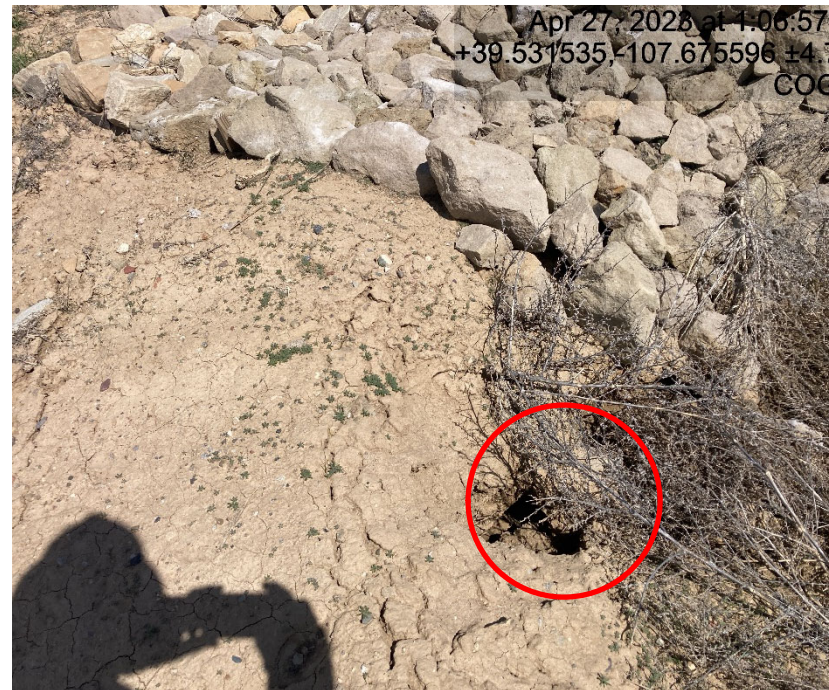
Circle indicates inlet of tunneling through
sediment trap

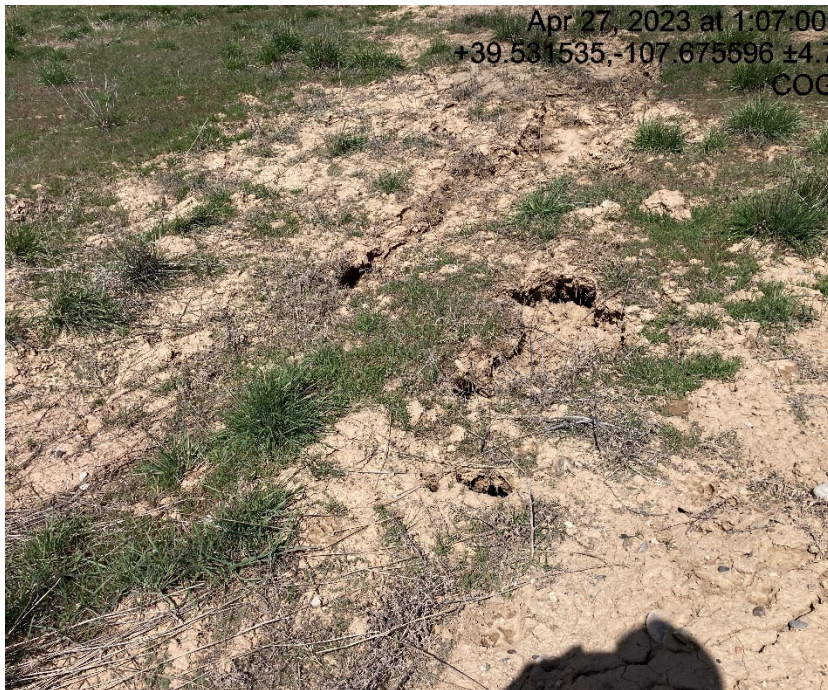
Outlet side of sediment trap tunneling and erosion channels with sediment migration

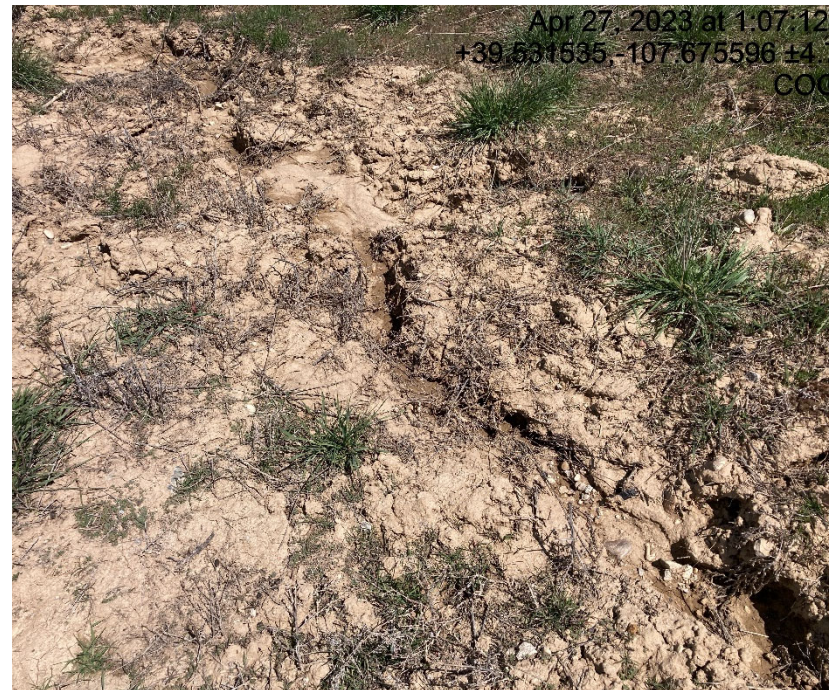
Outlet side of sediment trap tunneling and erosion channels with sediment migration

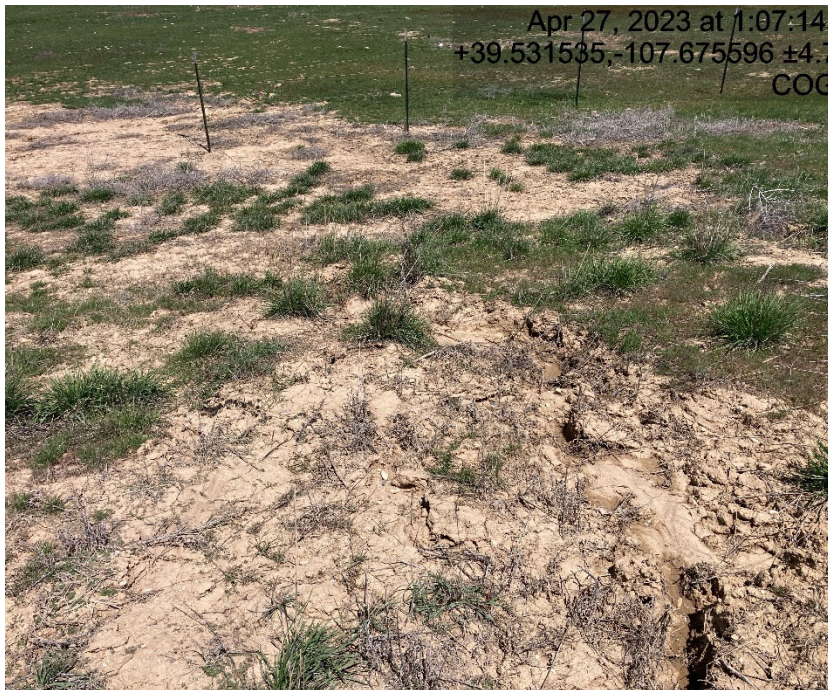
Sediment migration choking out vegetation

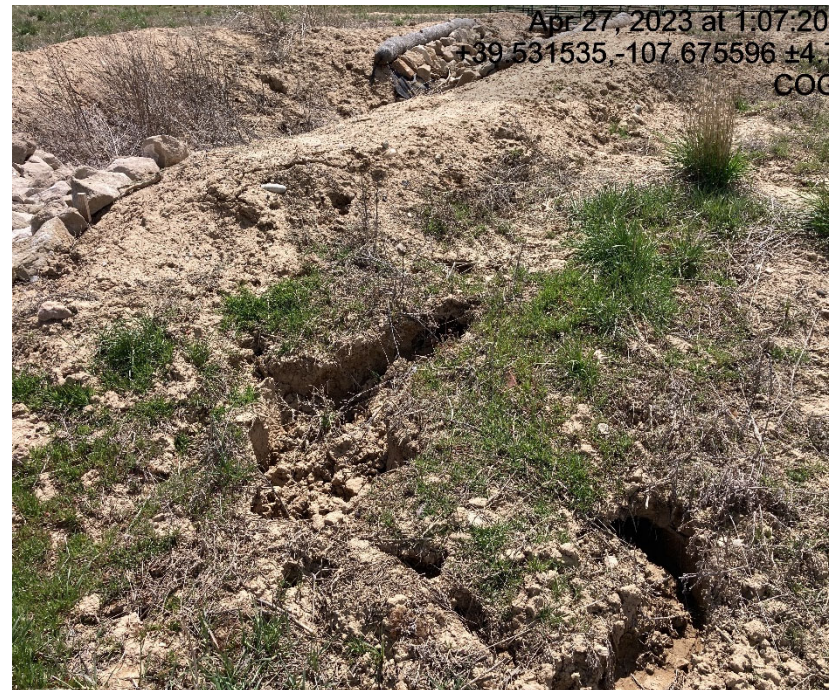
Outlet side of sediment trap tunneling and erosion channels with sediment migration

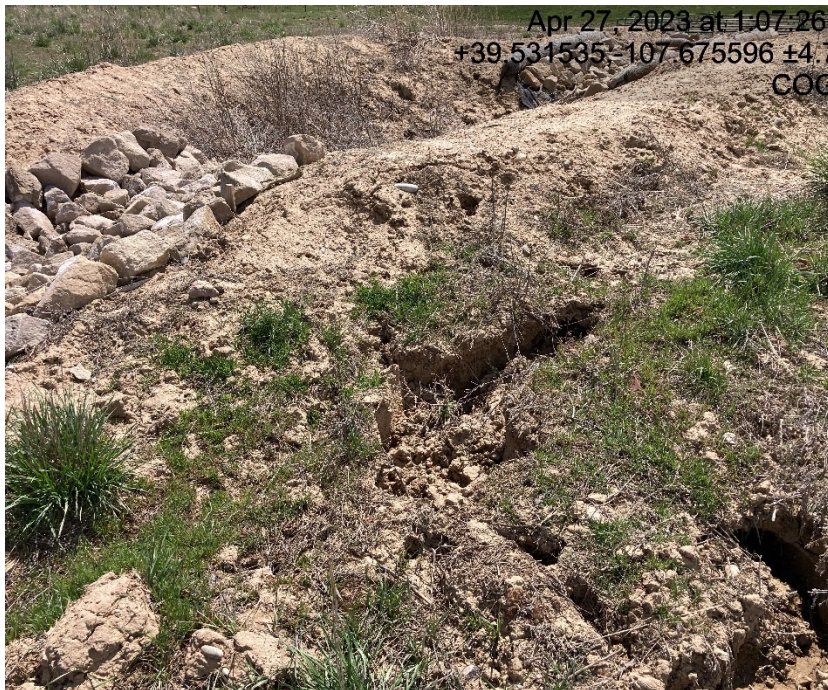
Outlet side of sediment trap tunneling and erosion channels with sediment migration

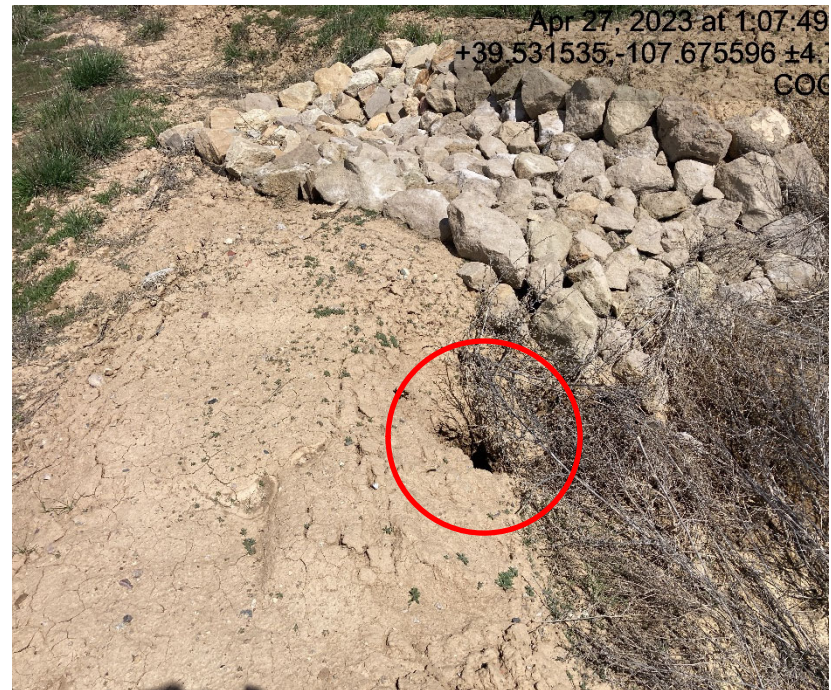
Circle indicates inlet of tunneling through sediment trap

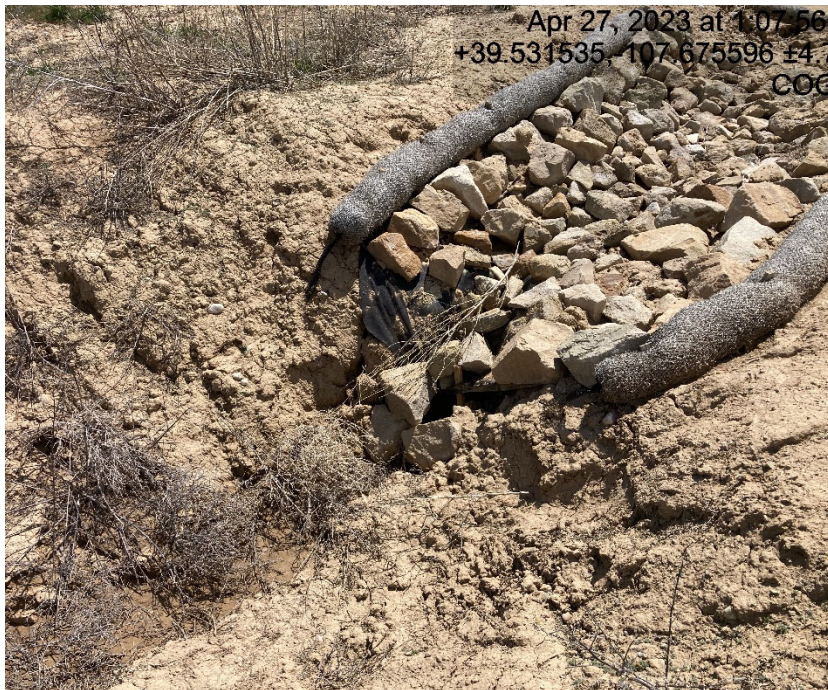
BMP's Failing

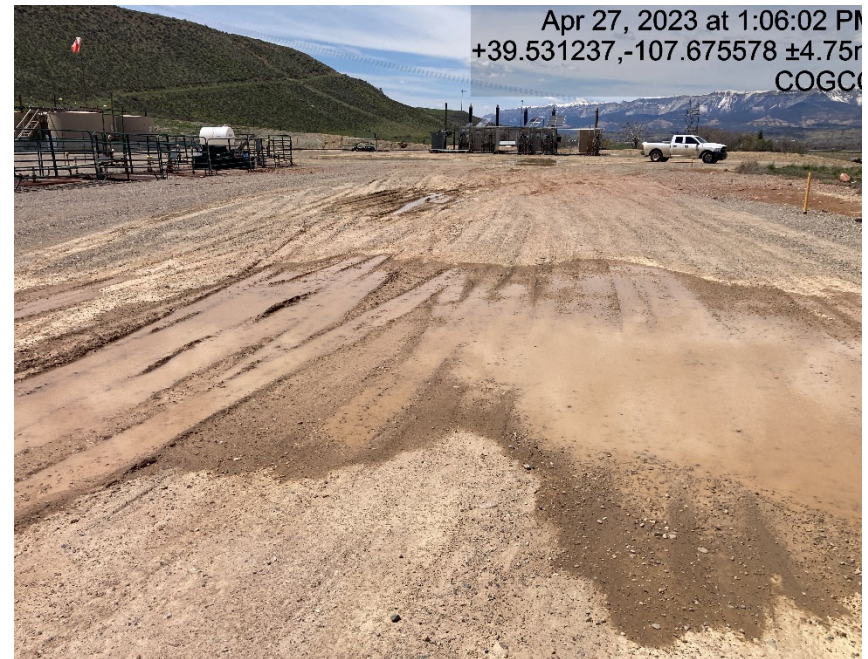
Location sill shows signs of lack of stabilization/compaction

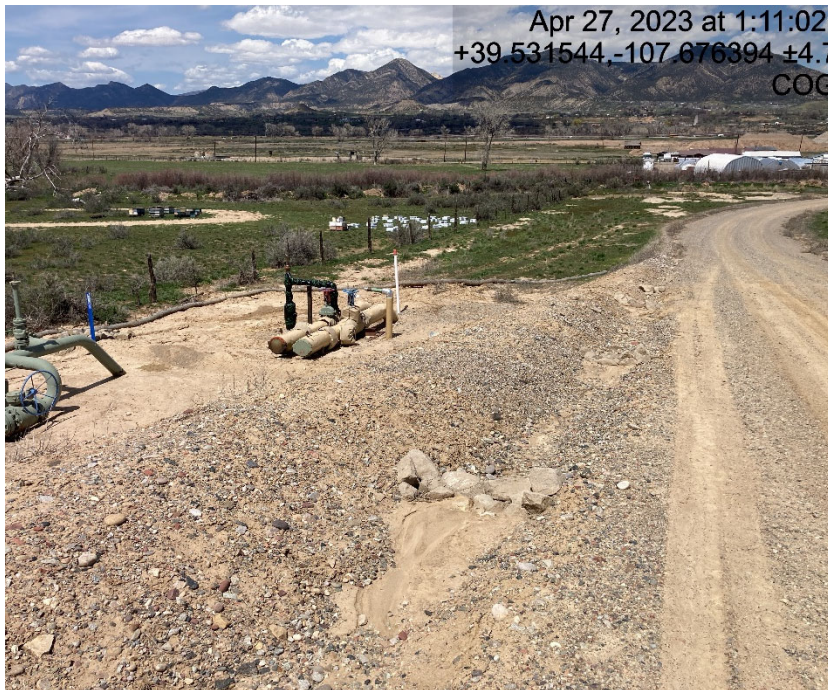
Access road BMP's Failing Photo from follow up inspection

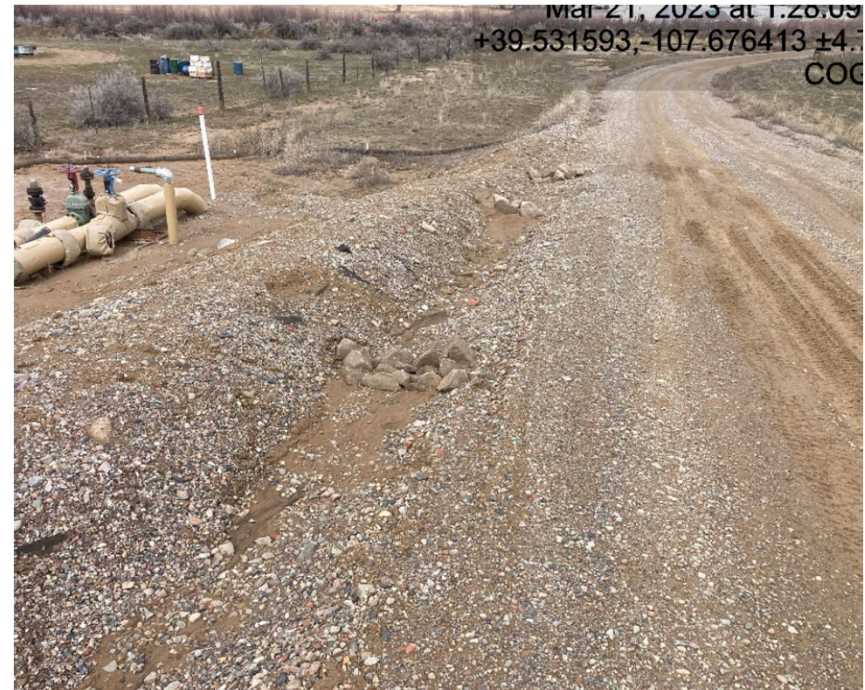
Access road BMP's Failing Photo from previous inspection

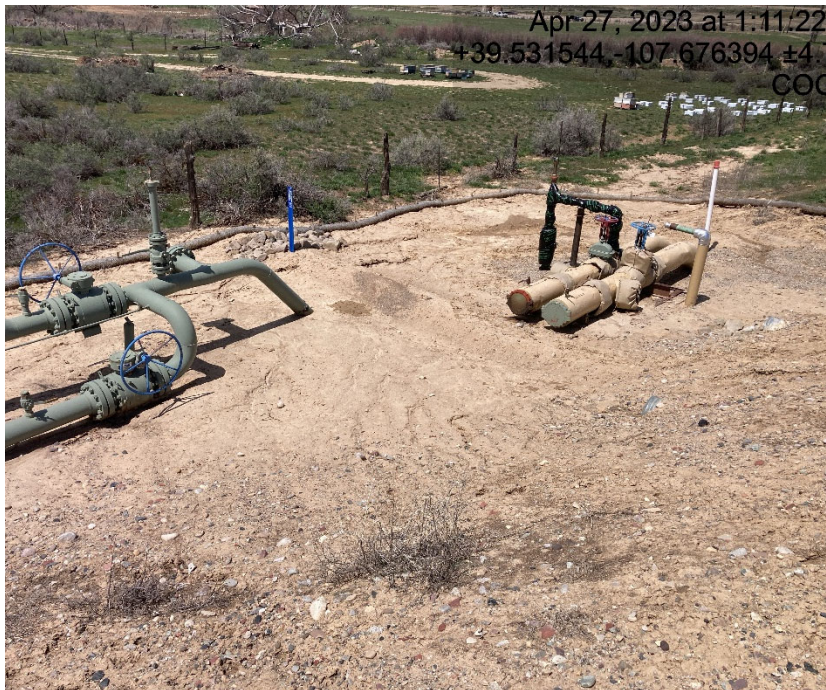
Photo from follow up inspection of erosion and failing BMP's
