Storm Water Management and Erosion control

Location Name: McPherson A

Location #: 335539

COLORADO
Oil & Gas Conservation
Commission
Department of Natural Resources

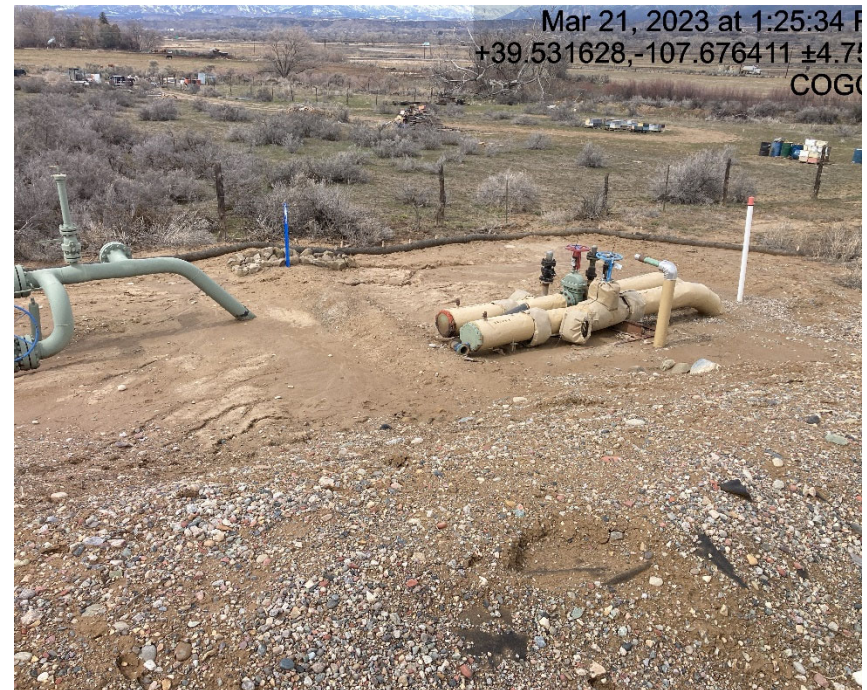
Photo from previous inspection of erosion and failing BMP's

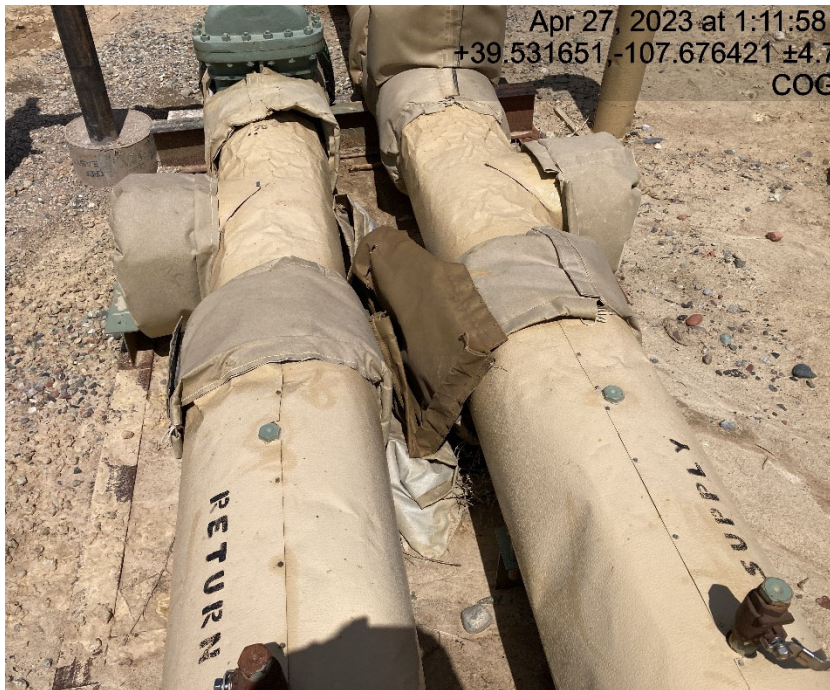
Debris

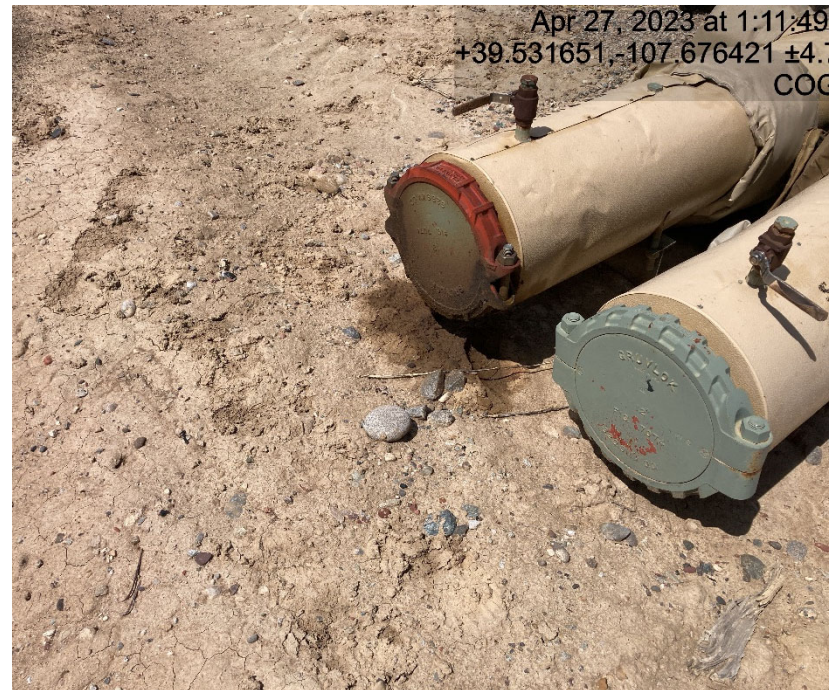
Staining next to all erosion and sediment migration

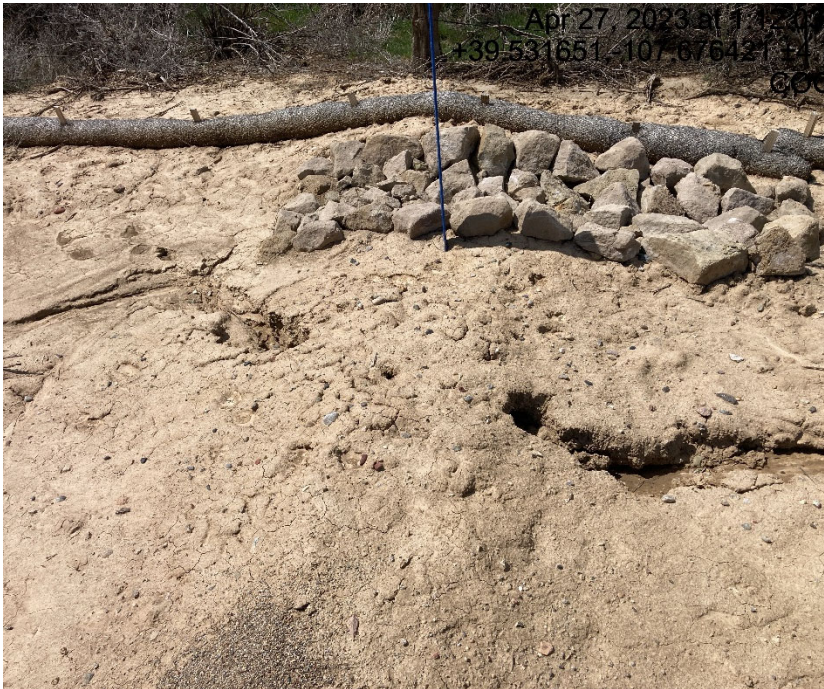
Erosion and tunneling next to rip rap

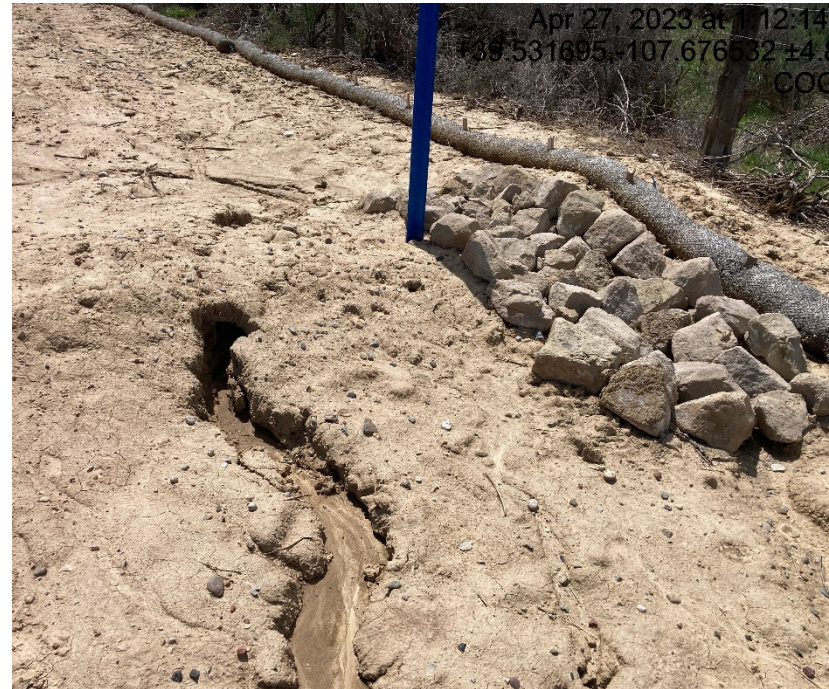
Erosion and tunneling next to rip rap

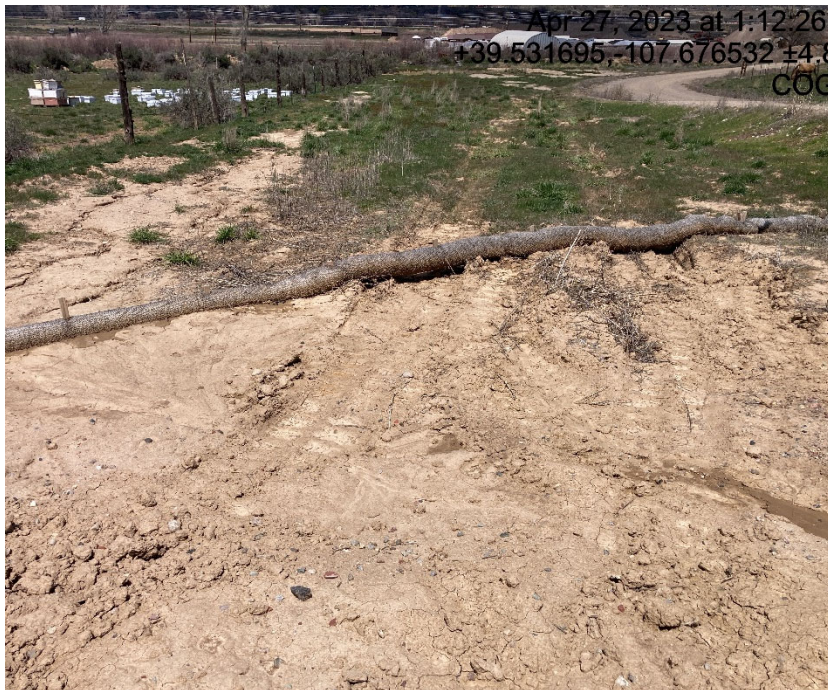
BMP's have been moved for equipment to enter and replaced in adequately.

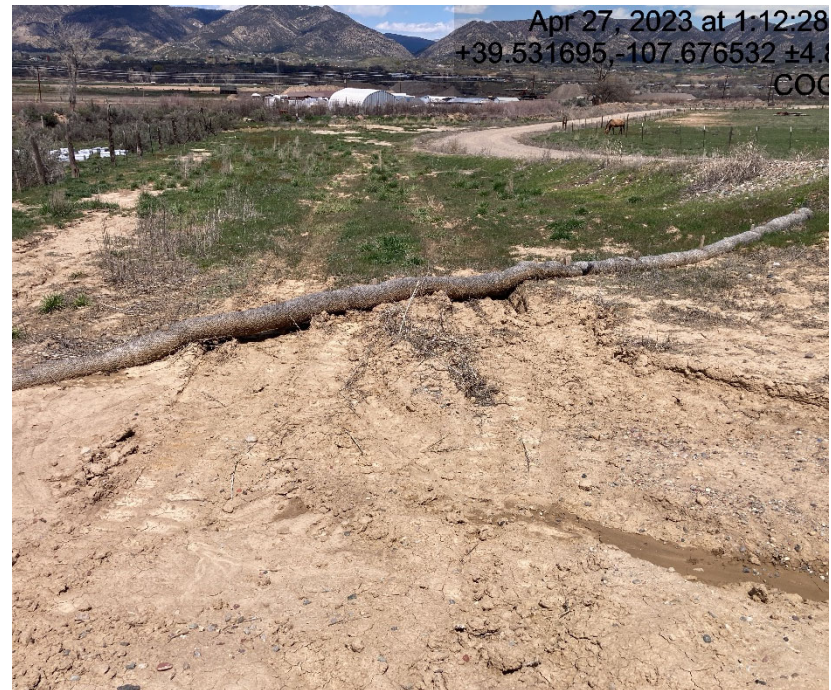
BMP's have been moved for equipment to enter and replaced in adequately.

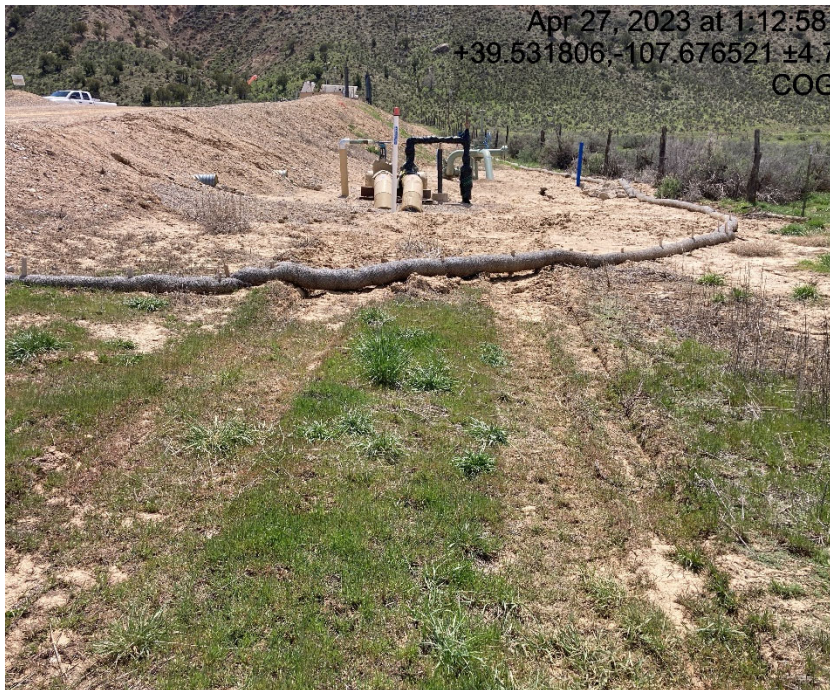
BMP's have been moved for equipment to enter and replaced in adequately.

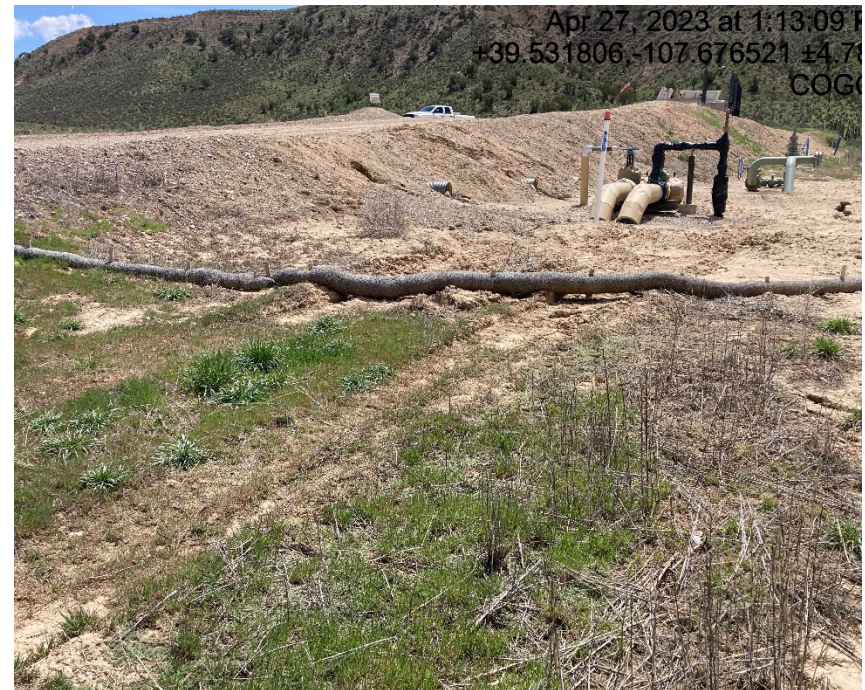
BMP's have been moved for equipment to enter and replaced in adequately.

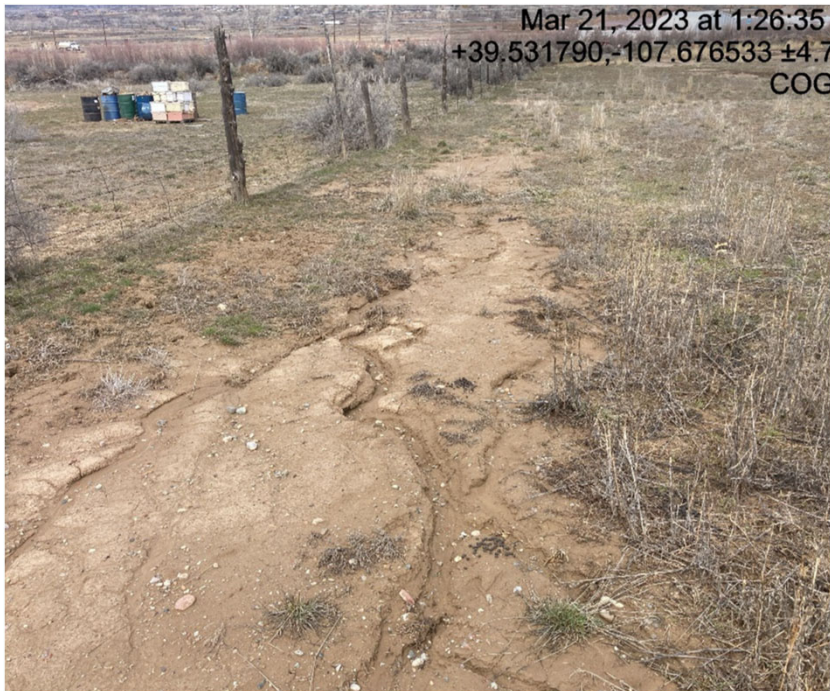
BMP's Failing and erosion channels with sediment migration. Photo from previous inspection

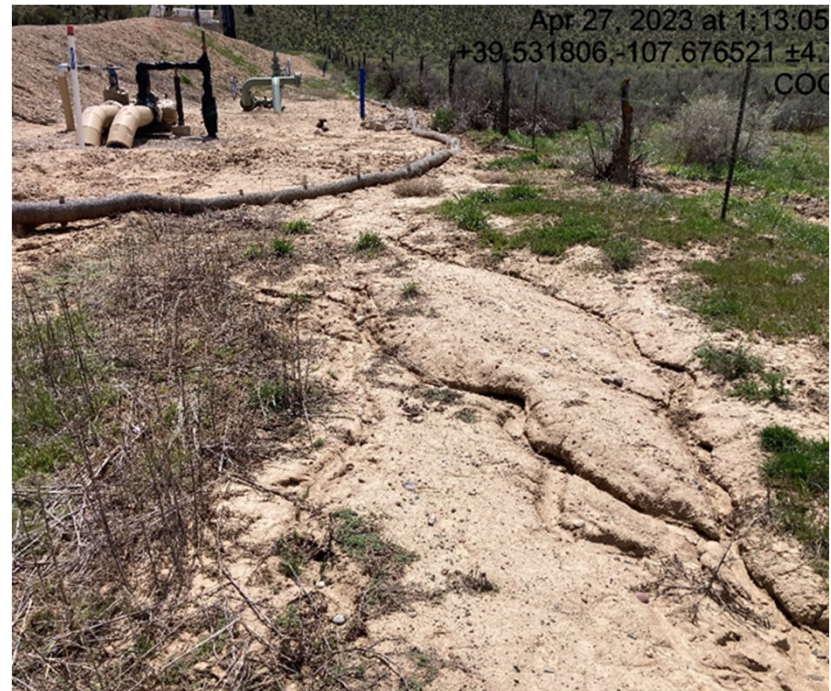
BMP's Failing and erosion channels with sediment migration. Photo from follow up inspection

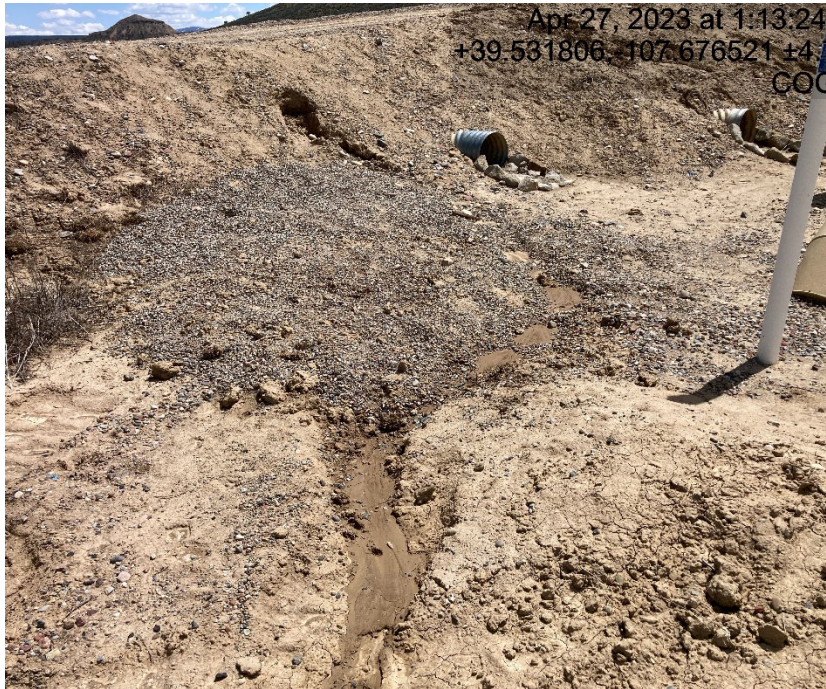
Outlet from tunneling occurring in access road ditch and erosion.

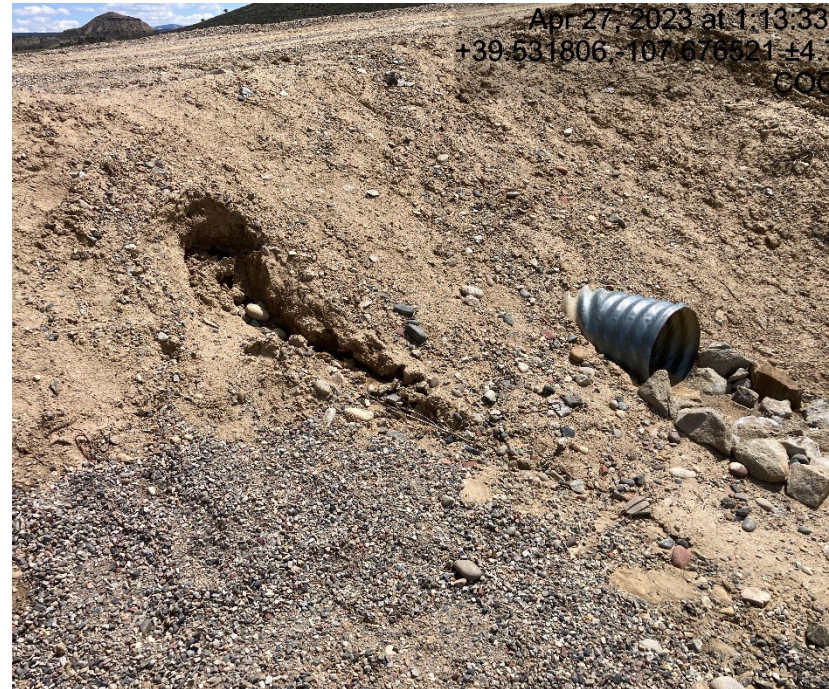
Outlet from tunneling occurring in access road ditch and erosion.

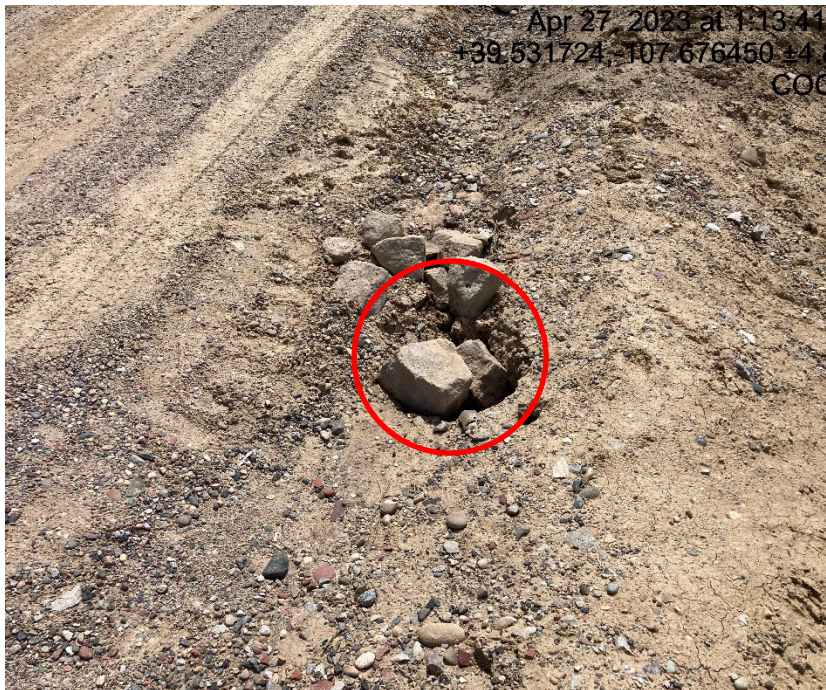
Tunneling through ditch at check dam out the side of the fill slope next to culvert

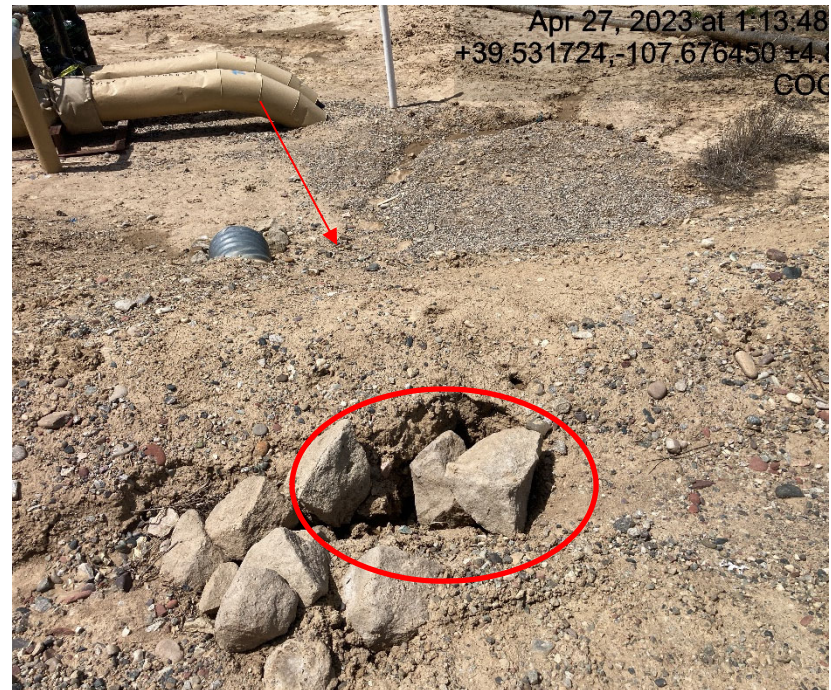
Tunneling through ditch at check dam out the side of the fill slope next to culvert. Circle is inlet and arrow is pointing to outlet.
