## Inspection Photos

Location Name: TEP ROCKY MOUNTAIN LLC CLOUGH RMV 96-28 Pad

Location ID: 335122

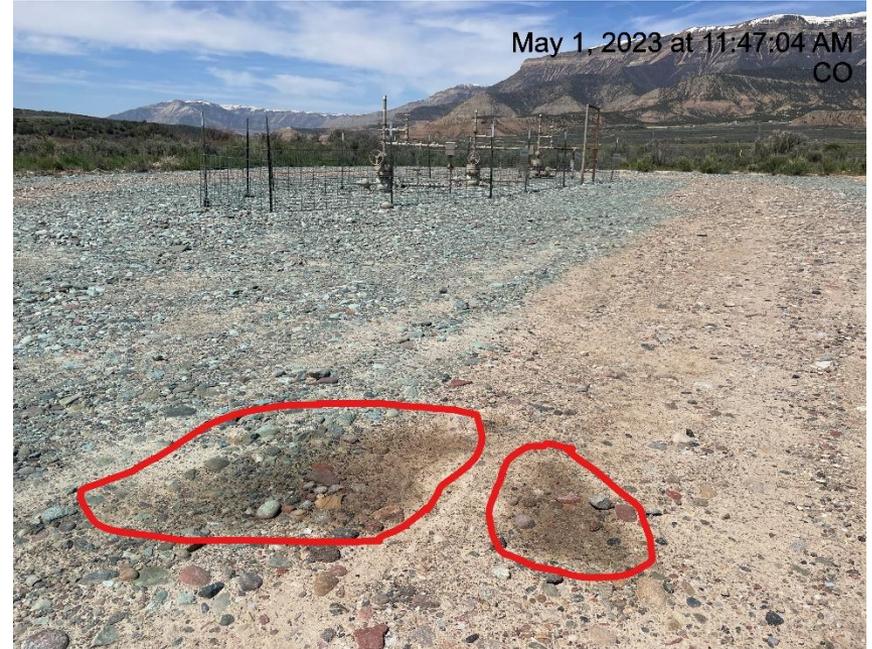
Photo # 6643 Stained soils & gravel

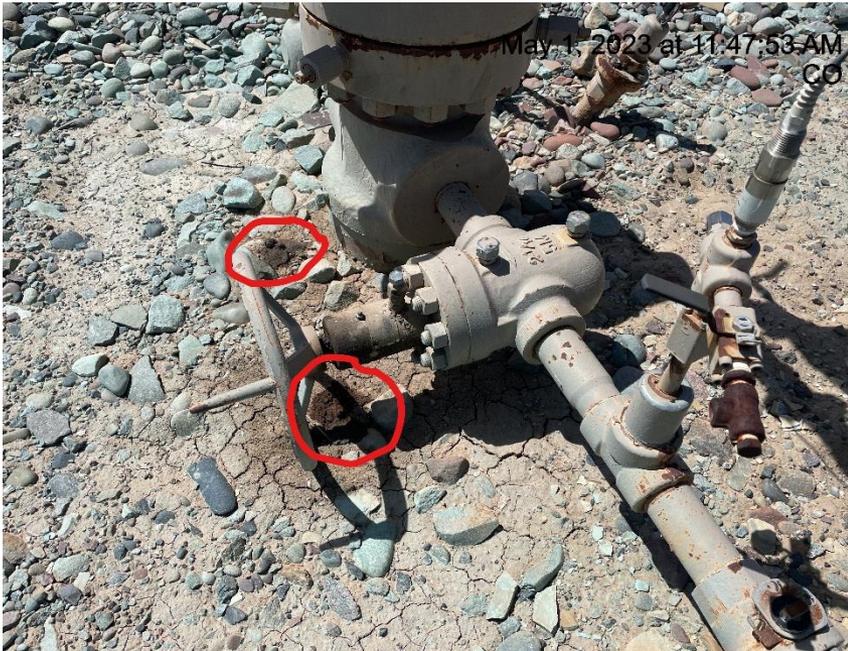
Photo # 6645 Stained soils & gravel

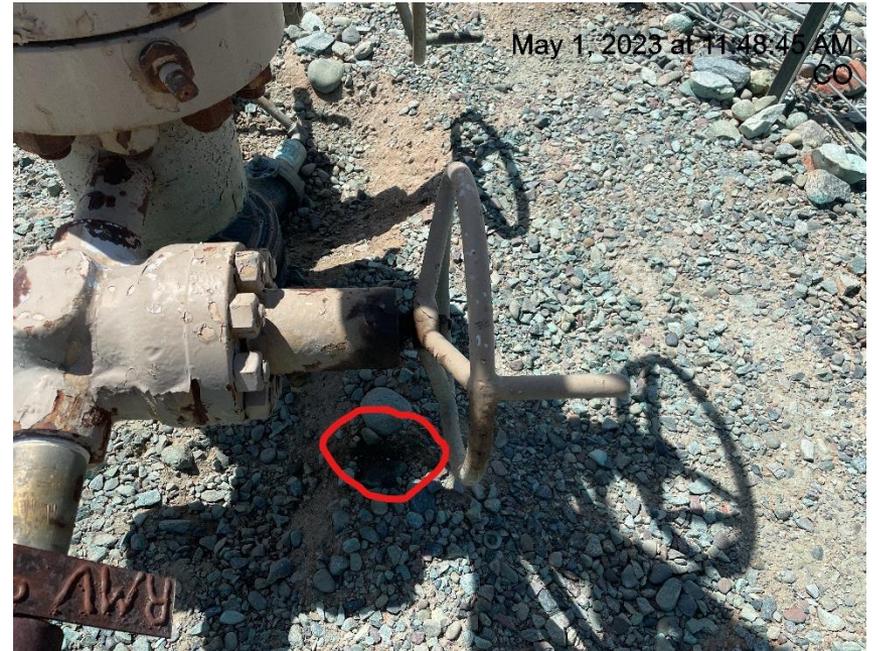
Photo # 6649 Stained soils & gravel

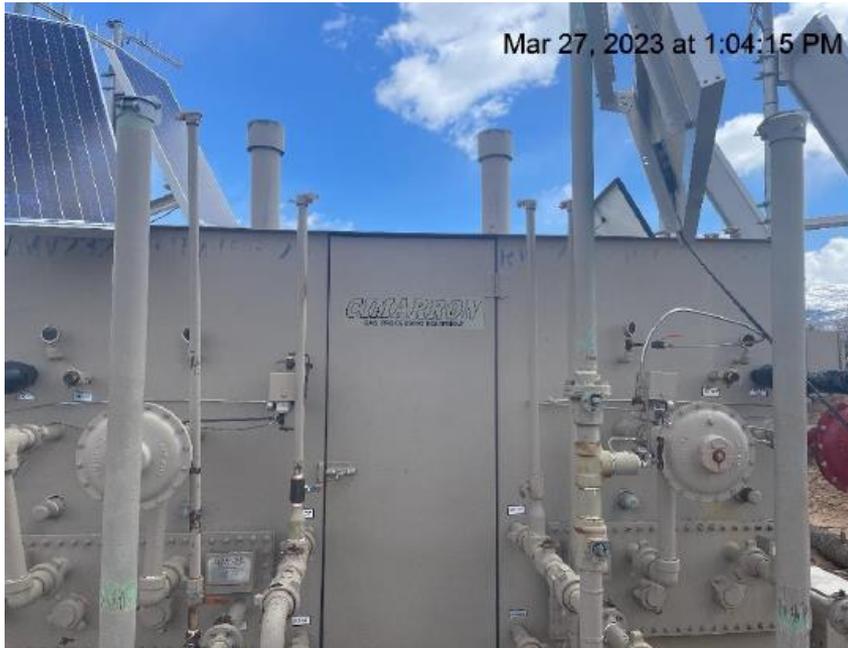
**Photo # 3430 From Inspection 708900178 conducted on 03/27/2023 Meter calibration info not conspicuously posted**

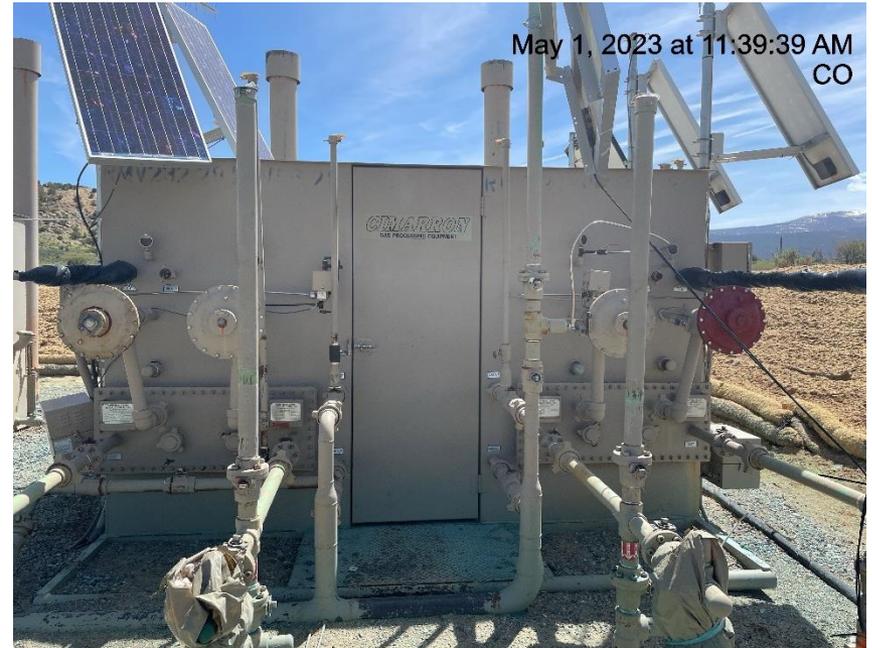
**Photo # 6632 Meter calibration info not conspicuously posted**

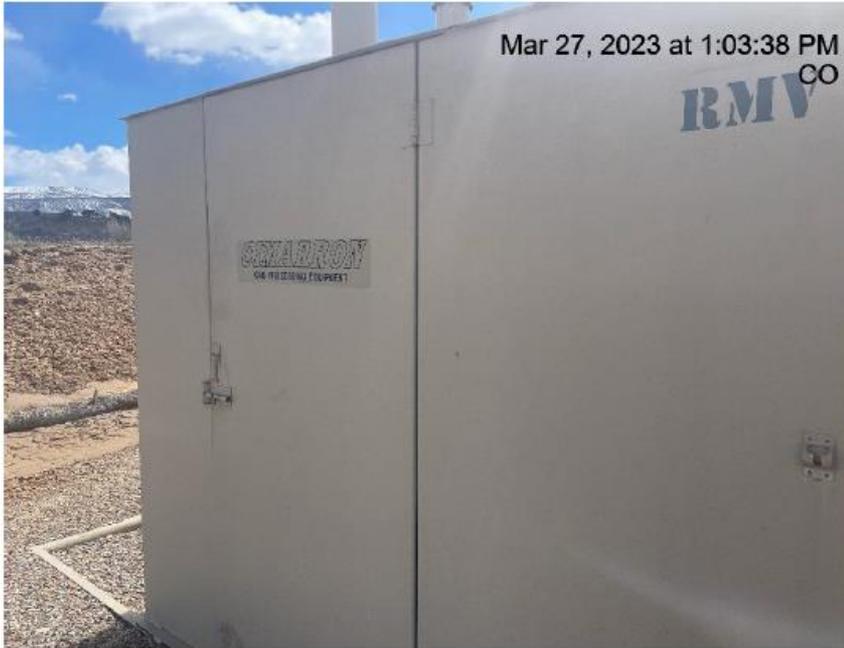
Photo # 3429 From Inspection 708900178 conducted on 03/27/2023 Meter calibration info not conspicuously posted

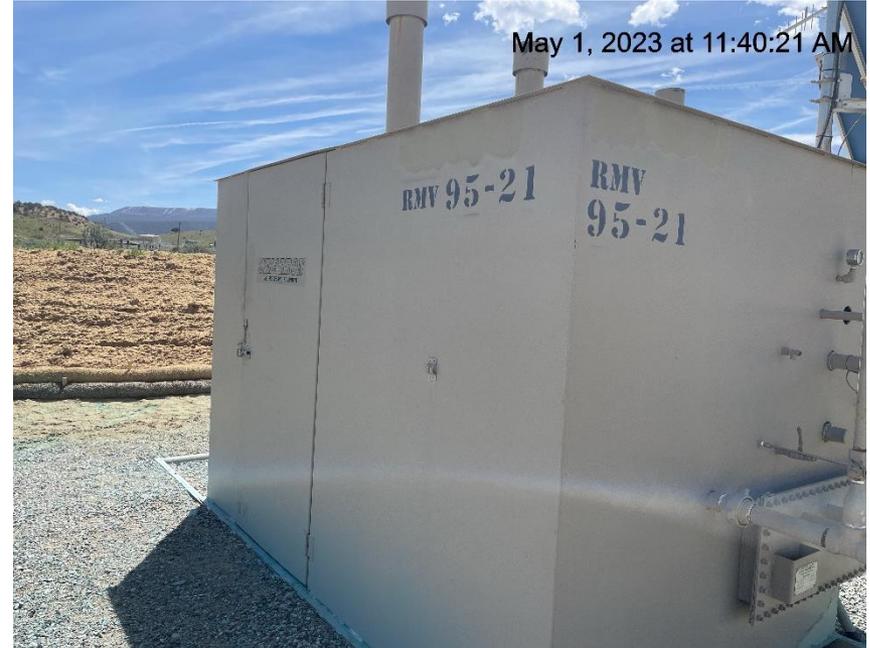
Photo # 6633 Meter calibration info not conspicuously posted

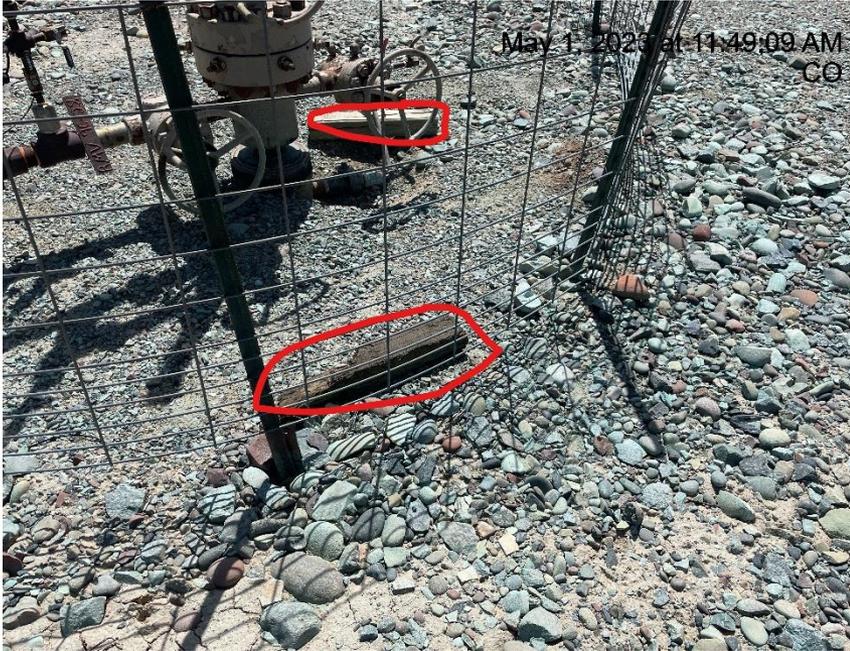
Photo # 6650 Debris

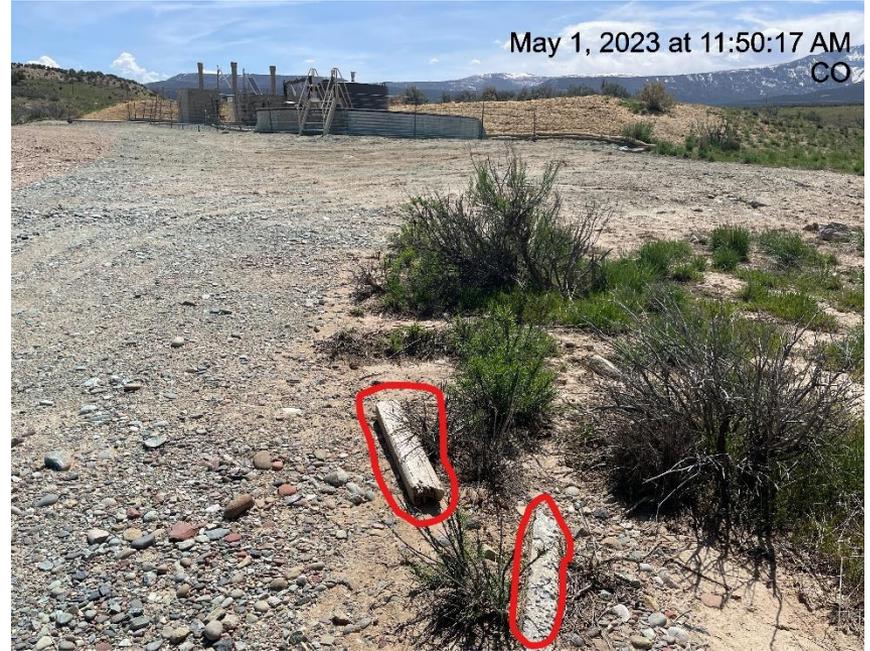
Photo # 6654 Debris

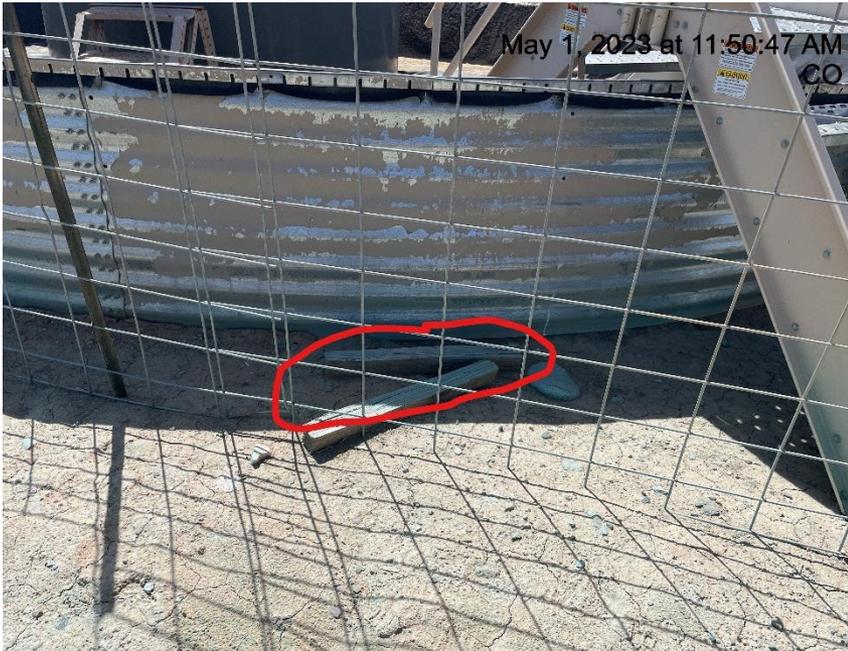
Photo # 6655 Debris
