# Stormwater Management and Erosion control

## Location Name: CAERUS PICEANCE LLC SGV /12H PAD

### Location #: 312697

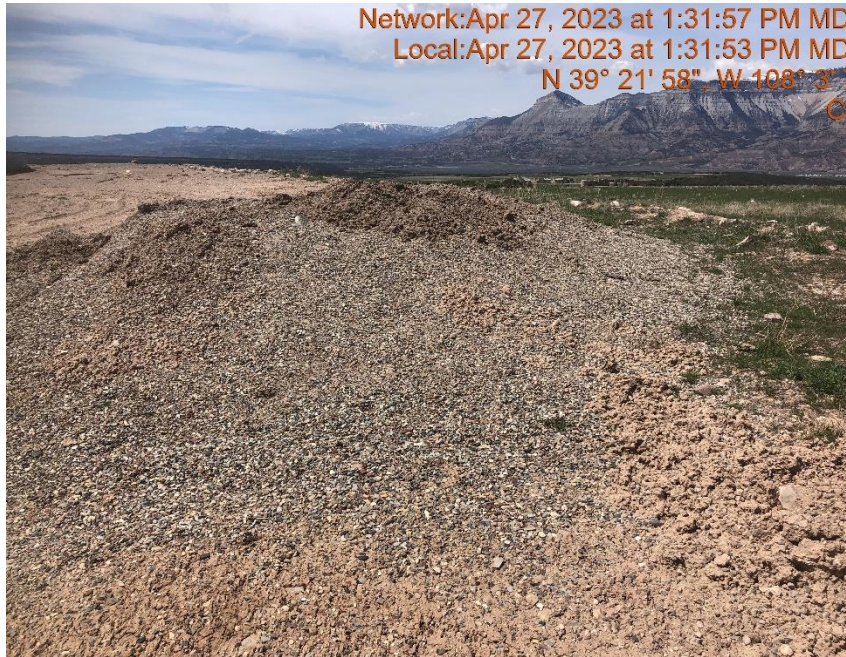
**Photo #9781 Insufficient stockpiled soils BMPs.**

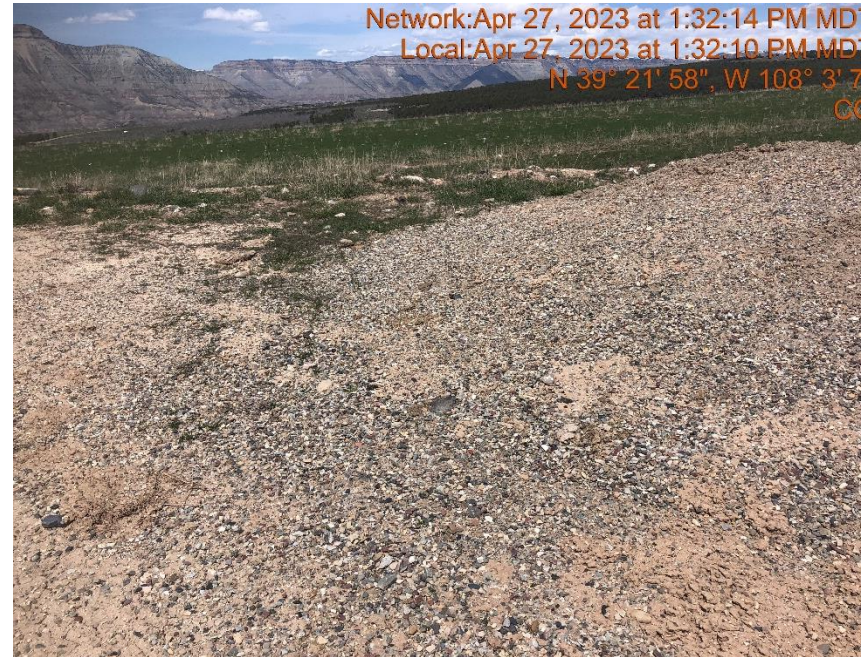
**Photo #9784 Insufficient stockpiled soils BMPs.**

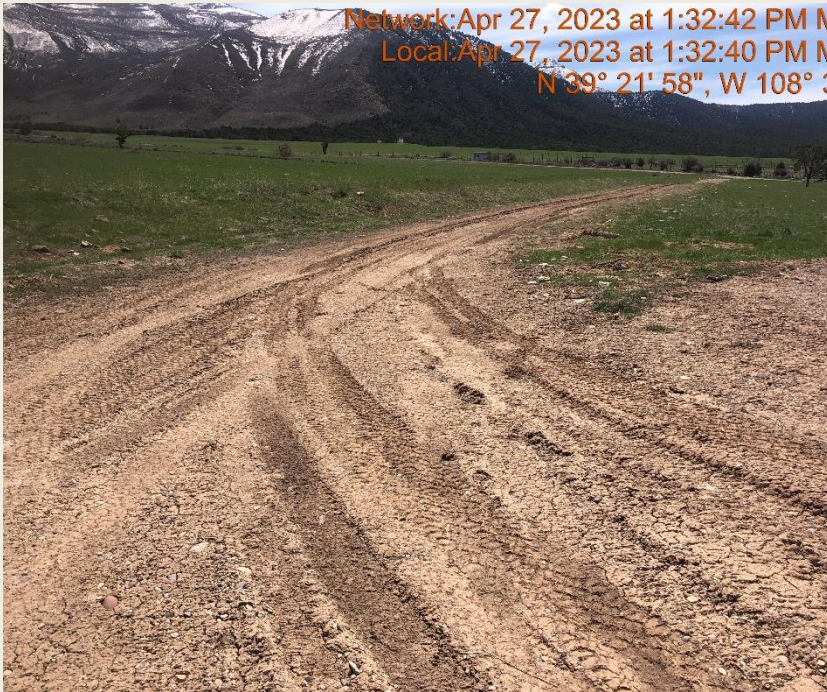
**Photo #9785 Access road lacks stabilization.**

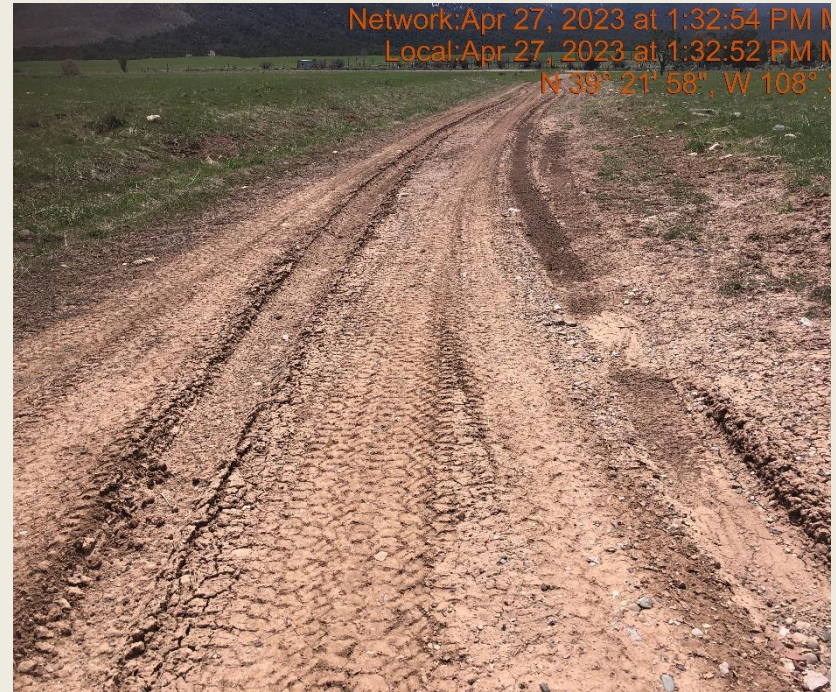
**Photo #9786 Access road lacks stabilization.**

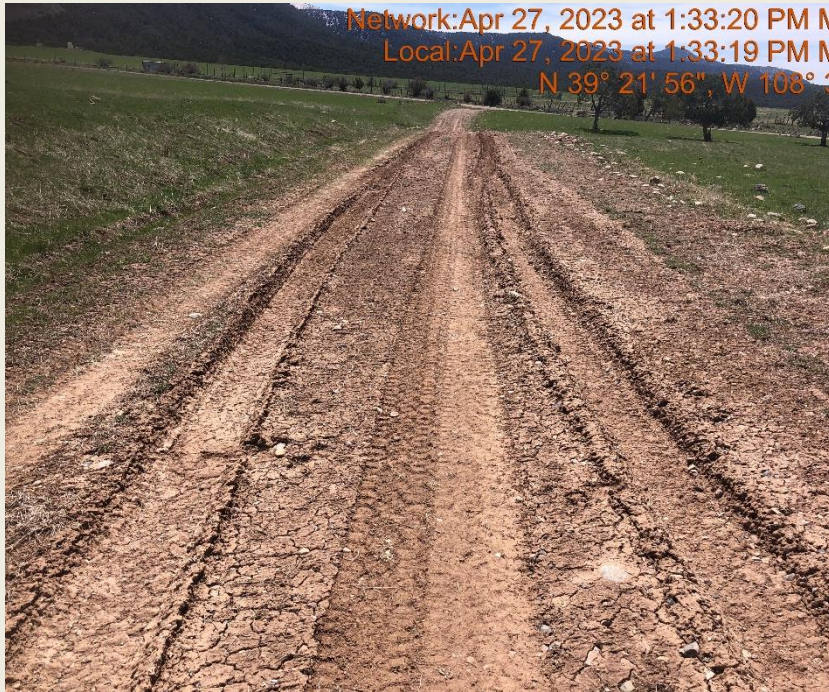
**Photo #9788 Access road lacks stabilization.**

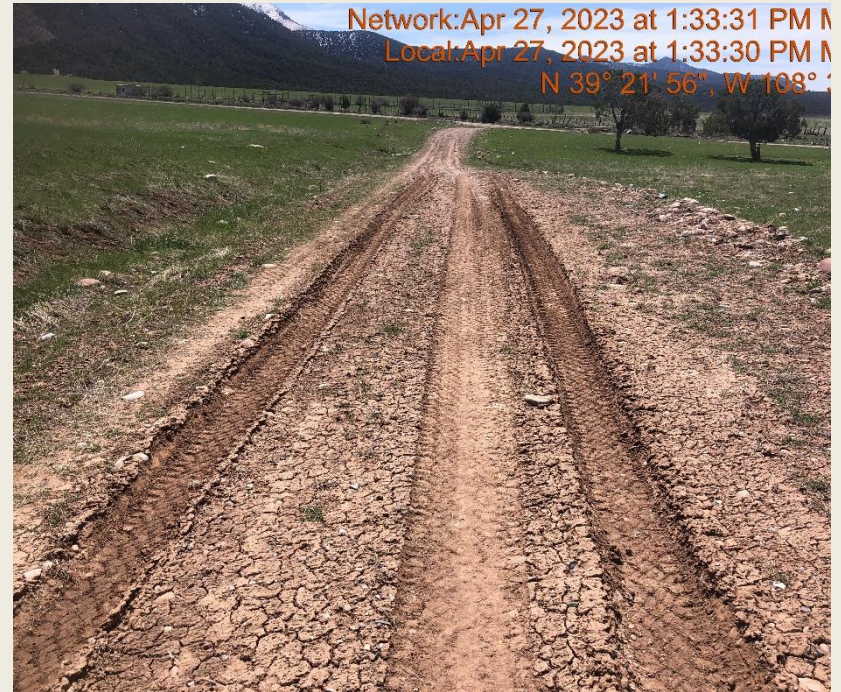
**Photo #9789 Insufficient tracking BMP at entrance to access roads.**
