**Scout Energy Management LLC
Union Pacific 16-27
Location #314609**

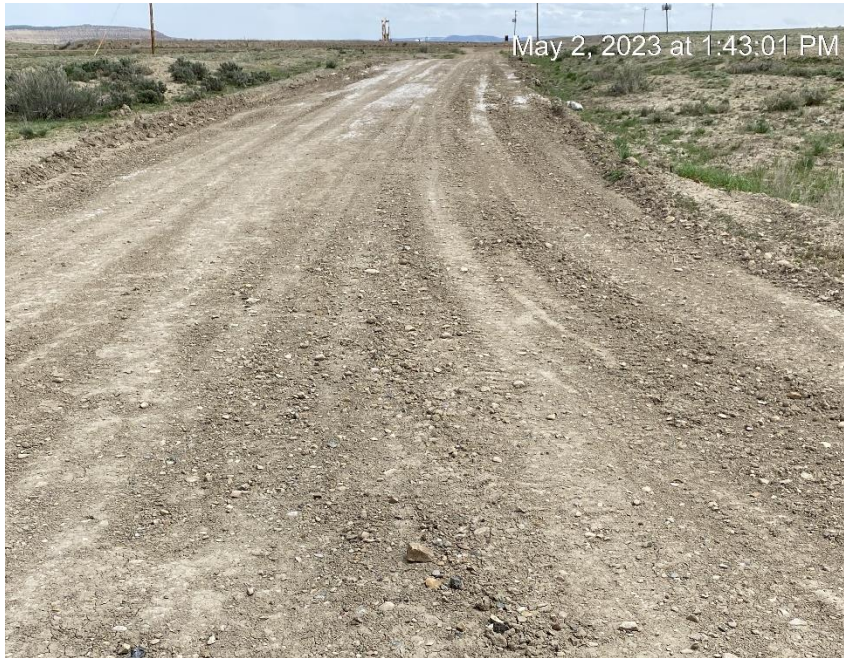
Access road to location

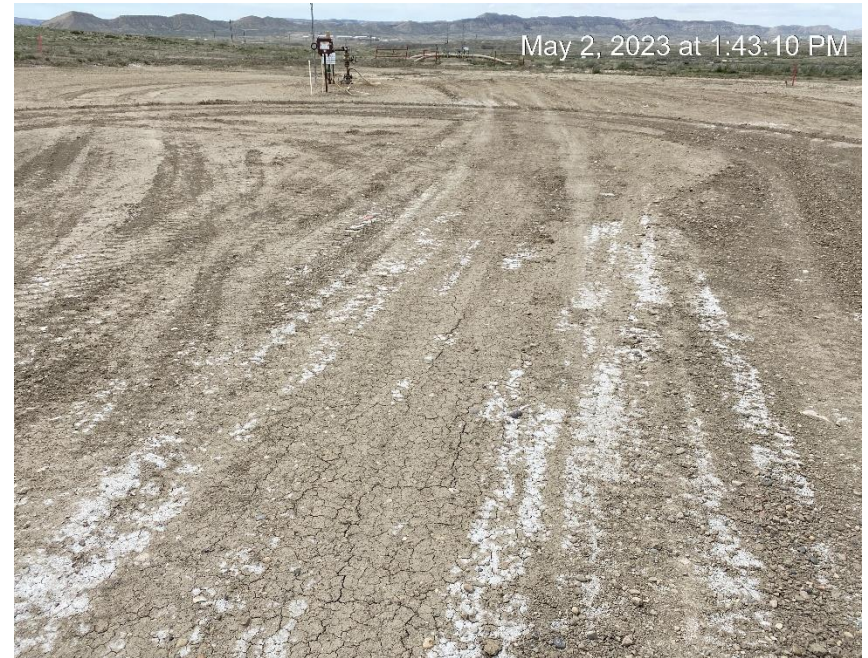
Entrance to location

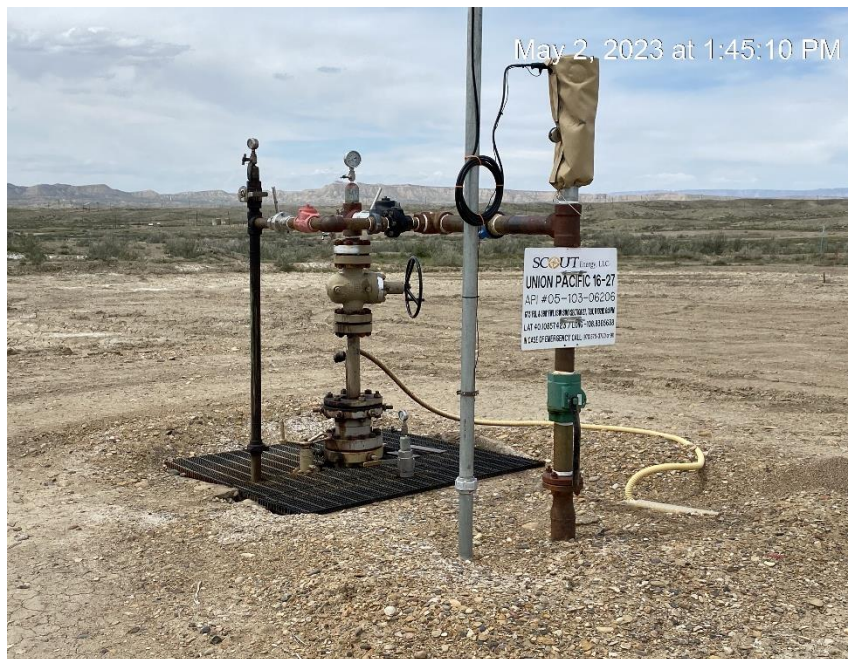
Wellhead and well sign

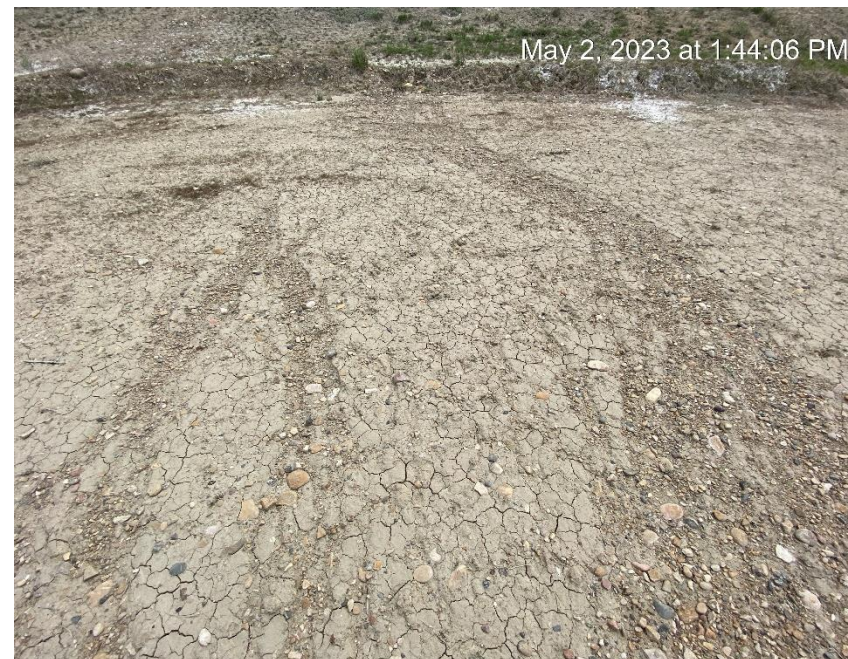
Erosion and sediment migration to location

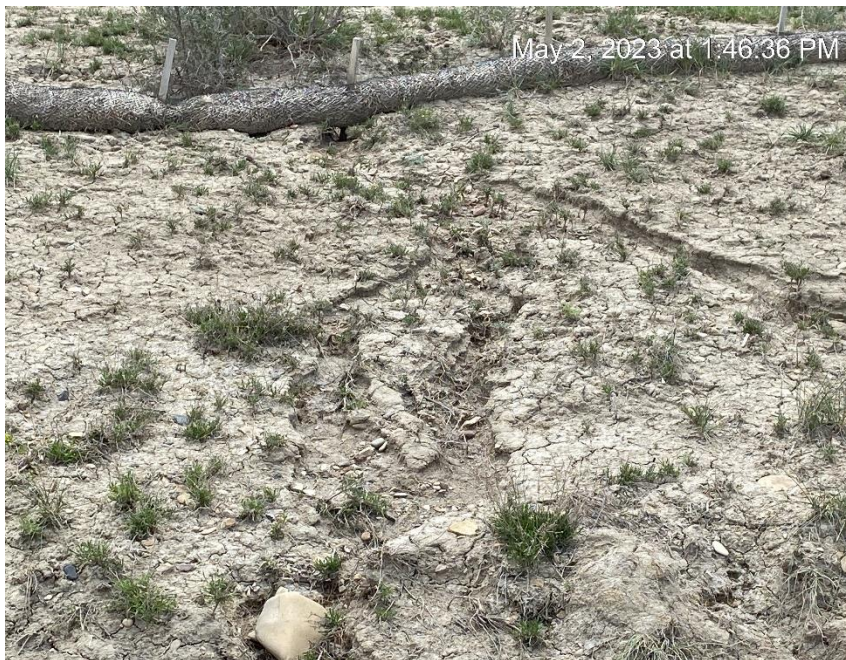
BMP lack of maintenance

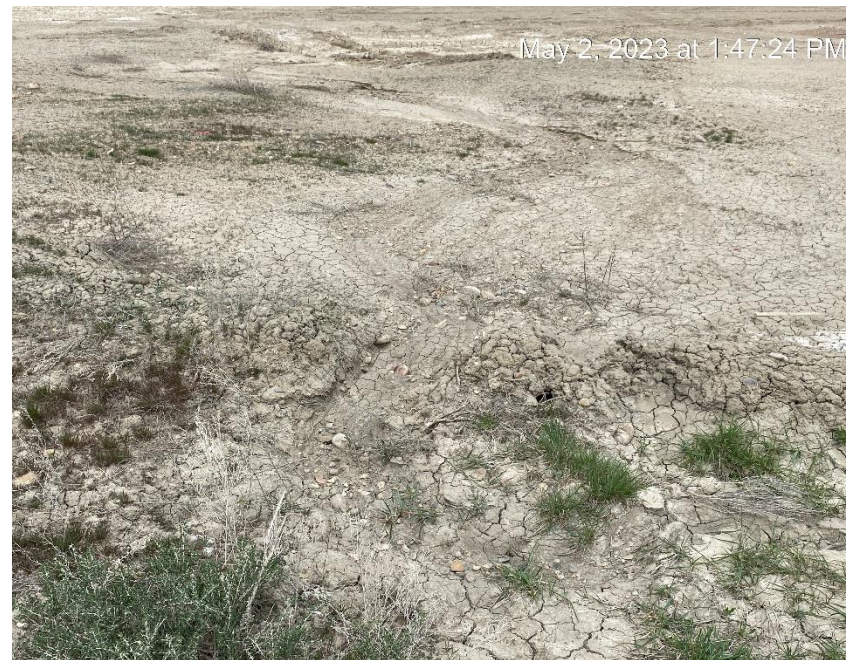
Sediment migration from diversion ditch

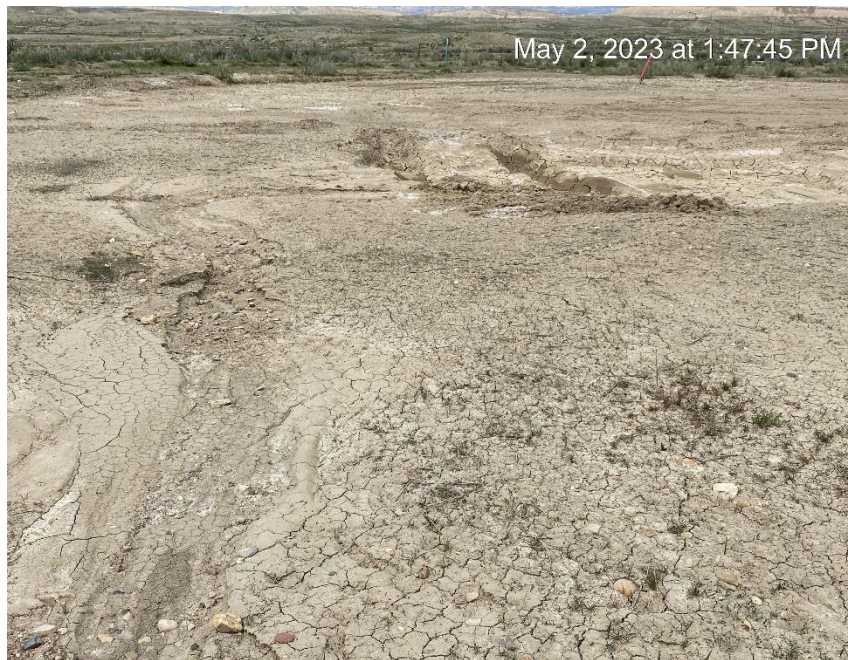
Erosion and sediment migration

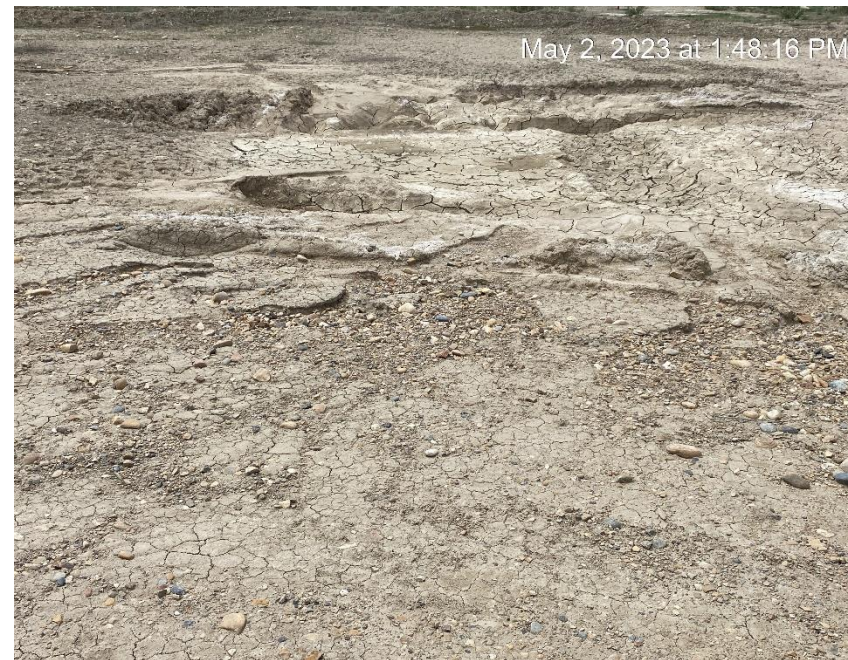
Erosion and sediment migration

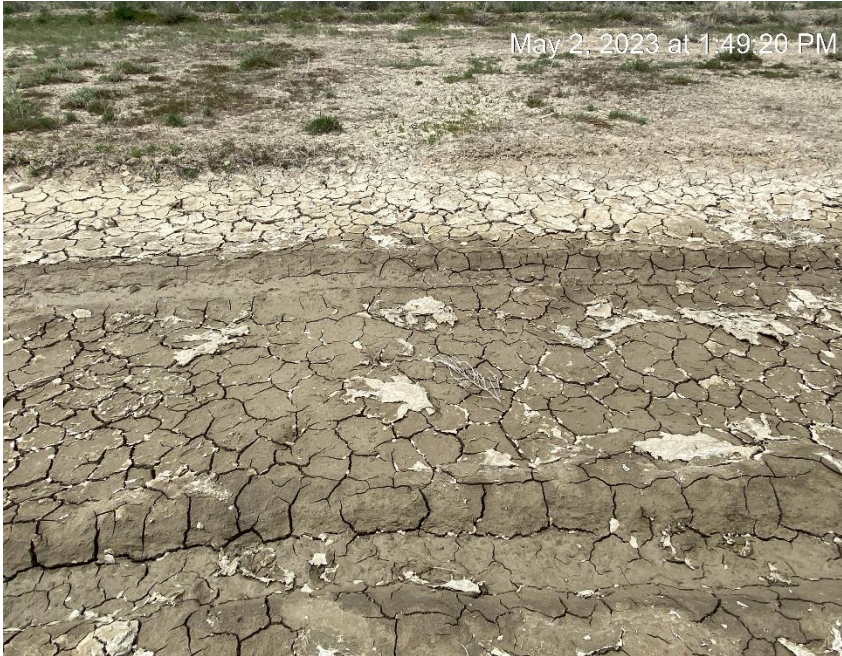
West side of location sediment migration

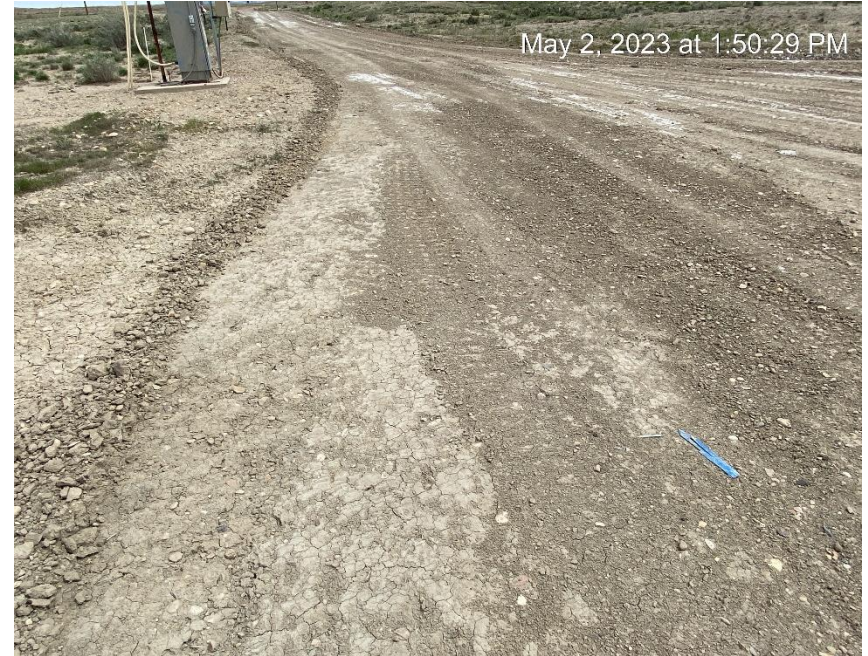
Vehicle tracking BMPs need implemetation
