## Inspection Photos

Location Name: CAERUS PICEANCE LLC M. DUTTON-68S95W /7SWSW.

Location ID: 334127

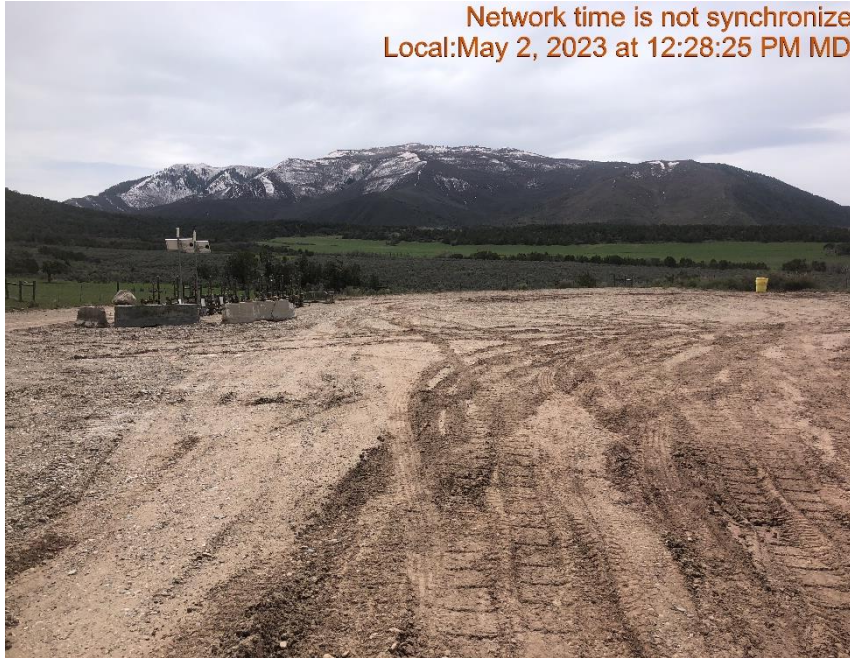
Photo #9792 From entrance to location.

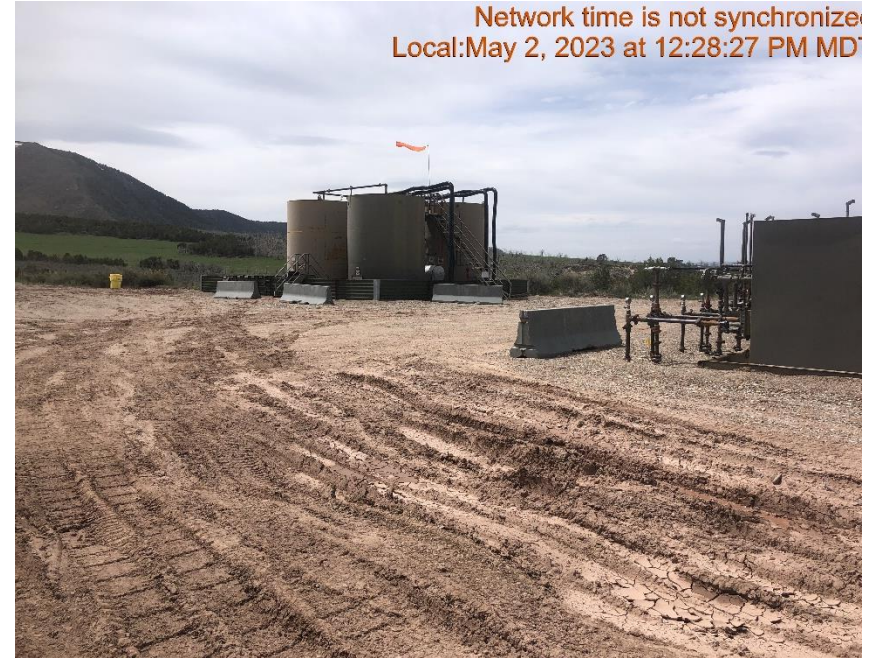
Photo #9793 From entrance to location

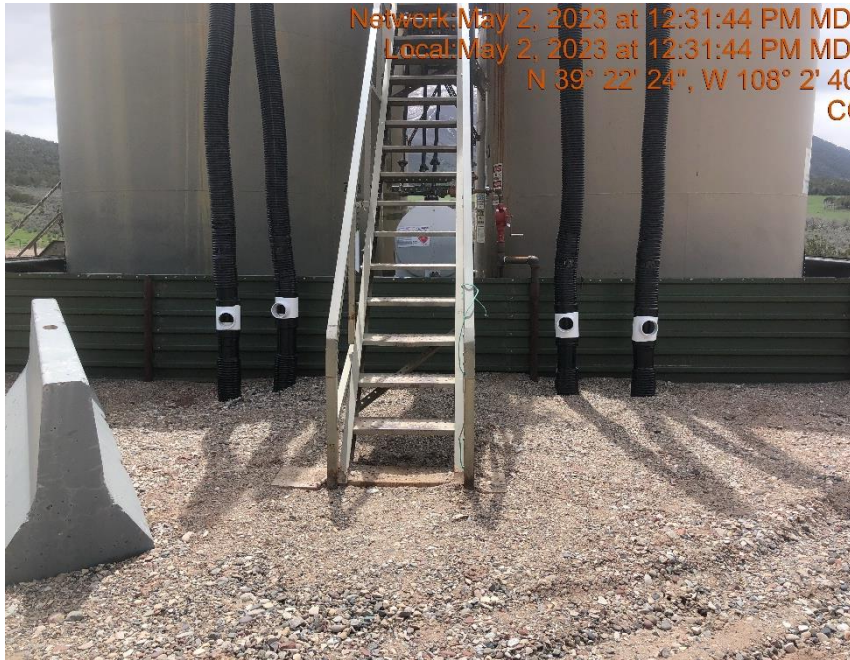
**Photo #9809 Multiple flowline heating insulation open ended.**

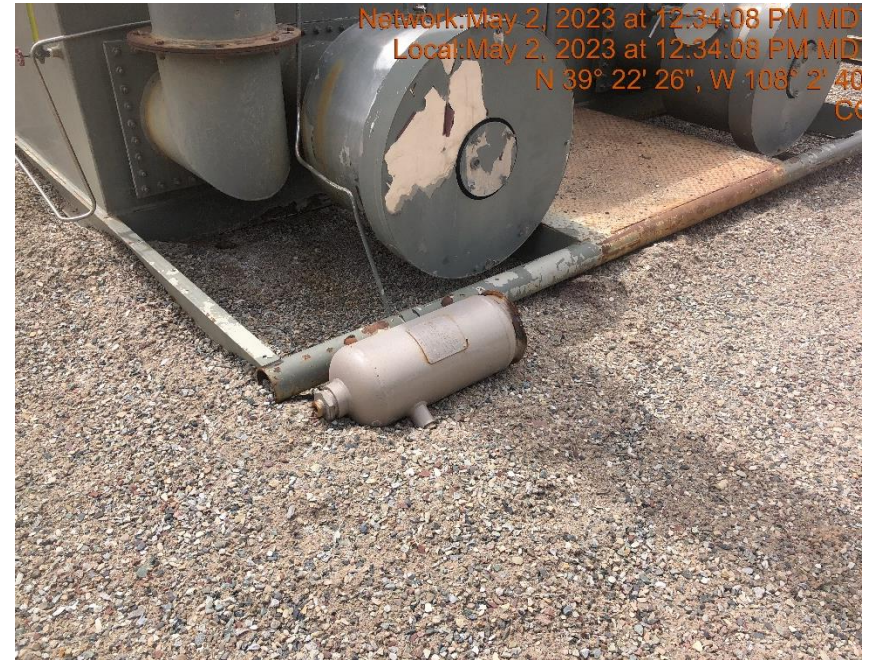
**Photo #9815 Unused equipment.**
