Stormwater Management and Erosion control
Location Name: CAERUS PICEANCE LLC M. DUTTON-68S95W /7SWSW
Location #: 334127

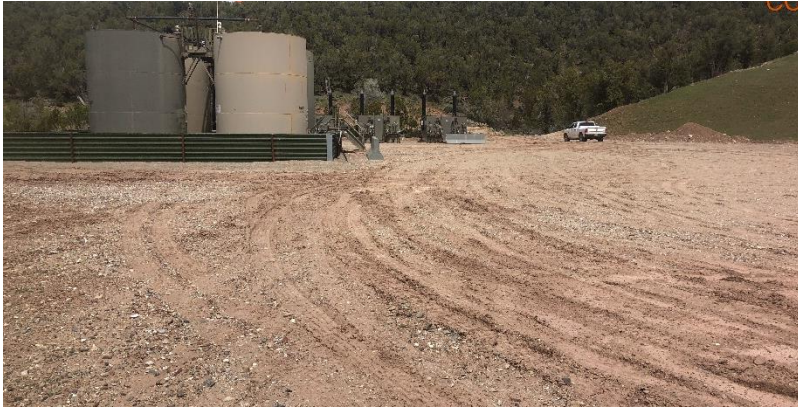
Northwest corner of location.

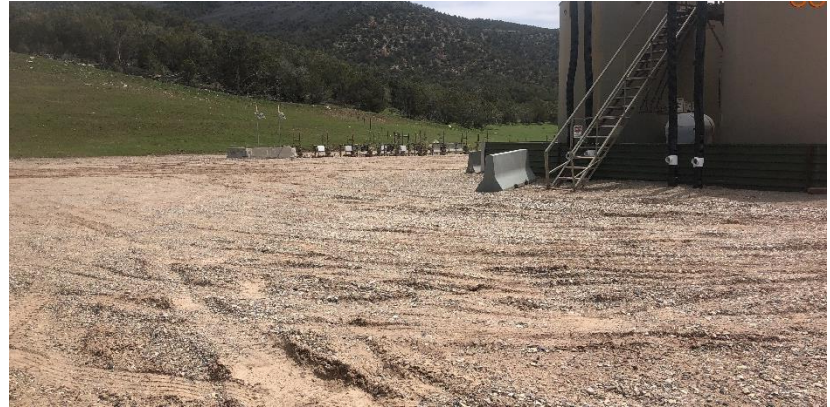
Northeast corner of location.

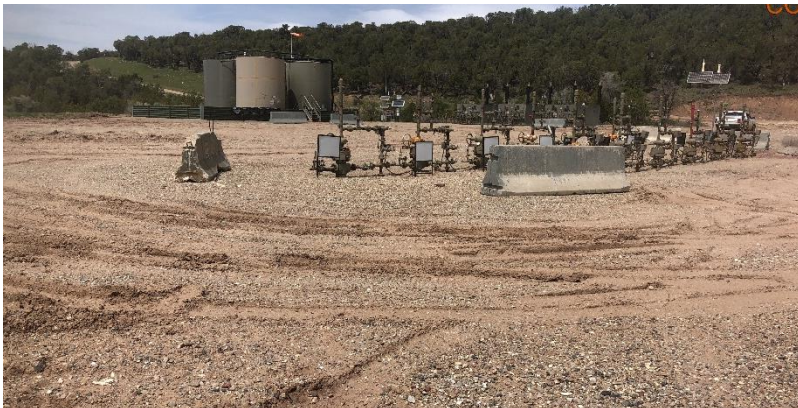
Southwest corner of location.

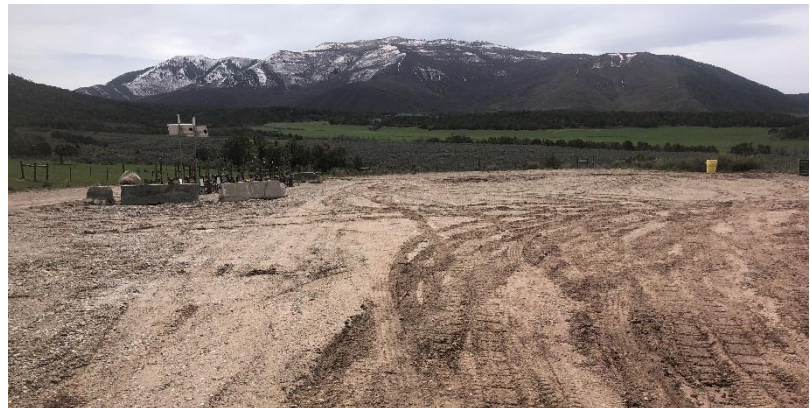
Southeast corner of location.

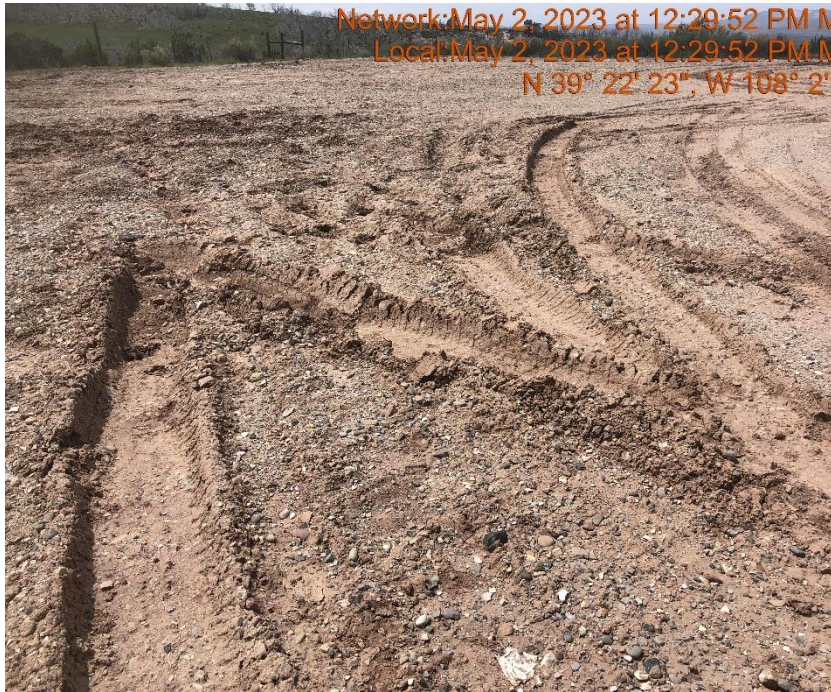
Photo #9800 Location lacks stabilization.

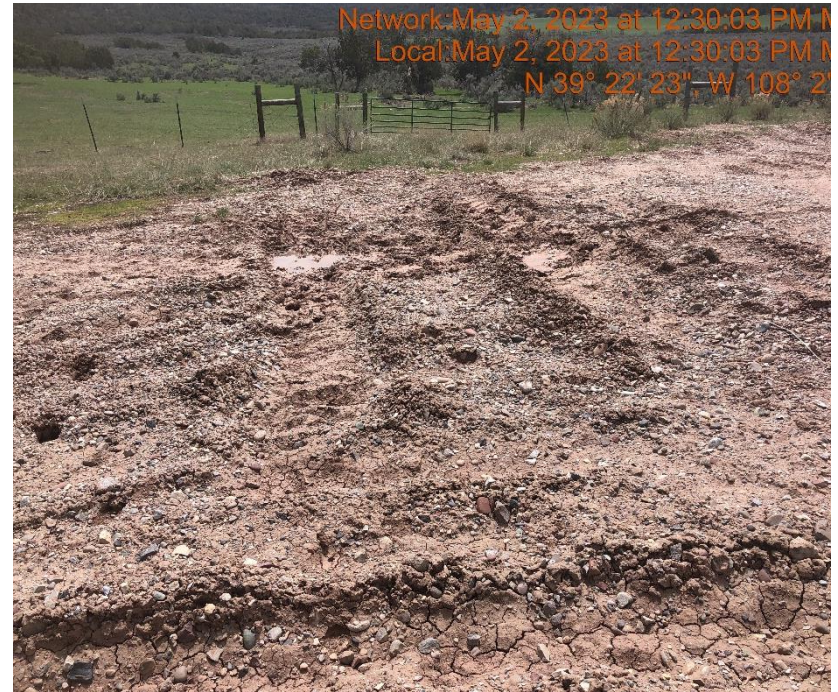
Photo #9801 Location lacks stabilization.

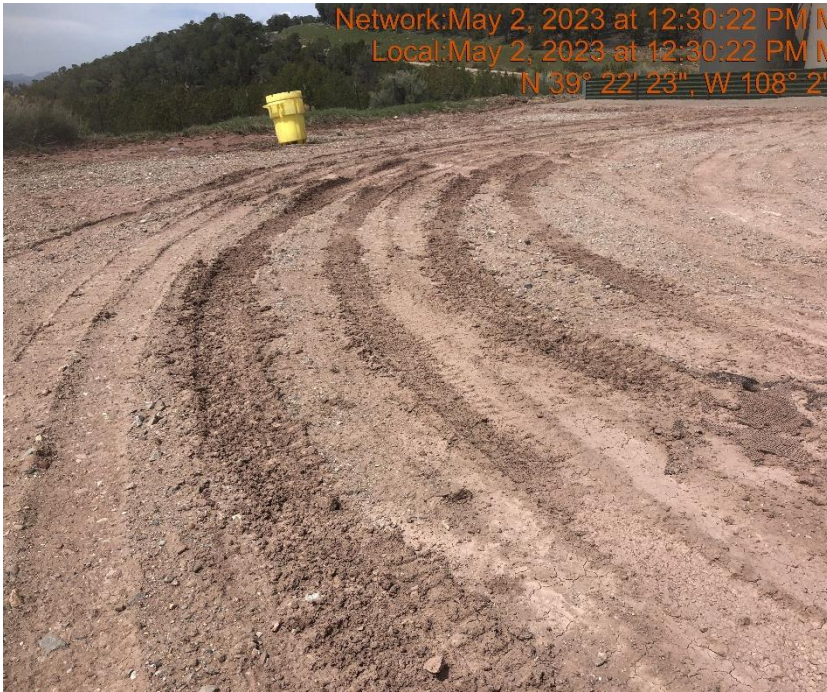
Photo #9802 Location lacks stabilization.

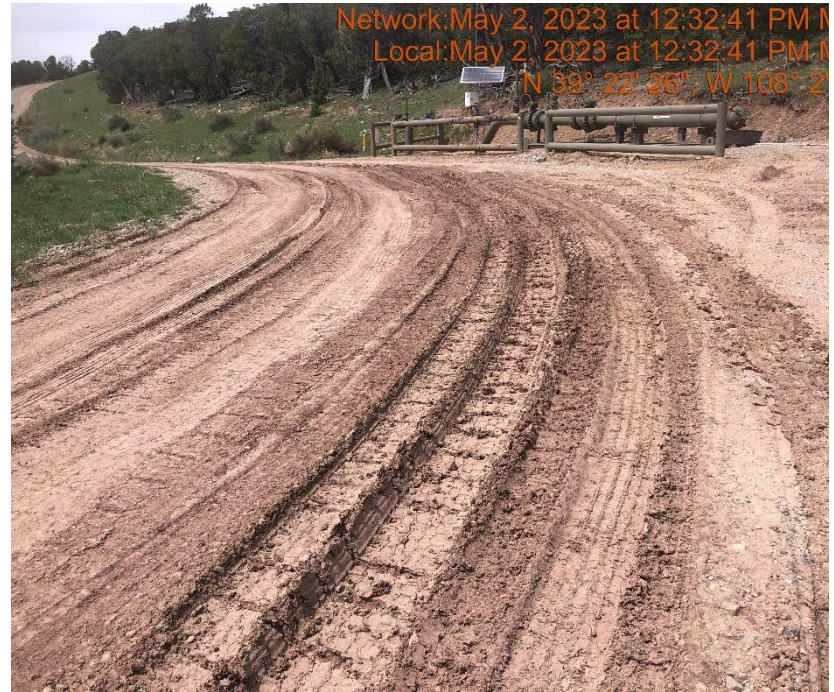
Photo #9811 Insufficient track BMP at entrance to location to minimize the transport of sediment.

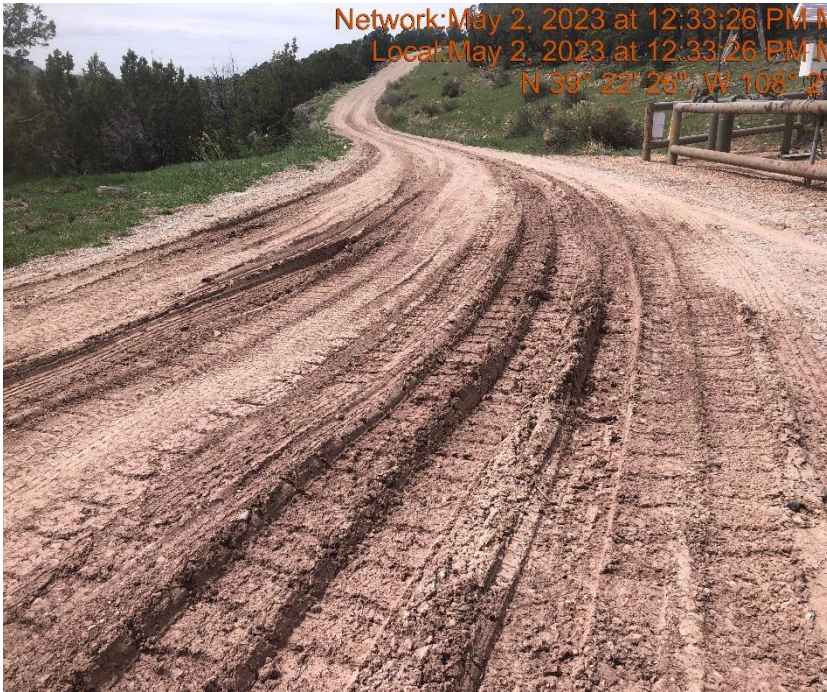
Photo #9814 Insufficient track BMP at entrance to location to minimize the transport of sediment.

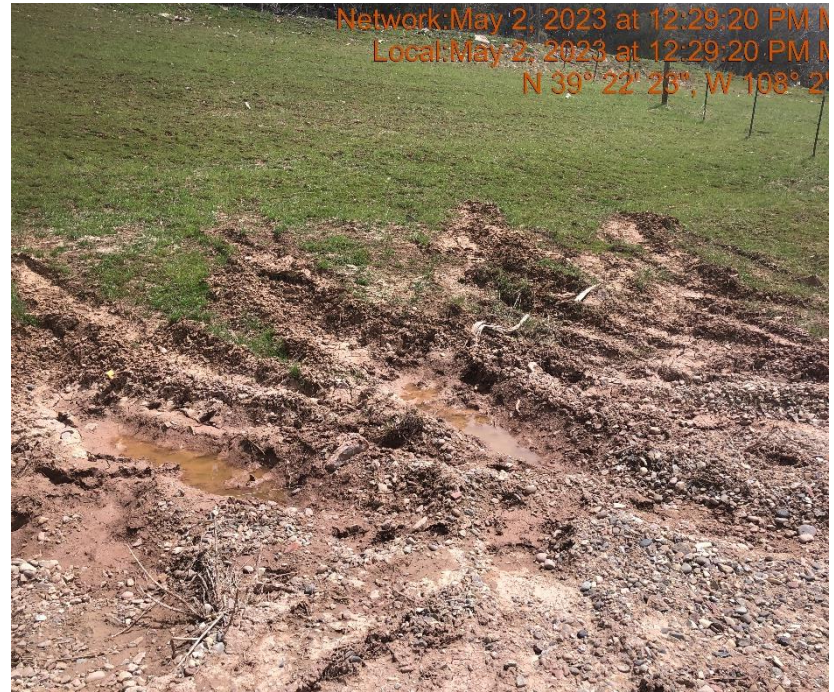
Photo #9796 Expanded use of the location.

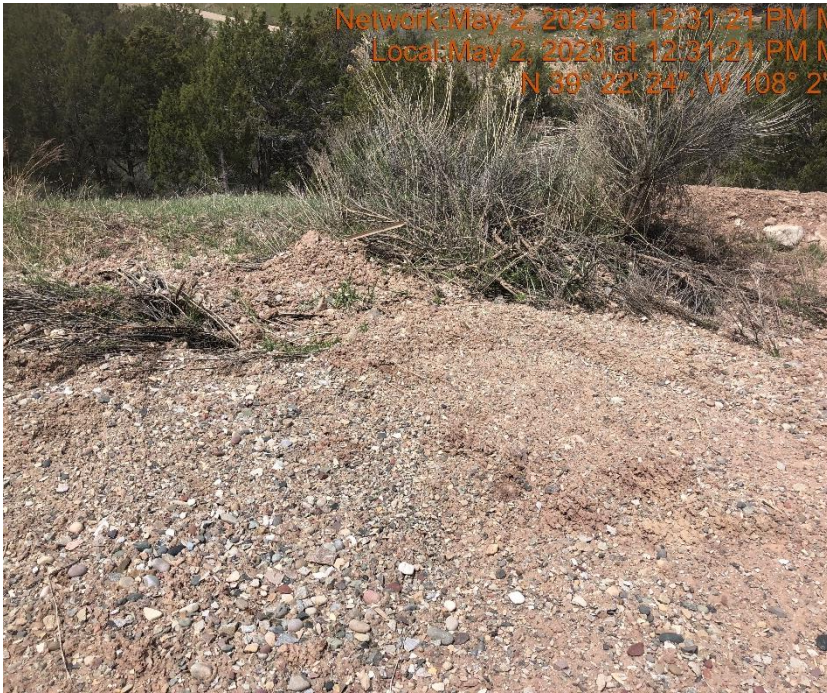
Photo #9806 sediment choking off vegetation

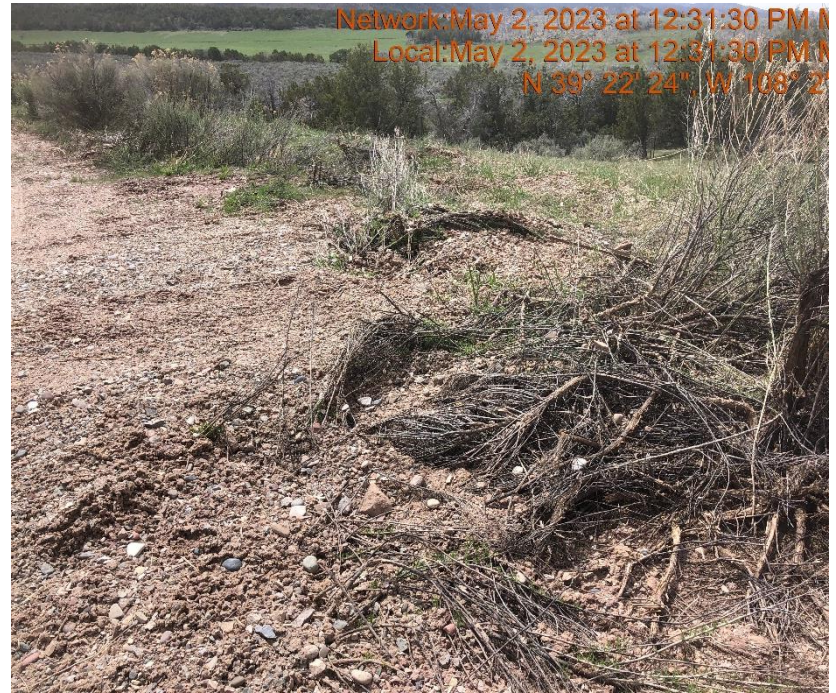
Photo #9807 sediment choking off vegetation

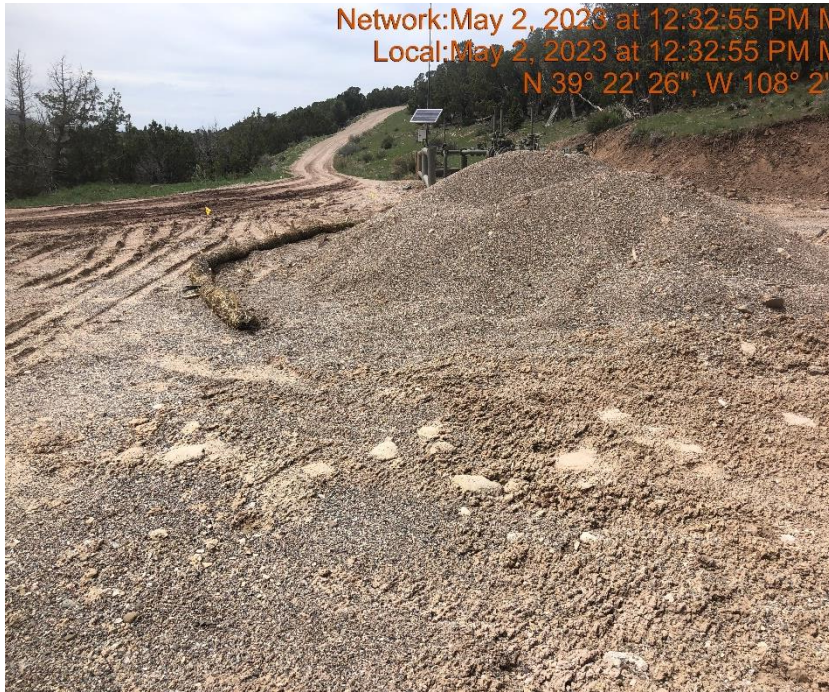
Photo #9812 Insufficient stockpiled soils BMP's.

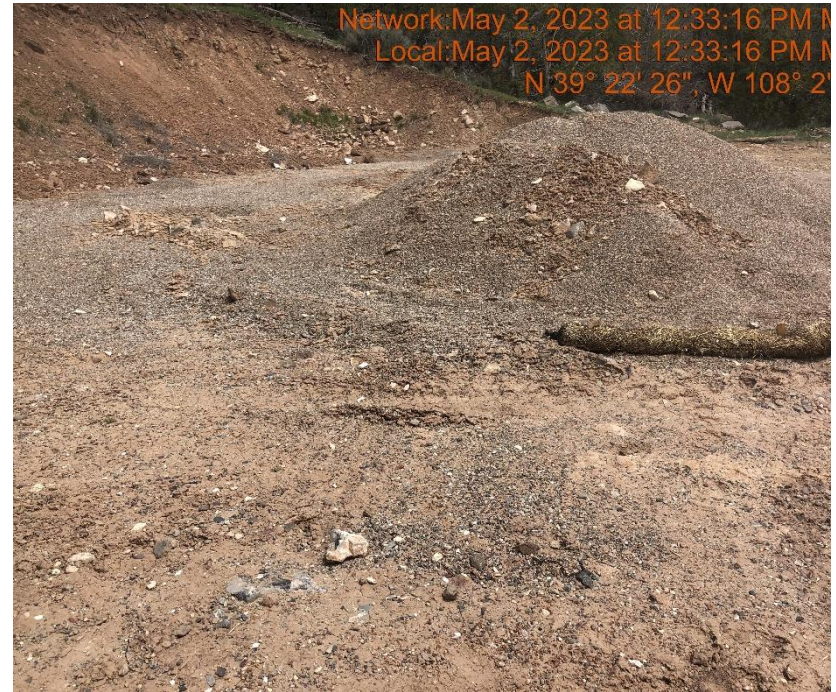
Photo #9813 Insufficient stockpiled soils BMP's.
