Scout Energy Management LLC
U P 3-34
Location #314375

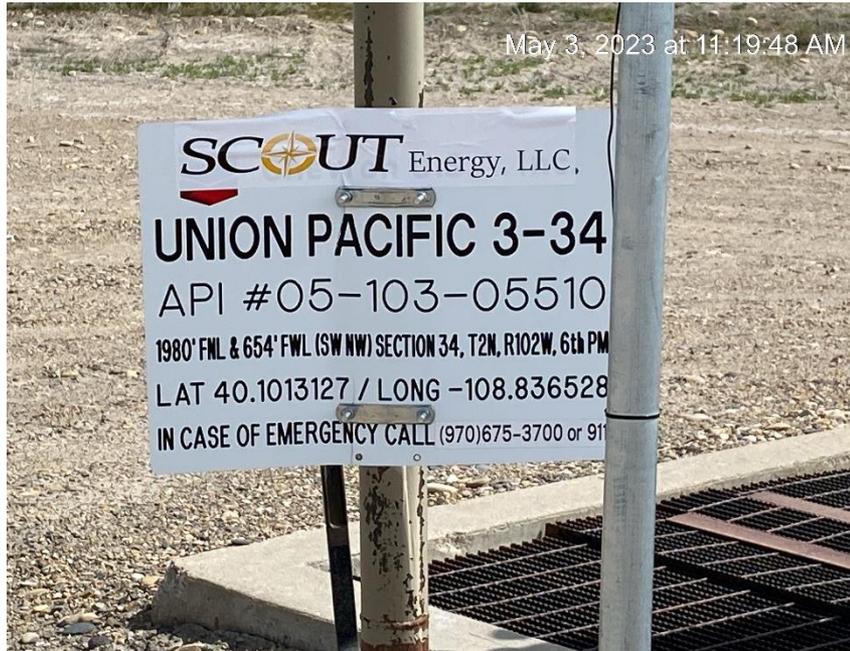
Well sign lacking public road used to access the well information

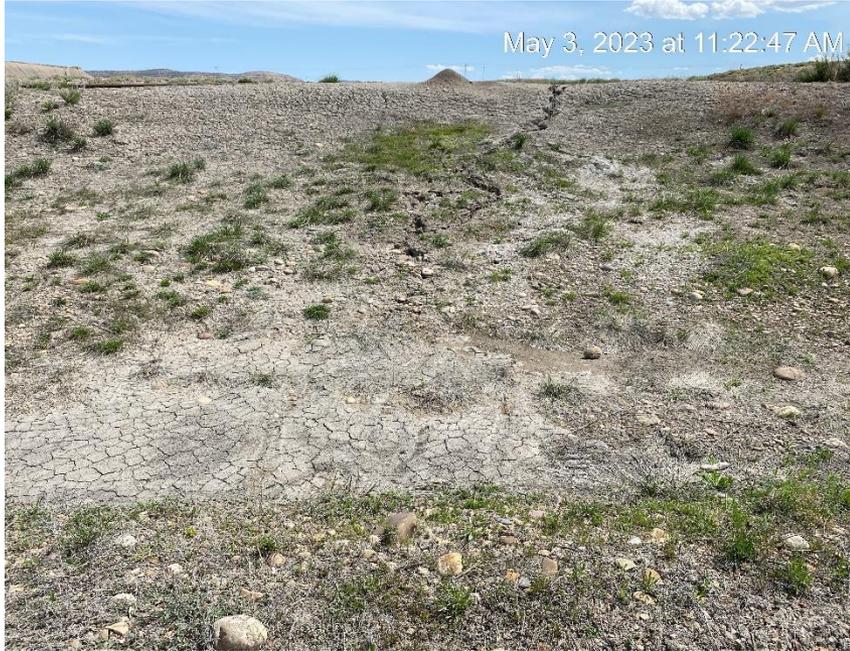
Erosion and sediment migration

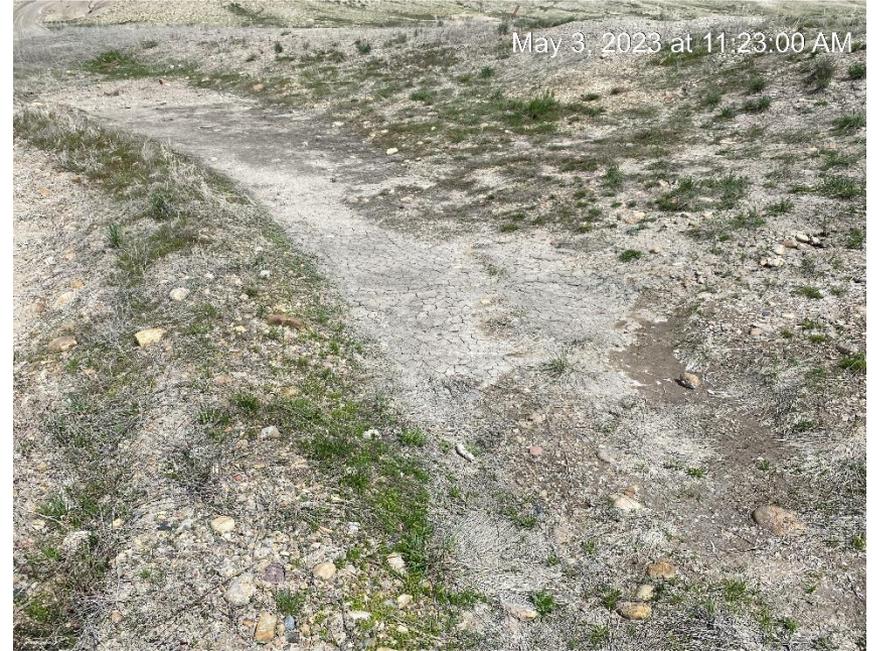
Sediment migration from slope
