**Scout Energy Management LLC
Union Pacific 17-27
Location #314616**

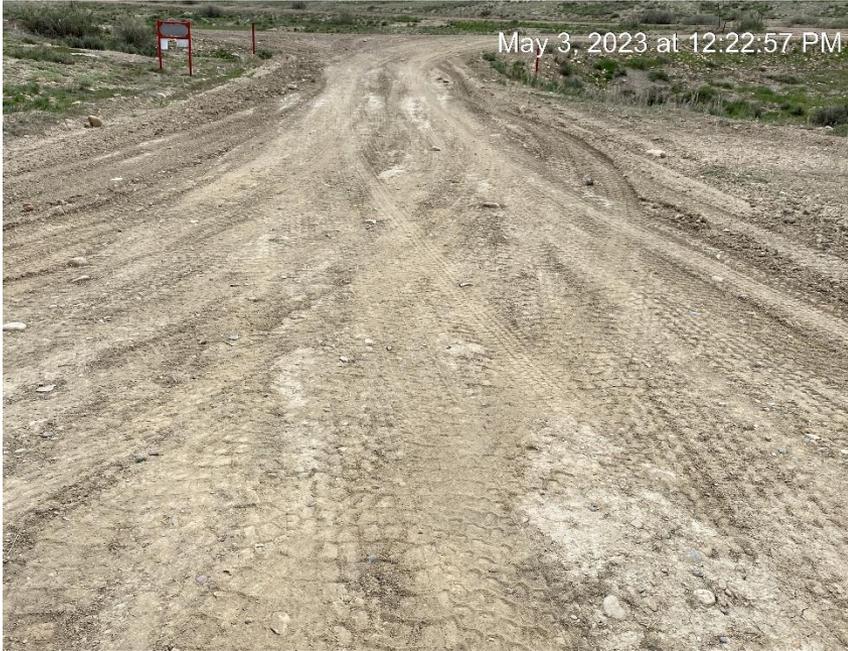
Access road to location

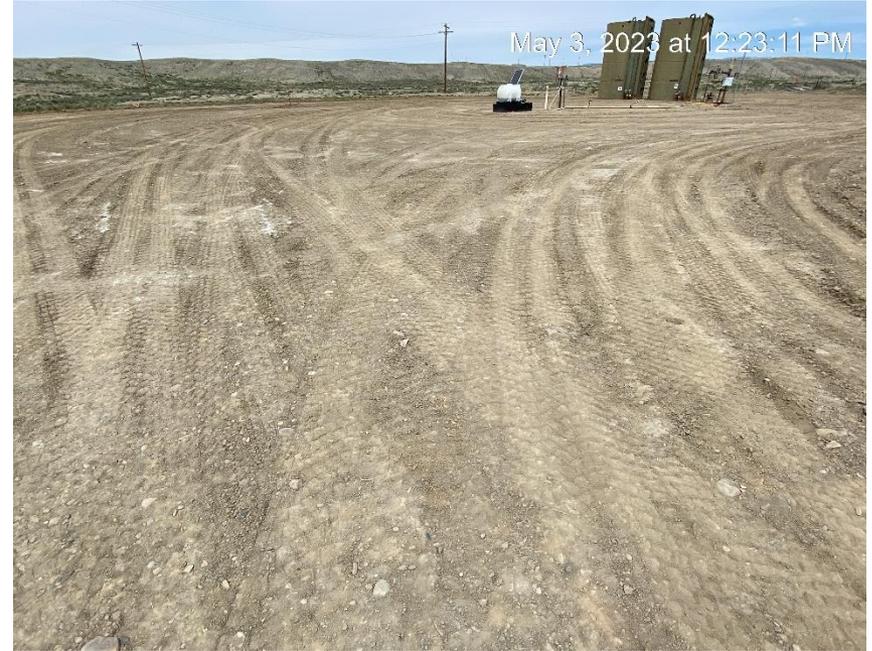
Entrance to location view

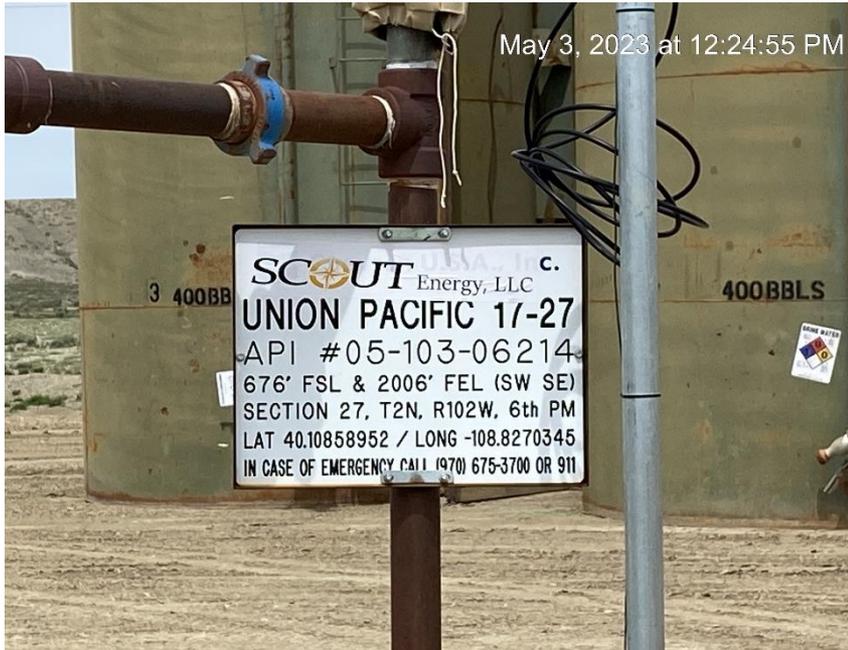
Well sign lacking public road used to access location information

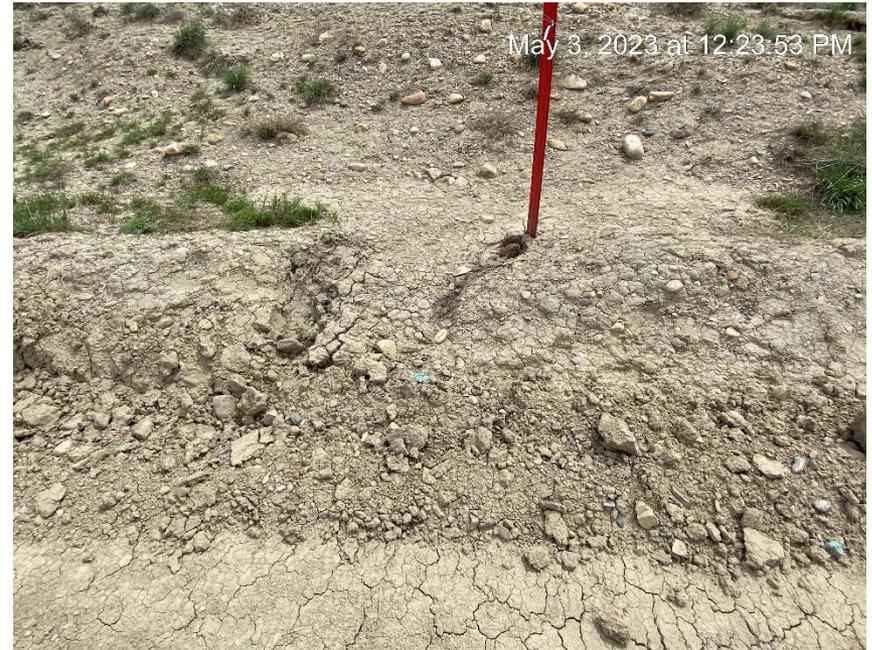
Slope erosion and sediment migration

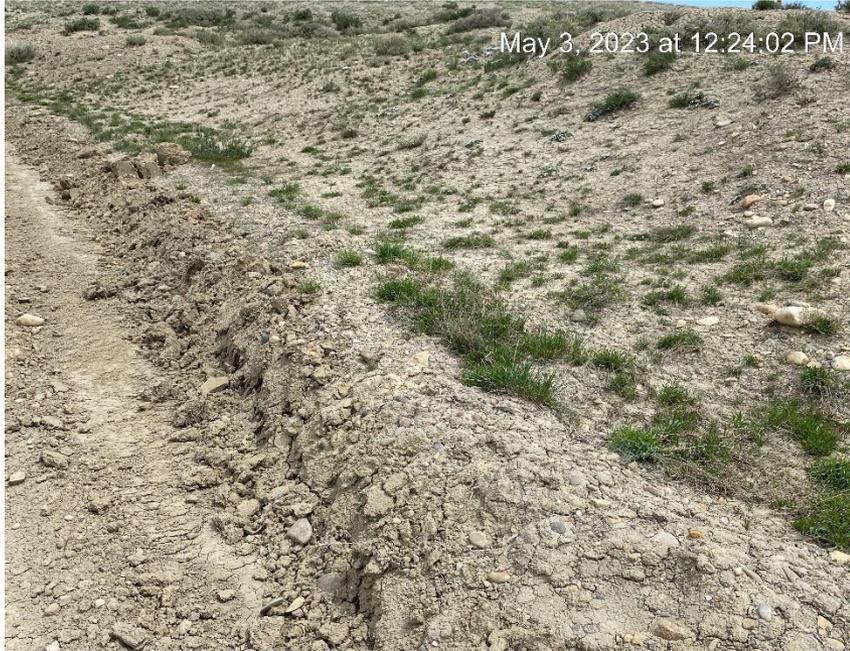
Sediment migrating off slope

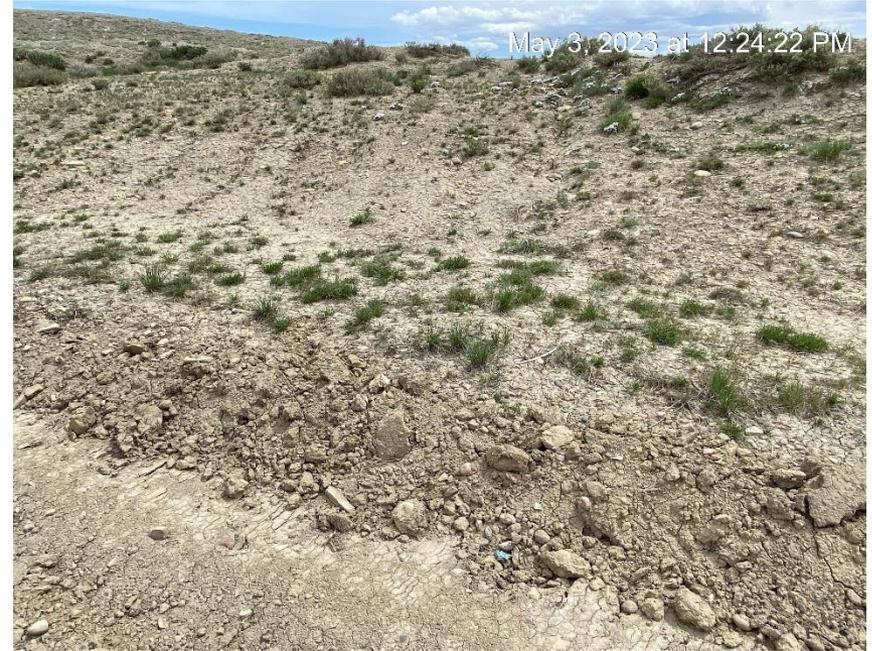
Sediment migration off slope

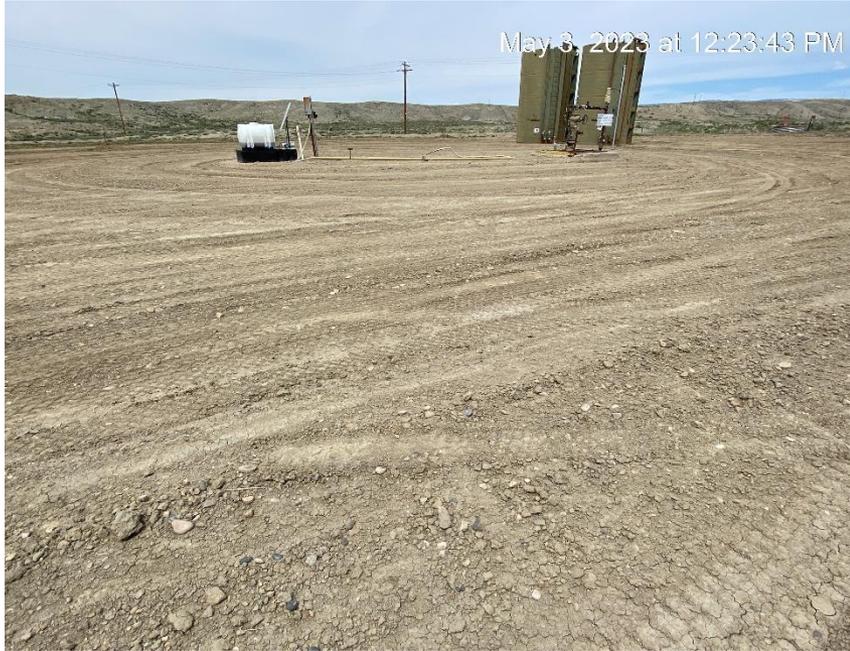
Location view from Southeast corner

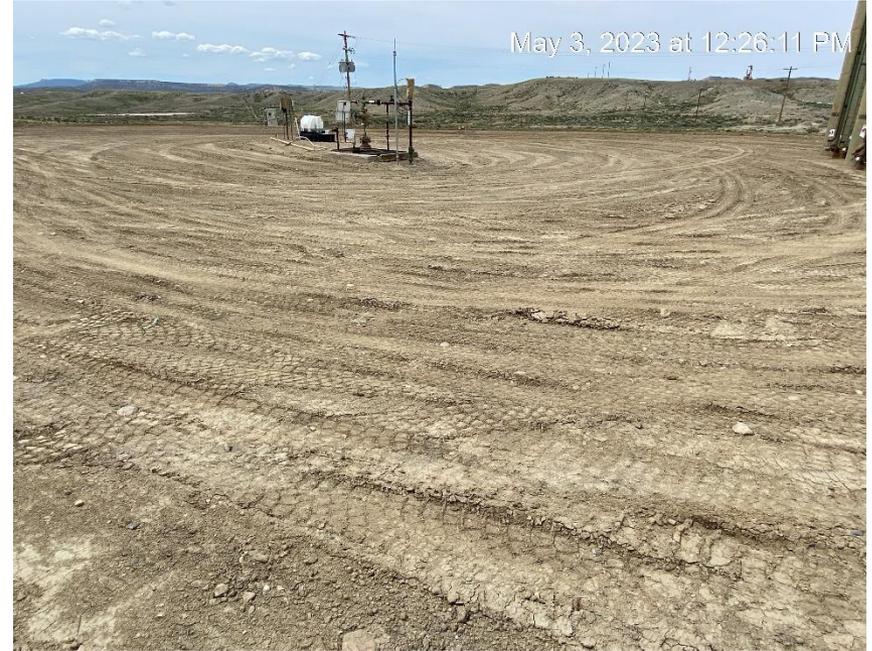
Location view from Northeast corner

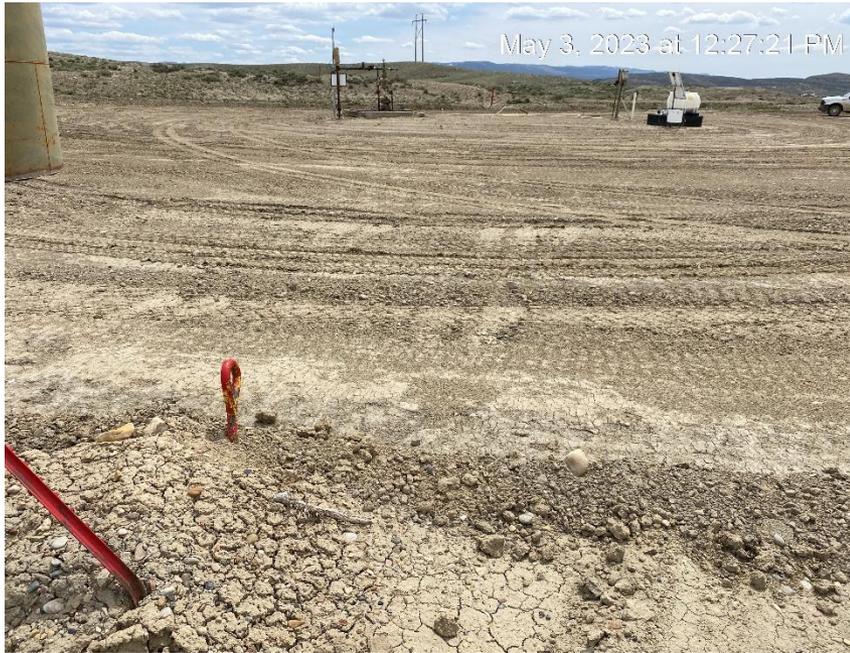
Location view from Northwest corner

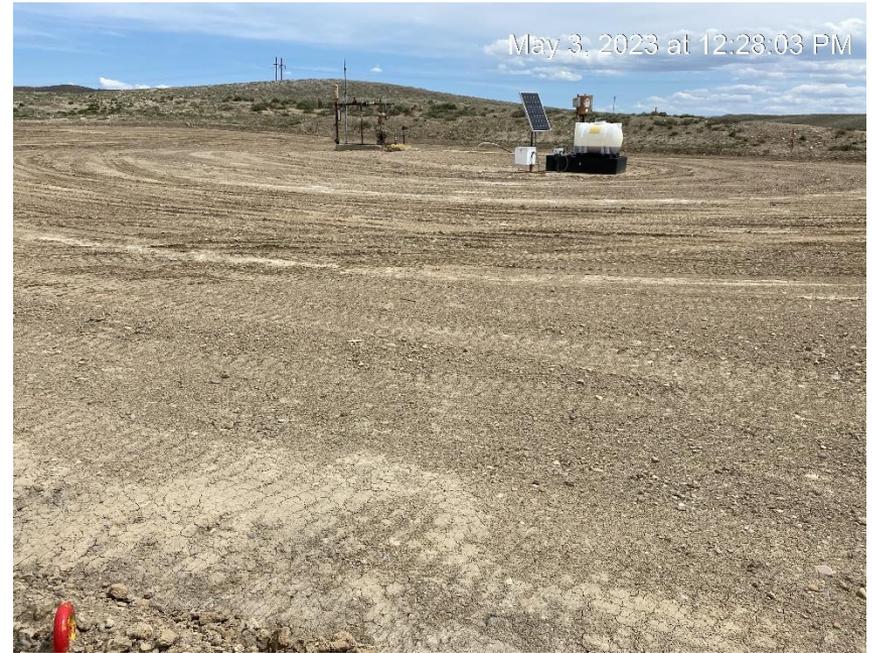
Location view from Southwest corner
