**Scout Energy Management LLC  
A.C. McLaughlin 73X  
Location #315337**

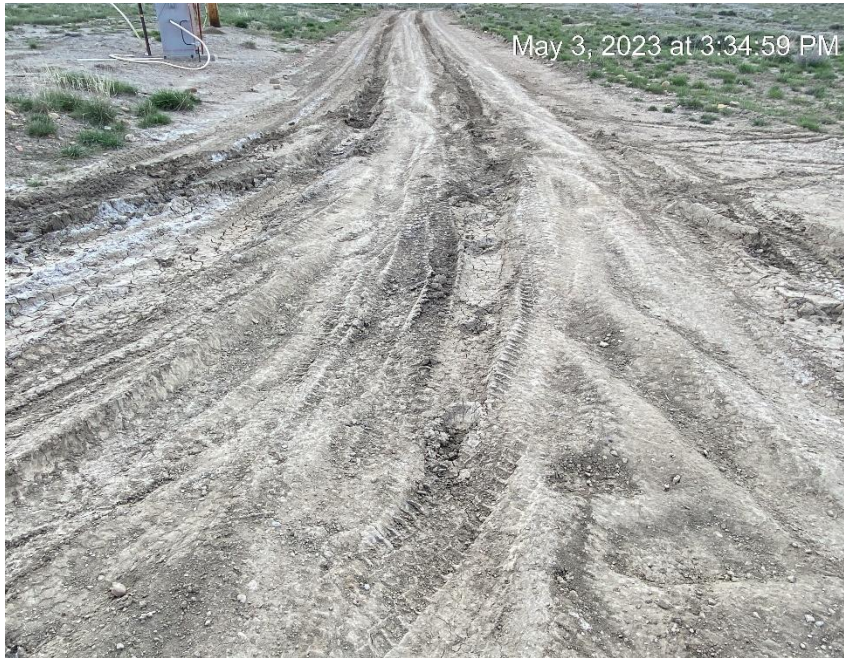
**Access road to location**

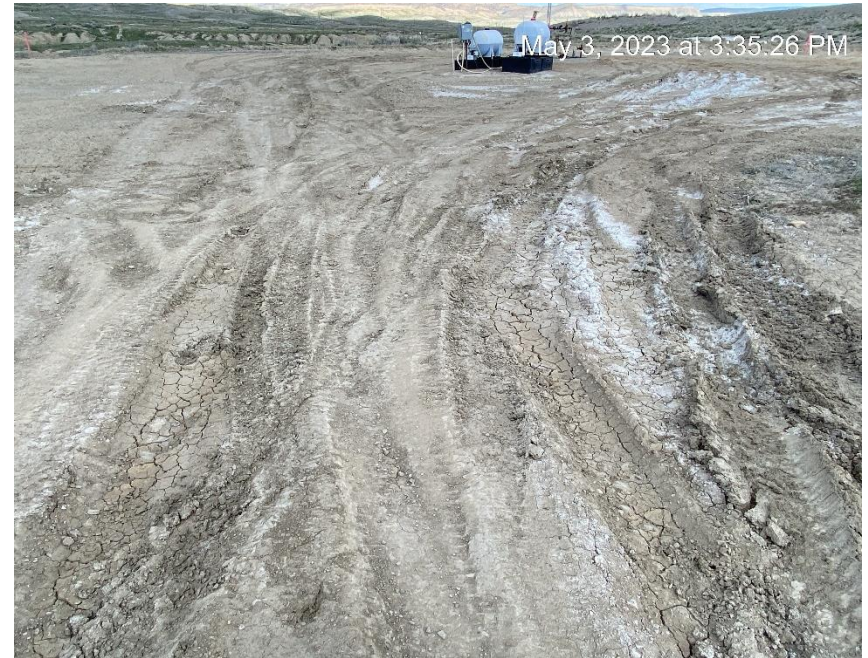
**Entrance to location from access road**

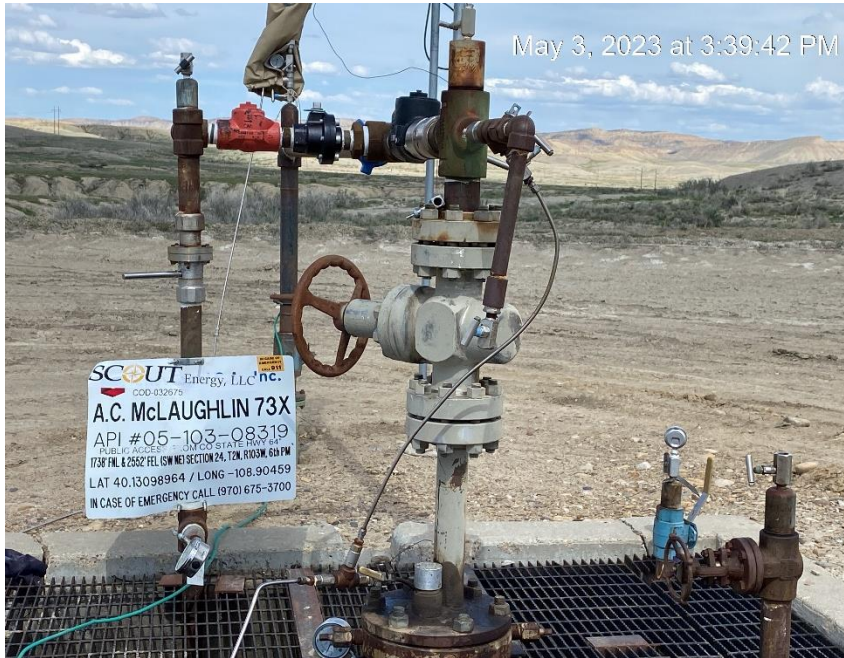
Wellhead view and sign

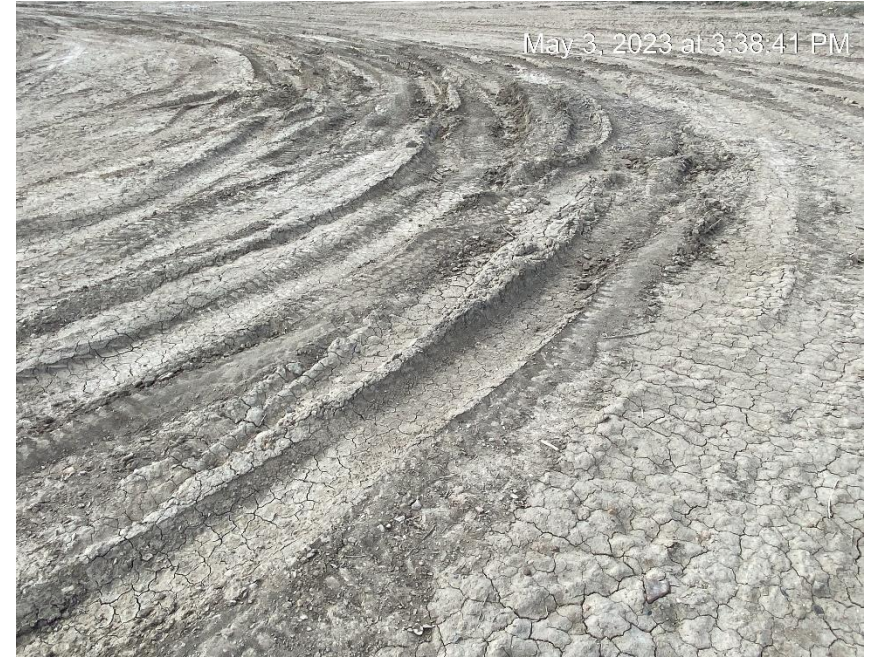
Lack of stabilization. No vehicle tracking pads

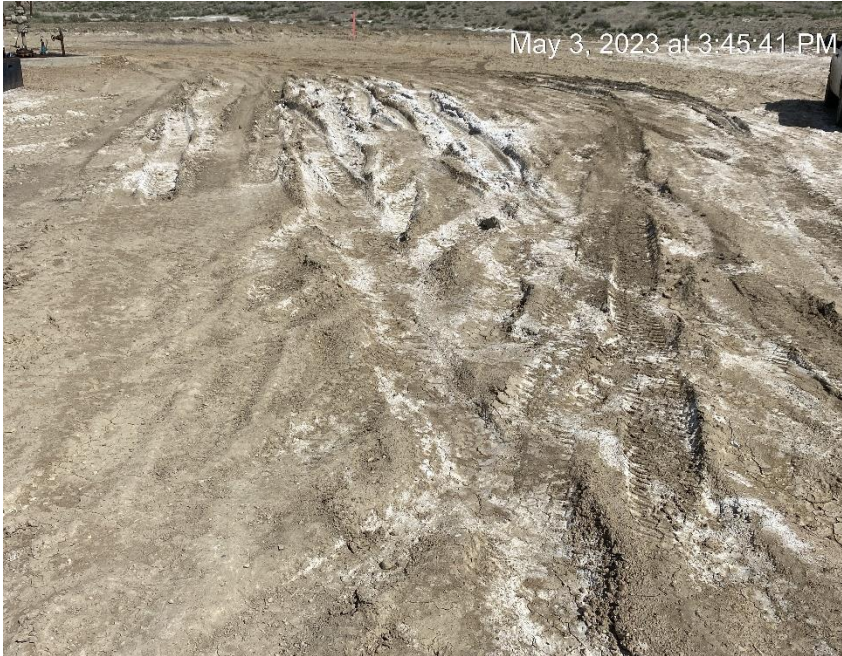
**Lack of stabilization. No vehicle tracking pads**

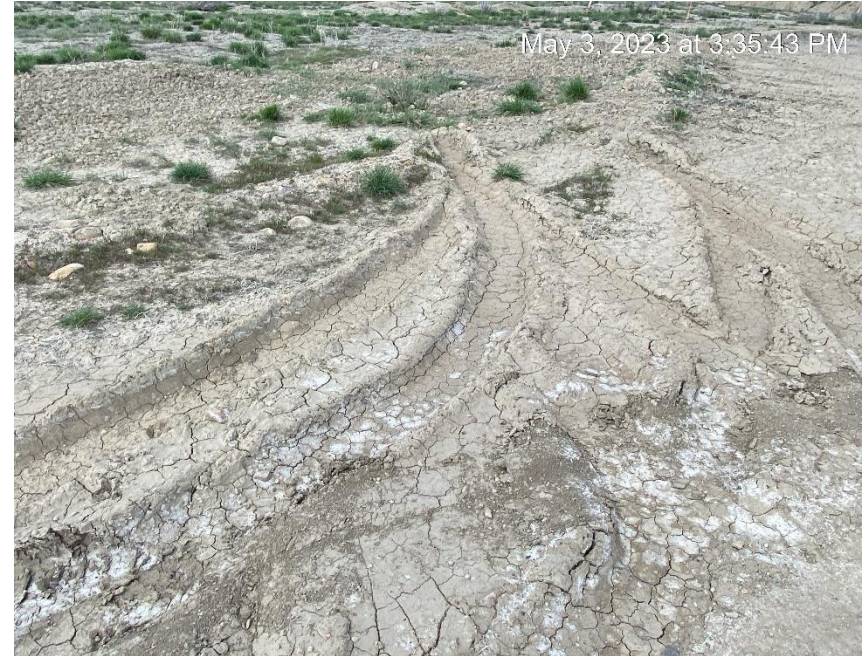
**Lack of stabilization. Vehicle tracking**

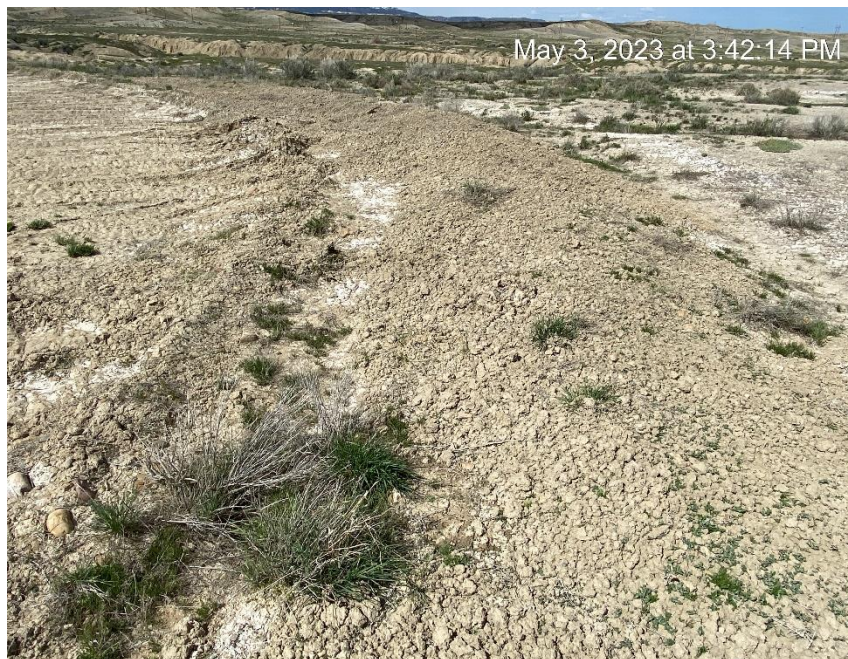
**Sediment movement and migration**

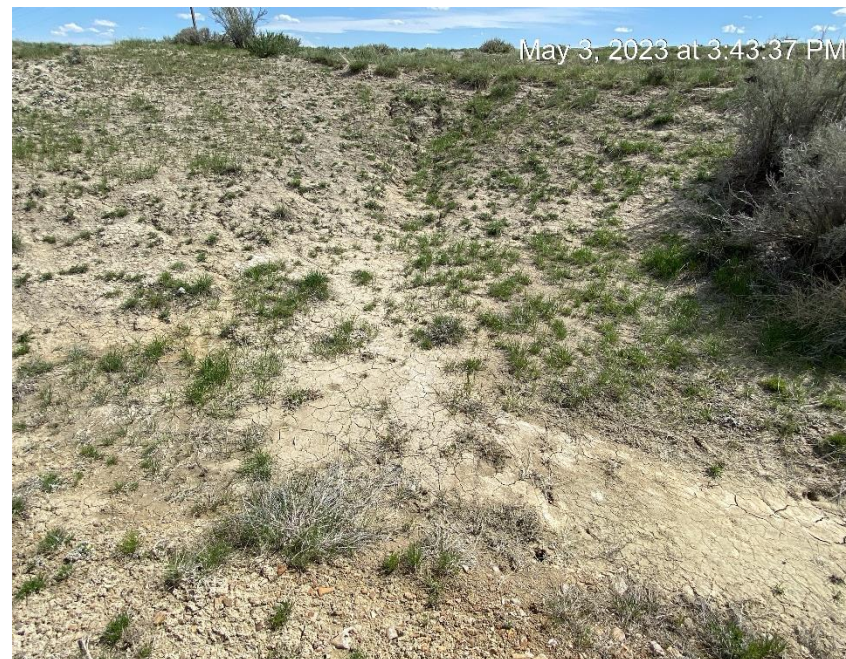
**Unstable slope sediment migration**

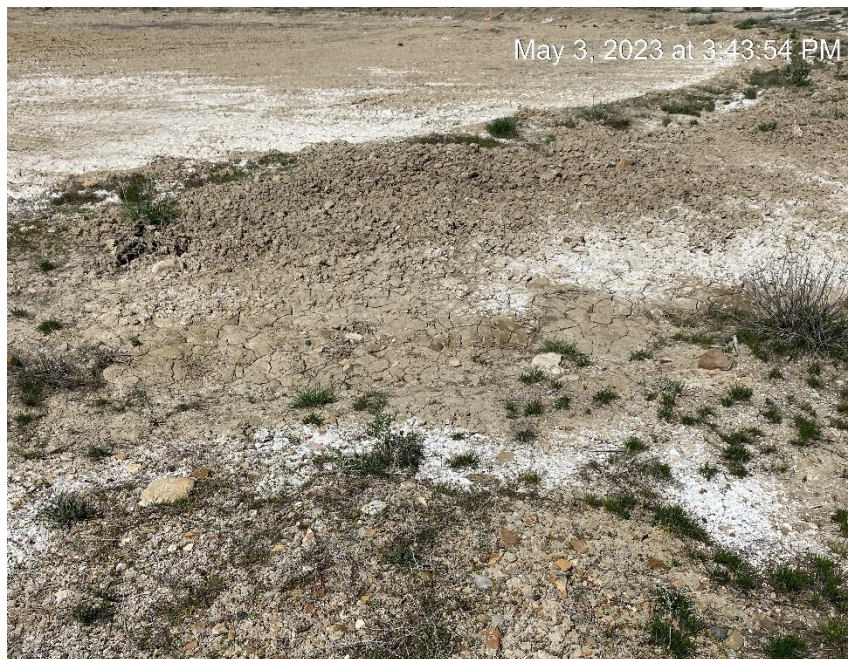
**Sediment movement and migration**

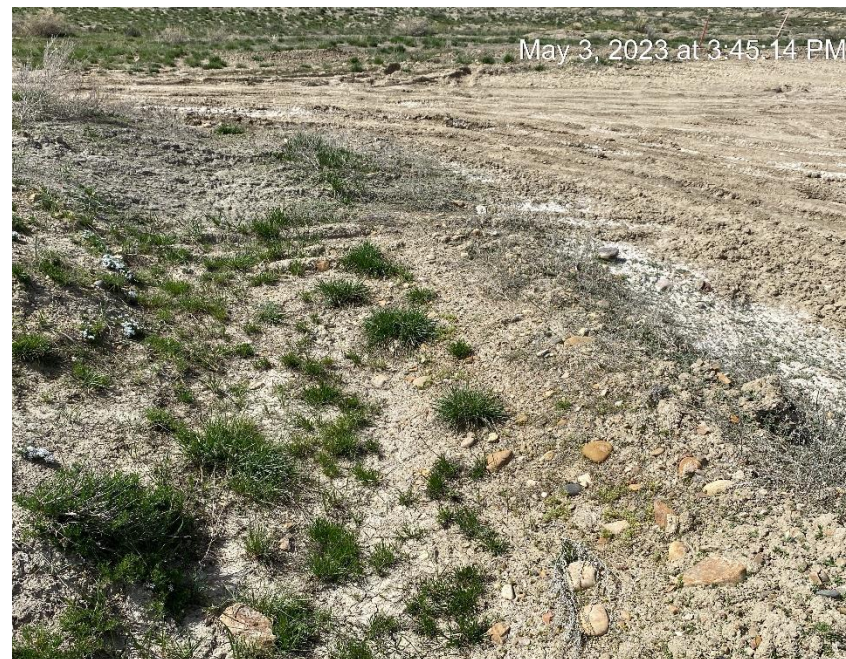
**Diversion ditch to location**

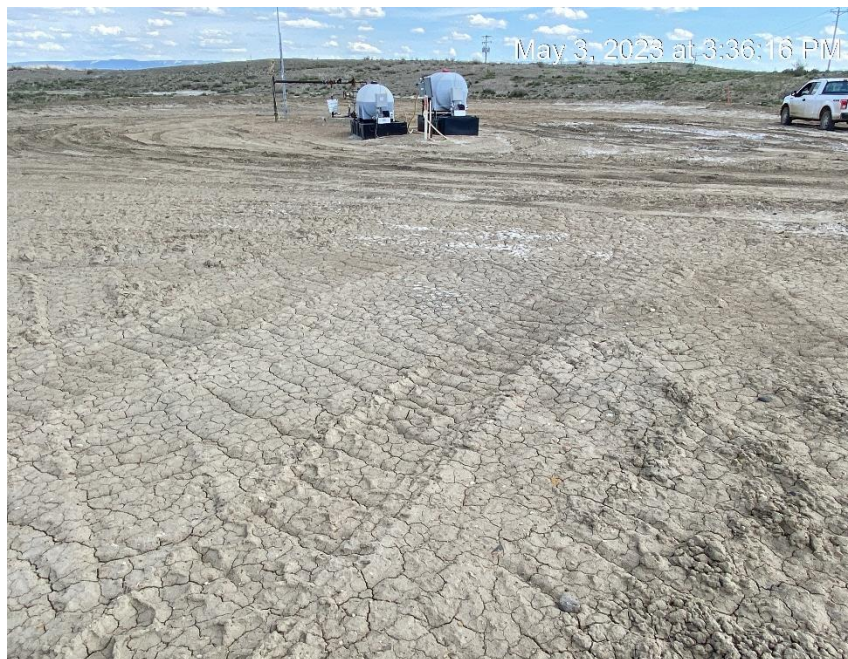
**Location view from Northwest corner**

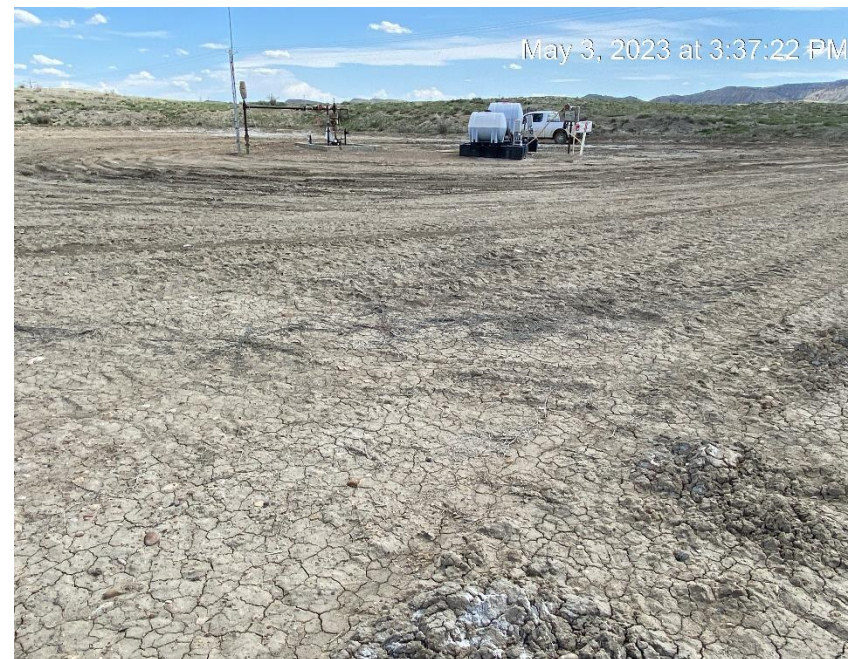
**Location view from Northeast corner**

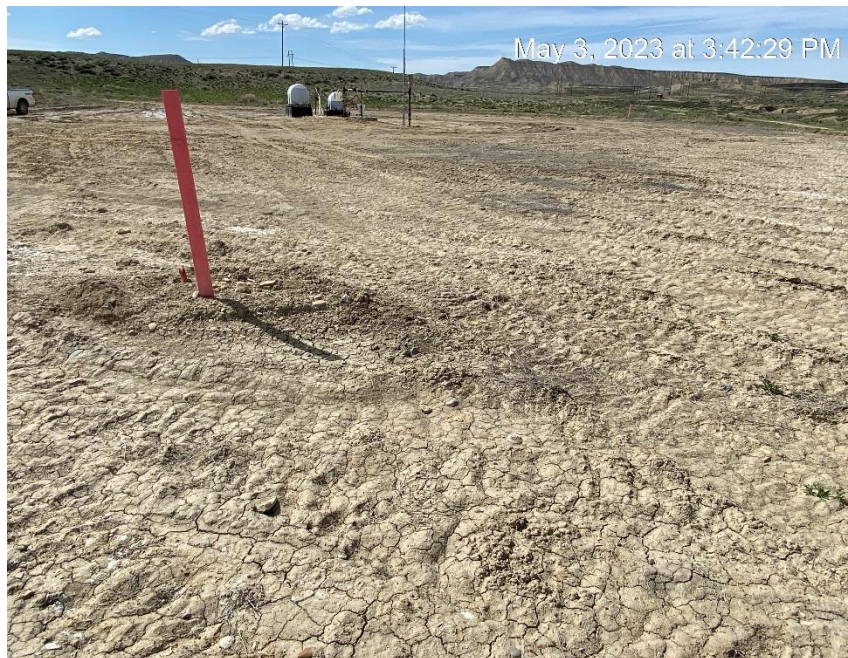
**Location view from Southeast corner**

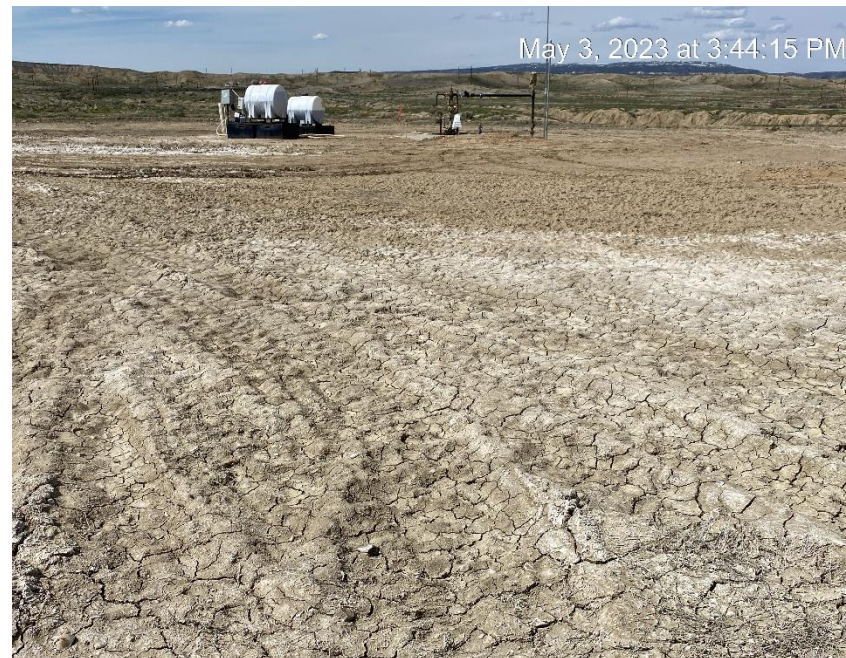
**Location view from Southwest corner**
