## Inspection Photos

Location Name: TEP ROCKY MOUNTAIN LLC CLOUGH 31-23H Pad

Location ID: 323919

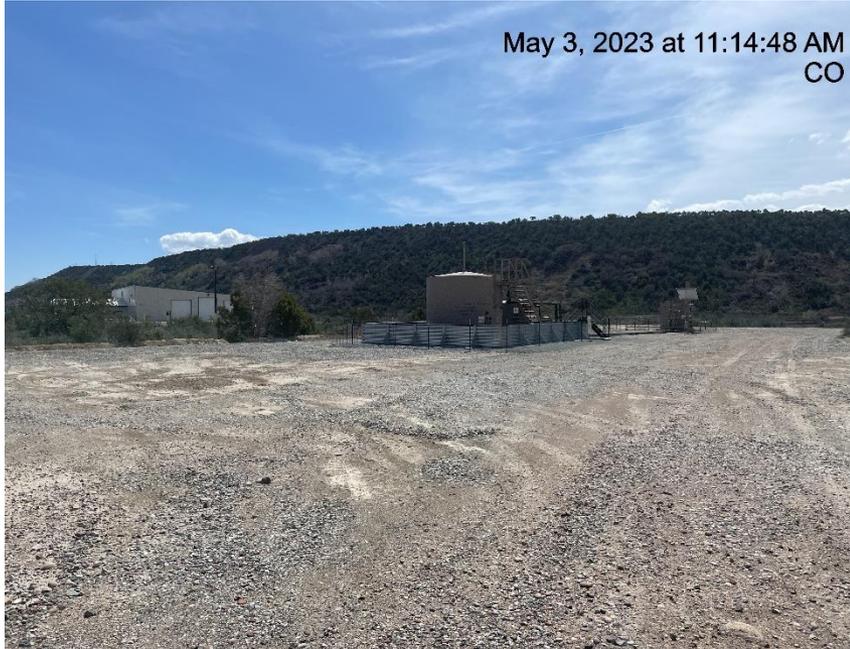
Photo # 6792 From entrance to location

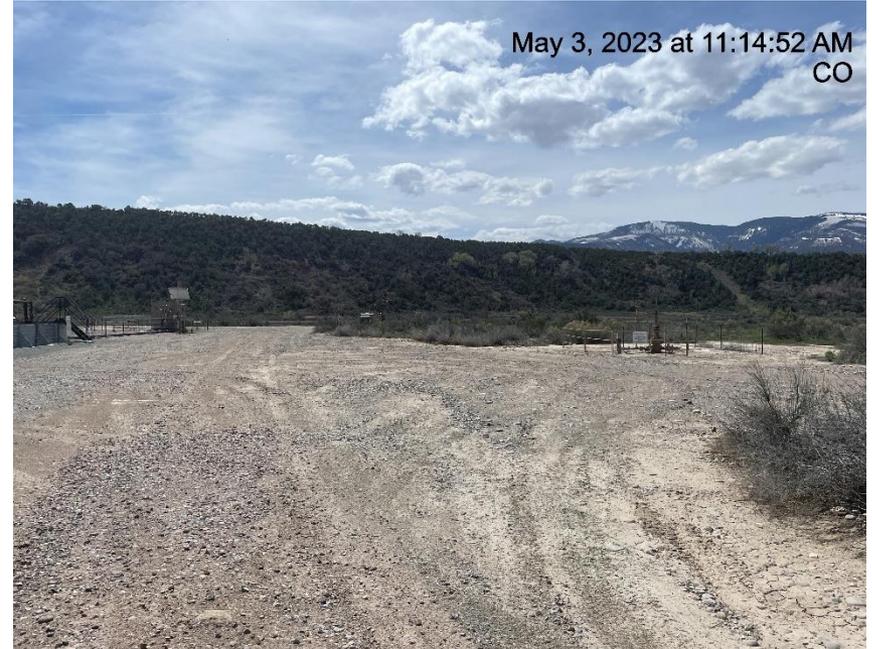
Photo # 6793 From entrance to location

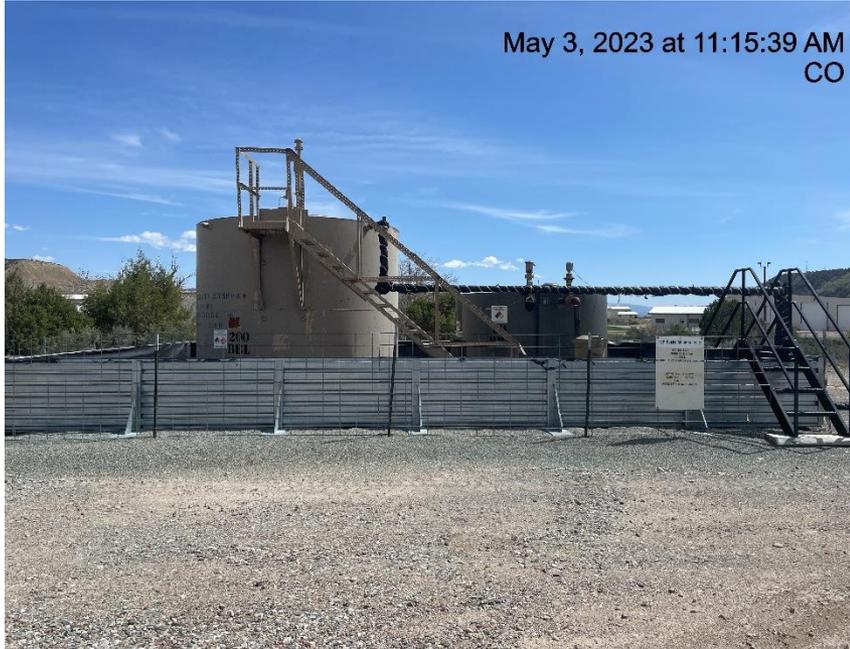
Photo # 6794 Location

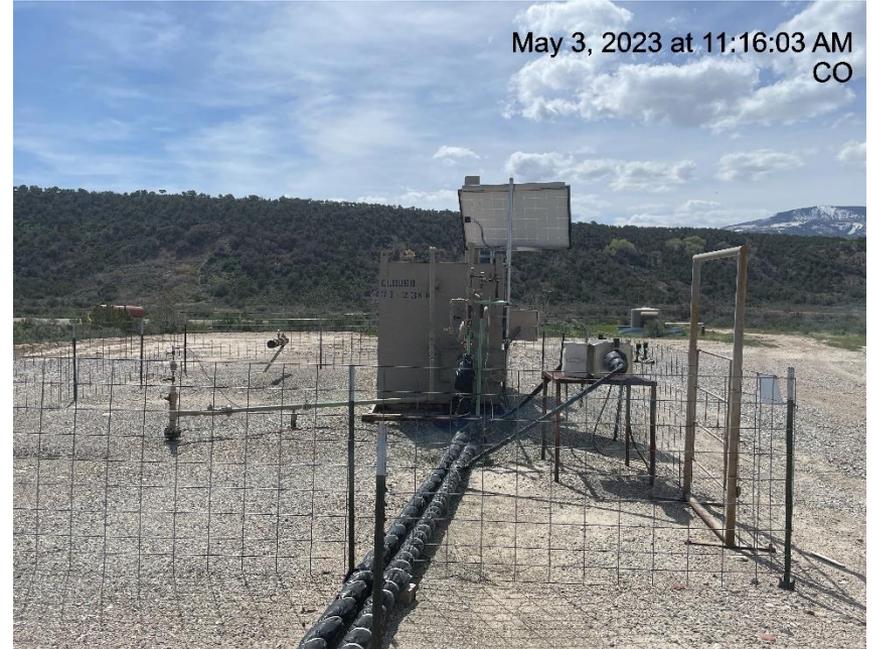
Photo # 6795 Location

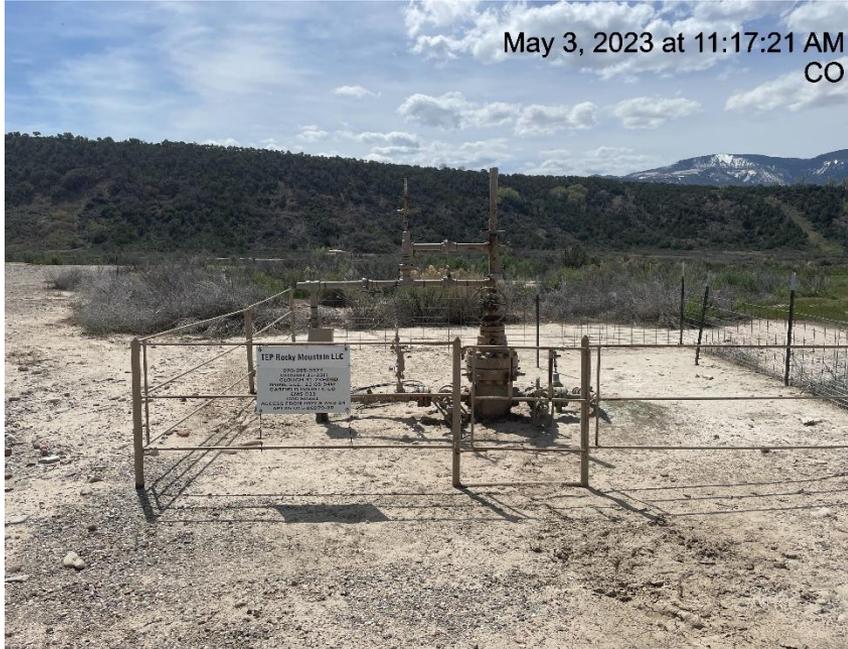
Photo # 6796 Location

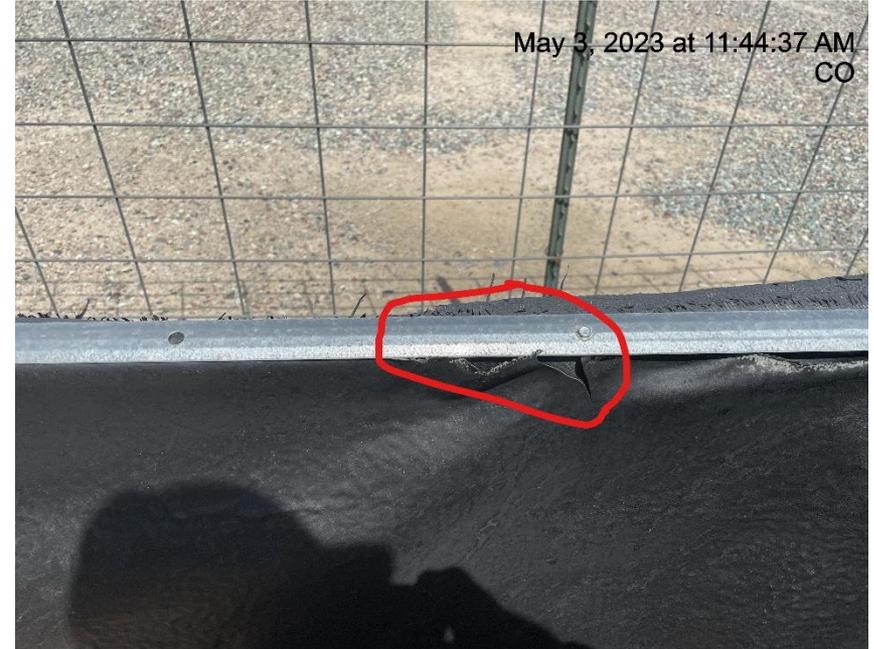
Photo # 6825 Containment needs maintenance

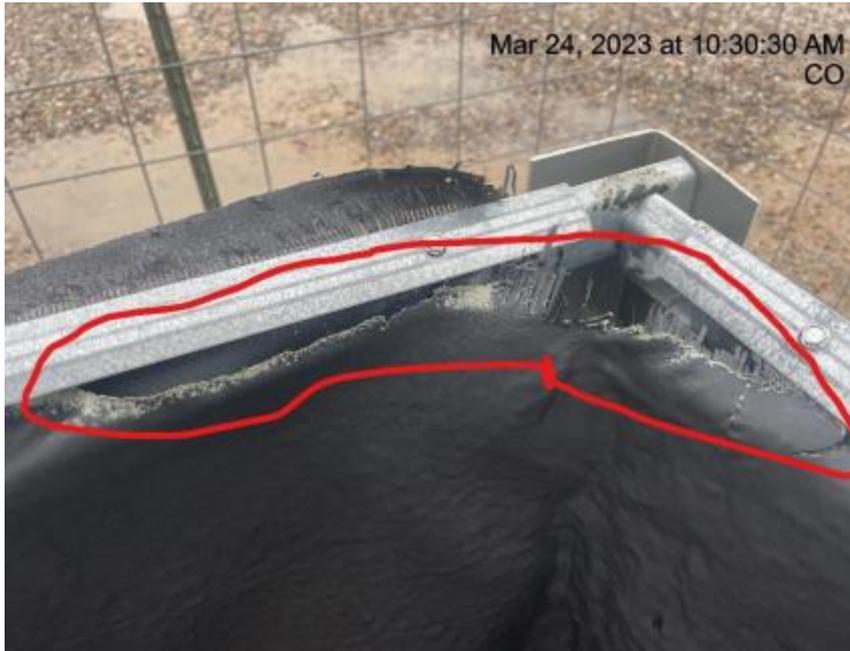
Photo # 3120 From Inspection 708900164 conducted on 03/24/2023 Containment needs maintenance

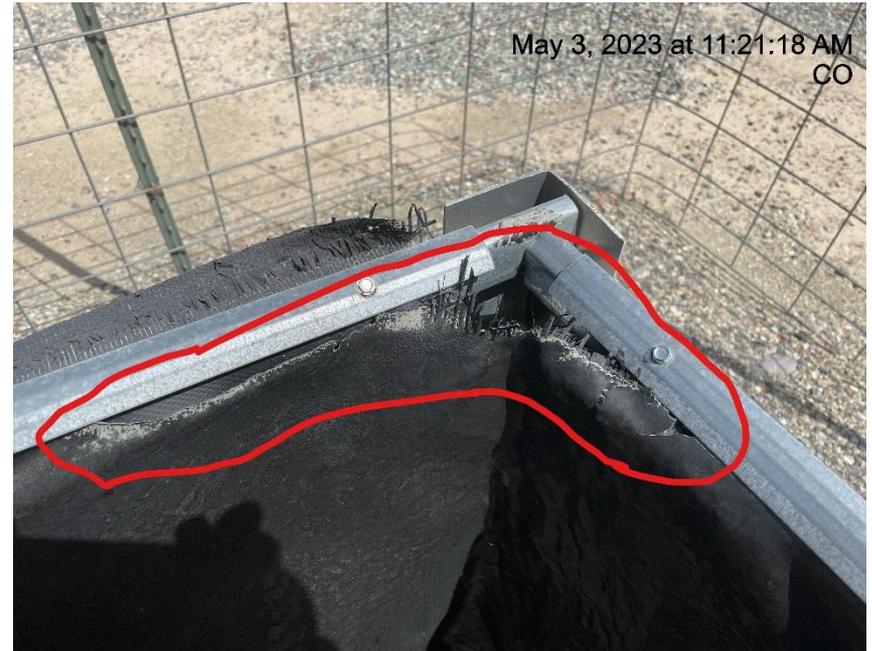
Photo # 6800 Containment needs maintenance

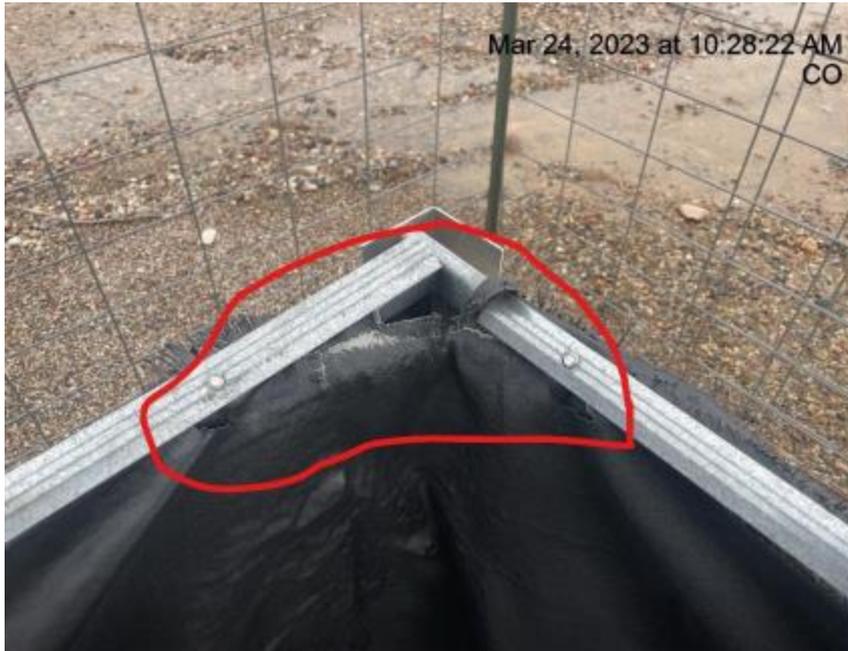
Photo # 3119 From Inspection 708900164 conducted on 03/24/2023 Containment needs maintenance

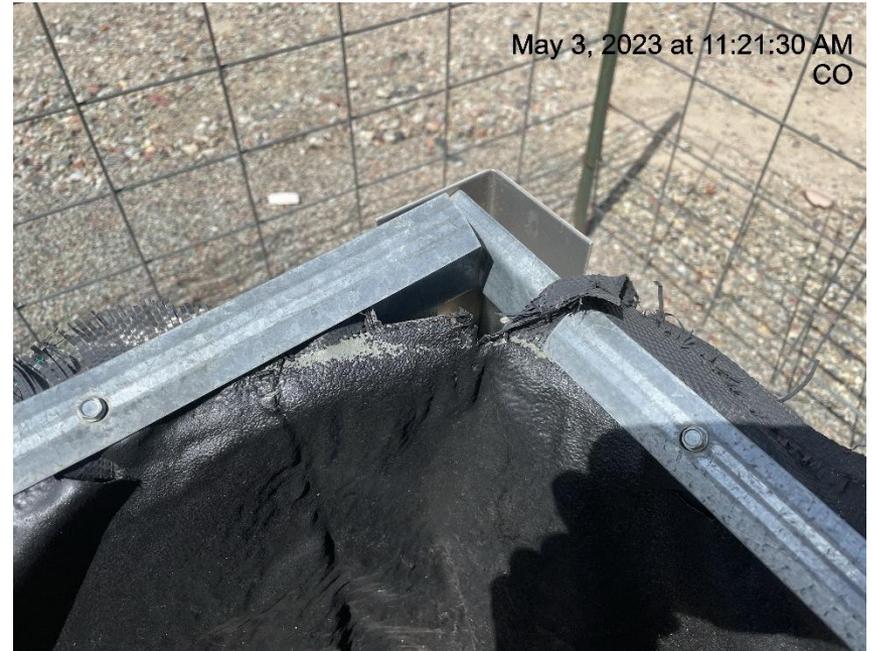
Photo # 6801 Containment needs maintenance

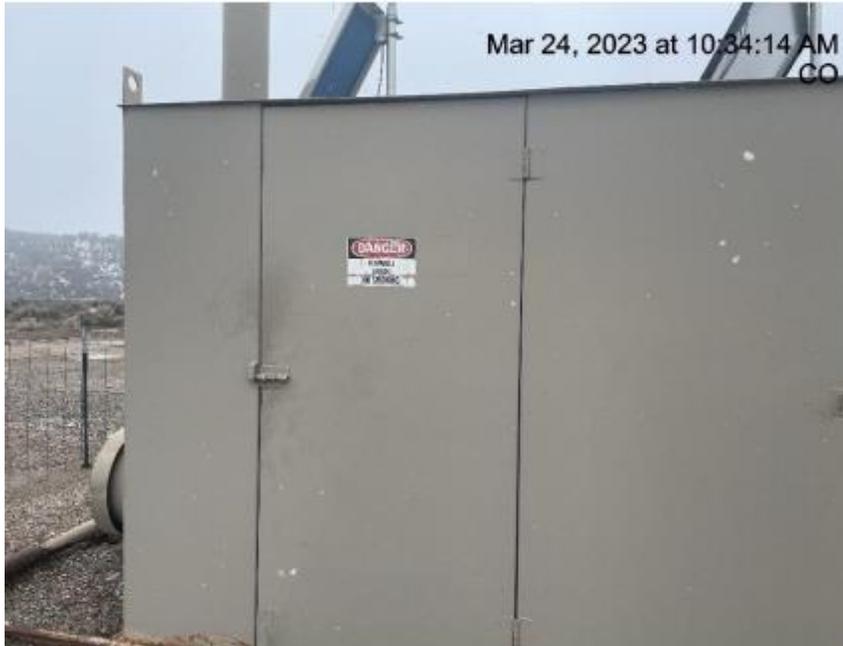
Photo # 3124 From Inspection 708900164 conducted on 03/24/2023 Meter calibration info not conspicuously posted

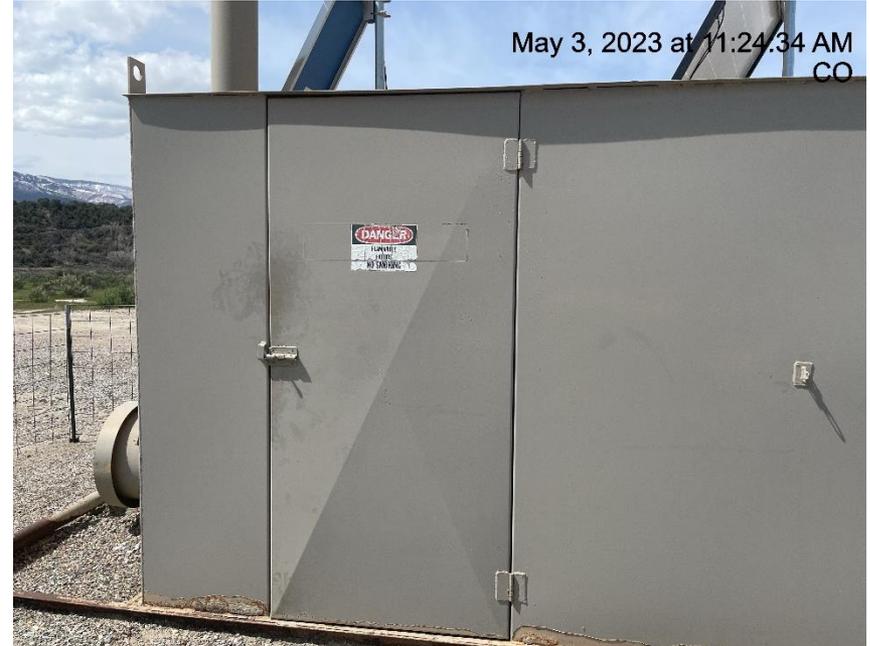
Photo # 6805 Meter calibration info not conspicuously posted
