VISION ENERGY LLC, SOUTH SHALE RIDGE-68S98W/14NENE

Location # 324270

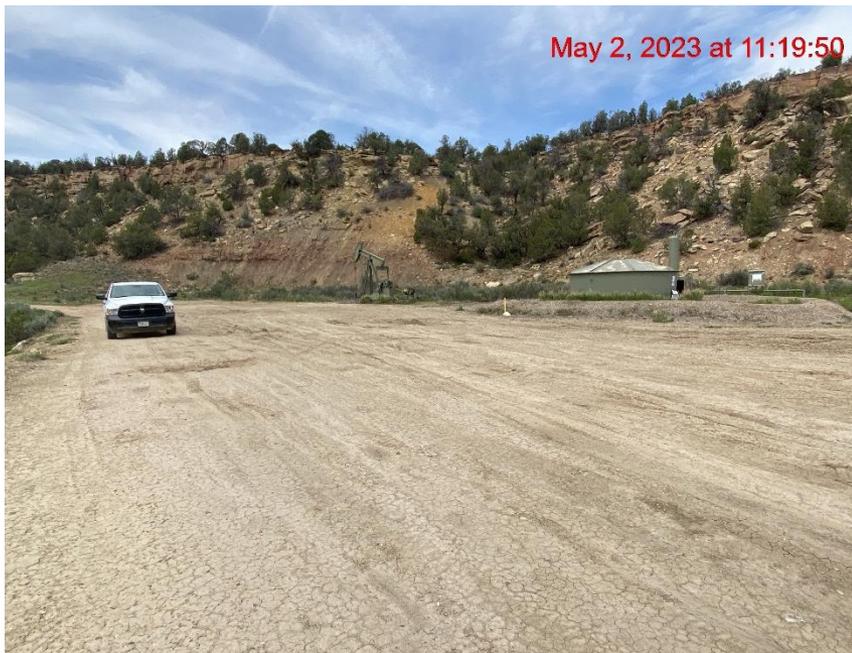
Location Entrance – Photo #02749

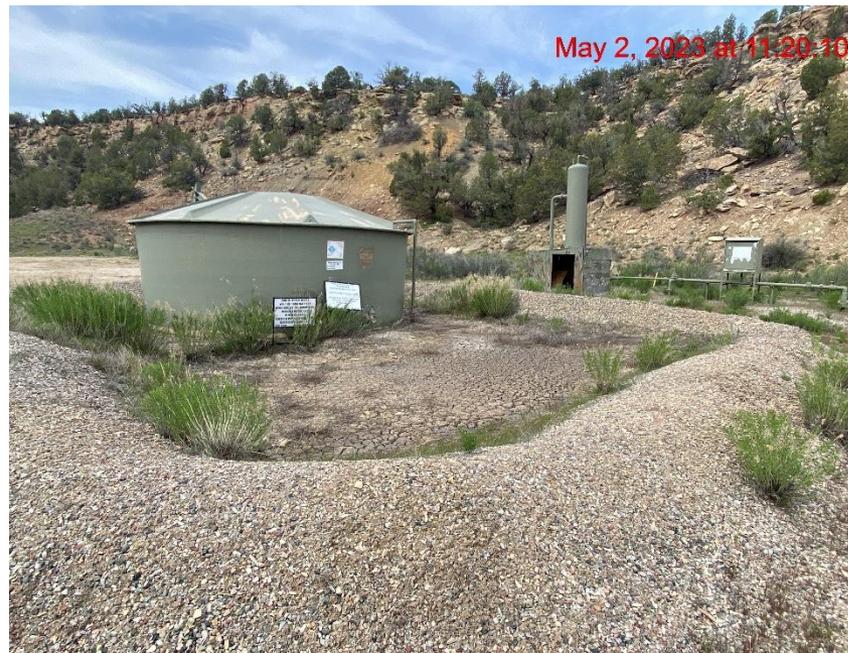
Tank Berm Permeability Insufficient due to Weed Growth – Photo #02750

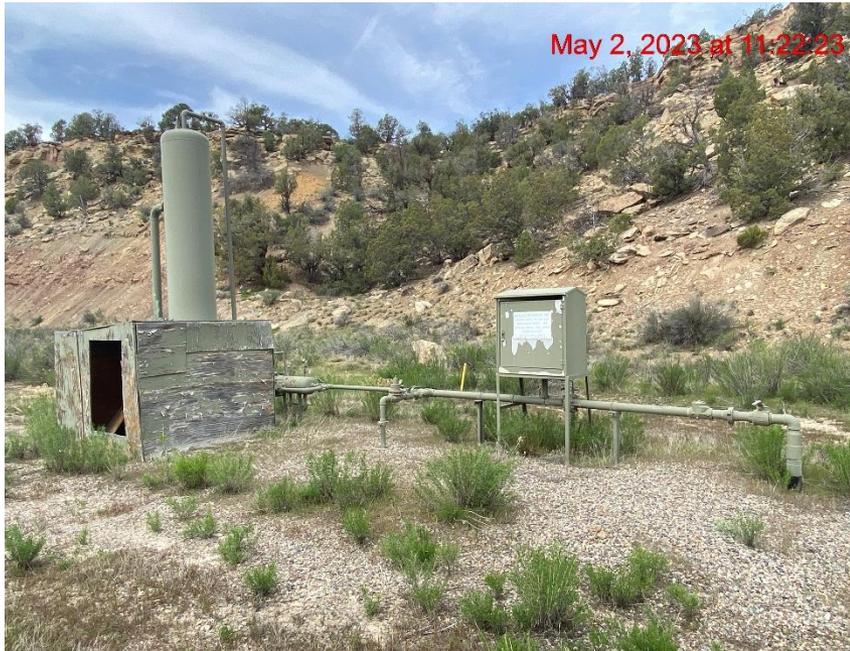
Separator/Weeds – Photo #02755

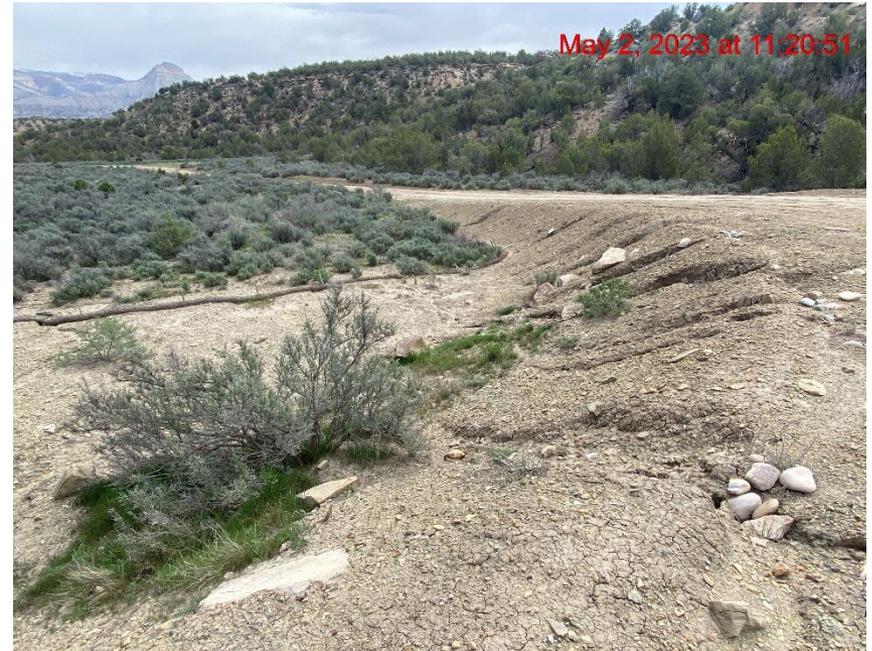
Rill Erosion Transporting Sediment from Location – Photo #02752

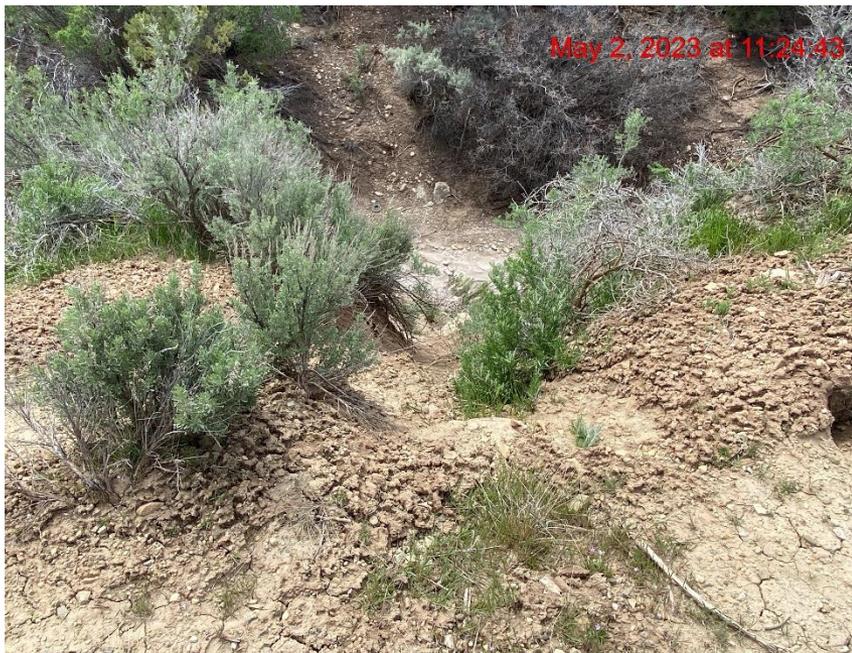
Sediment Transport from Access Road to Drainage Ditch – Photo #02762

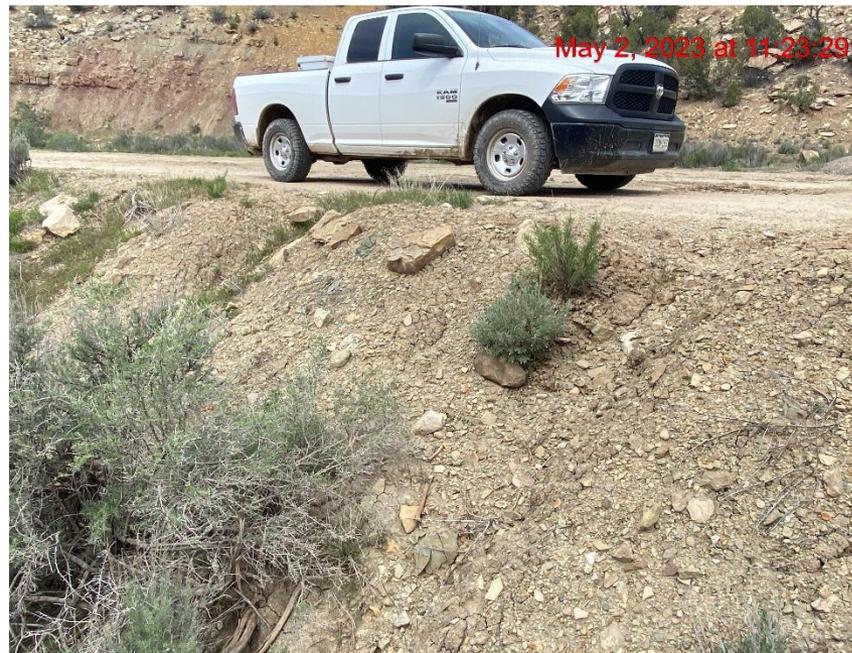
Sediment Transport from Access Road to Drainage Ditch – Photo #02759

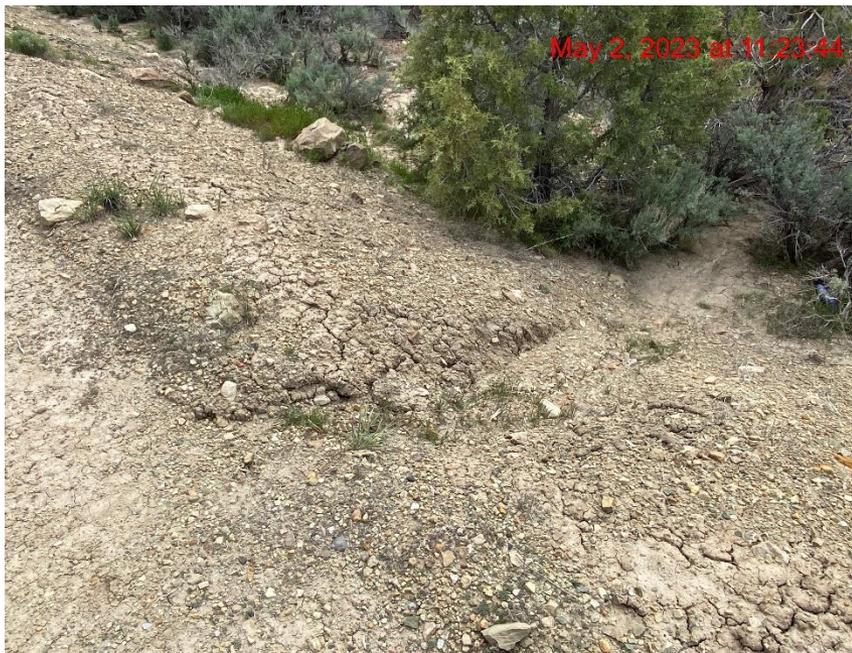
Sediment Transport from Access Road to Drainage Ditch – Photo #02760

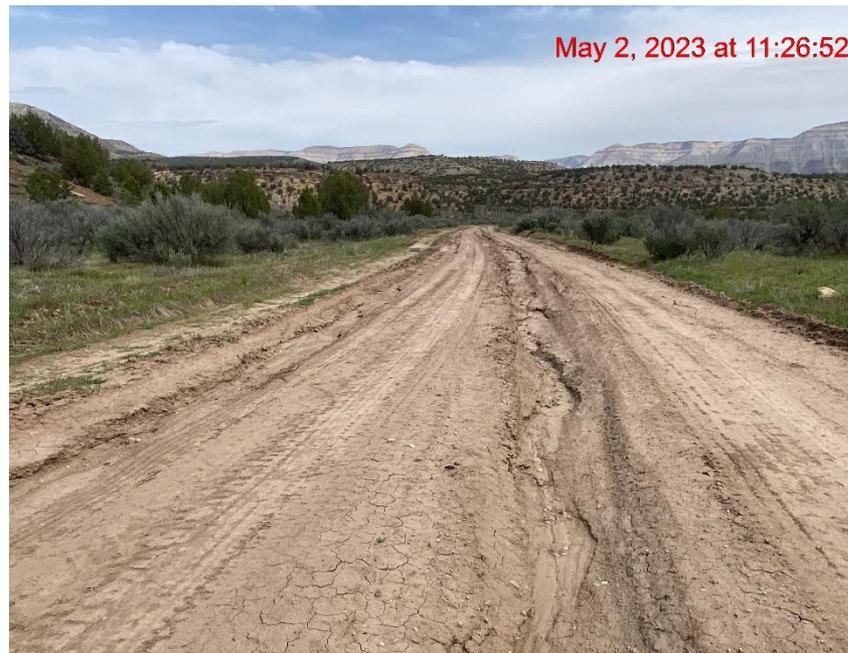
Rill Erosion on Access Road/Lack of Stabilization – Photo #02765

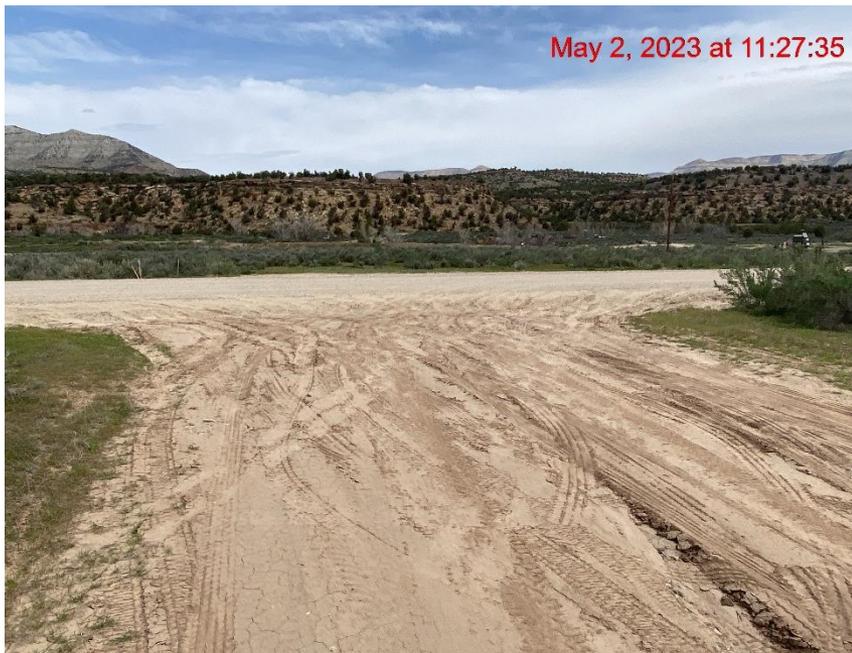
Insufficient Vehicle Tracking BMPs at Location Entrance/Exit – Photo #02766

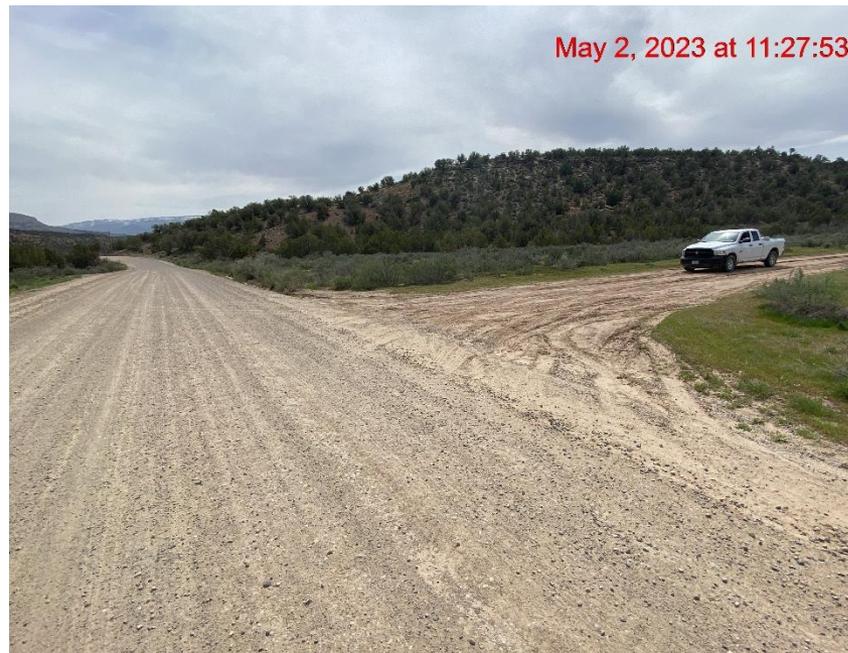
Insufficient Vehicle Tracking BMPs at Location Entrance/Exit – Photo #02767
