**Inspection Photos**  
**Location Name: Stubbs 1**  
**API: 05-061-05055**

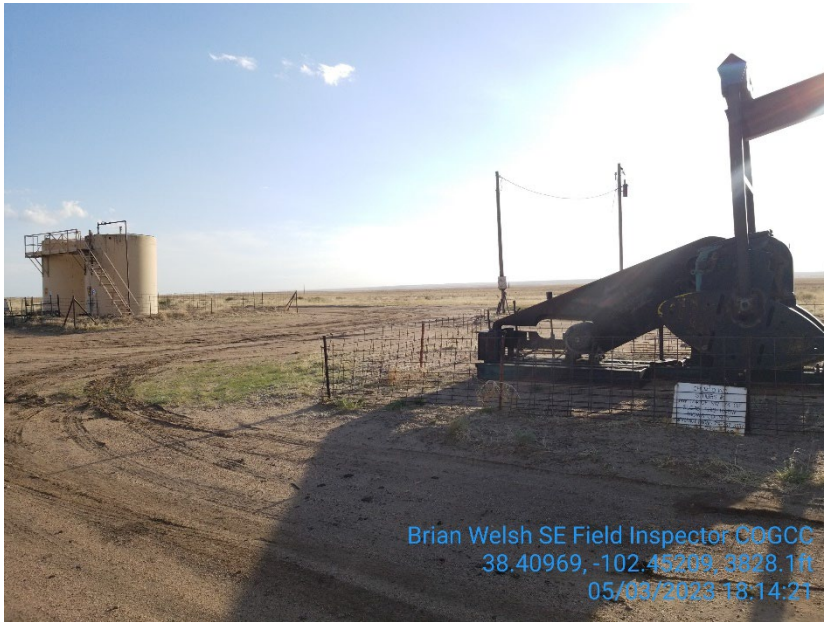
**1. Pumping unit and tank battery**

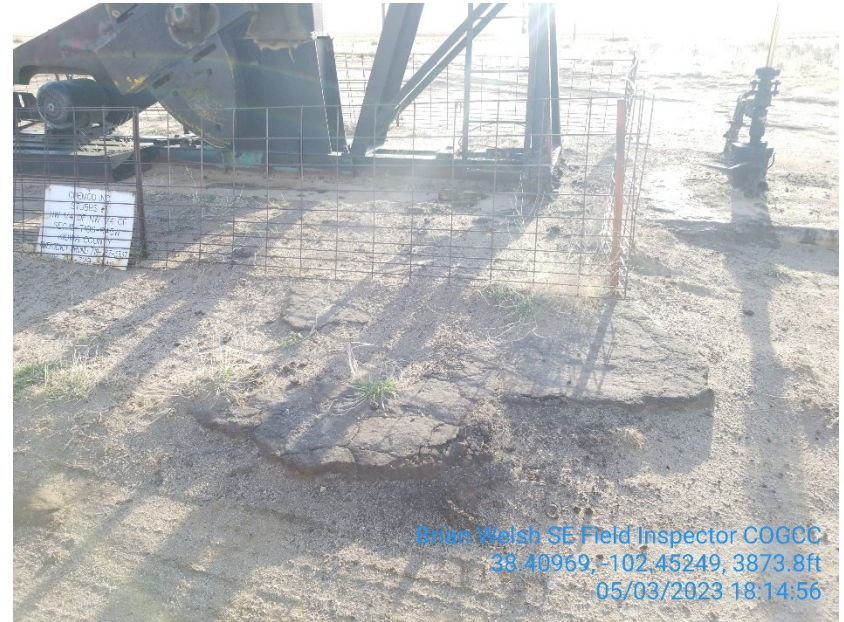
**2. Stained soil next to wellhead and unit**

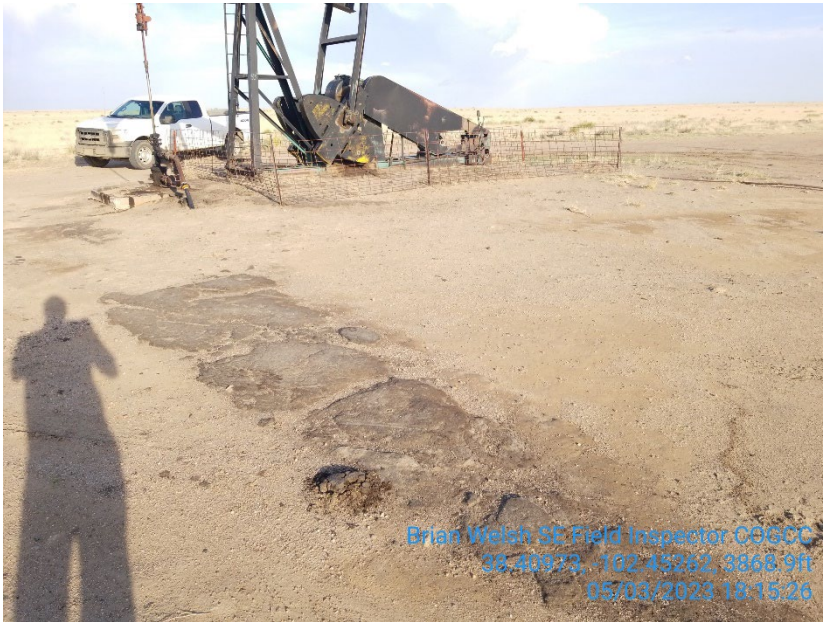
**3. Stained soil on west side of wellhead**

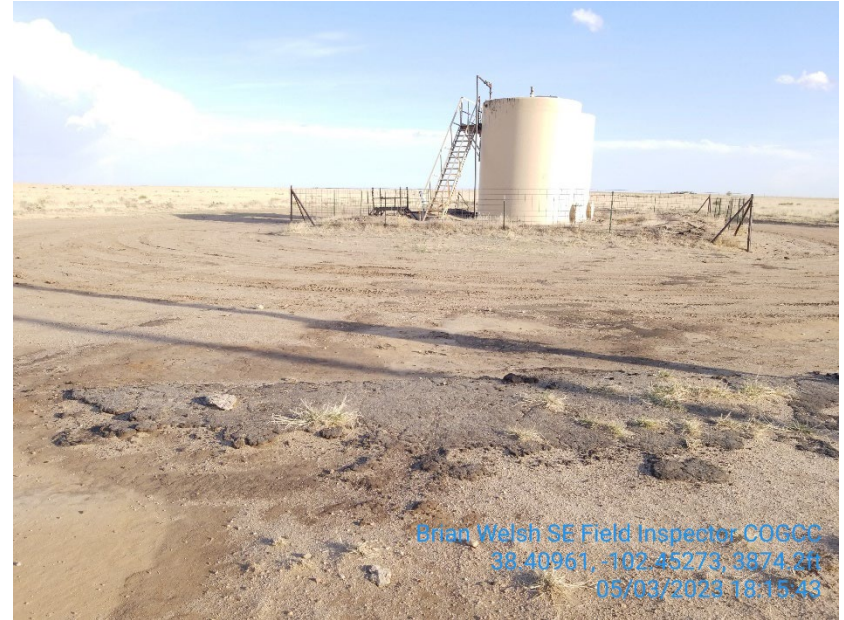
**4. This is stained soil next to power pole and straight north of tanks**

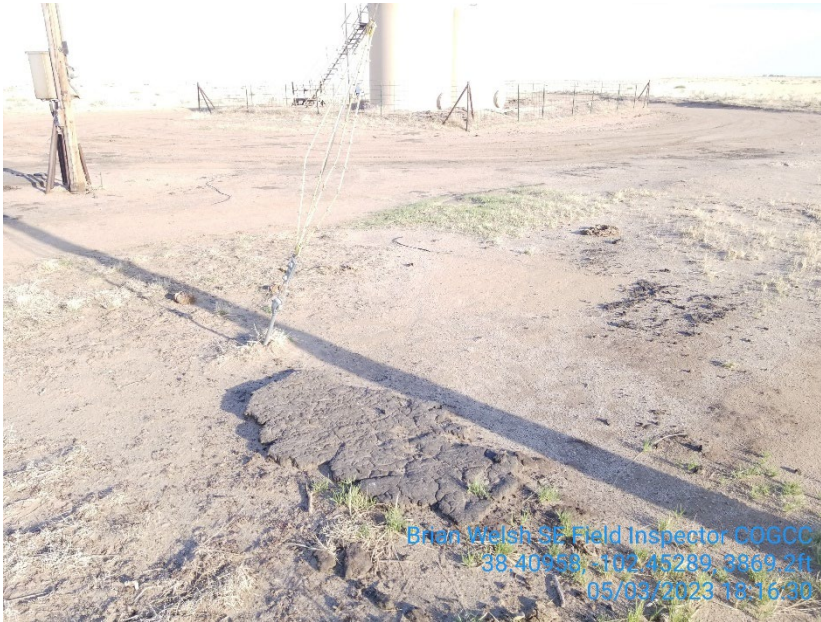
**5. The west power pole has this stained soil on the east side of it**

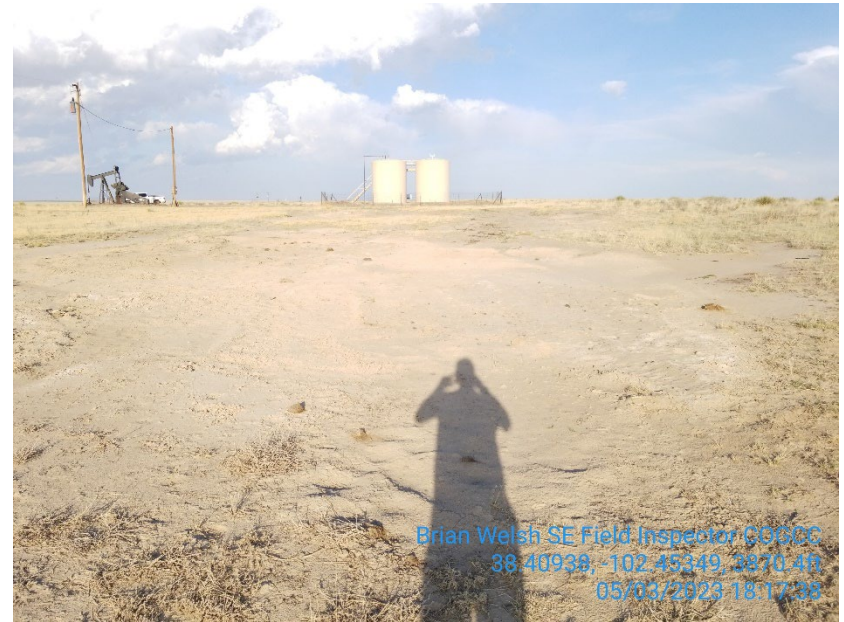
**6. This bare spot is west of the Stubbs oil tanks running downhill. There's no vegetation and the landowner has been complaining about bare spots all over his pasture. (Noted by Mr. Kosola on 8/23/22 Insp #700600410 CA date of 9/9/22. And noted on follow-up inspection #700600414 on 8/30/22)**

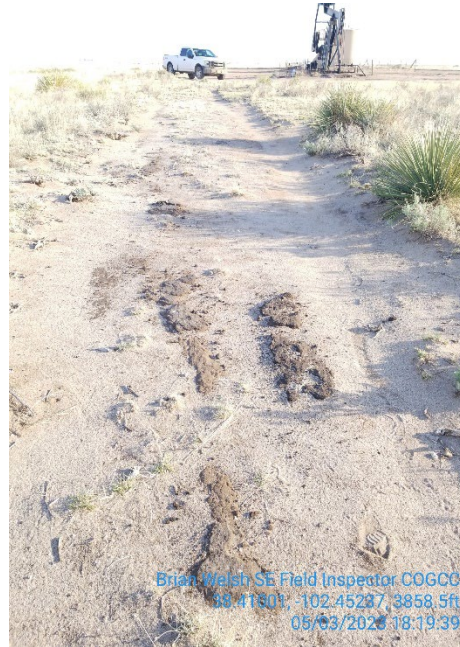
**7. Here is some more stained soil that the landowner has also complained about to the north of the Stubbs wellhead along an old access trail**
