Inspection Photos

API: 009-06236

Operator: DOVER ATWOOD CORPORATION

Inspection Date: 5/3/2023

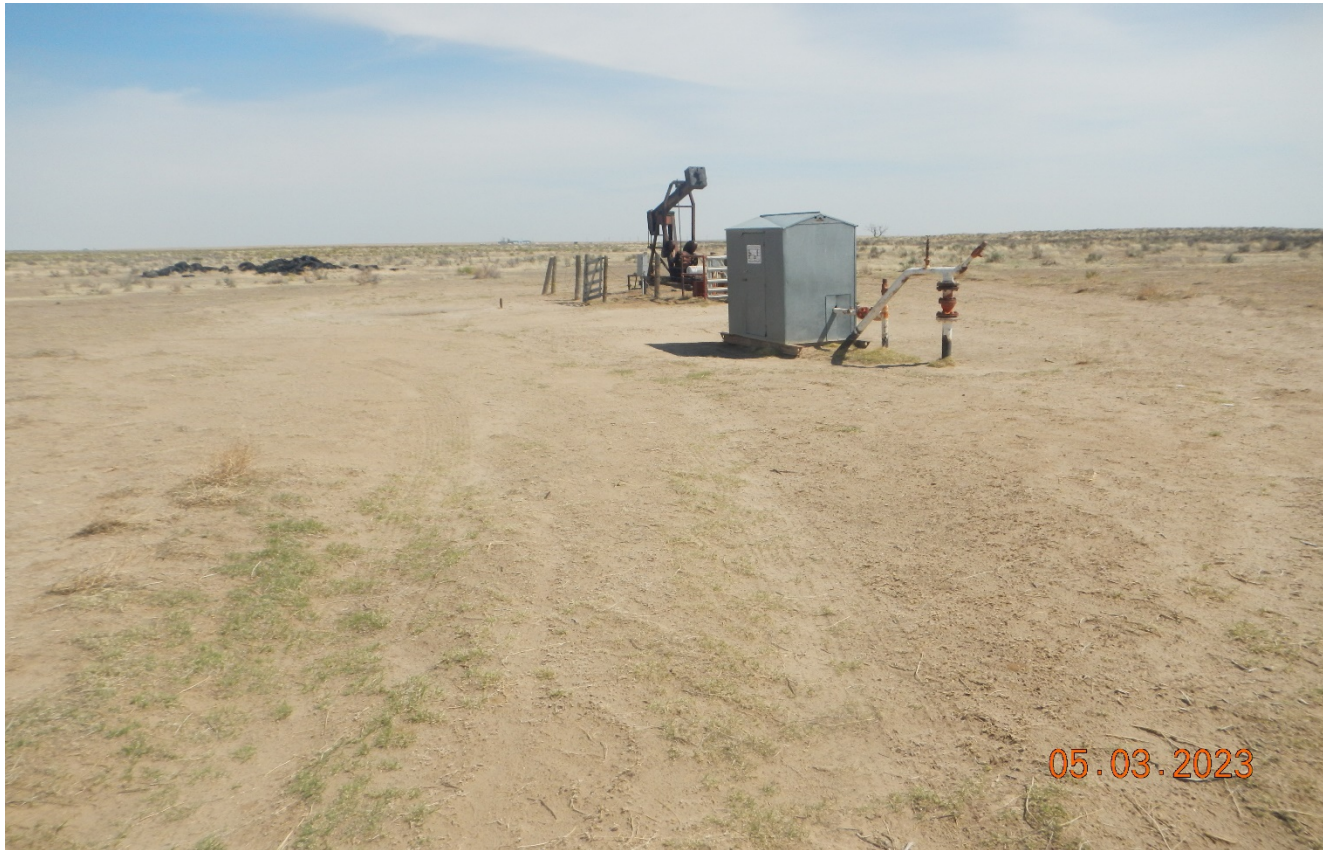
Photo 1. Facing northeast toward wellsite.

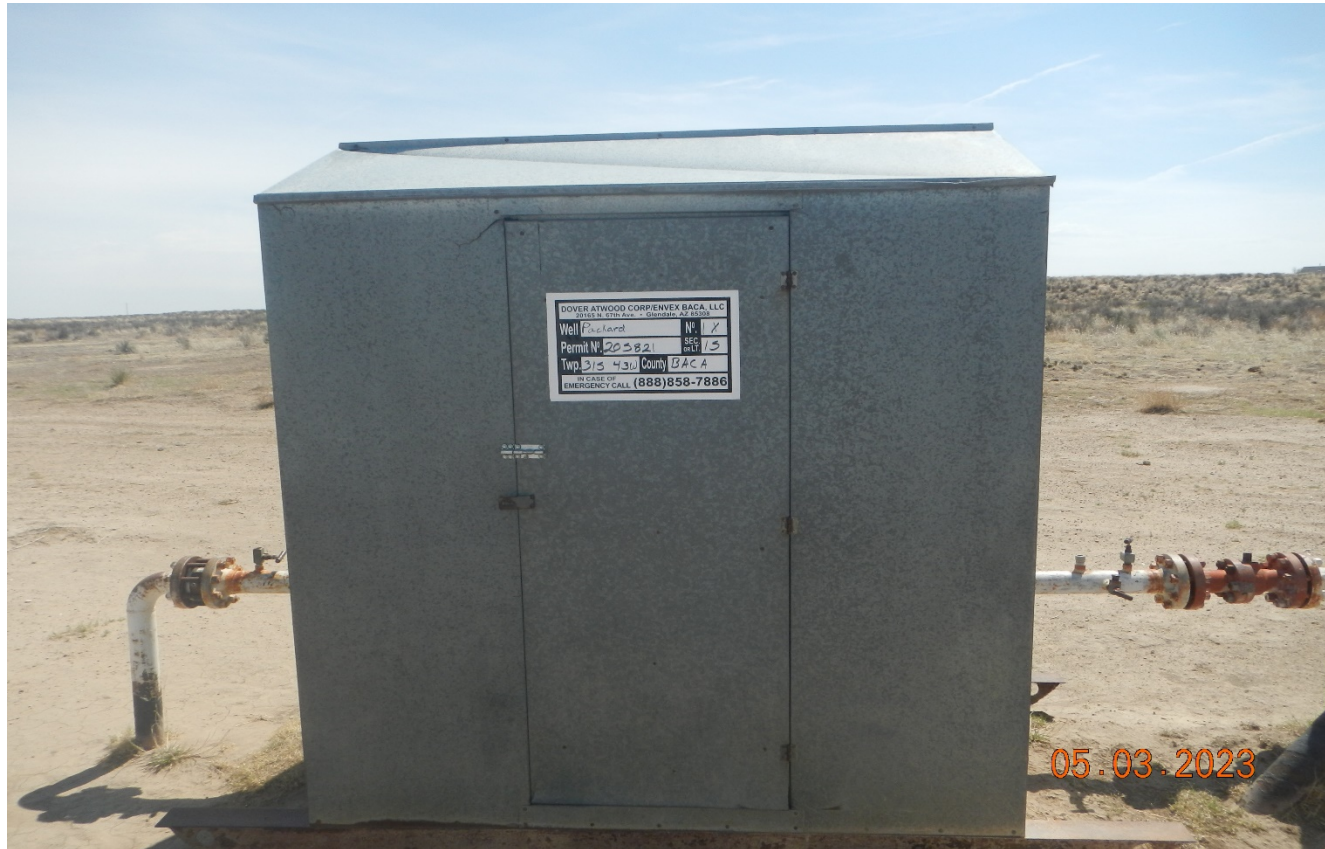
Photo 2. A new sign has been posted on the meter shed however, the sign does not meet the requirements of Rule 605.d.

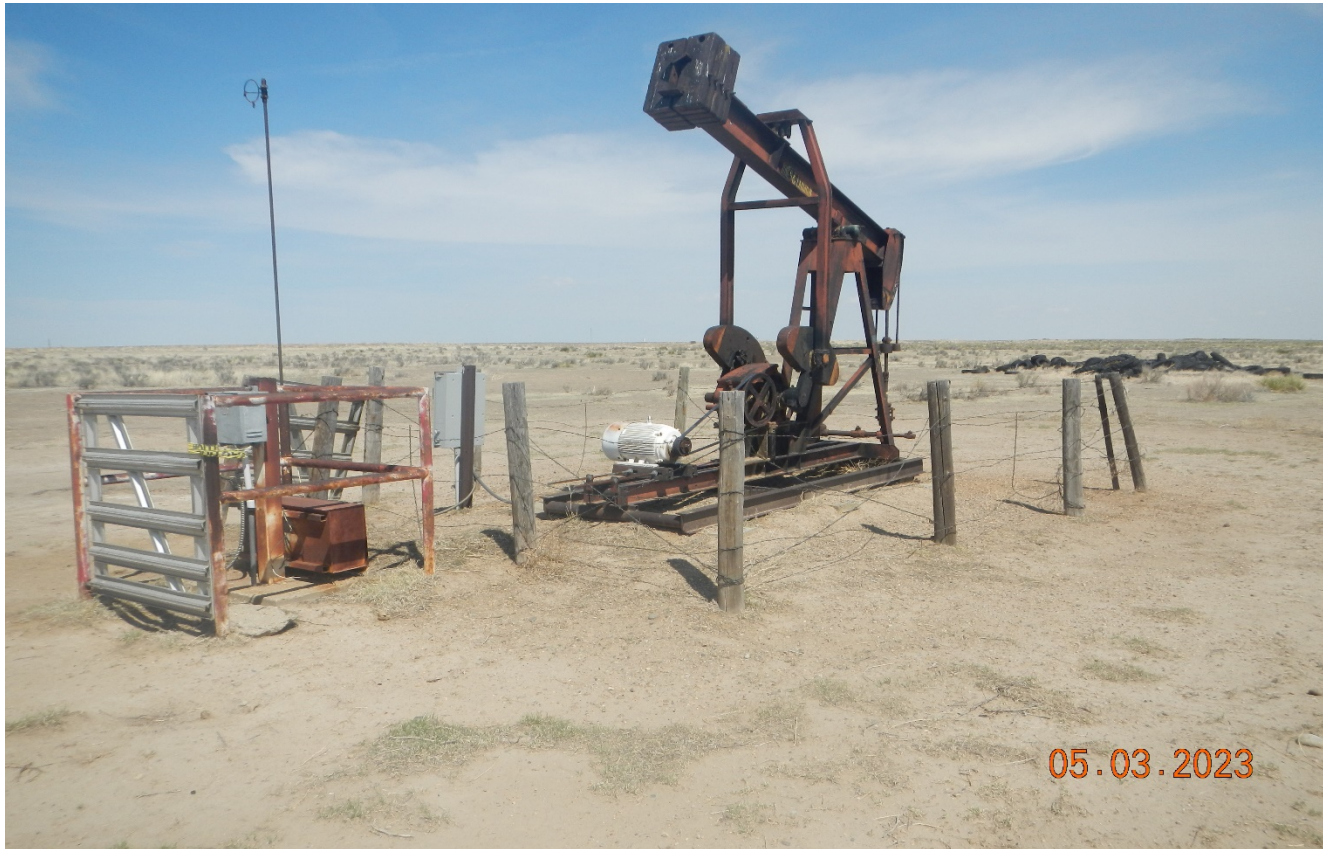
Photo 3. Facing toward the wellsite production equipment.

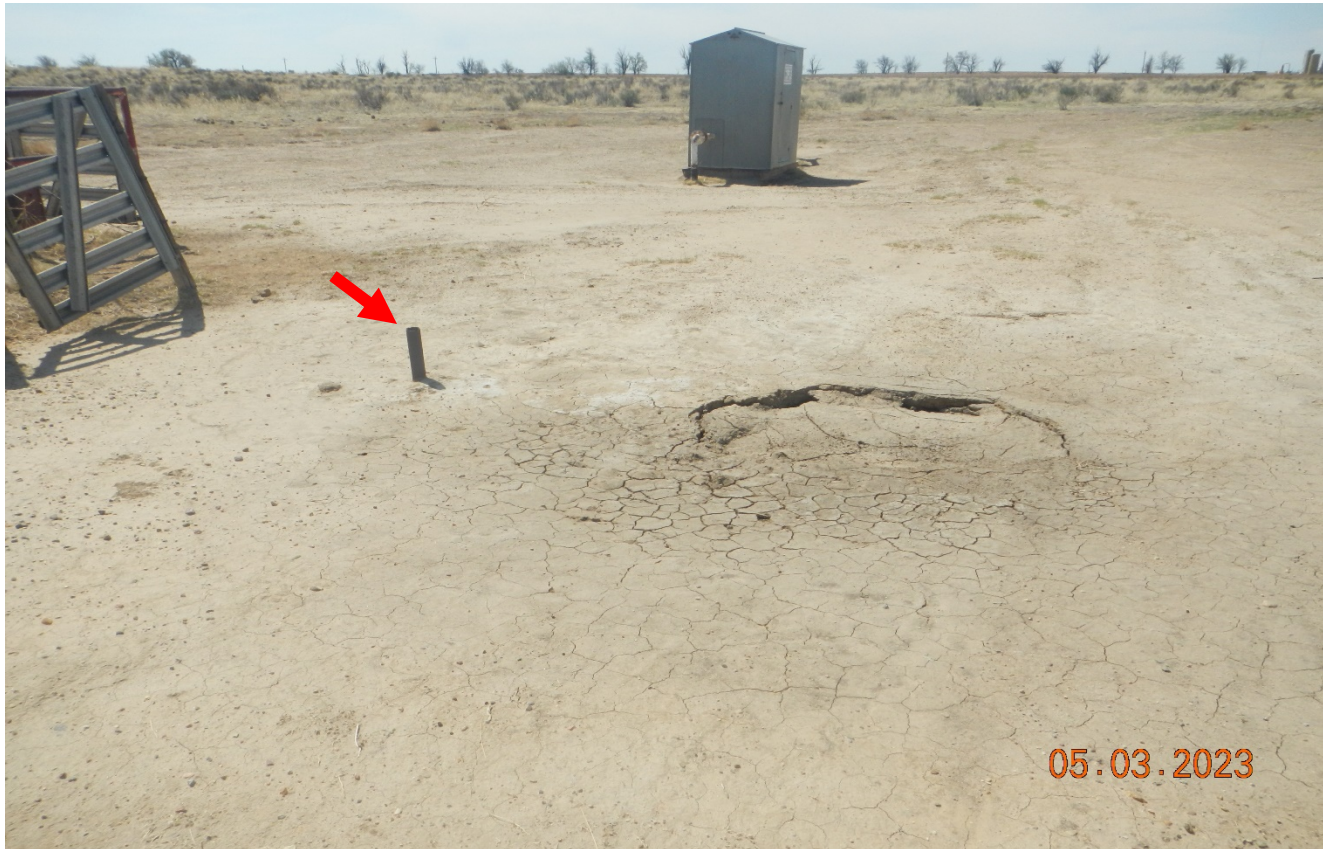
Photo 4. This is the area the broken tank was at. There is an uncapped pipe riser at the red arrow that likely fed into the tank which need to be removed.
