Inspection Photos

ID:438617

Operator: DOVER ATWOOD CORPORATION

Inspection Date: 5/3/2023

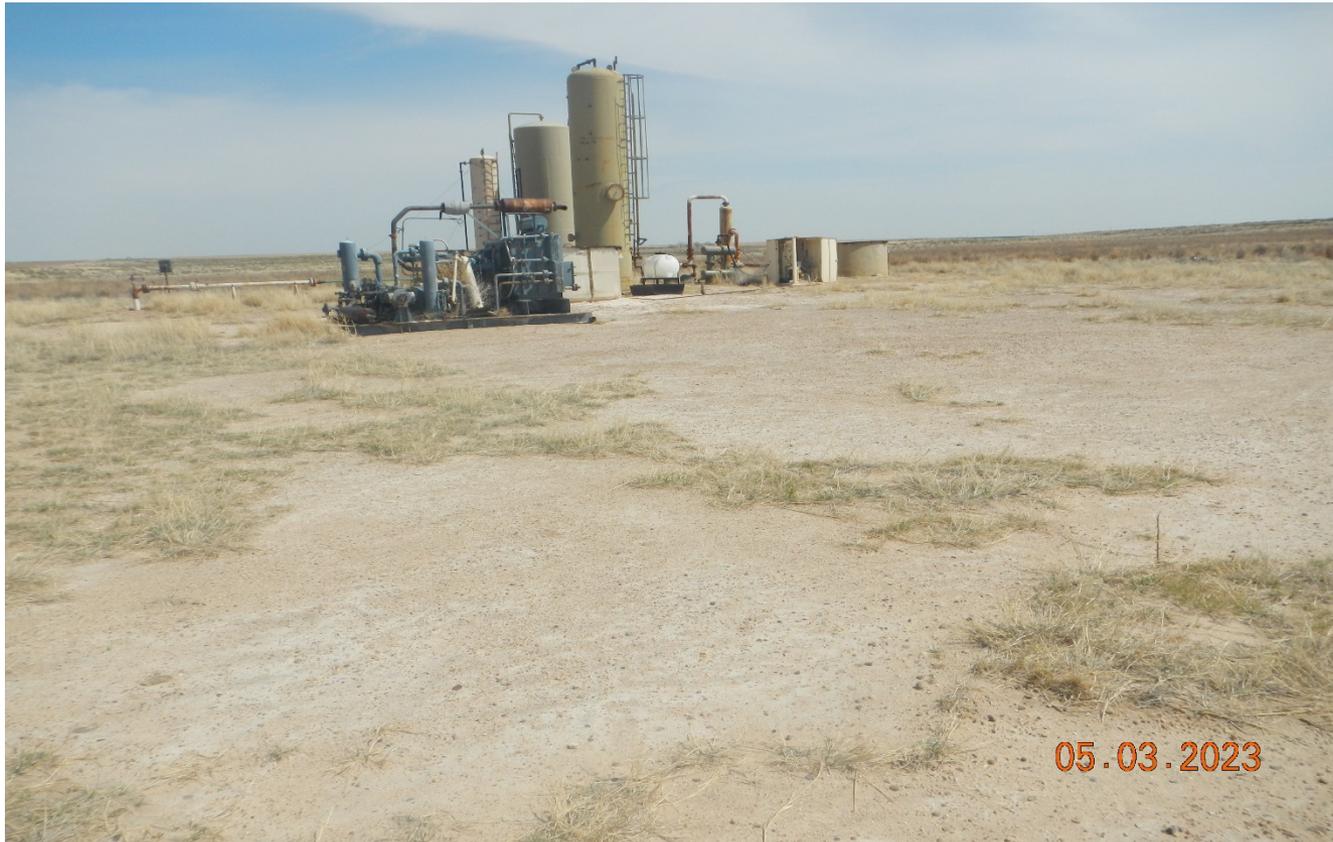
Photo 1. Facing northeast toward the gas treatment facility.

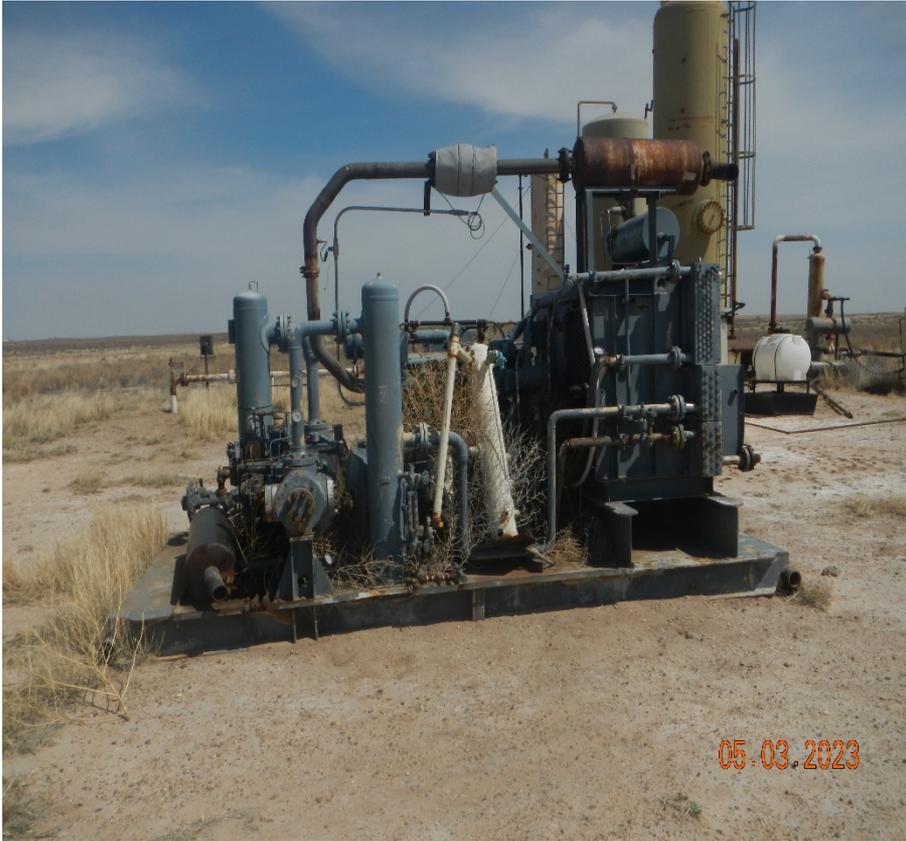
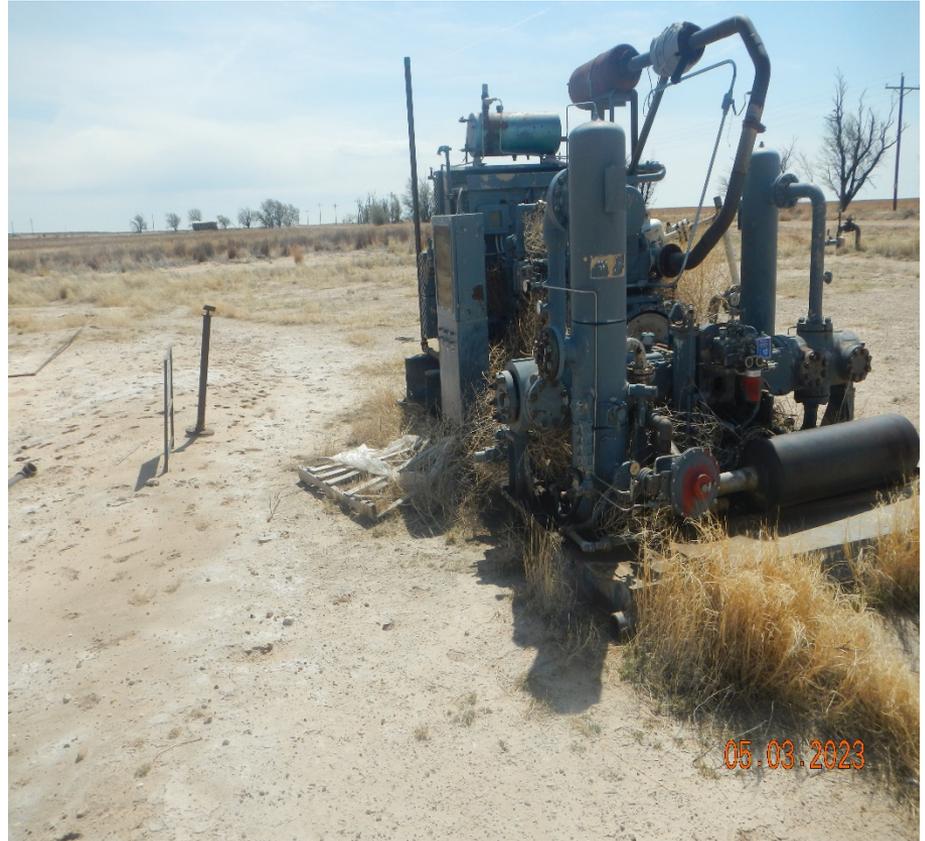
Photo 2. There is an unused compressor stored on location that need to be removed. The compressor engine has various unconnected parts and does not appear to be functional. Previous corrective action is not completed.

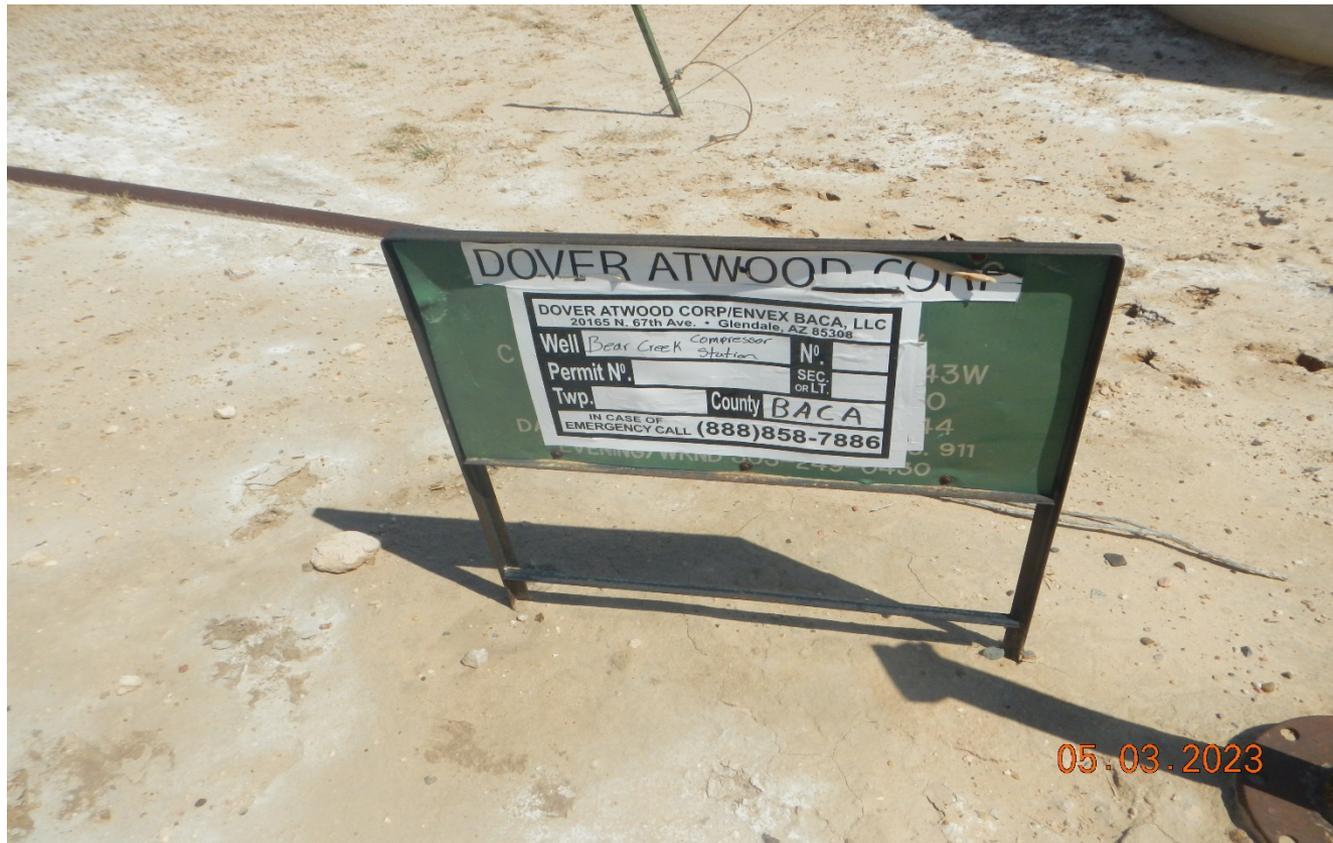
Photo 3. The facility sign is obscured behind the compressor. The sign does not meet the requirements and is not legible. Previous corrective action is not completed.

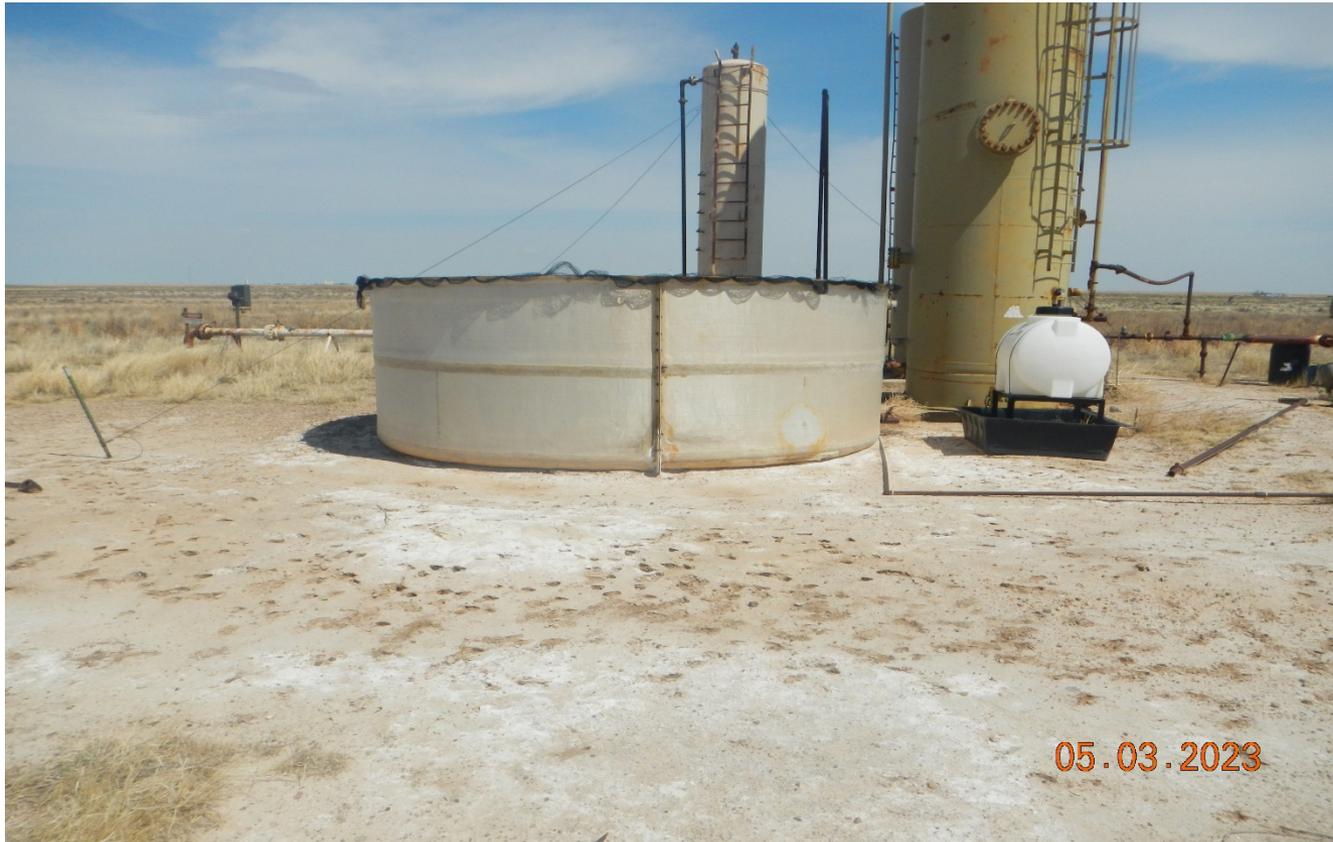
Photo 4. Facing toward the open top tank. It appears the tank has previously leaked due to white stained soil. There is no secondary containment around the tank. There is no signage on the tank. Previous corrective action is not completed.

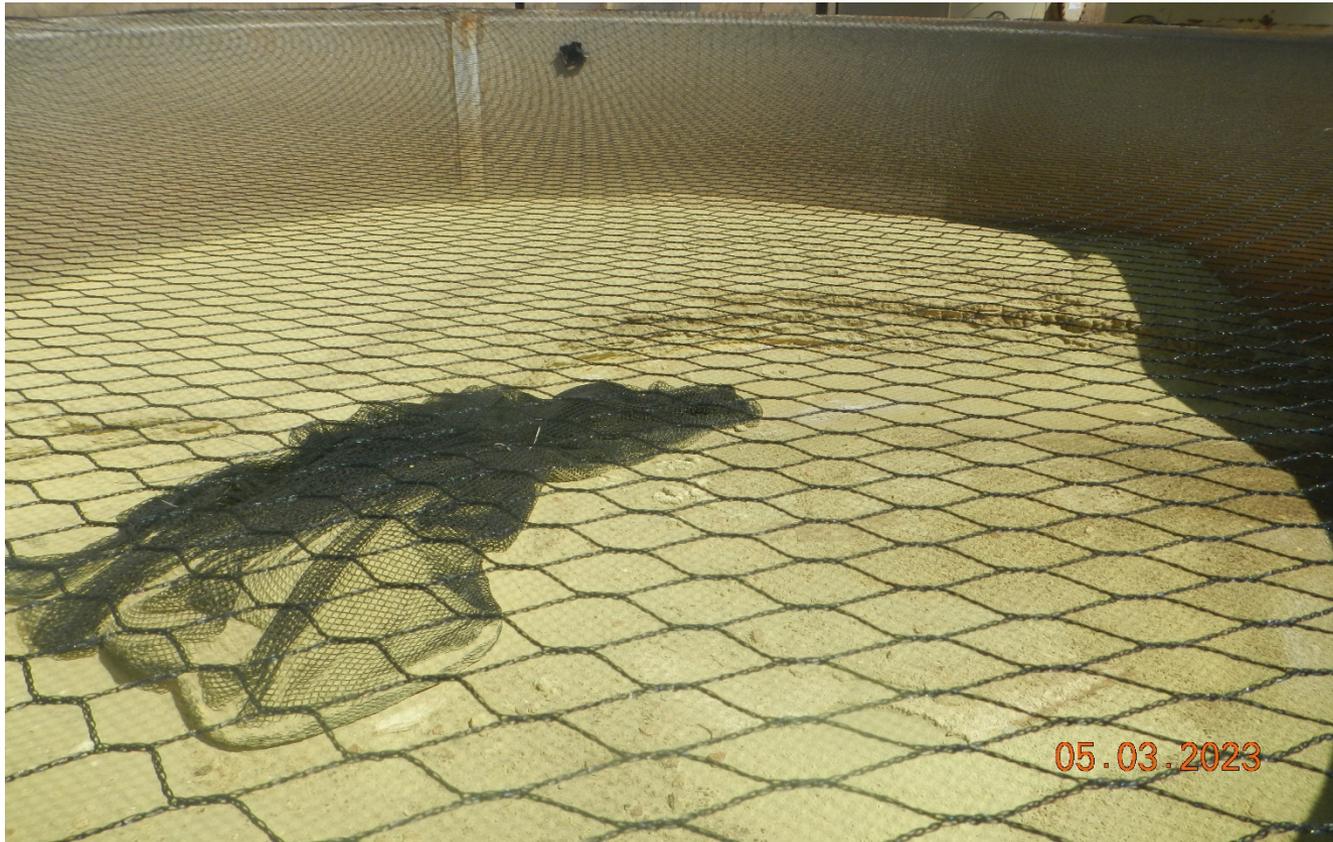
Photo 5. The netting over the tank has been reinstalled.

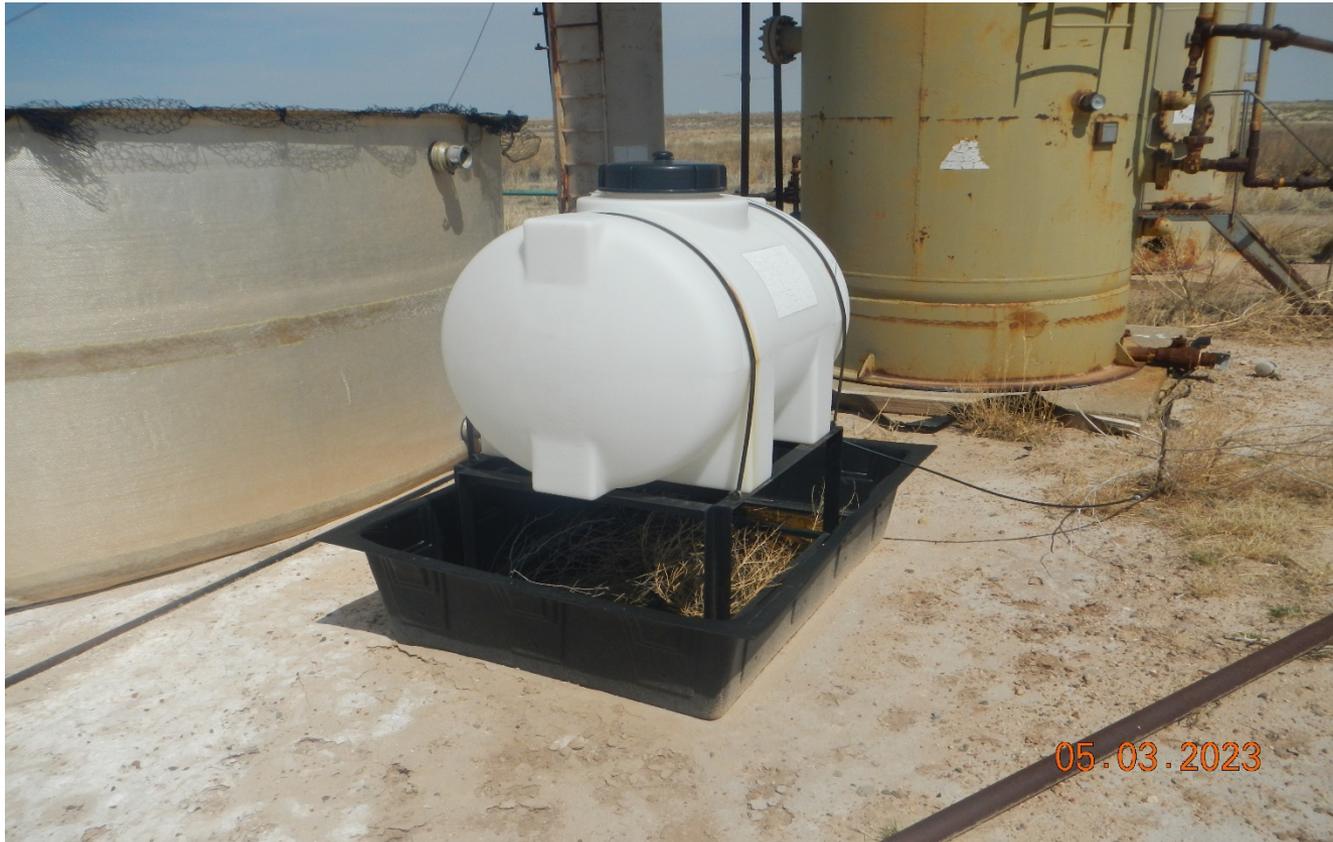
Photo 6. There is a new tank installed but the labeling is faded on the container so contents are unknown.

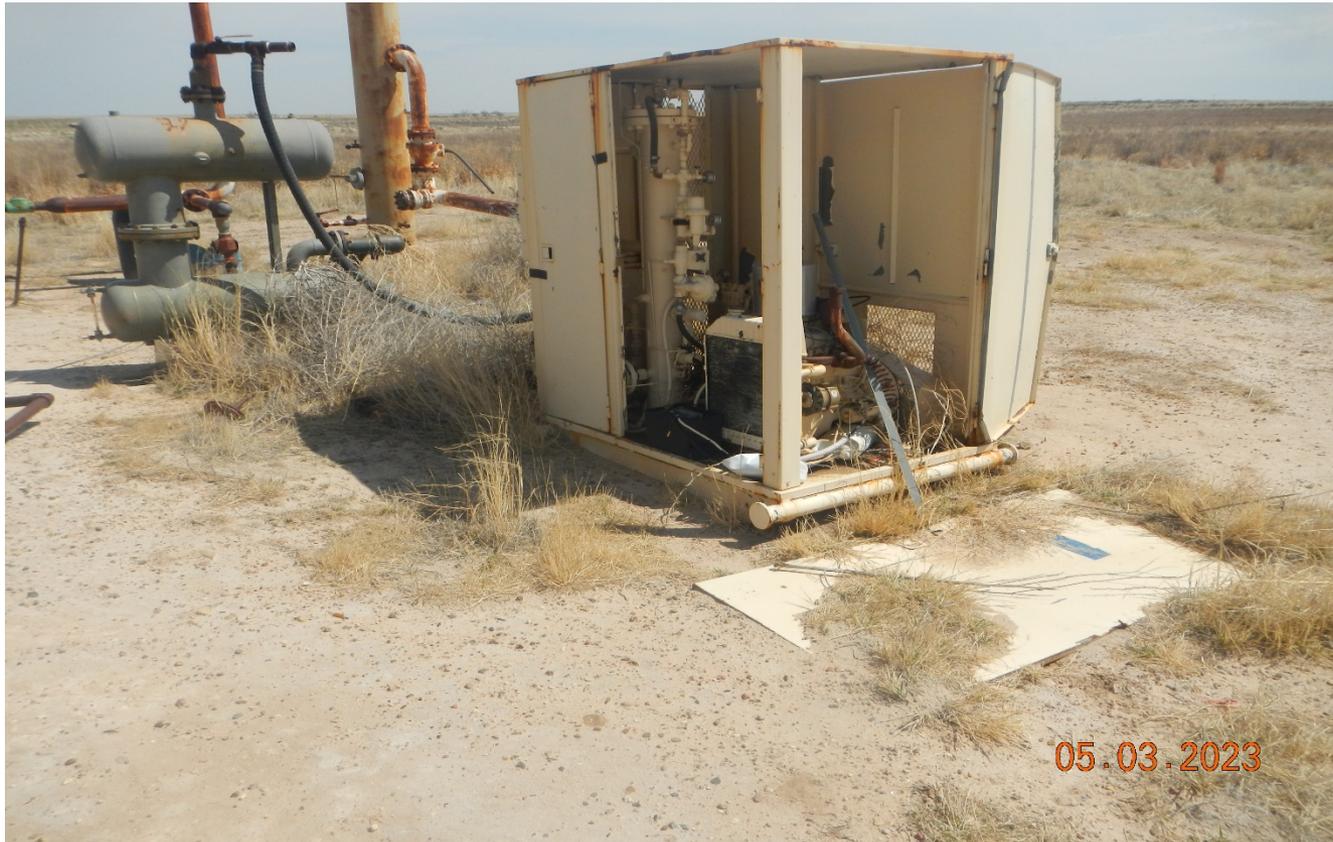
Photo 7. There is equipment not maintained on location. Door has fallen off this shed. Previous corrective action is not completed.

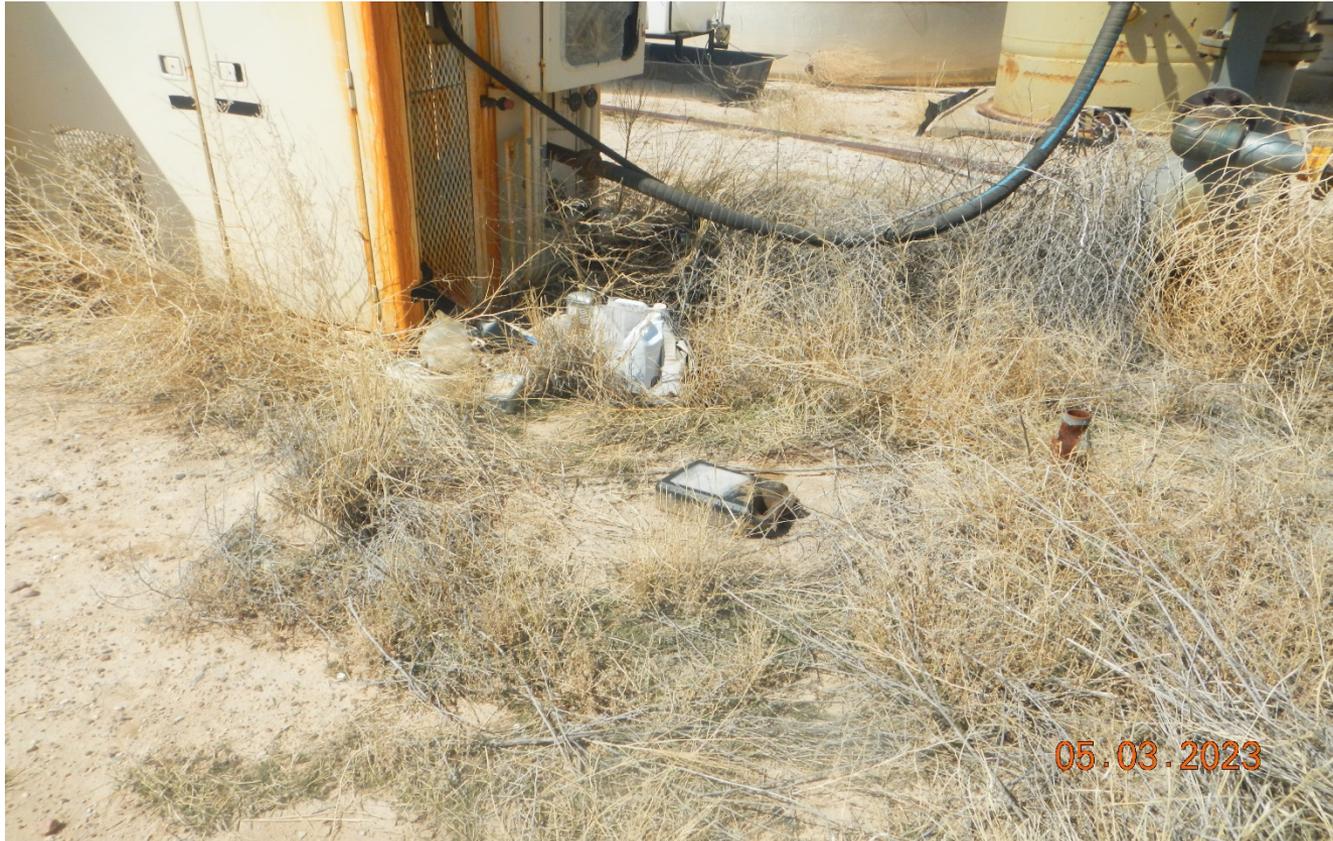
Photo 8. There is oil/chemical containers and trash not properly or disposed of. Previous corrective action is not completed.

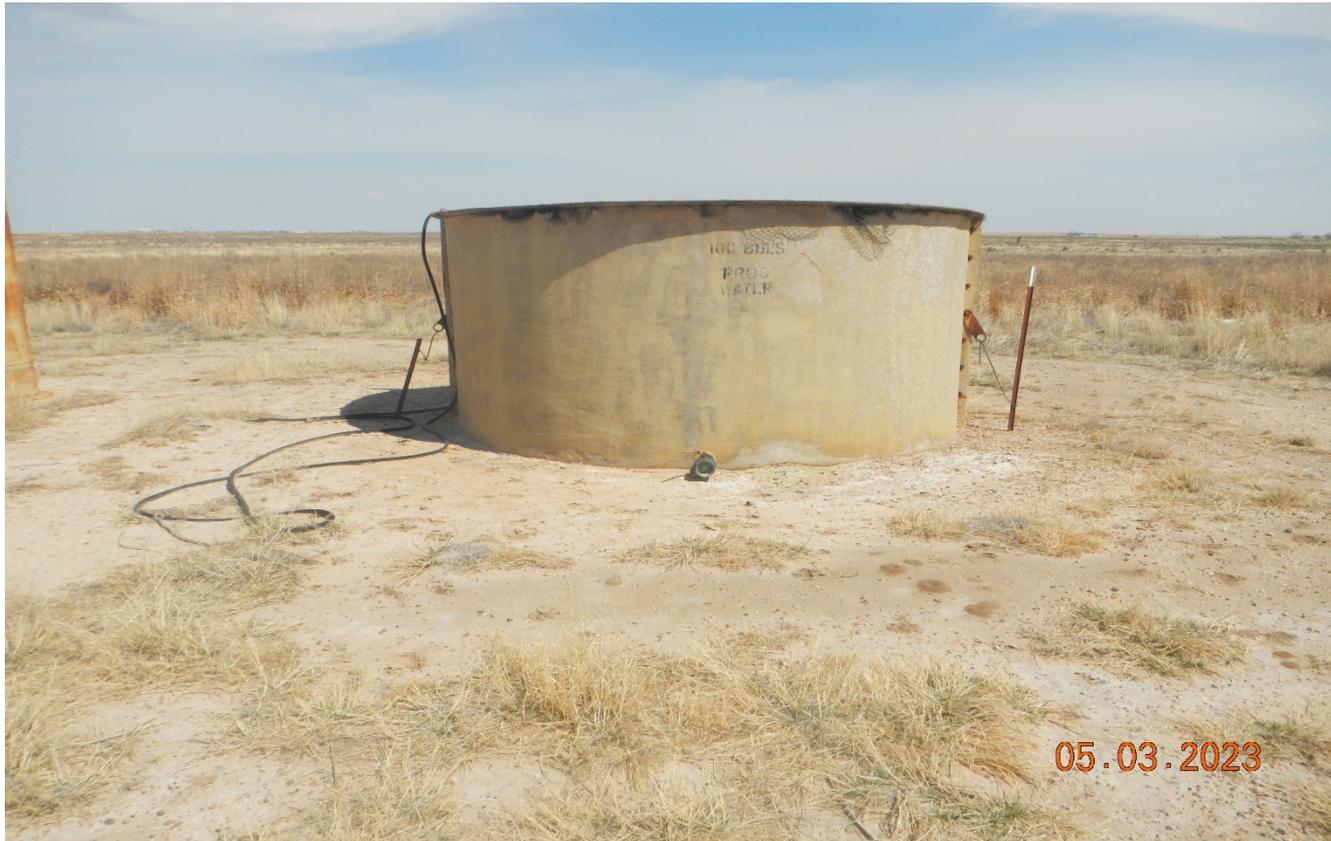
Photo 9. There is an open top tank at the east side of the location. It appears the tank has previously leaked due to white stained soil. There is no secondary containment around the tank. The signage has faded. Previous corrective action is not completed.

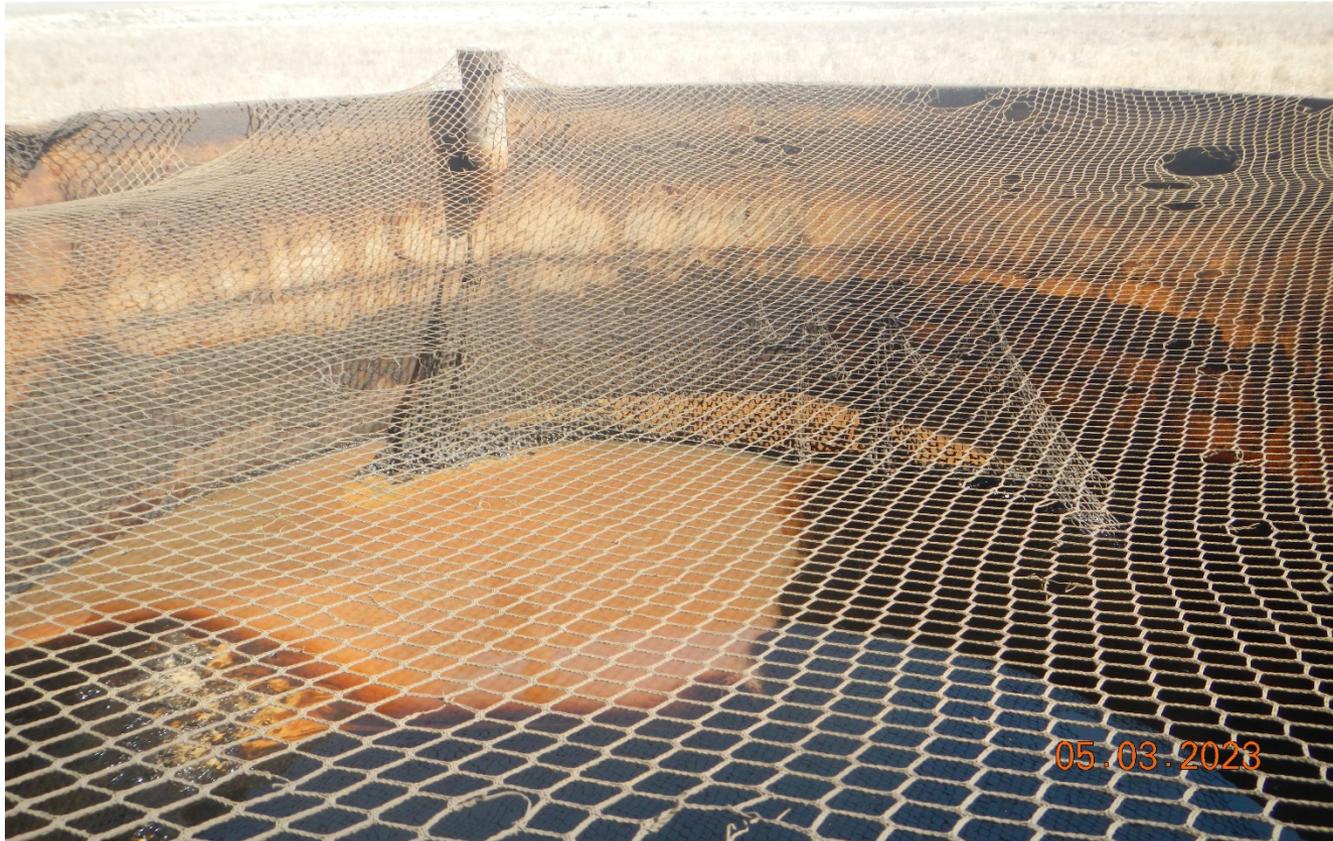
Photo 10. The liquid in the tank has been lowered.

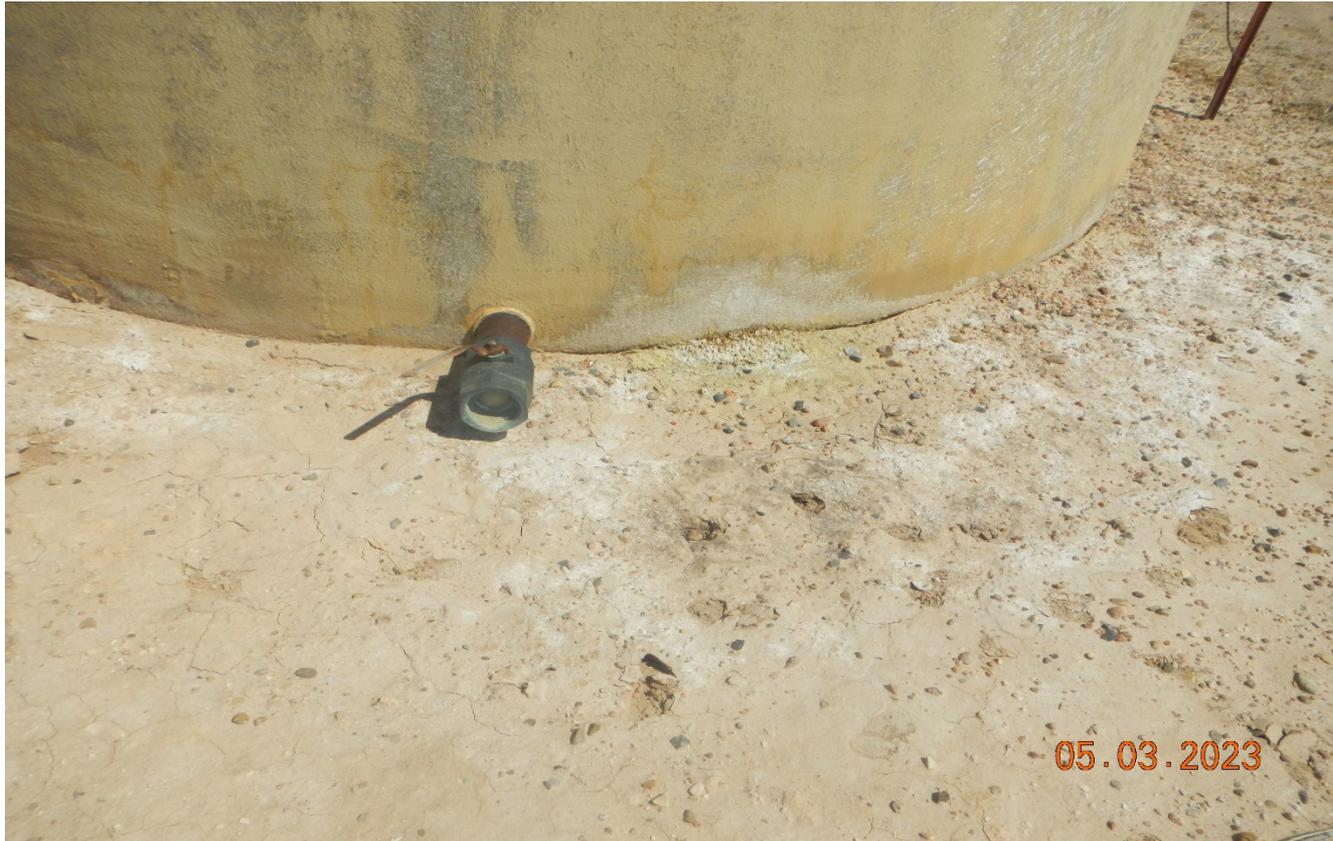
Photo 11. There are signs of a previous leak at the tanks due to white stained soils at the base of the tanks.

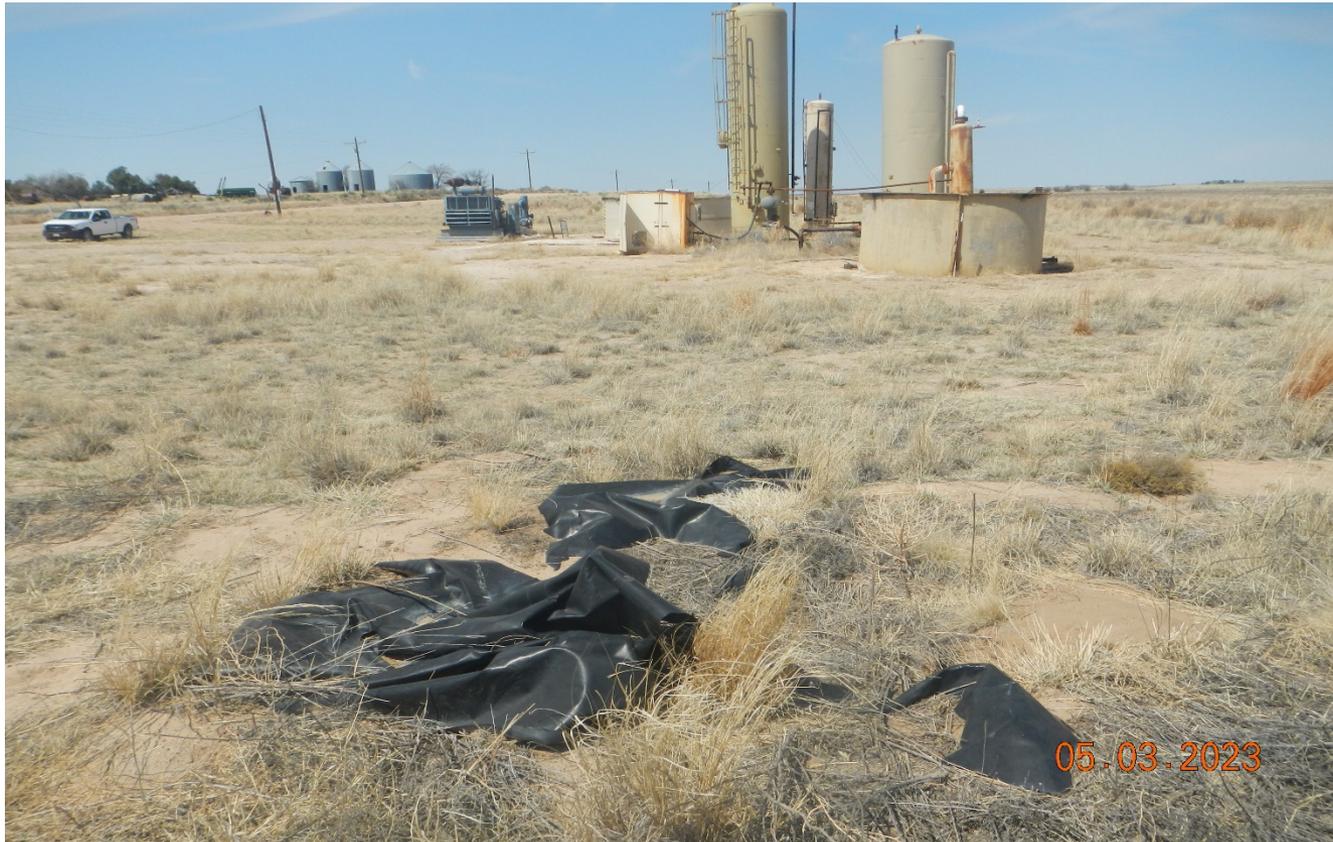
Photo 12. Facing west toward the location. There is a plastic liner debris at east side of the location that needs to be removed.

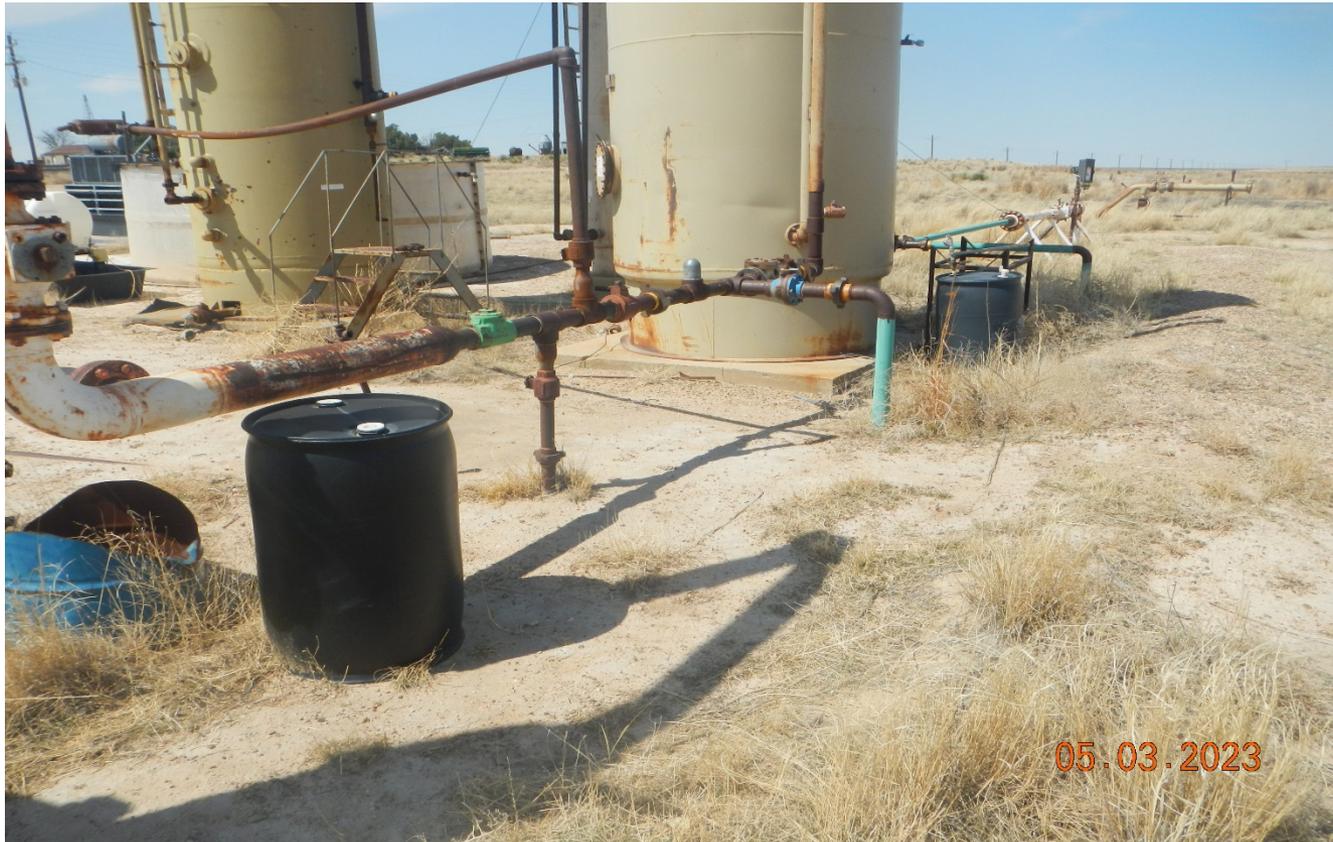
Photo 13. There is unused supplies and a black barrels with no labeling. There are weeds and vegetation around the equipment which is a fire hazard. Previous corrective action is not completed.

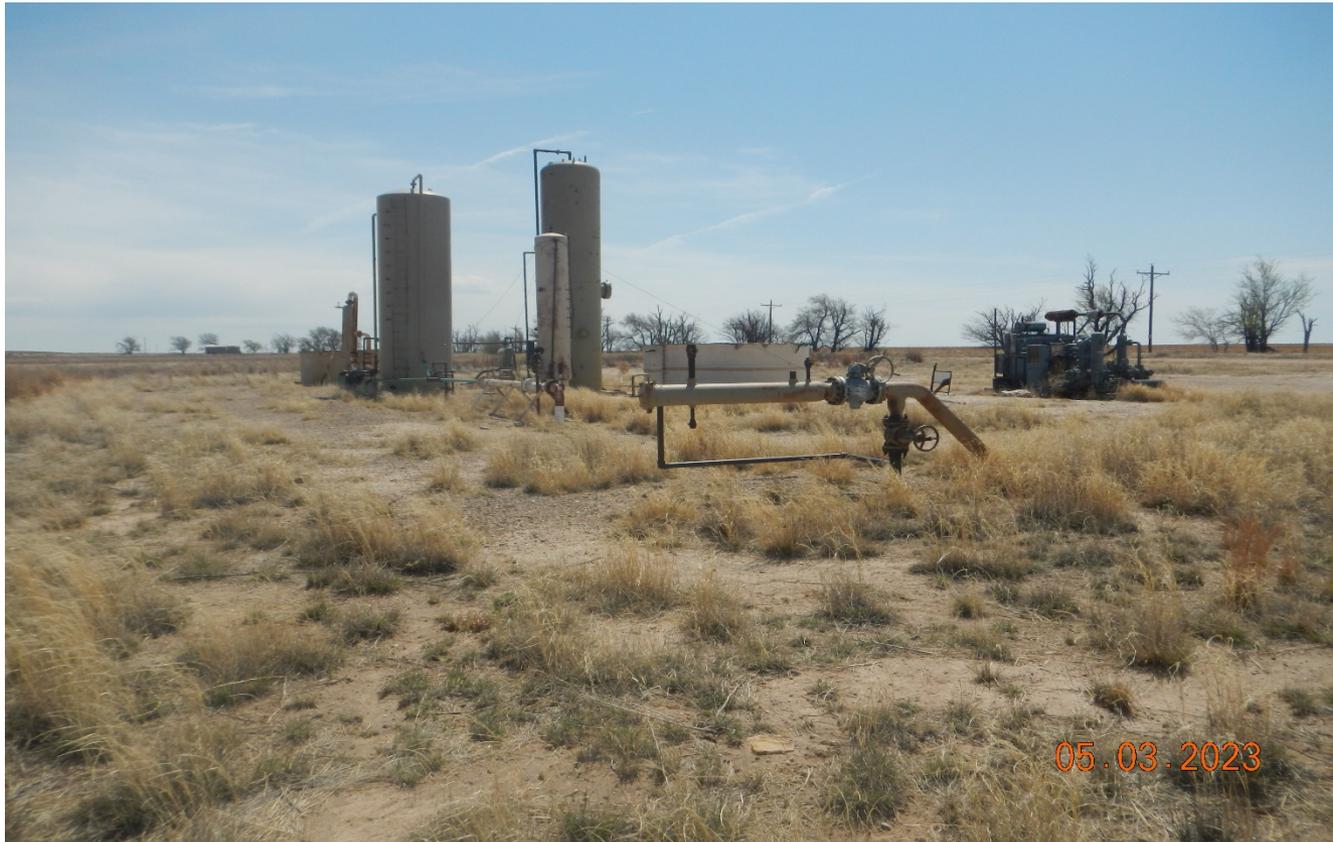
Photo 14. Facing east toward the facility.

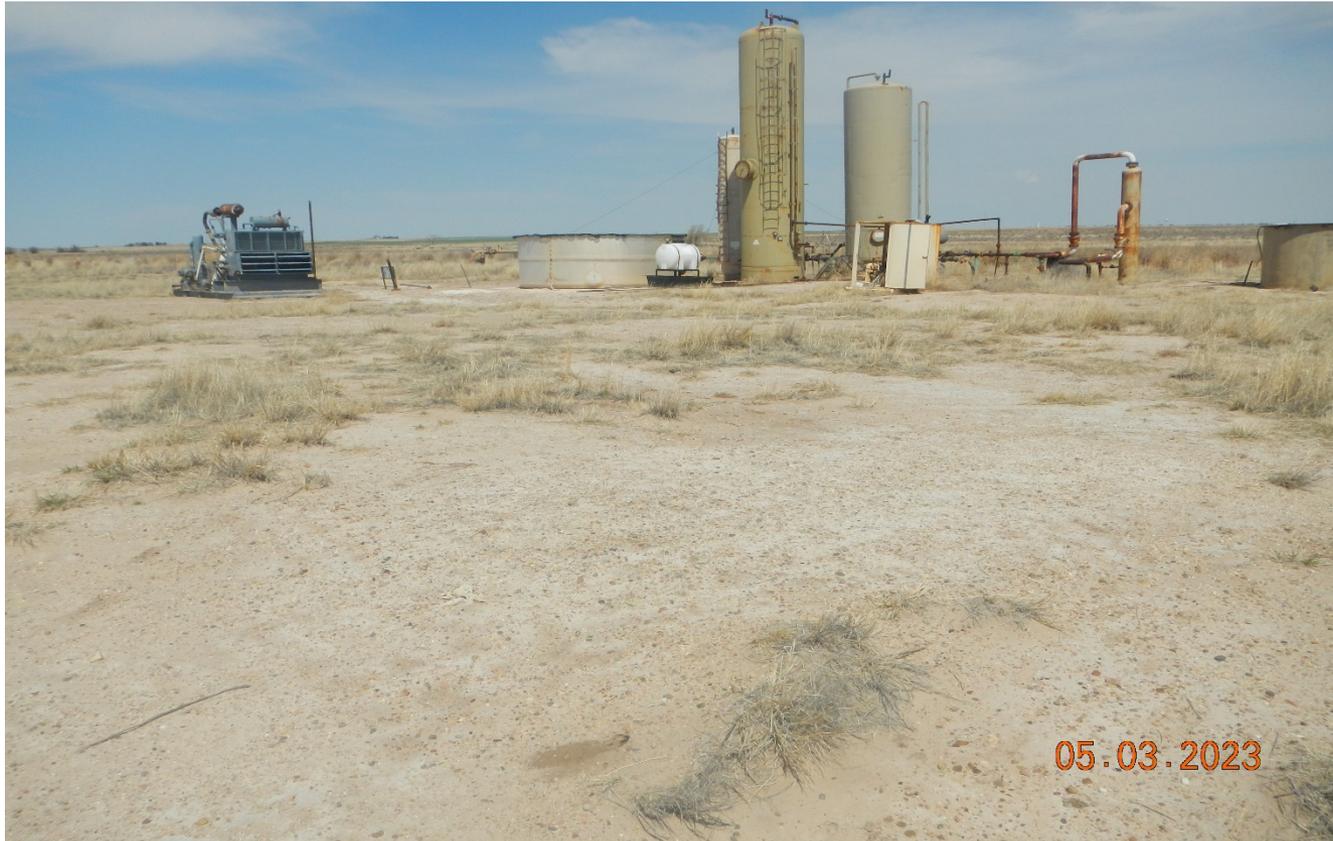
Photo 15. Facing north toward the facility. The surrounding disturbance area has areas that are bare of vegetation that need to be reclaimed per Rule 1003.

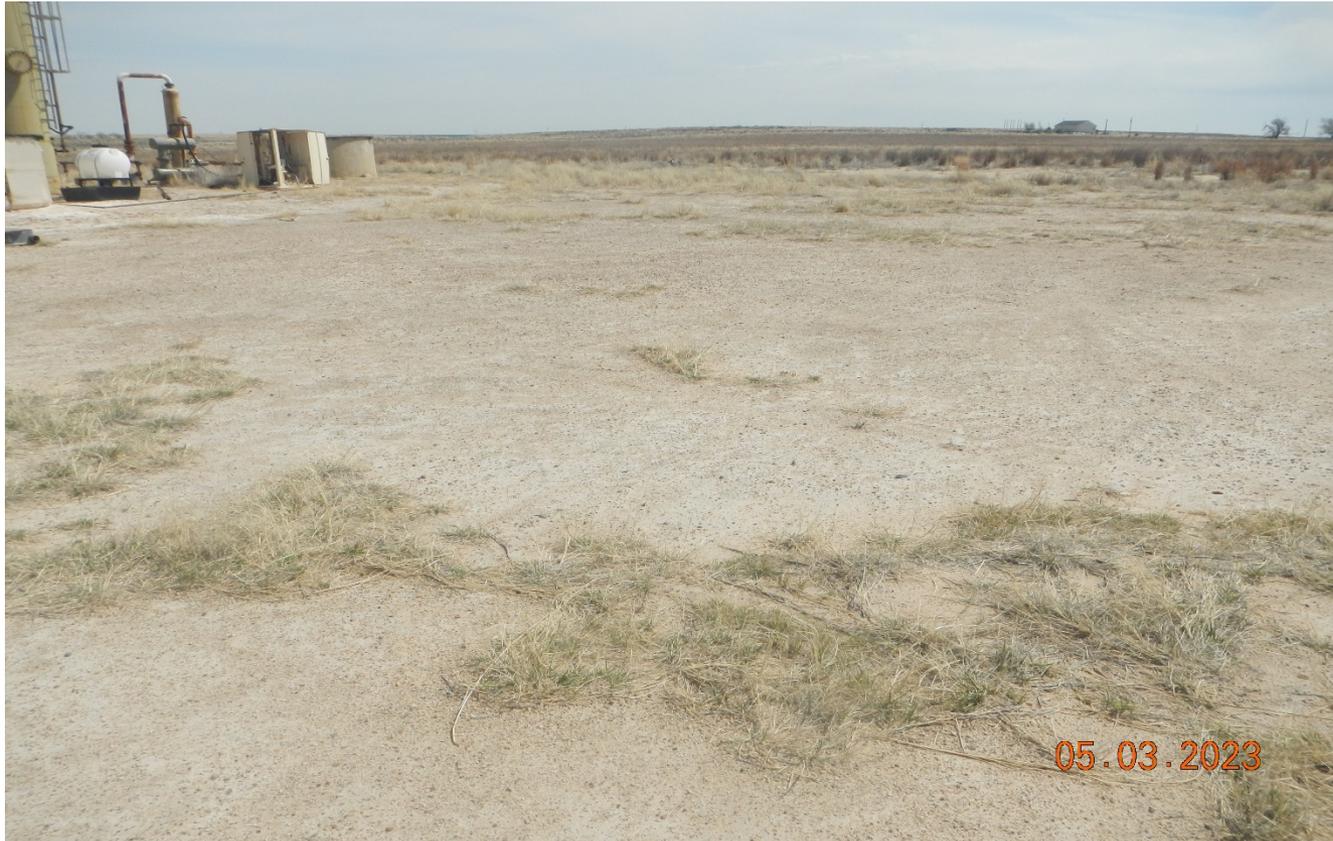
Photo 16. Facing east at the south side of the location. The surrounding disturbance area has areas that are bare of vegetation that need to be reclaimed per Rule 1003.
