# Inspection Photos

ID# 441082

Operator: DOVER ATWOOD CORPORATION

Inspection Date: 5/3/2023

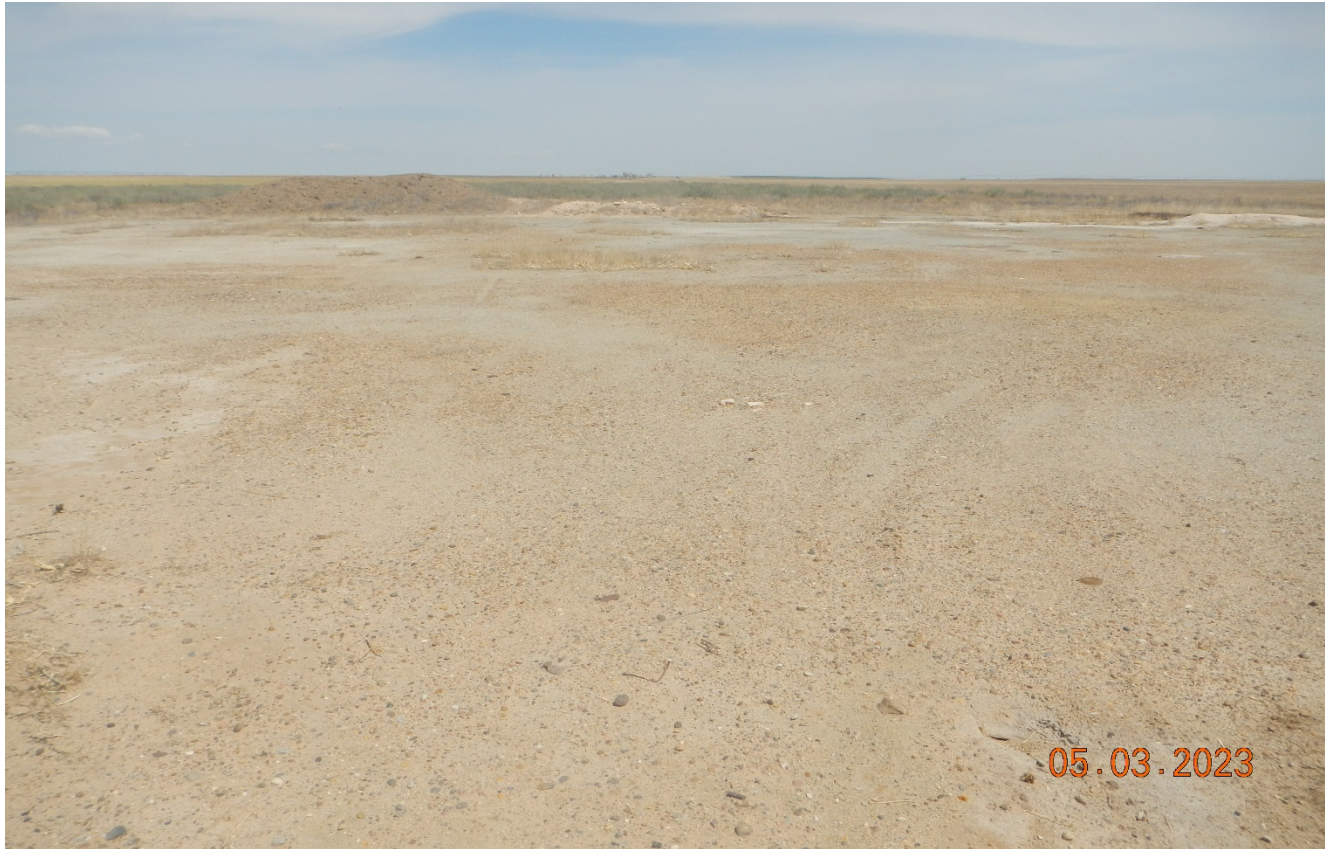
**Photo 1.** Facing north toward the location. The disturbed location has not been reclaimed. Previous corrective actions were not performed.

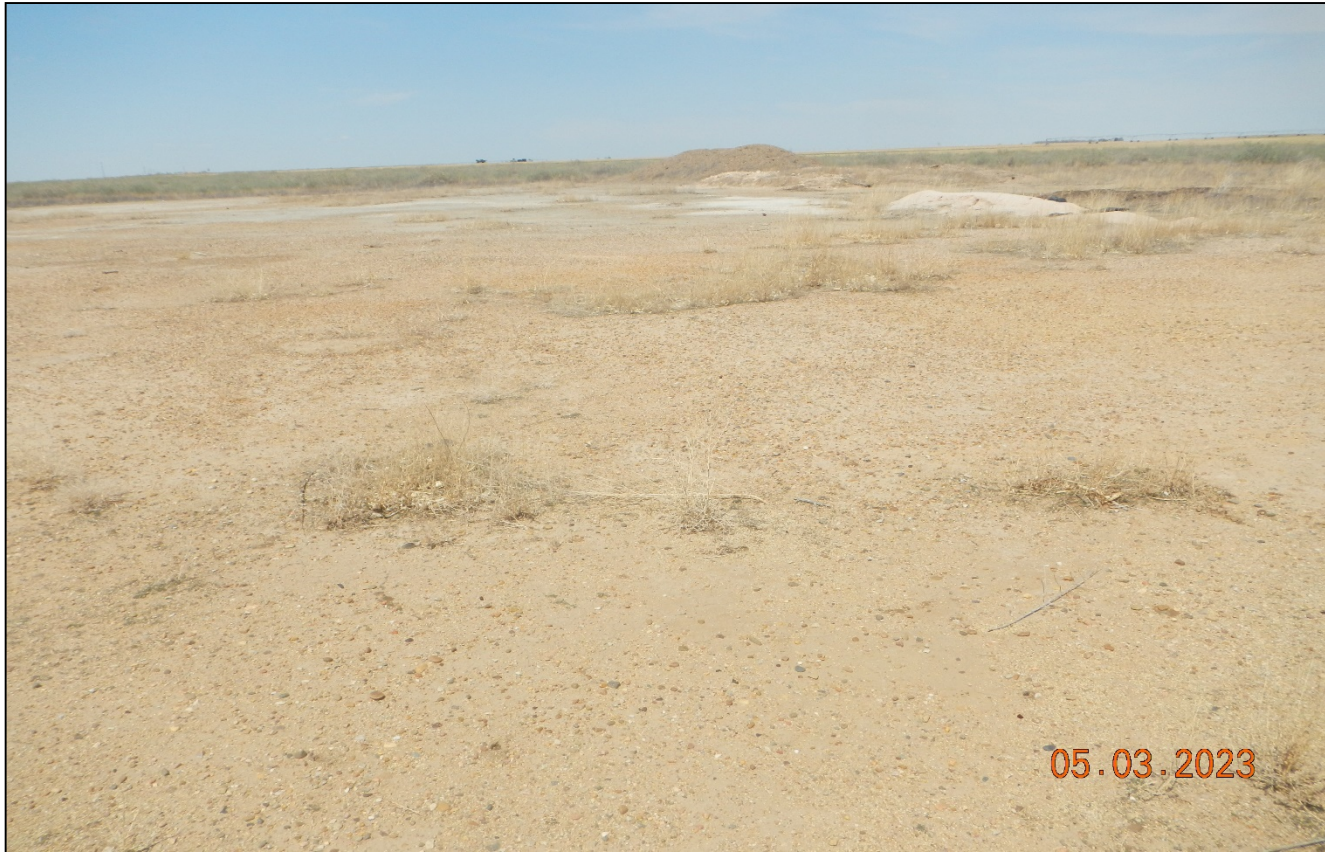
**Photo 2.** Facing northwest at the location. Soils are compacted and the location has not been reclaimed. Previous corrective actions were not performed. Soils must be decompacted by cross ripping to a depth of 18 inches.

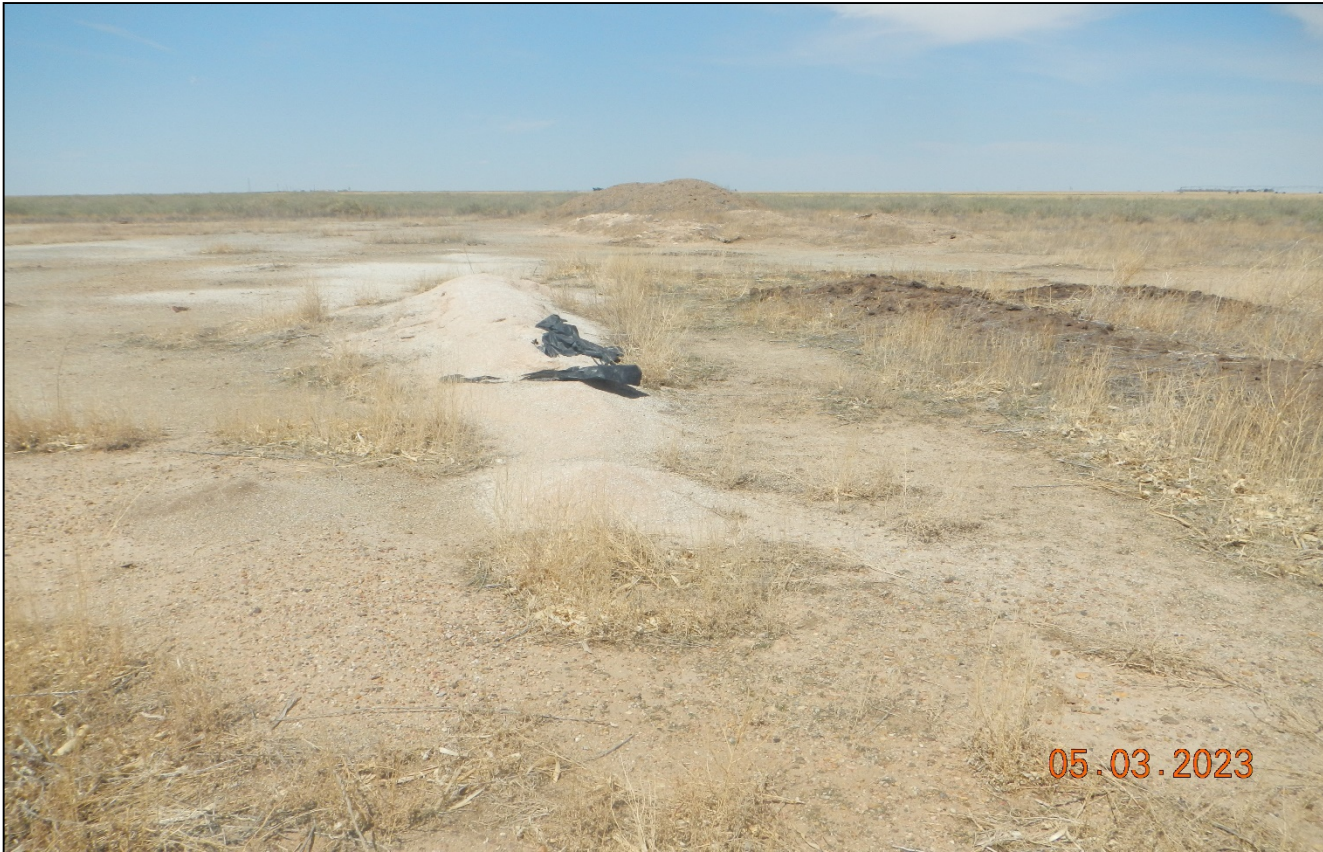
**Photo 3.** Facing east at the location. There are piles of manure and material left on the location. There are undesirable weeds throughout the location.

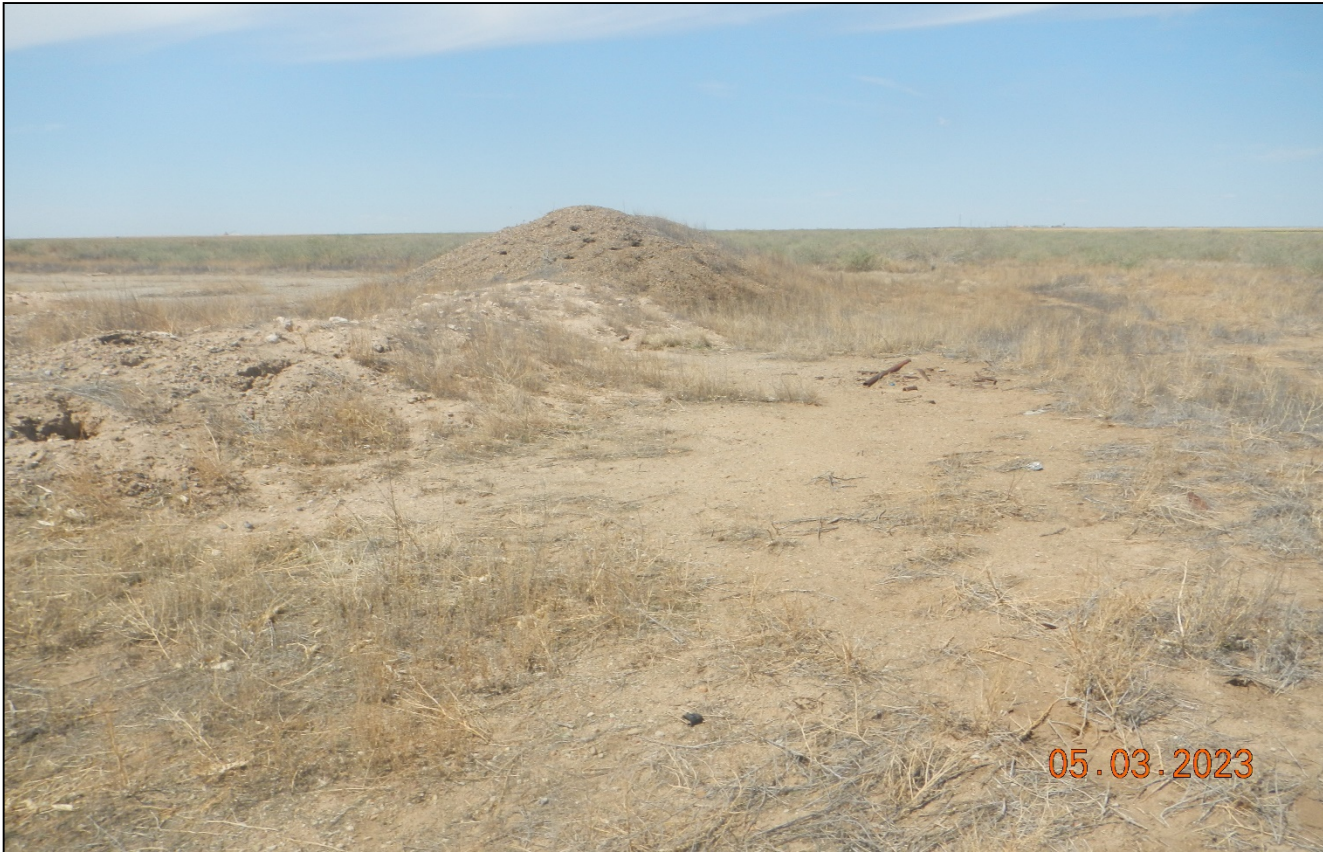
**Photo 4.** There are gravel and soil piles that remain at the north side of the location. The piles need to be removed. There are undesirable weeds on the piles.

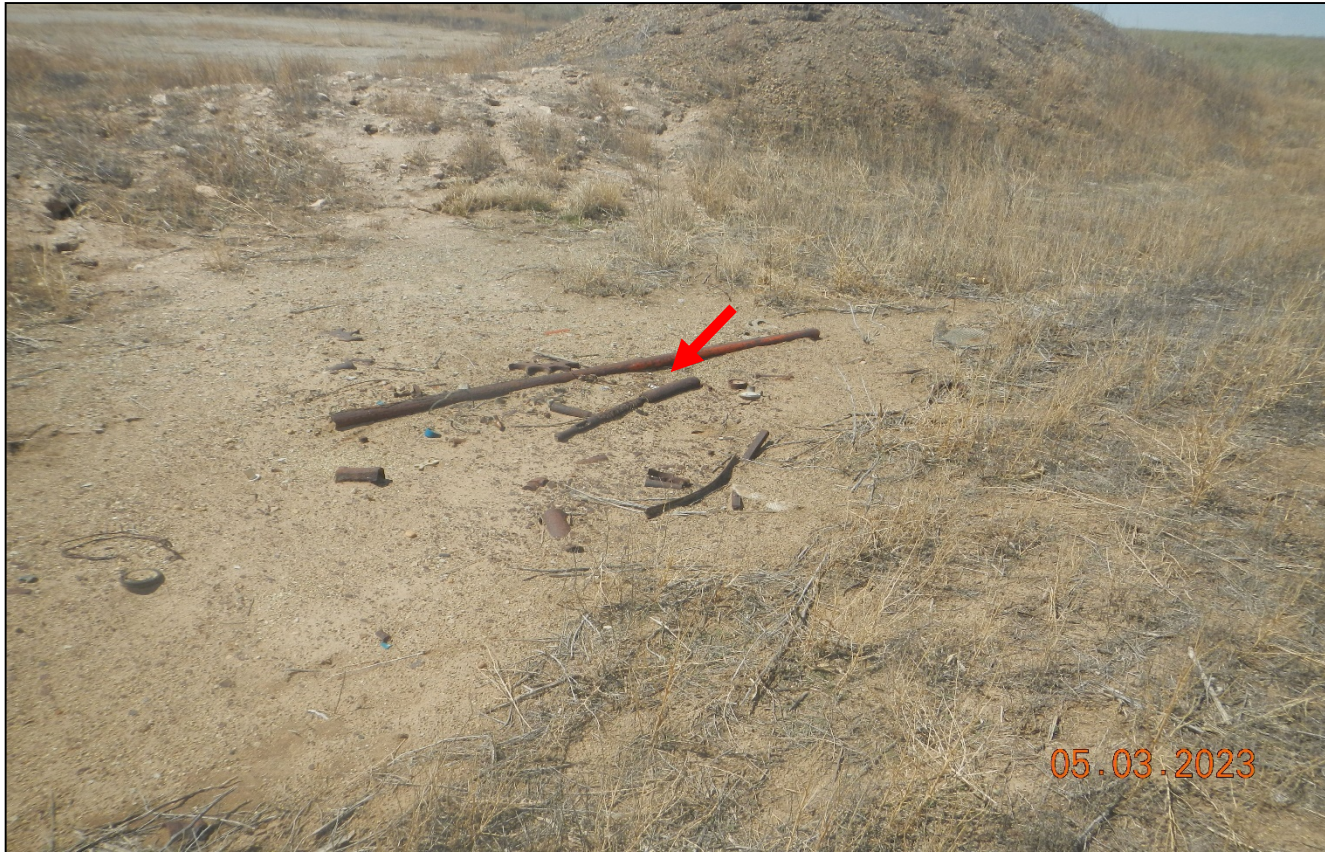
**Photo 5.** Facing southwest at the north side of the location. There is undesirable throughout the location which must be controlled. There is metal debris shown at red arrow.

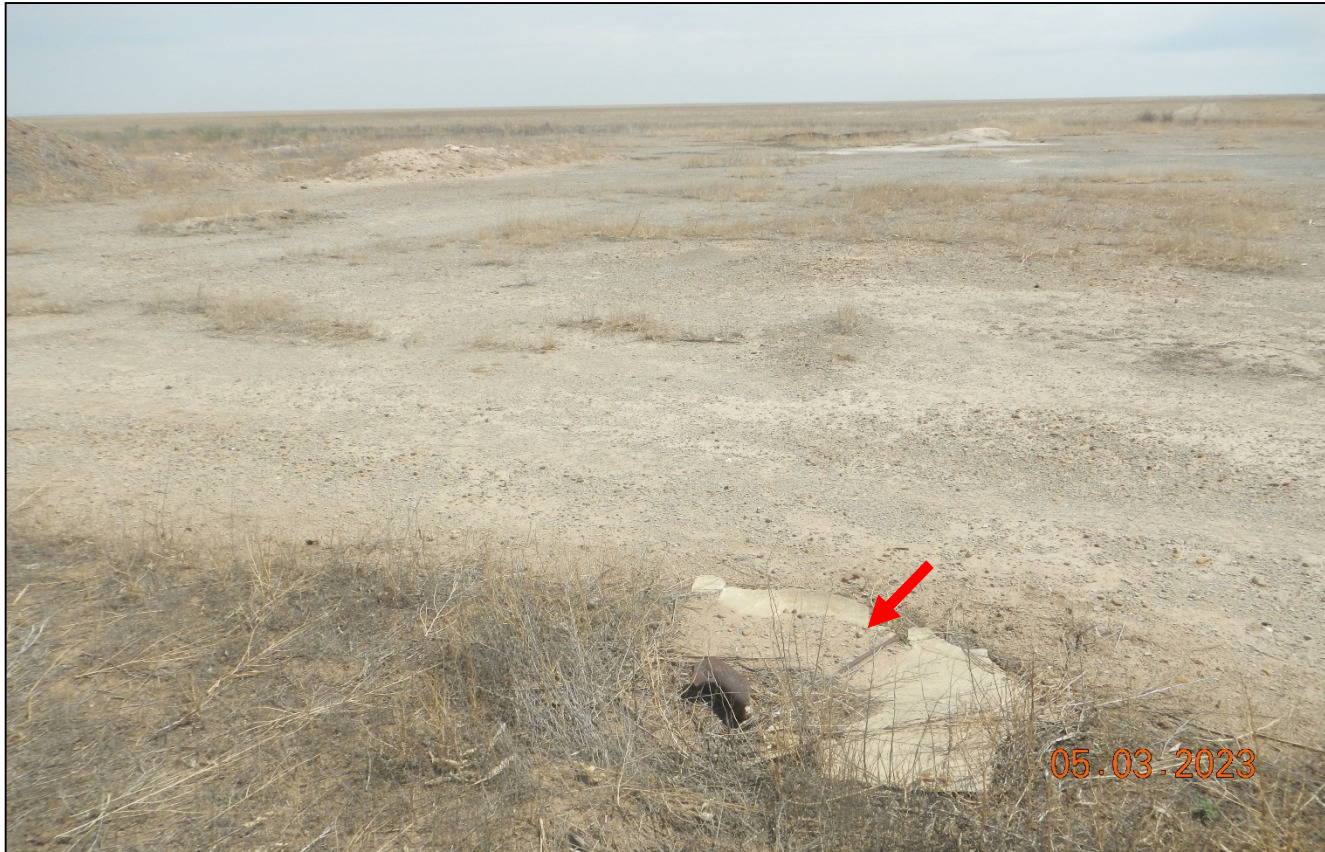
**Photo 6.** Facing west at the location. Soils are compacted and the location has not been reclaimed. There is fiberglass debris shown at red arrow. Previous corrective actions were not performed.

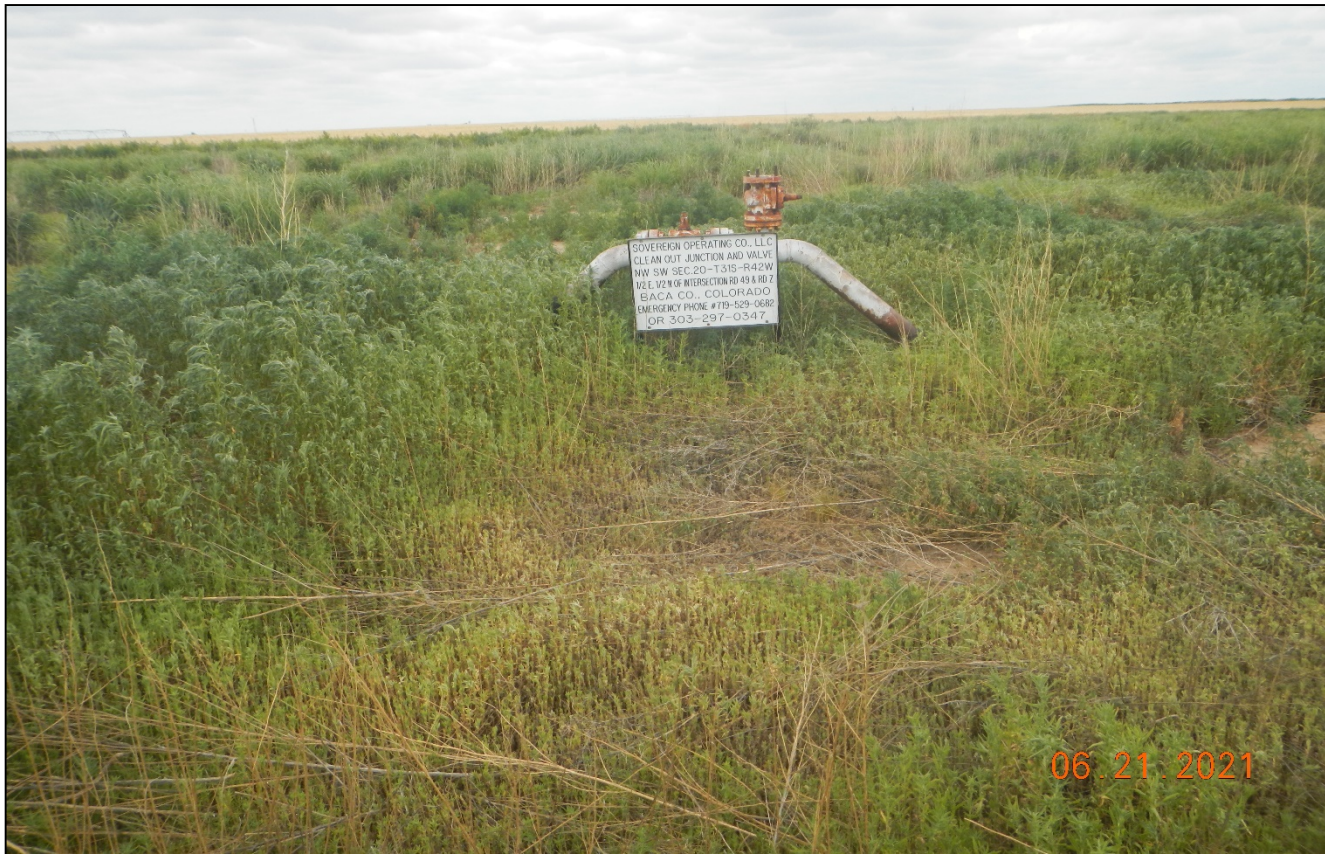
**Photo 7.** There is a cleanout junction 1850 ft. north of the pipeline which is associated with the former gas compressor station and must be removed. Photo taken from previous inspection.
