Inspection Photos

May 2, 2023

Location Name: McPherson A Pad

Inspection Document #: 702801490

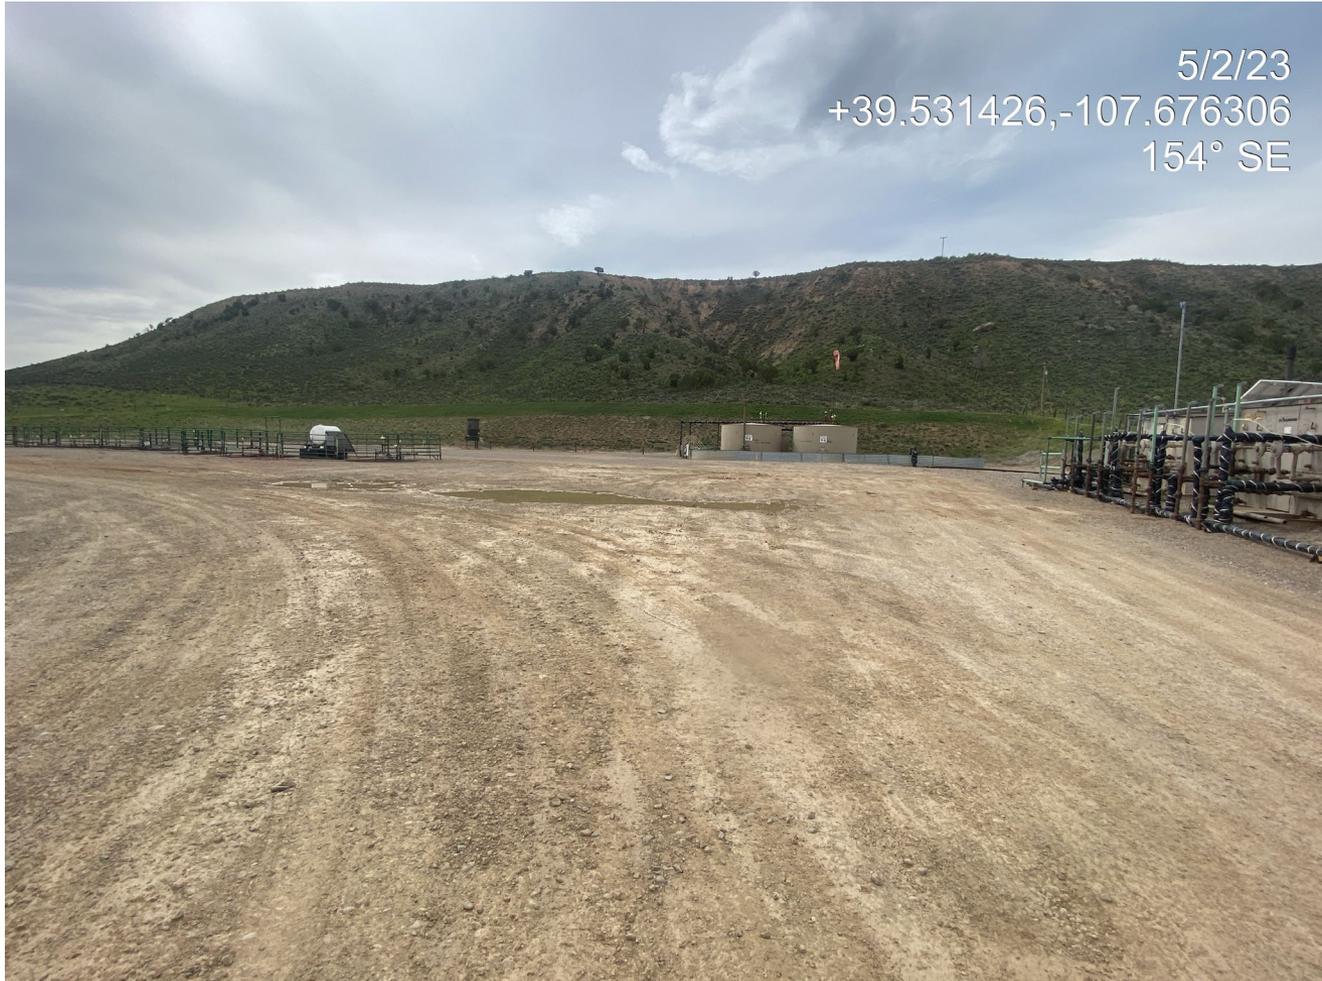
Photo 1. Photo taken from the entrance shows an overview of the location.

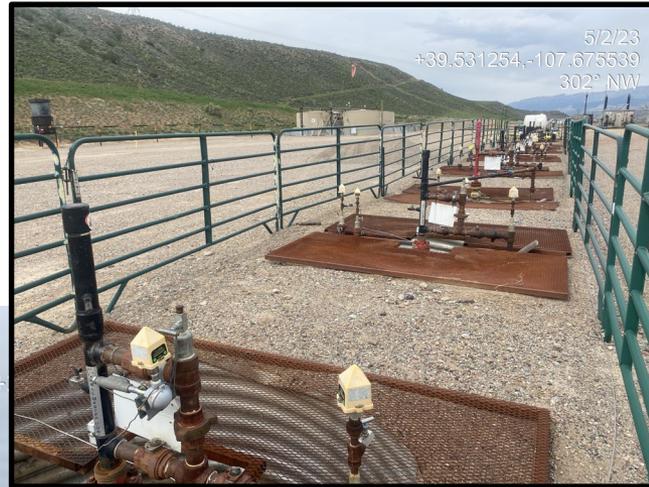
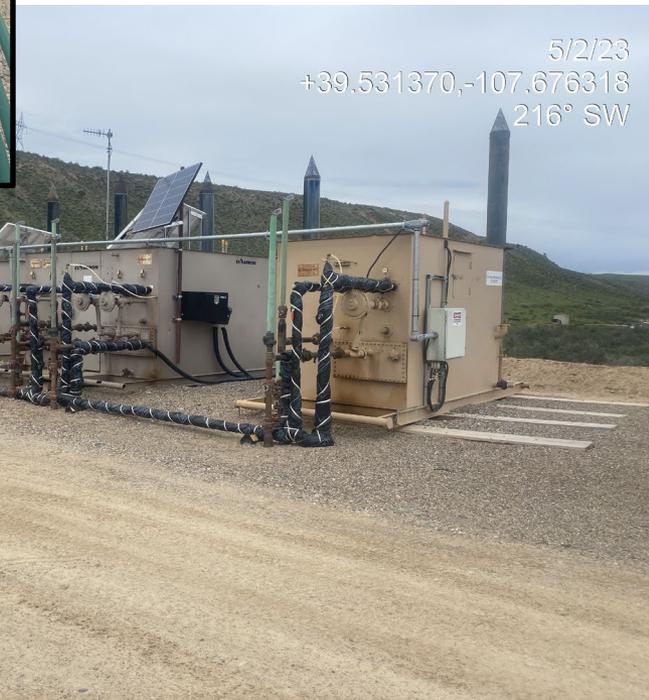
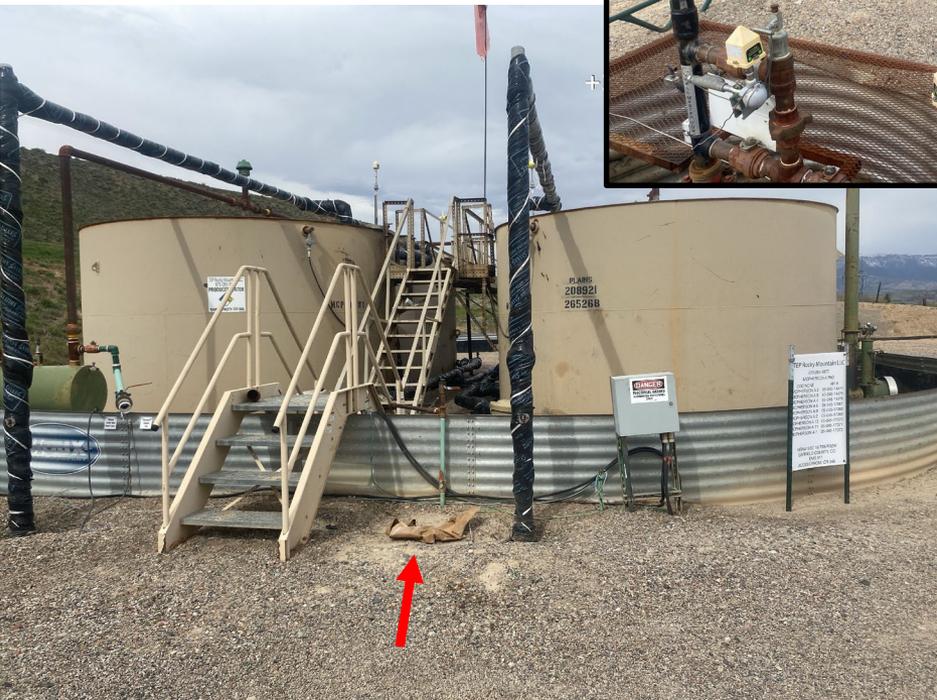
Photo 2. Photos show production areas. Note debris at the tank battery (arrow).

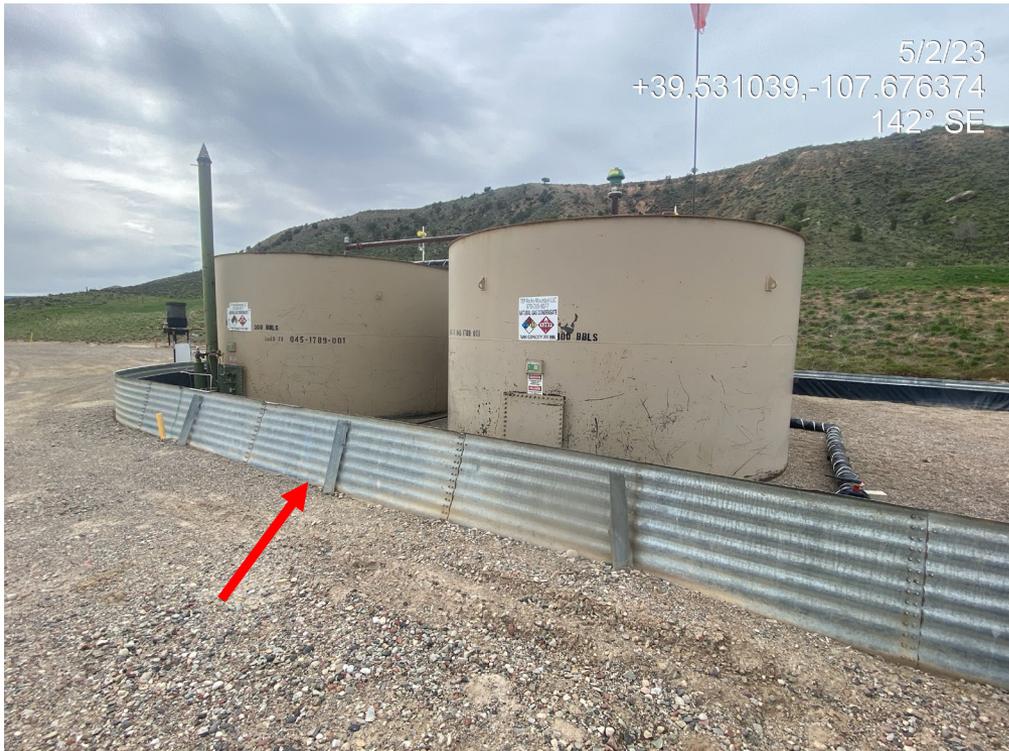
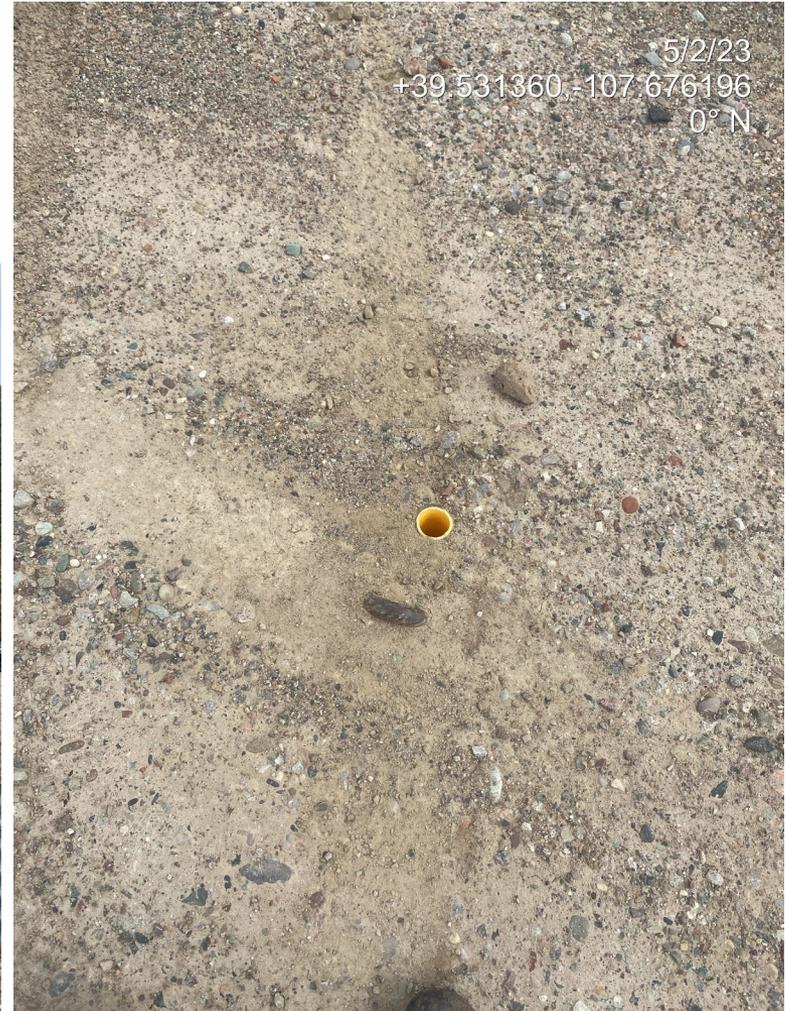
Photo 3. Photos show the tank secondary containment has been damaged (left) and an unmarked anchor (right).

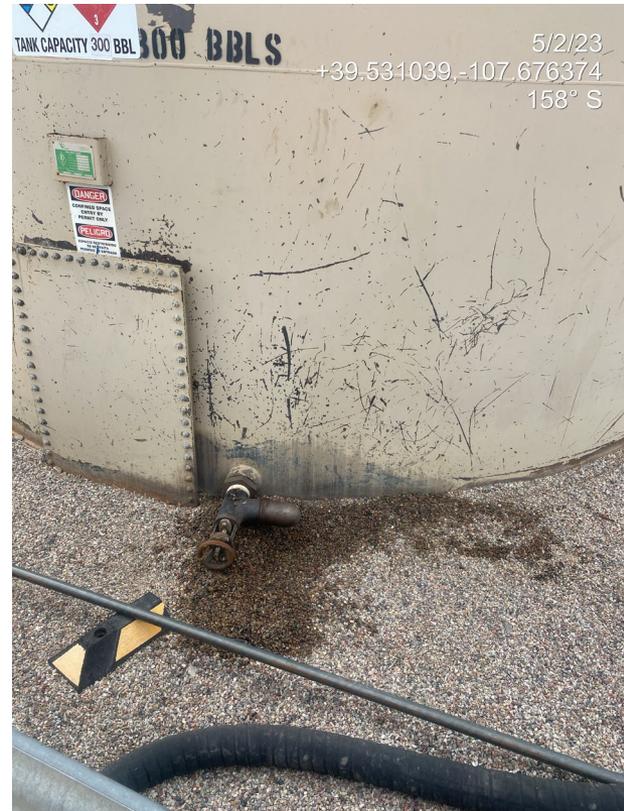
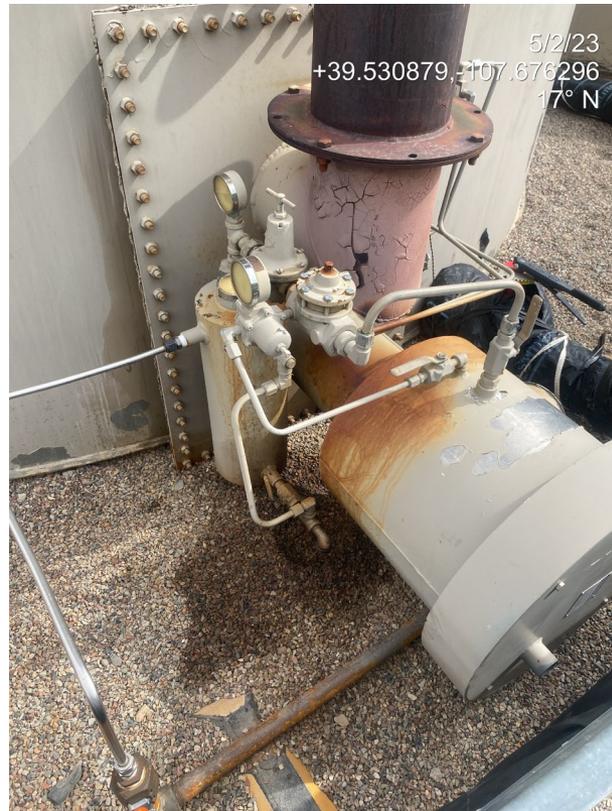
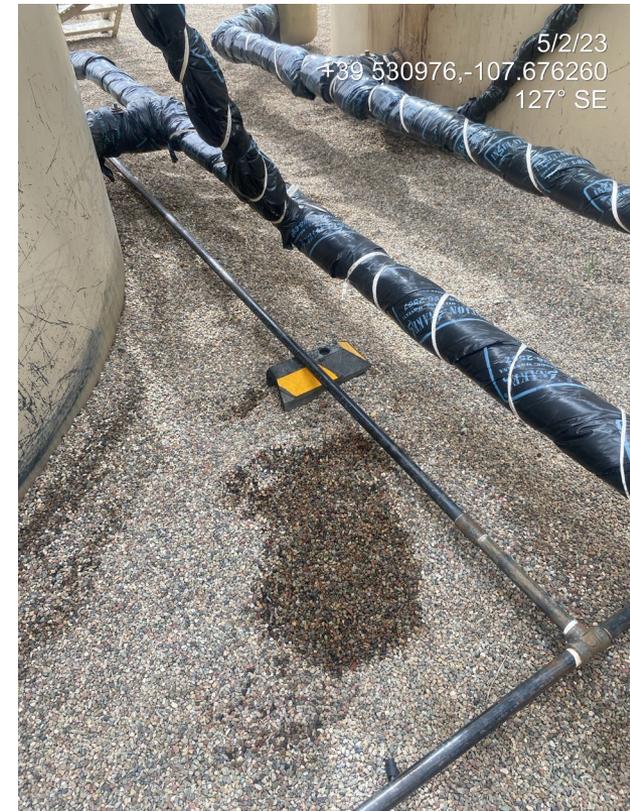
Photo 4. Photos show staining within the tank secondary containment.

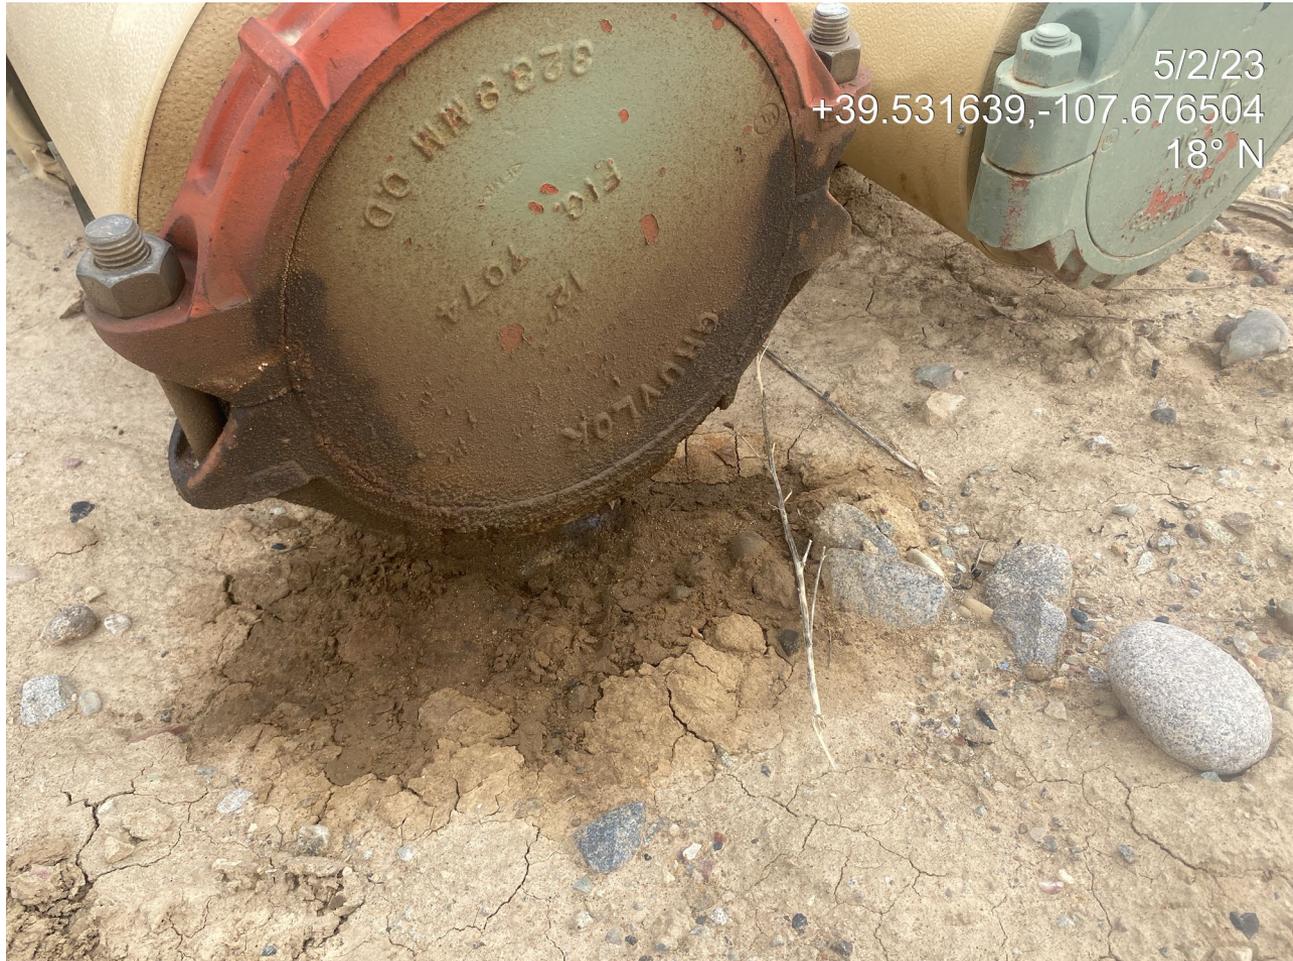
Photo 5. Photo shows staining at a pigging station to the northwest of the location.

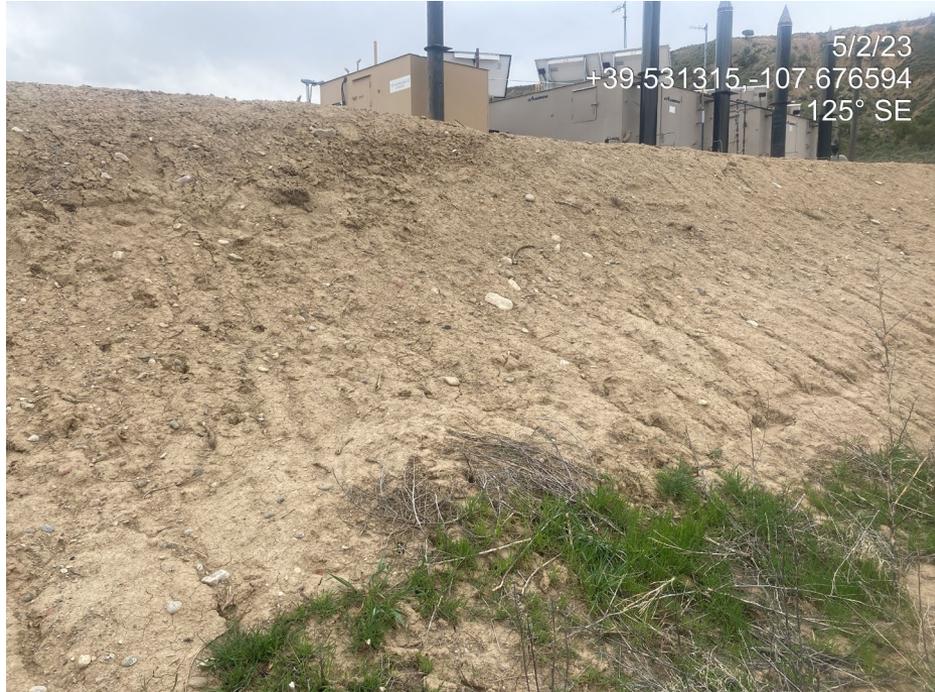
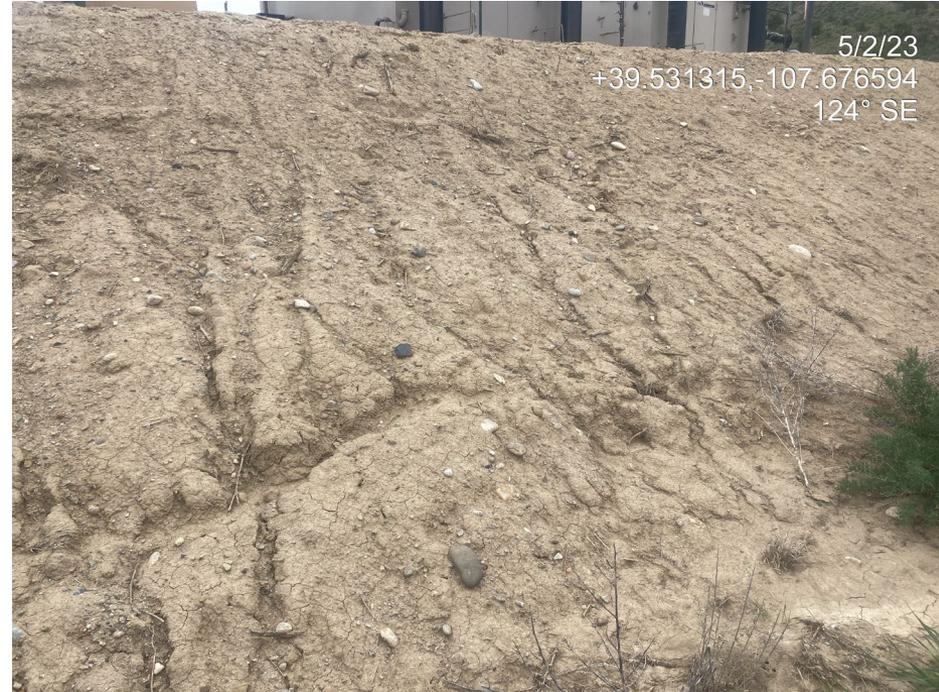
Photo 6. Photos show a berm to the west is unstabilized.

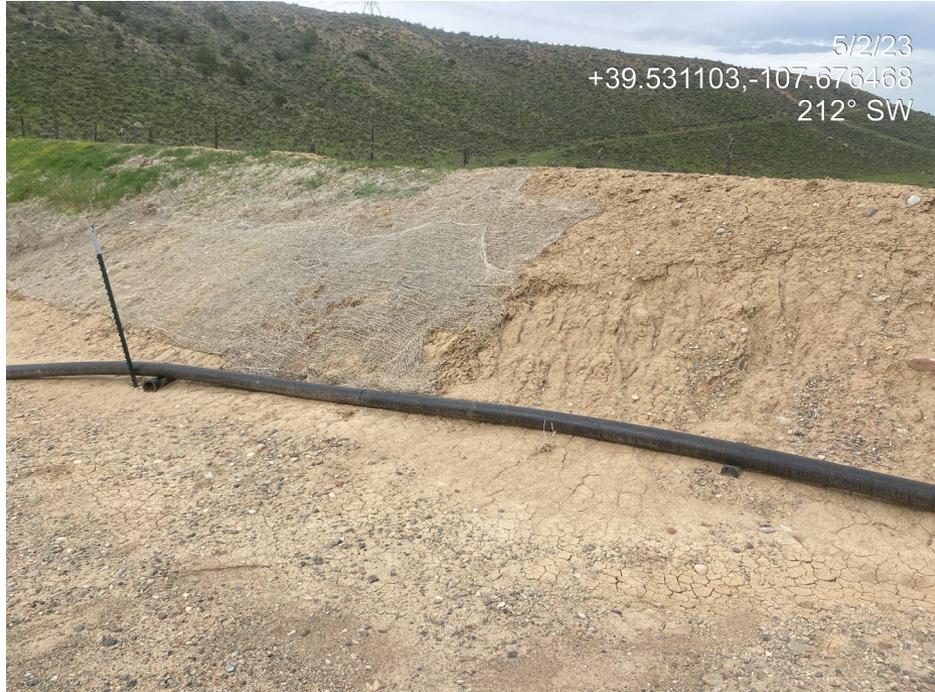
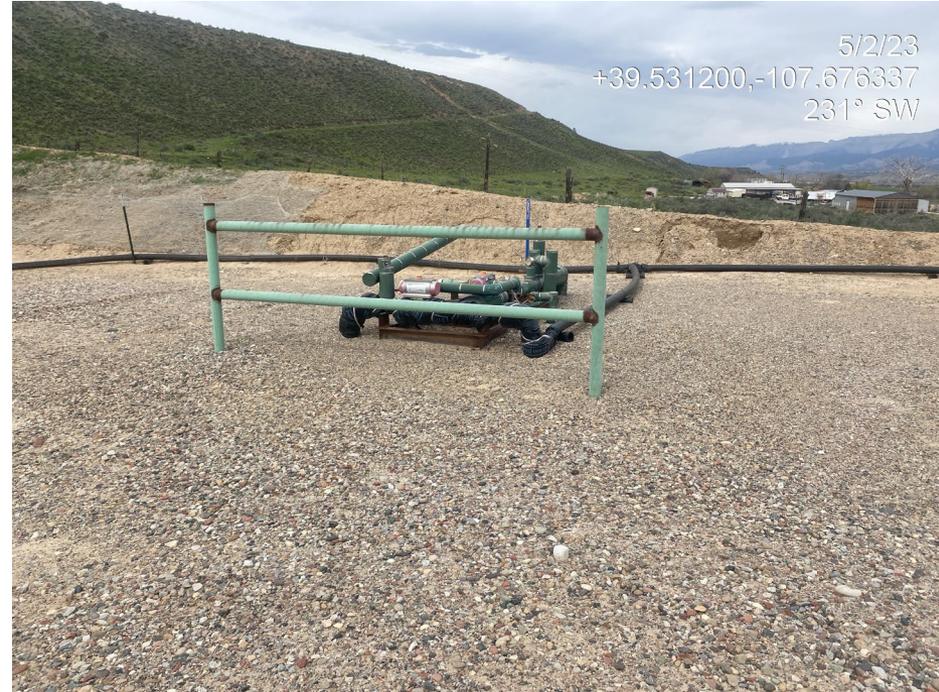
Photo 7. Photos show a berm to the west is unstabilized.

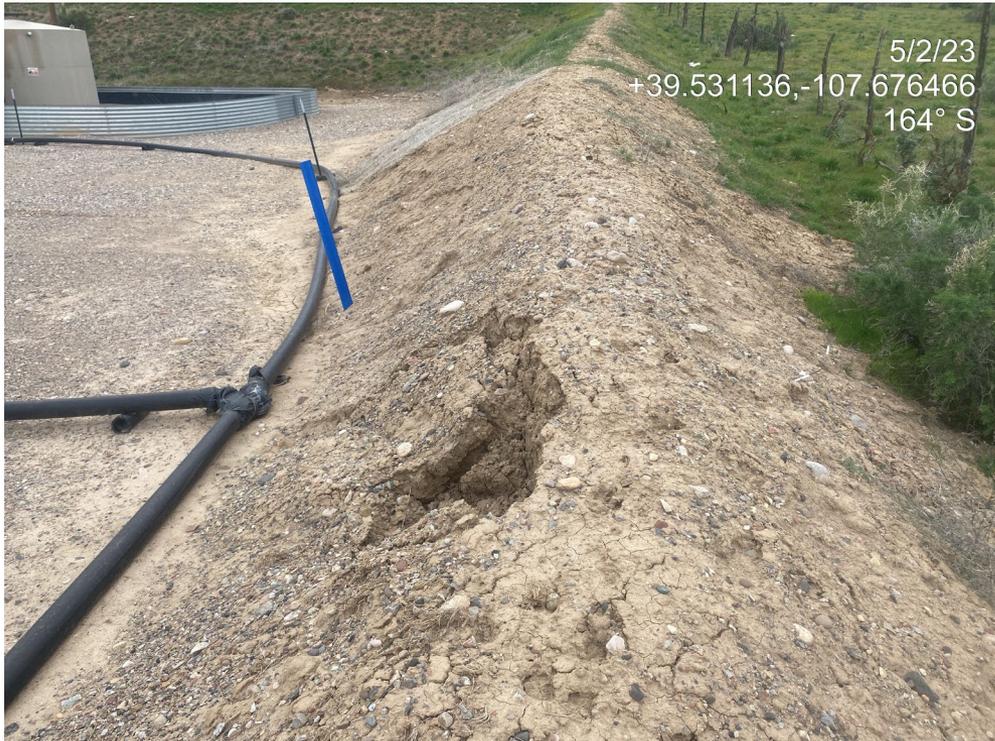
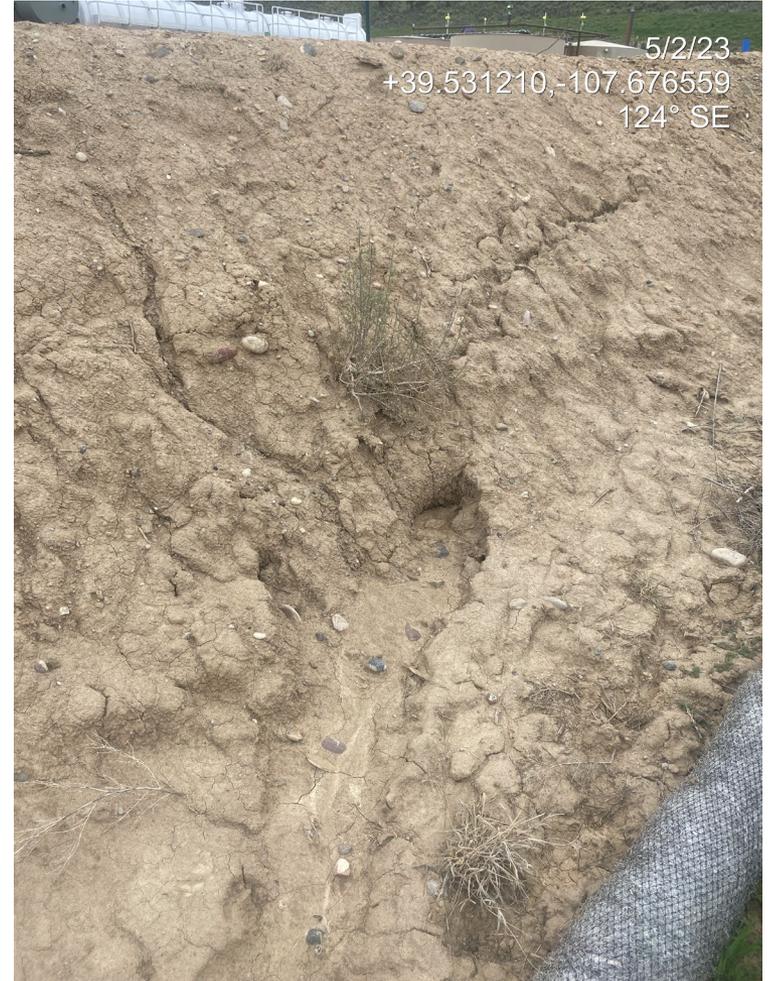
Photo 8. Photos show a berm to the west is unstabilized. Stormwater is traveling through the berm from the east (left) to the west (right).

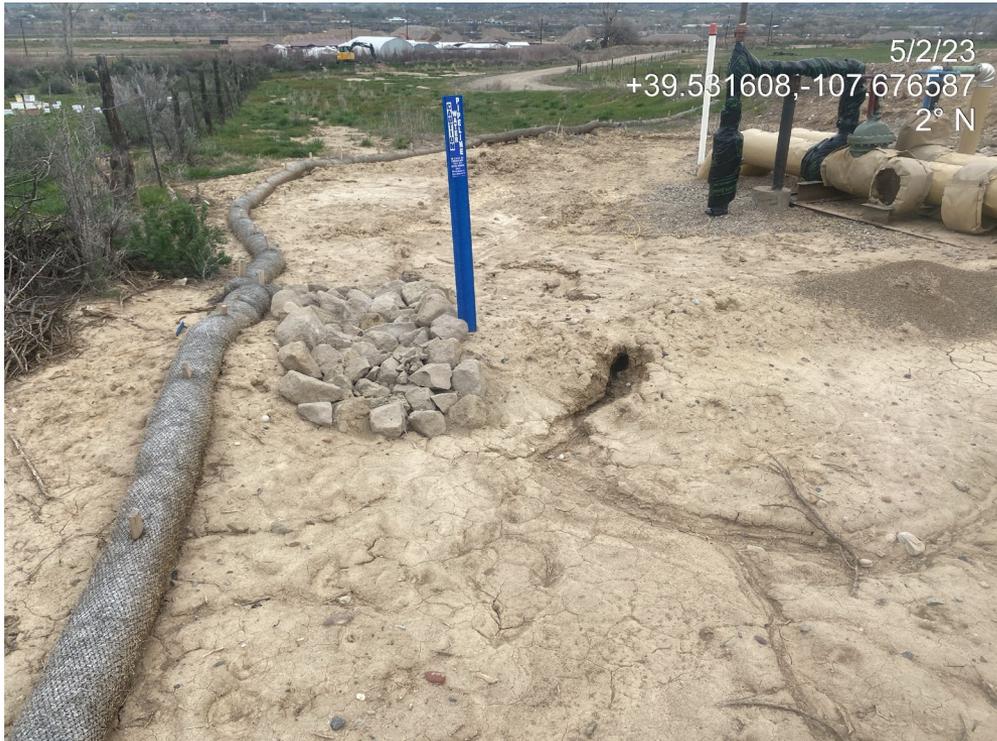
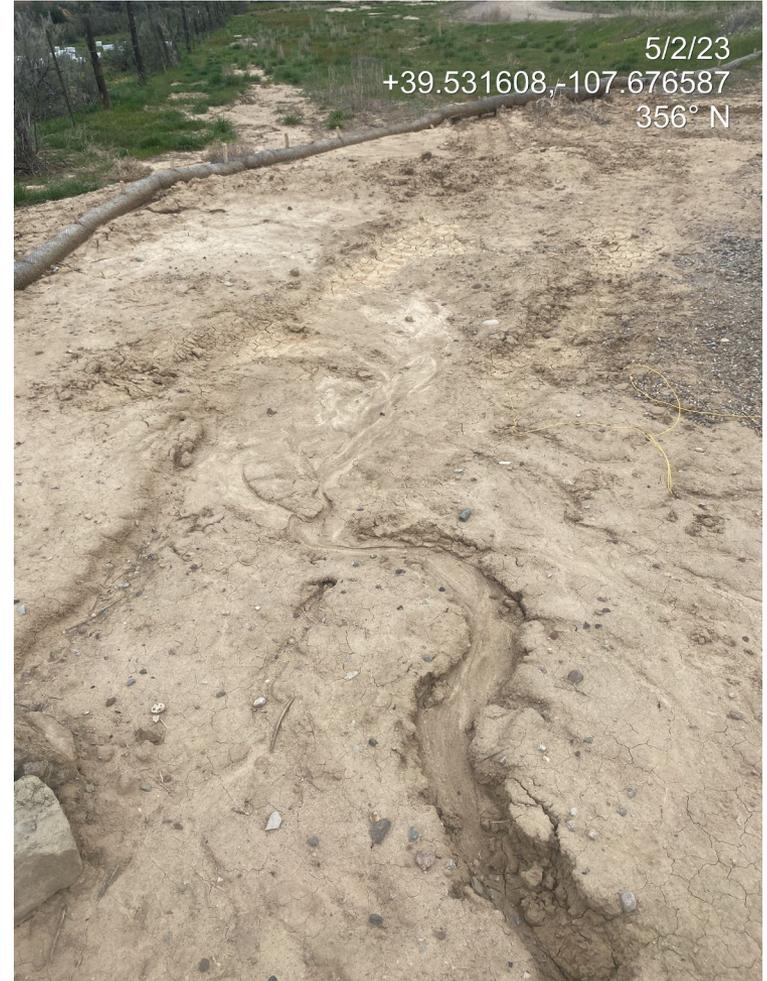
Photo 9. Photos taken to the northwest show stormwater is bypassing BMPs. Erosion degradation is evident.

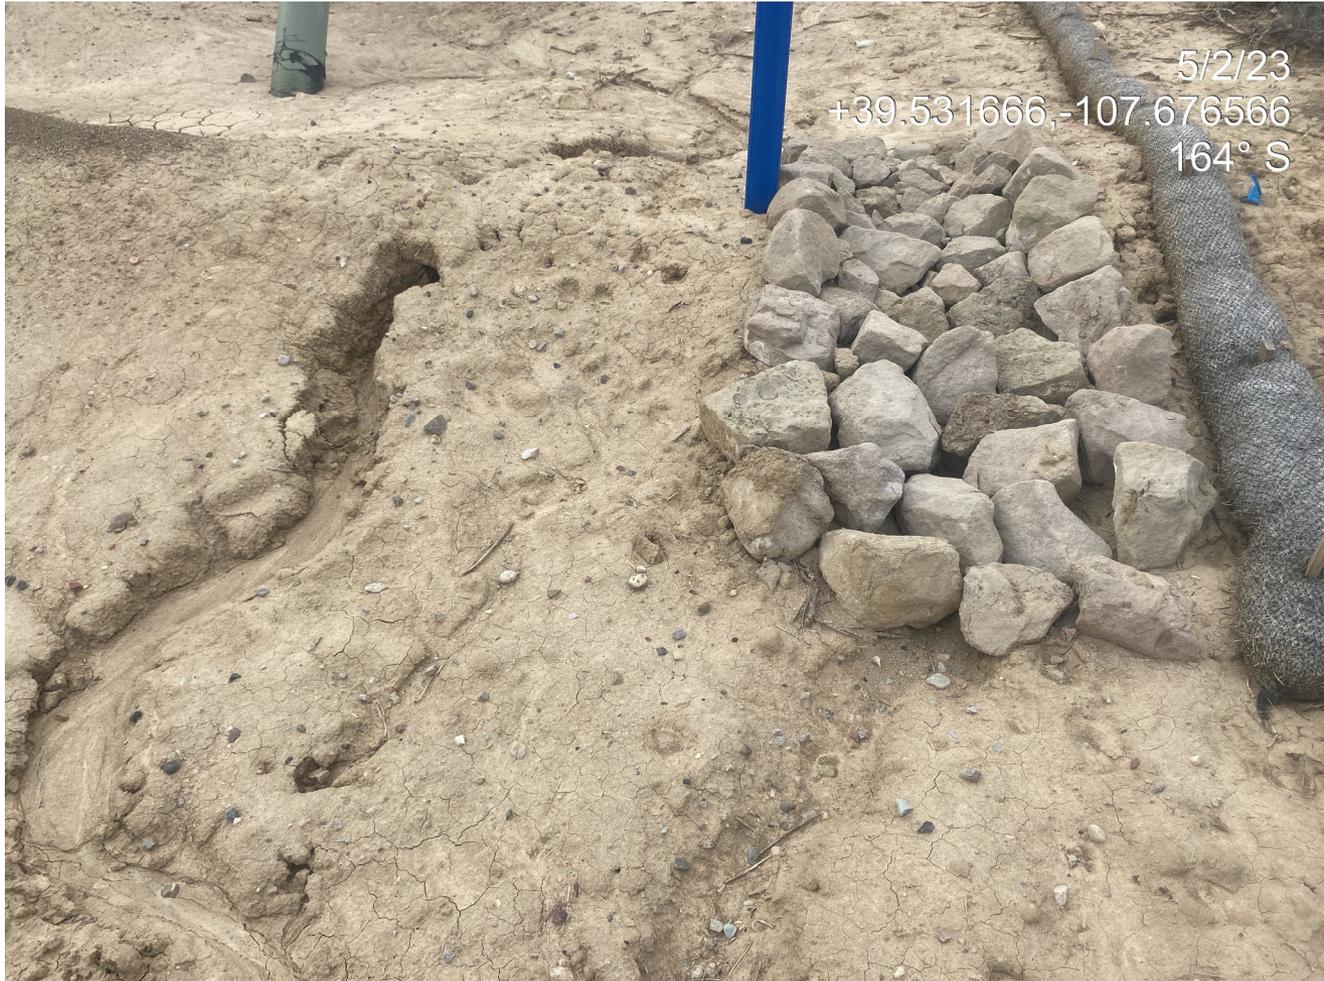
Photo 10. Photos taken to the northwest show stormwater is bypassing BMPs. Erosion degradation is evident.

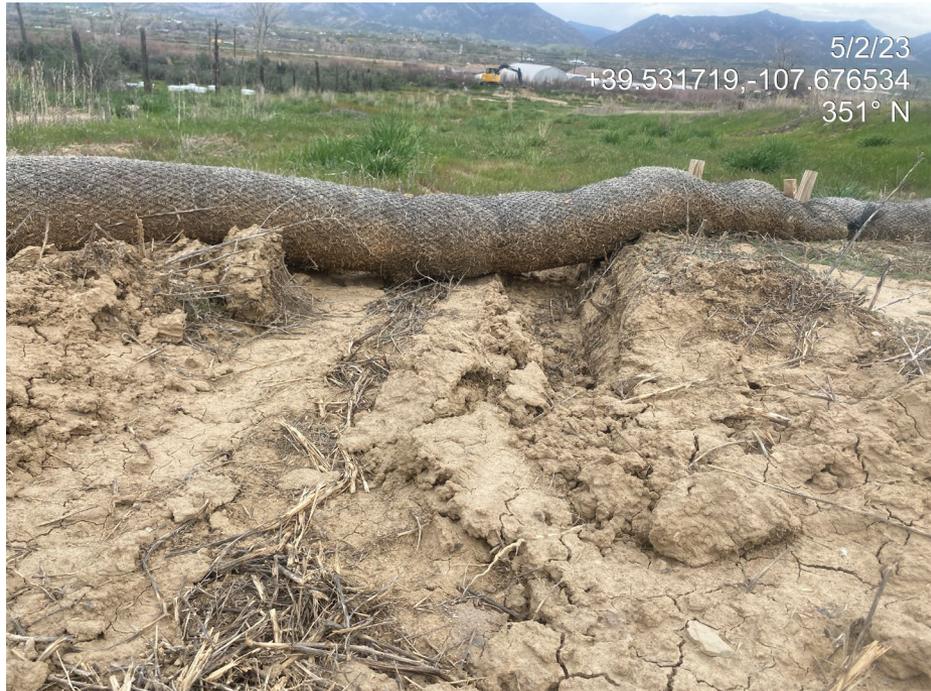
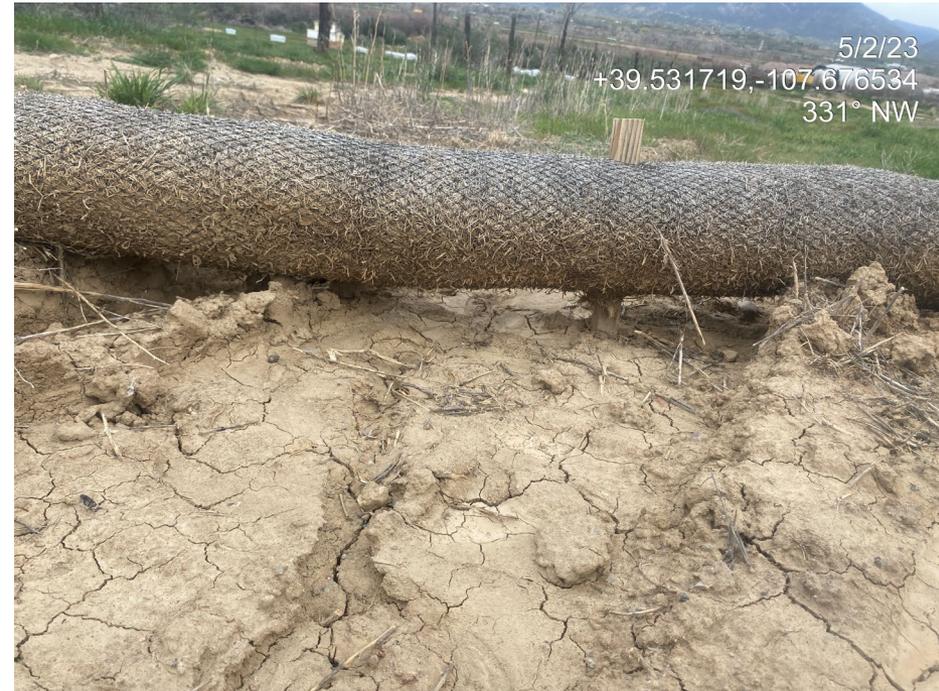
Photo 11. Photos taken to the northwest show BMPs not properly installed.

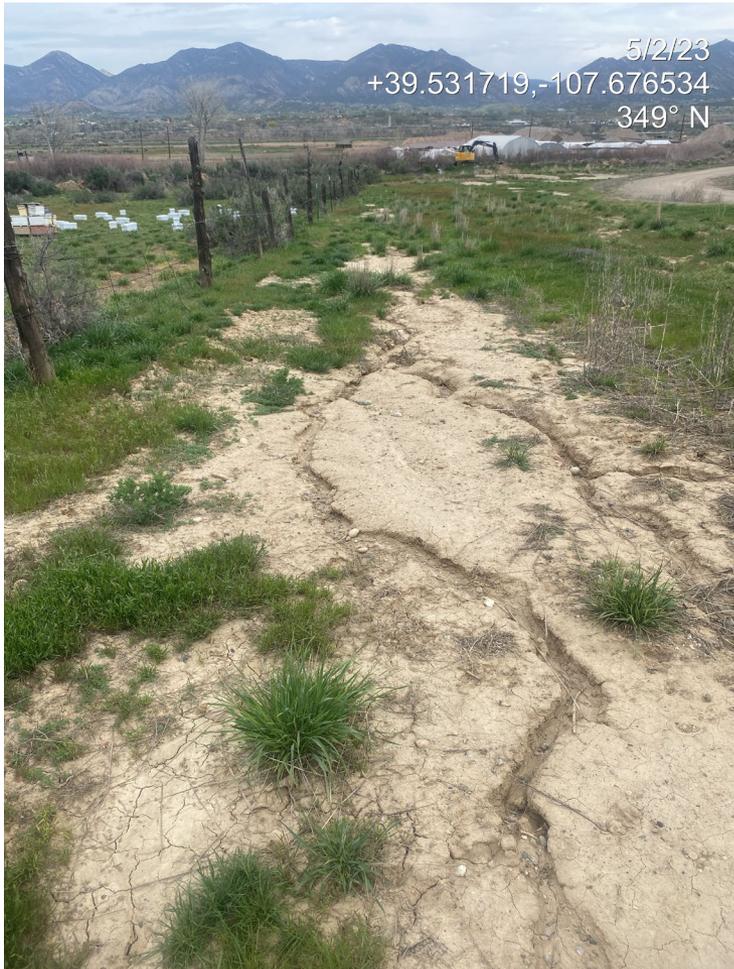
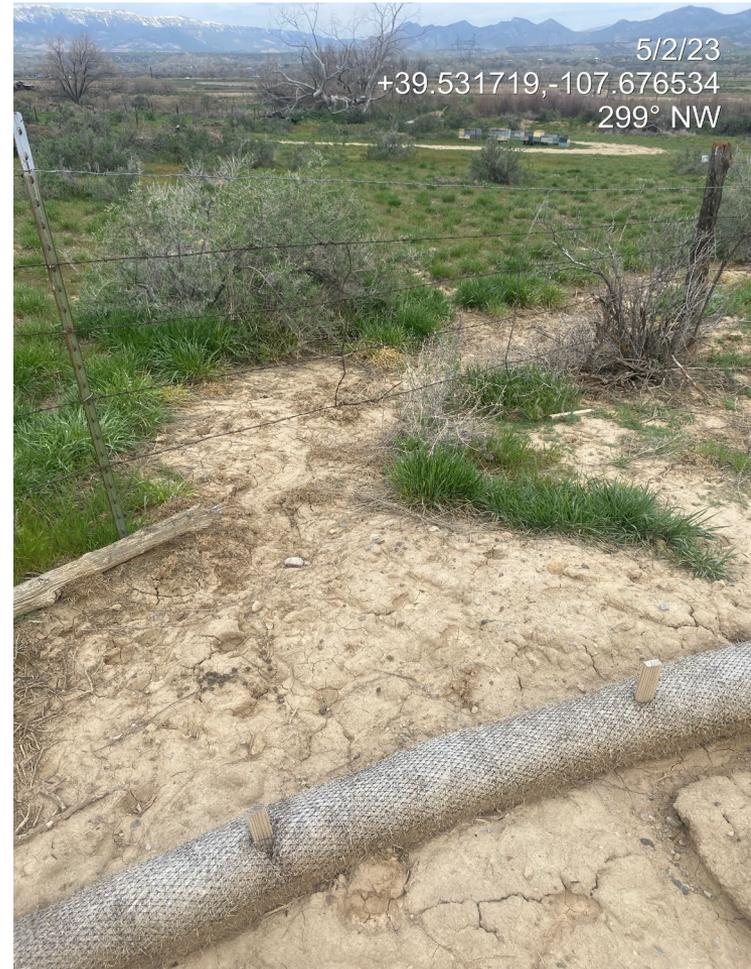
Photo 12. Photos taken to the northwest show erosion degradation migrating offsite downslope of BMPs and the unstabilized location.

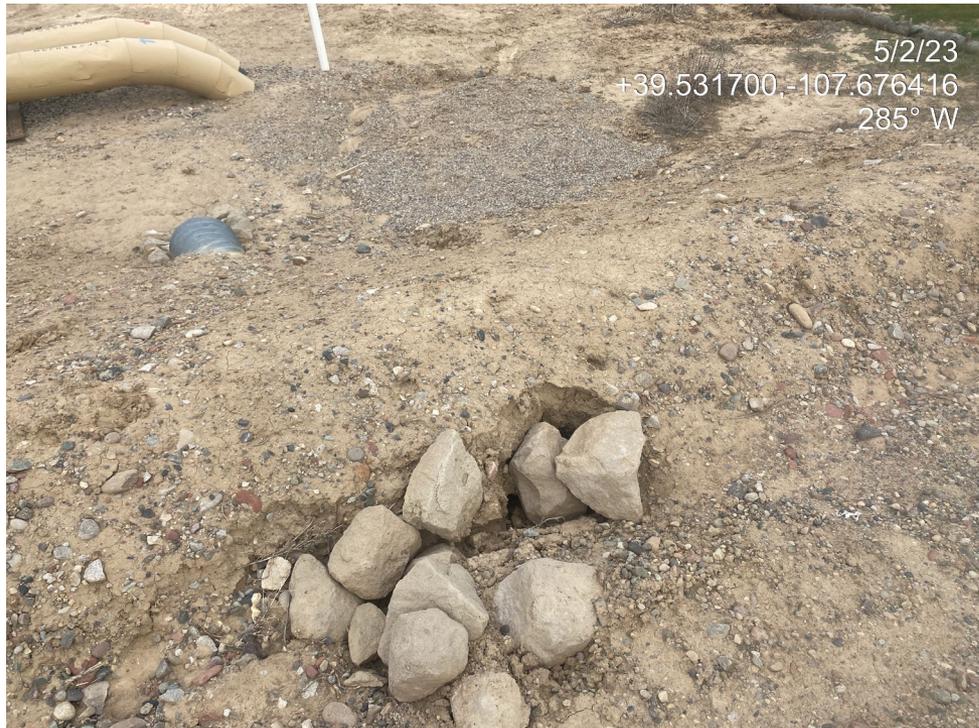
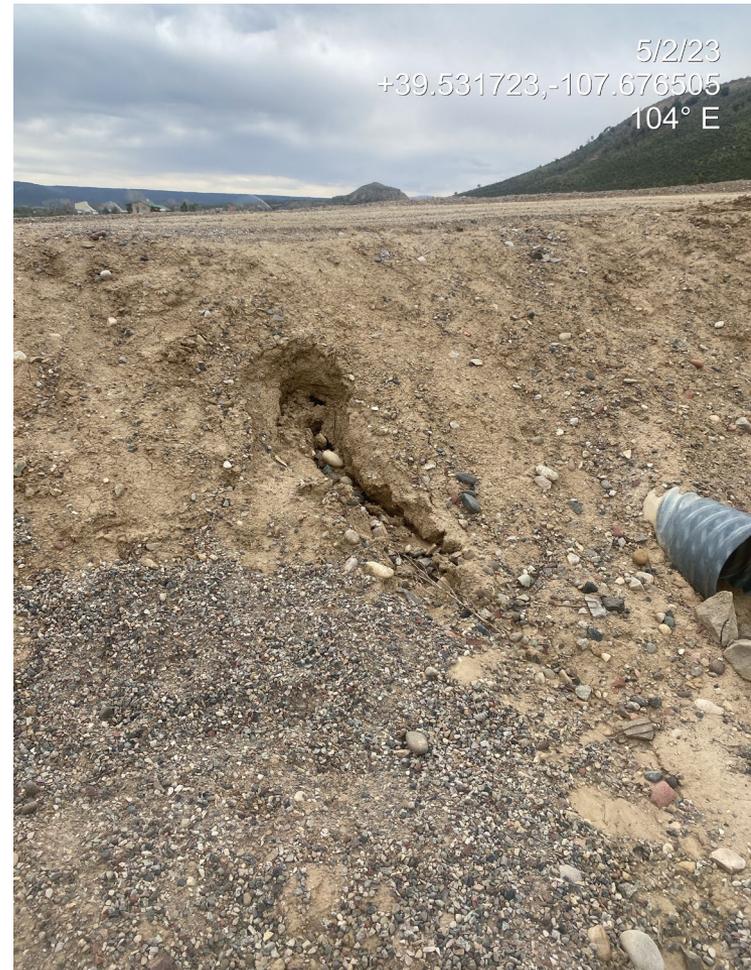
Photo 13. Photos taken to the northwest show where stormwater from the access road ditch is cutting through a berm (left) and exiting to the west (right).

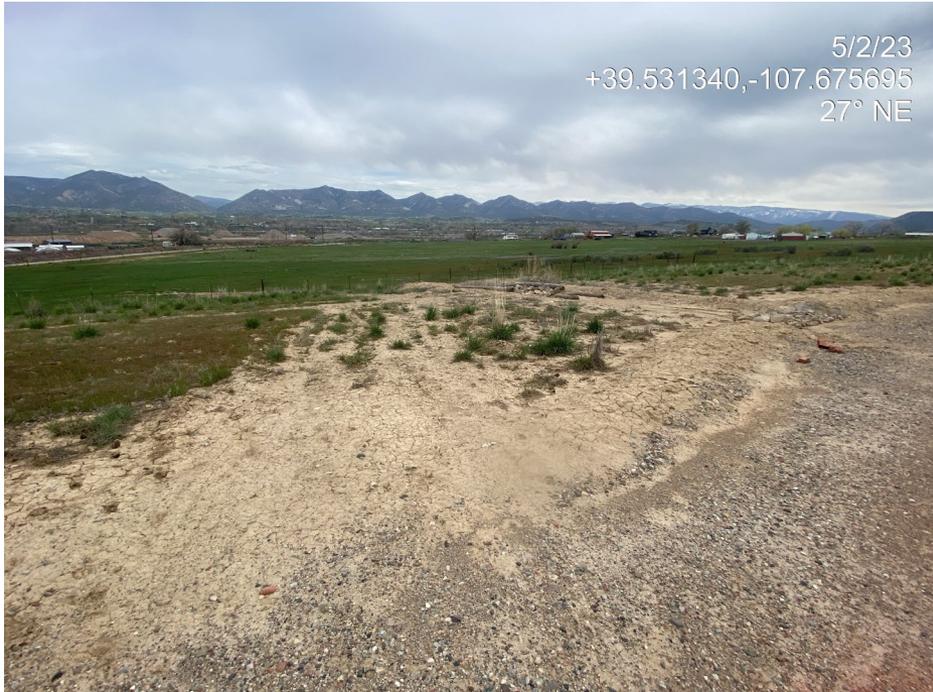
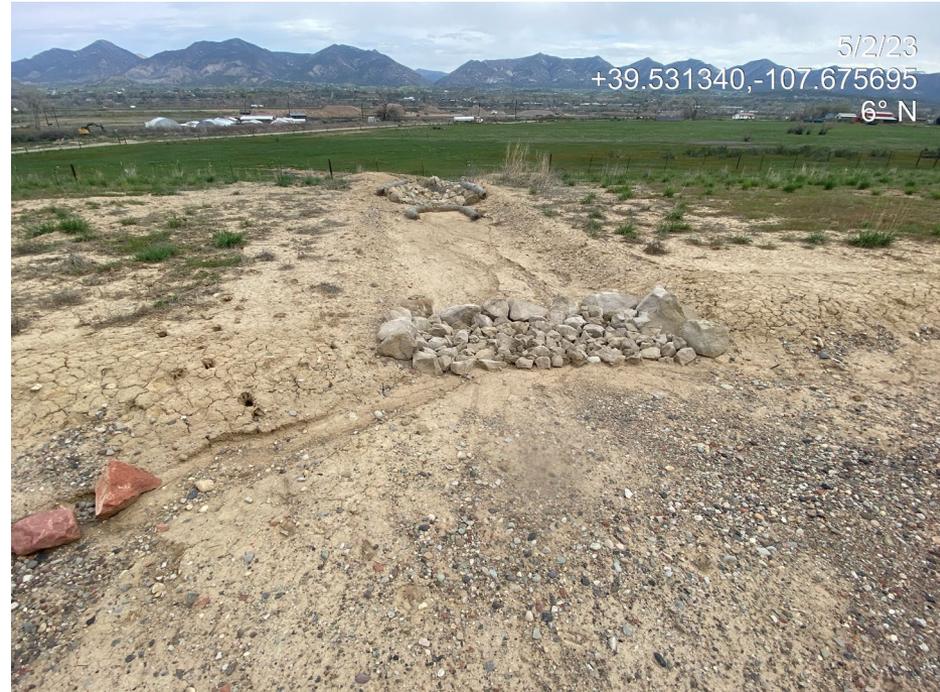
Photo 14. Photos show an overview of stormwater BMPs in the northern interim area of the location. Note lack of stabilizing perennial vegetation and sediment migration.

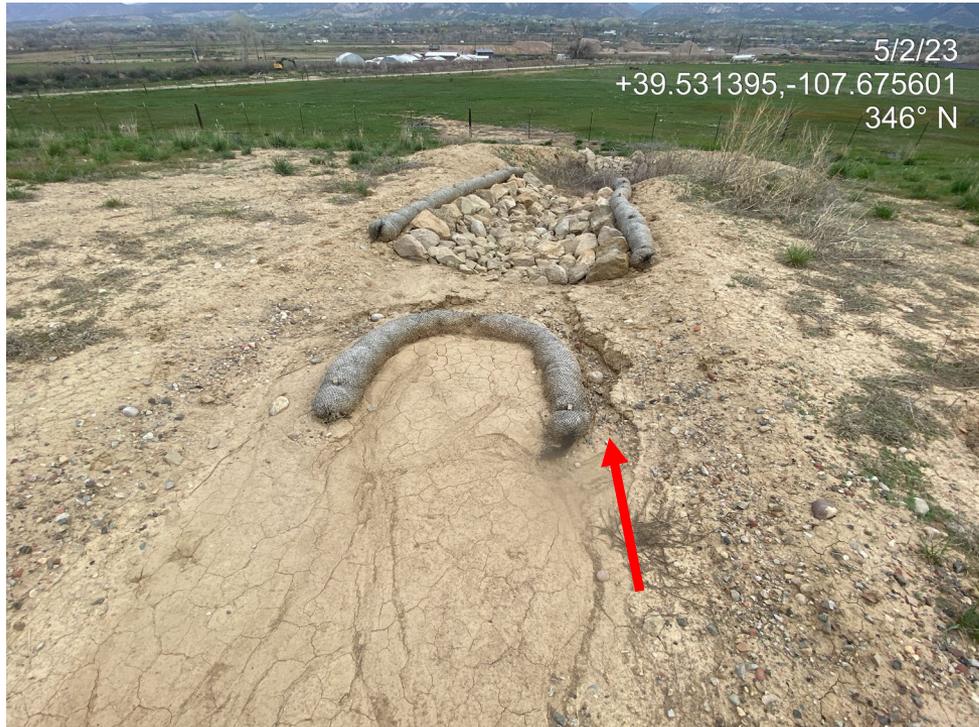
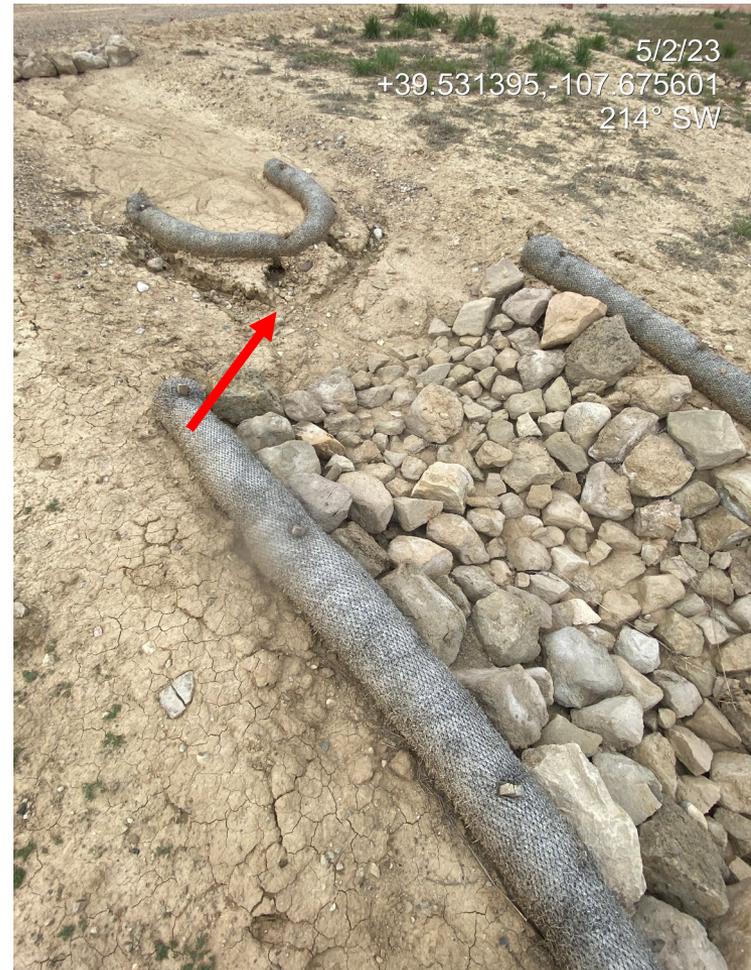
Photo 15. Photos show erosion degradation at stormwater BMPs in the northern interim area of the location.

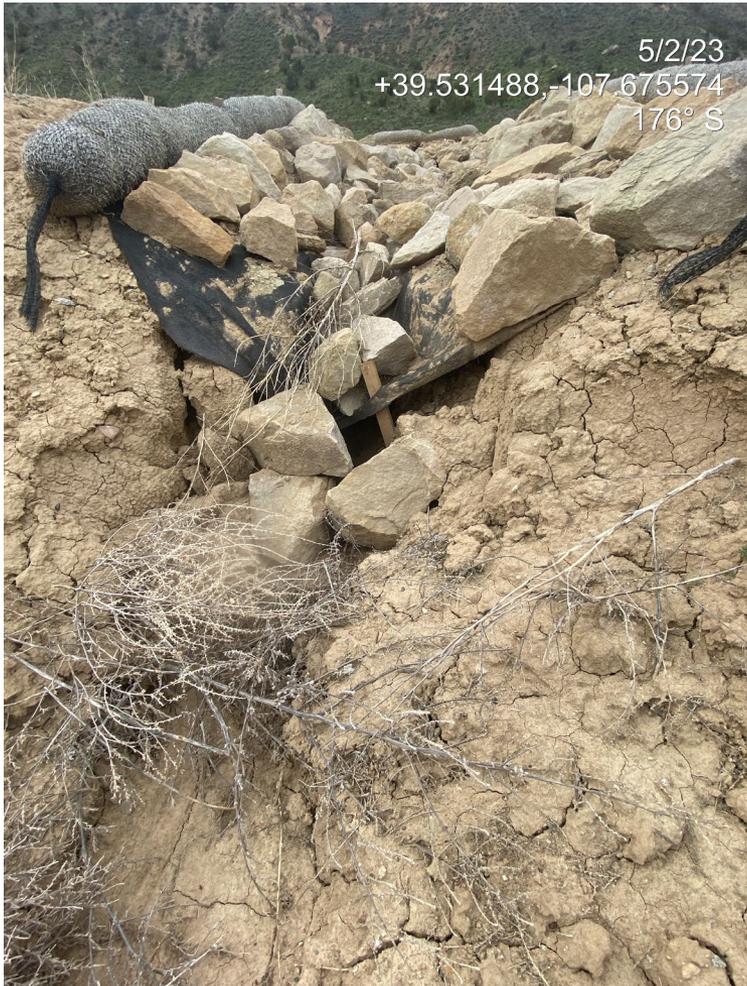
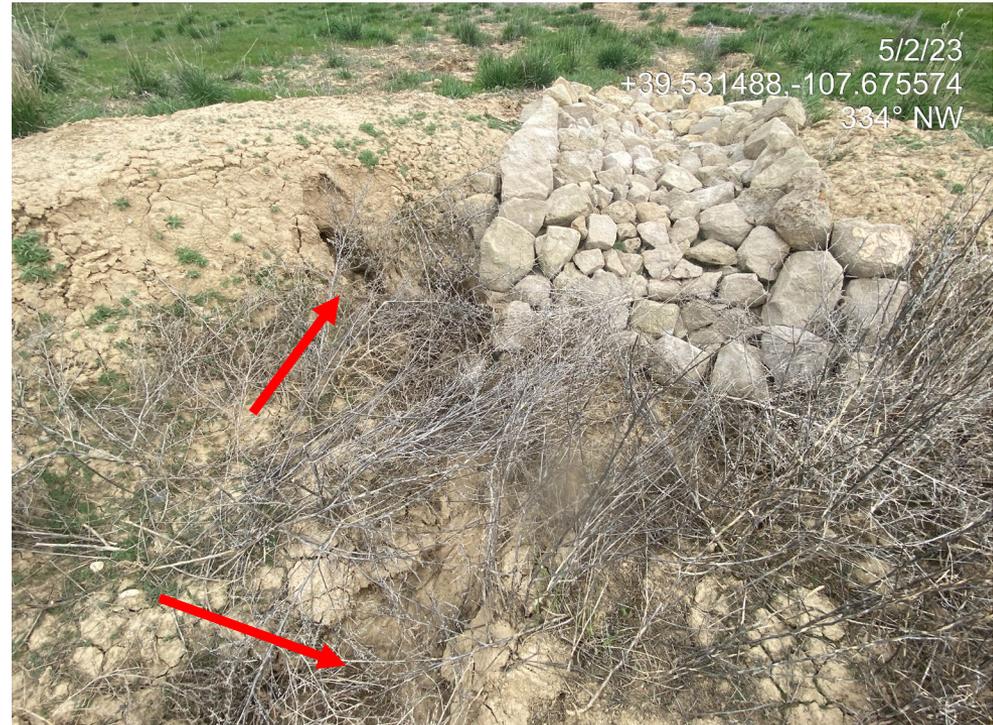
Photo 16. Photos show erosion degradation at stormwater BMPs in the northern interim area of the location. Stormwater is eroding the sediment trap at the inlet, (left) base and walls/outlet (right).
