Inspection Photos

May 2, 2023

Location Name: McPherson A Pad

Inspection Document #: 702801490

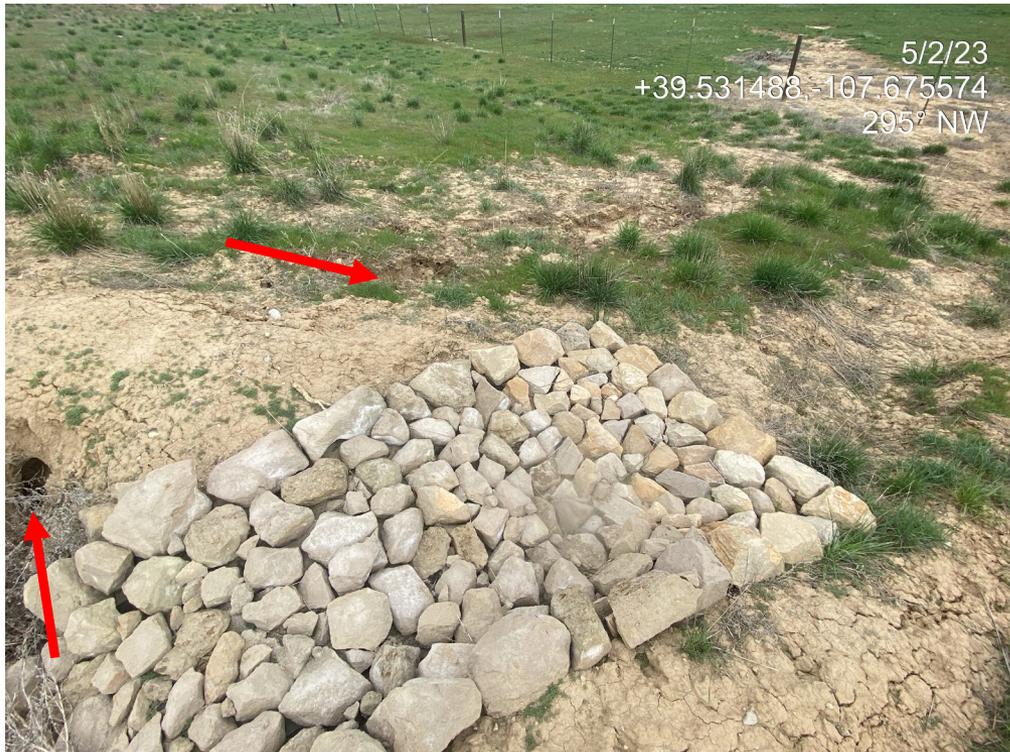
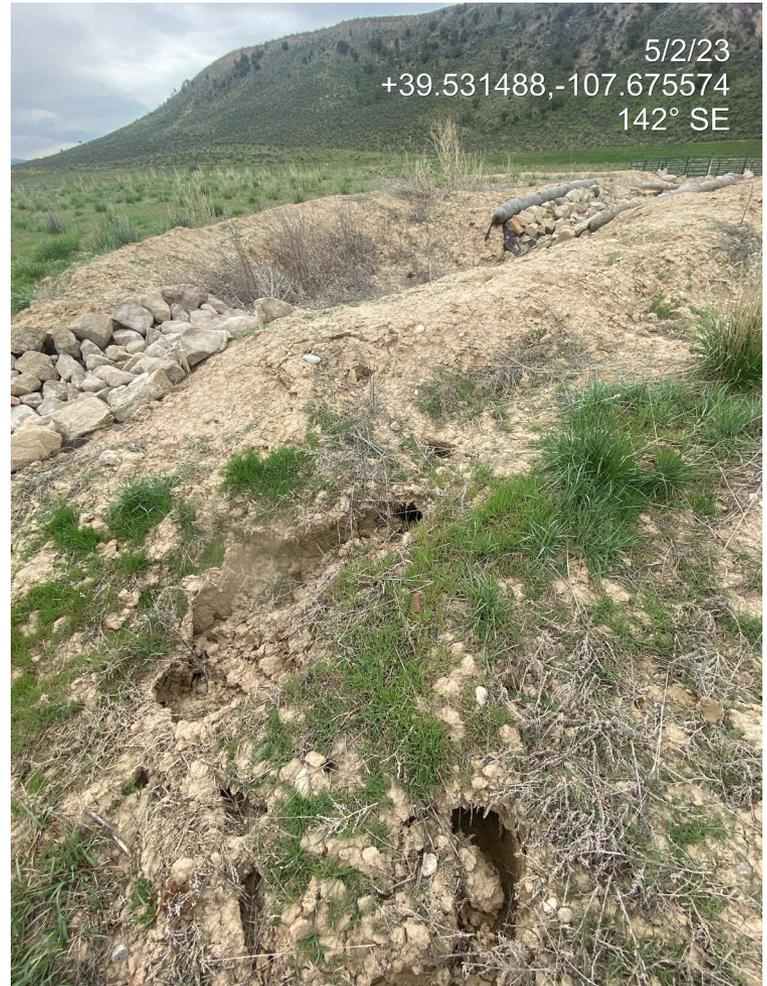
Photo 17. Photos show BMPs in the northern interim area of the location are not in proper functioning condition. Stormwater is bypassing the sediment trap outlet causing degradation.

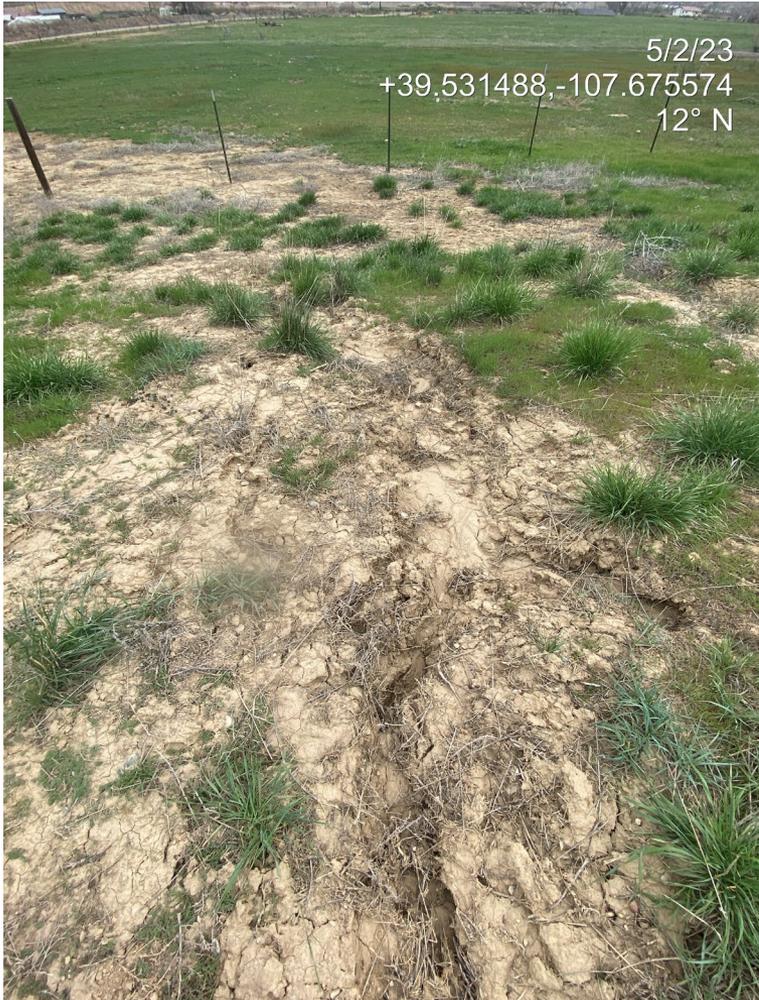
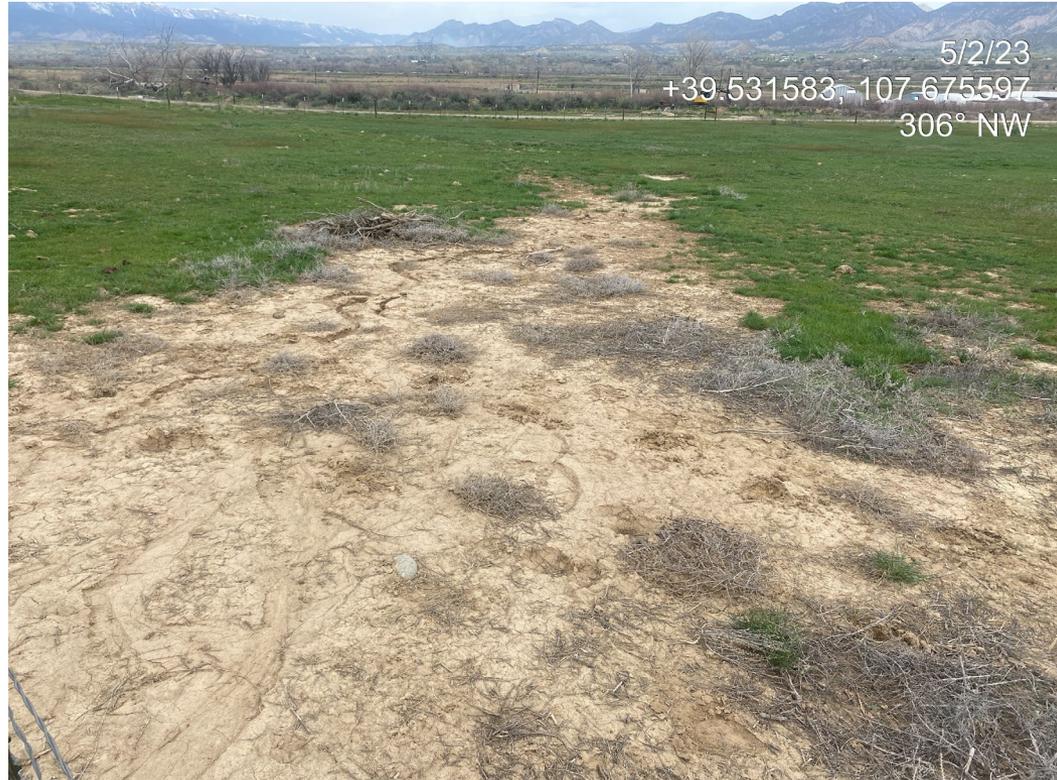
Photo 18. Photos show erosion and sediment transport in the northern interim area of the location (left) migrating offsite and causing degradation to the adjacent pasture (right).

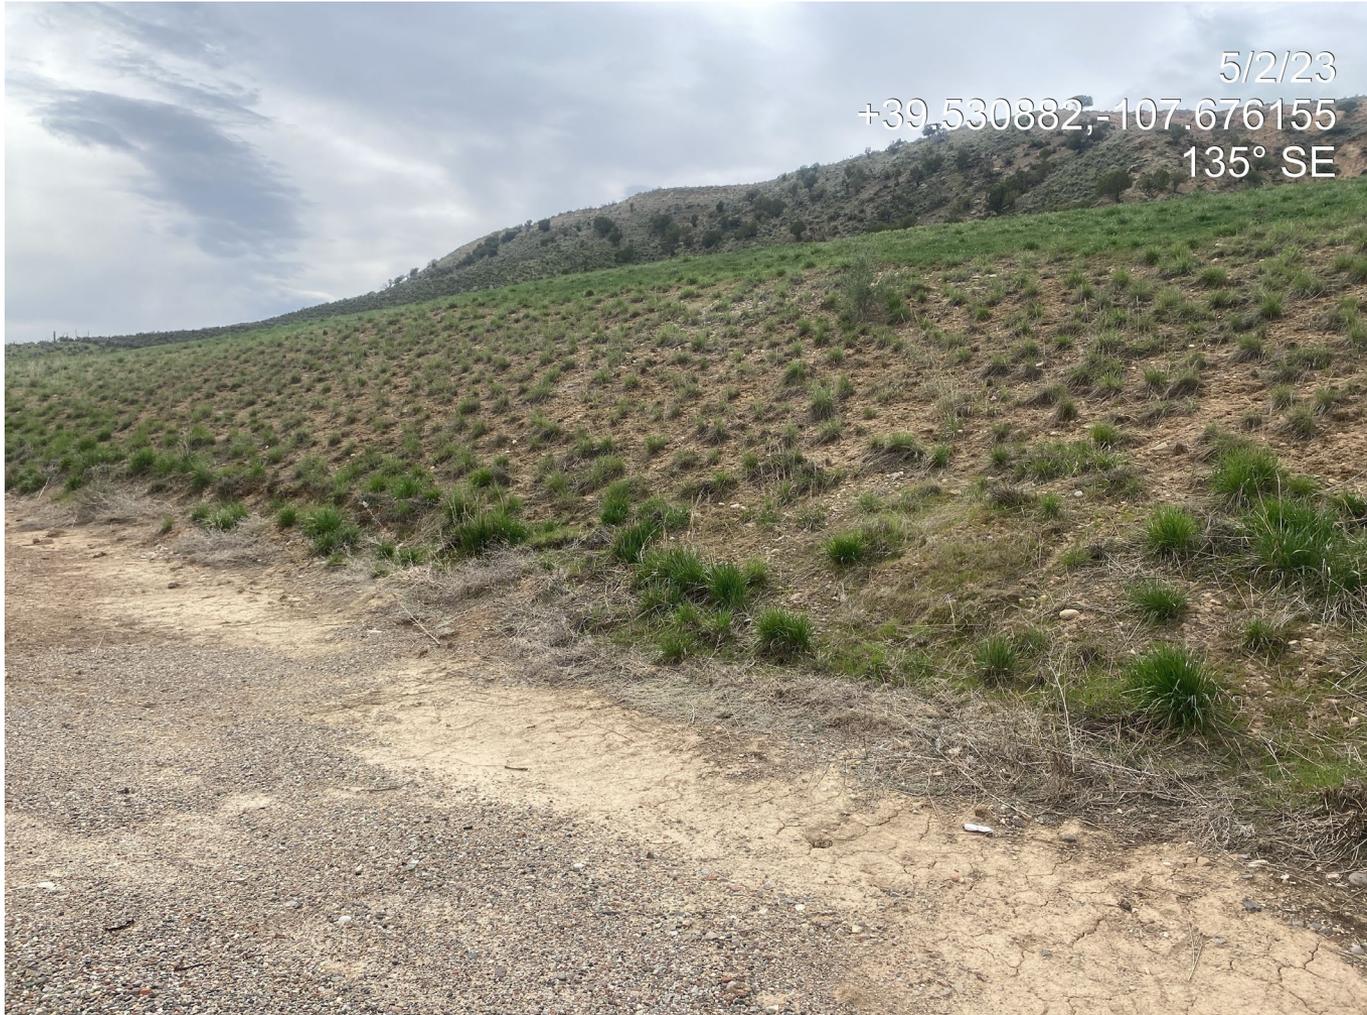
Photo 19. Photo shows a slope to the south stabilized by perennial grasses.

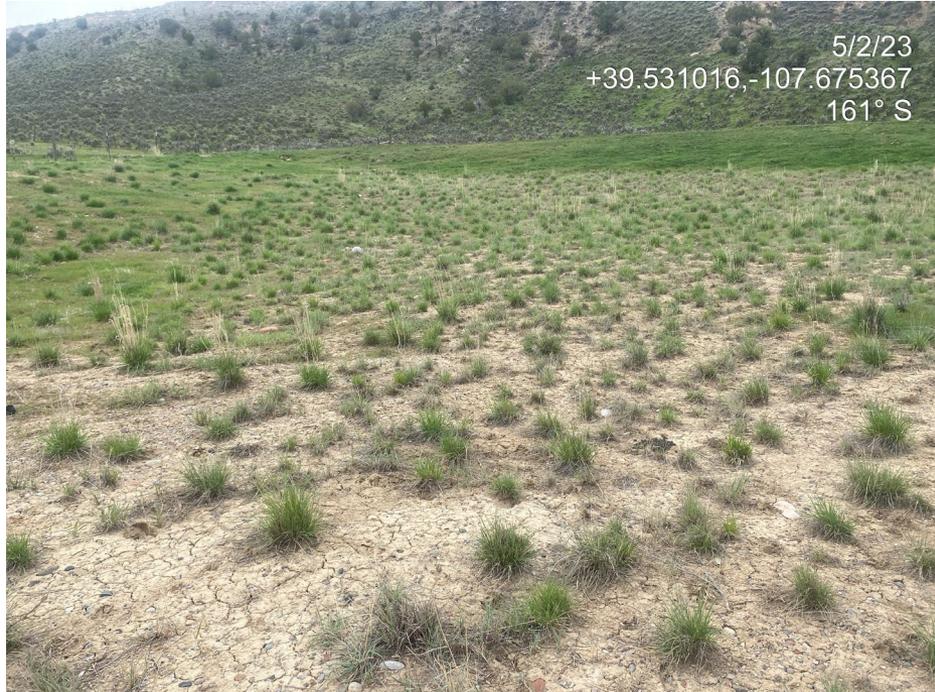
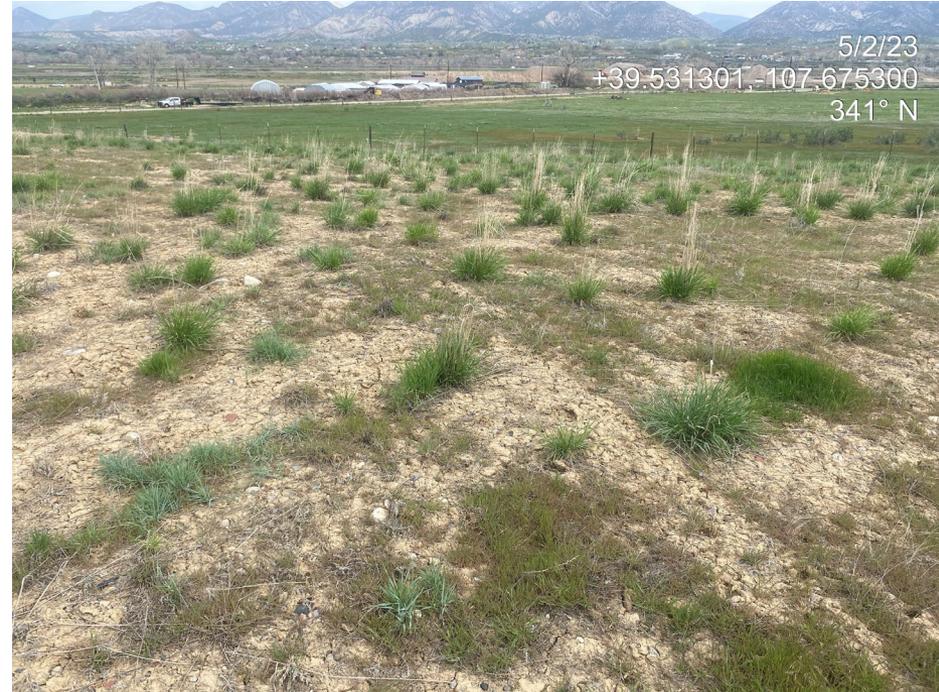
Photo 20. Photos show an example of interim areas to the south (left) and north (right).
