# Inspection Photos

API: 009-06047

Operator: DOVER ATWOOD CORPORATION

Inspection Date: 5/3/2023

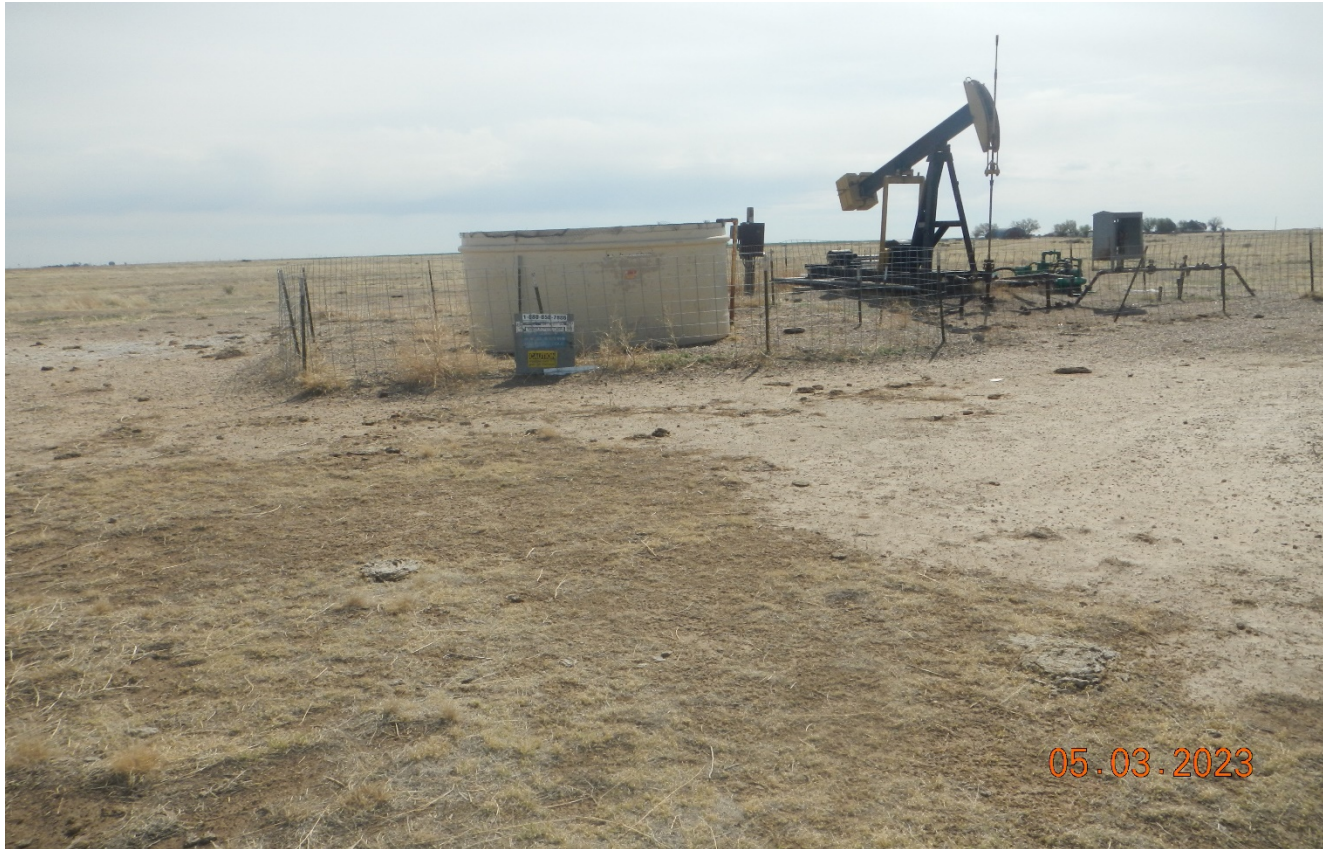
**Photo 1.** Facing toward the wellsite. The well sign does not comply with 605. Incorrect Operator Emergency number and missing information.

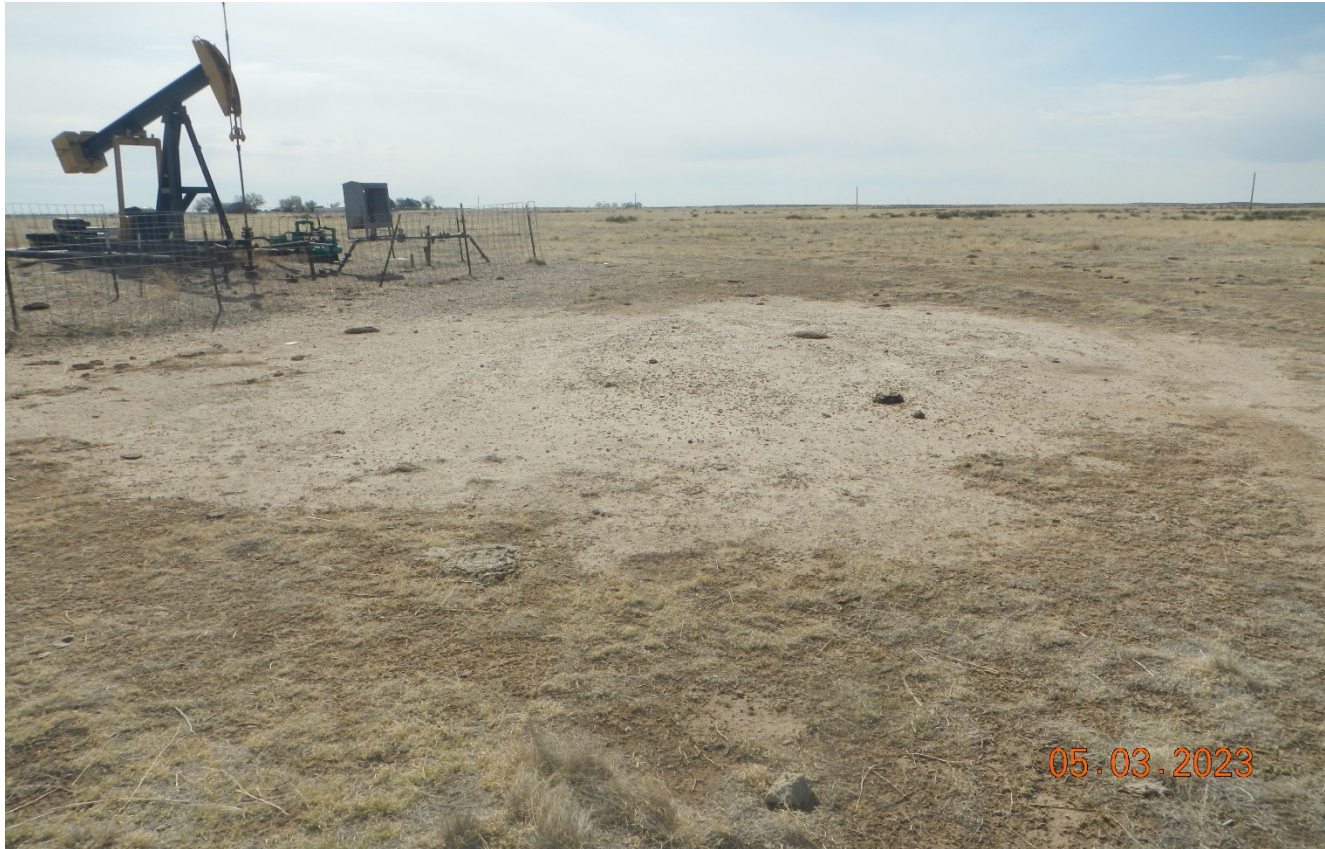
**Photo 2.** Facing southeast at the location. This area is bare of vegetation which maybe impacted soils from a historic spill.

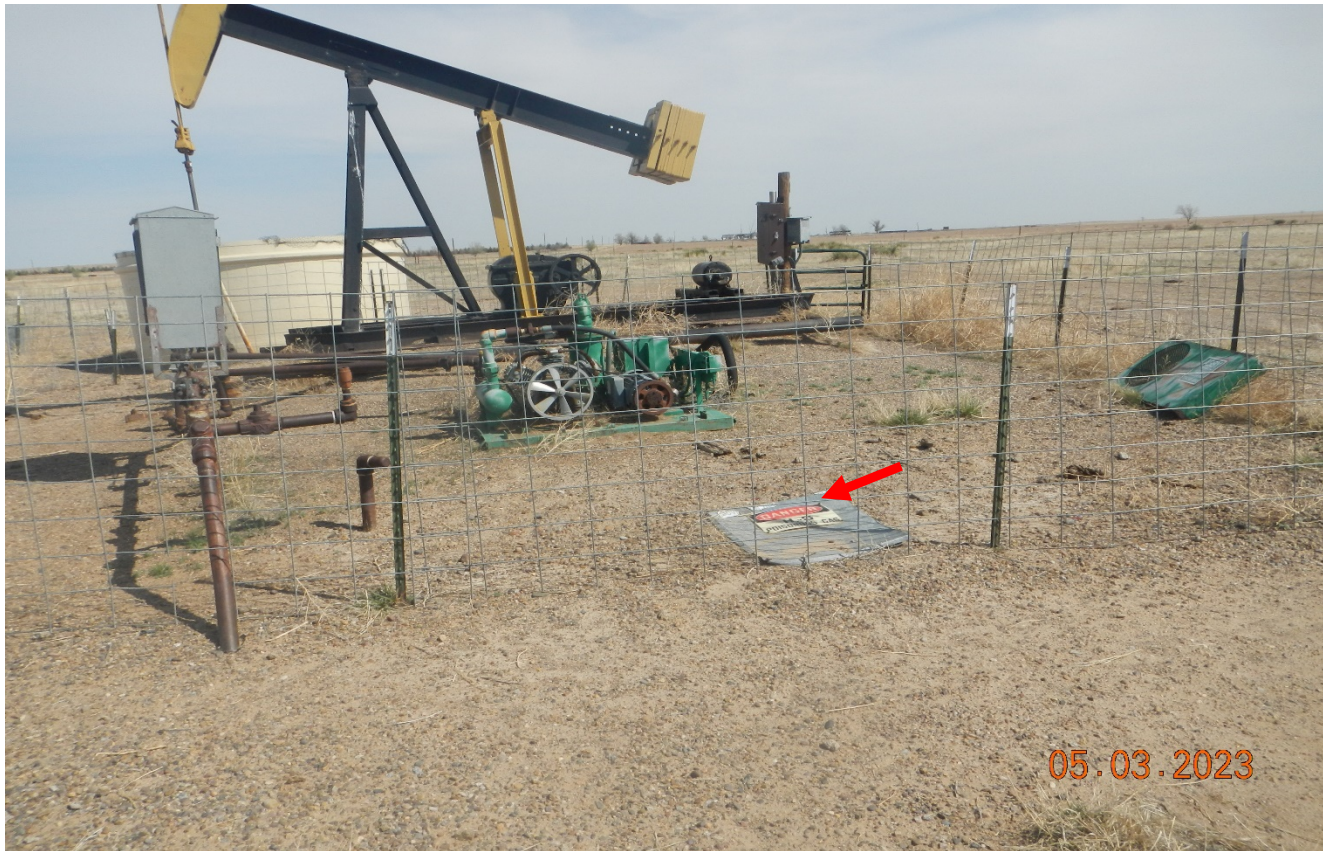
**Photo 3.** Facing toward the pumpjack. The H2S sign is laying on the ground.

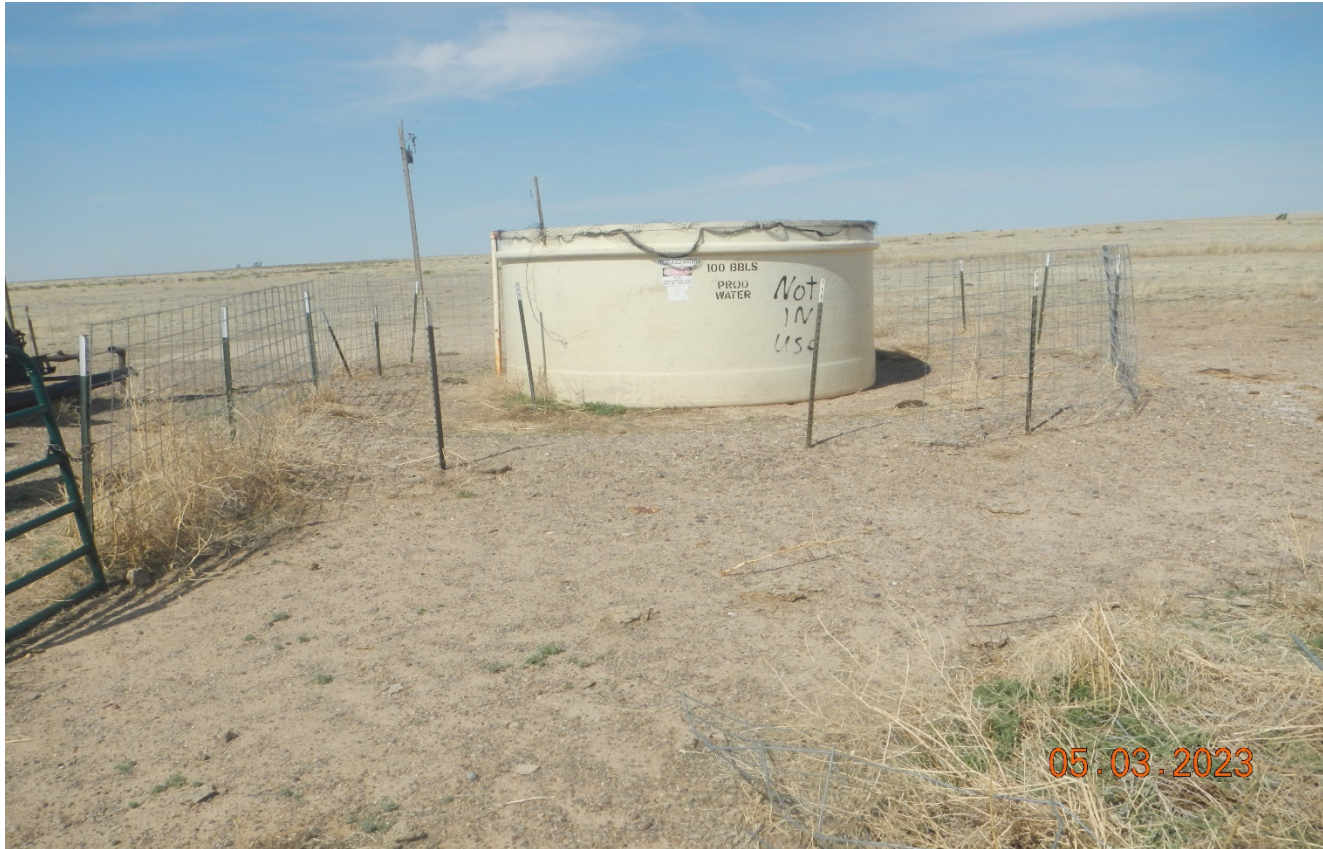
**Photo 4.** Facing toward the open top tank which still does not have secondary containment. The fence around the tank has fallen over in disrepair.

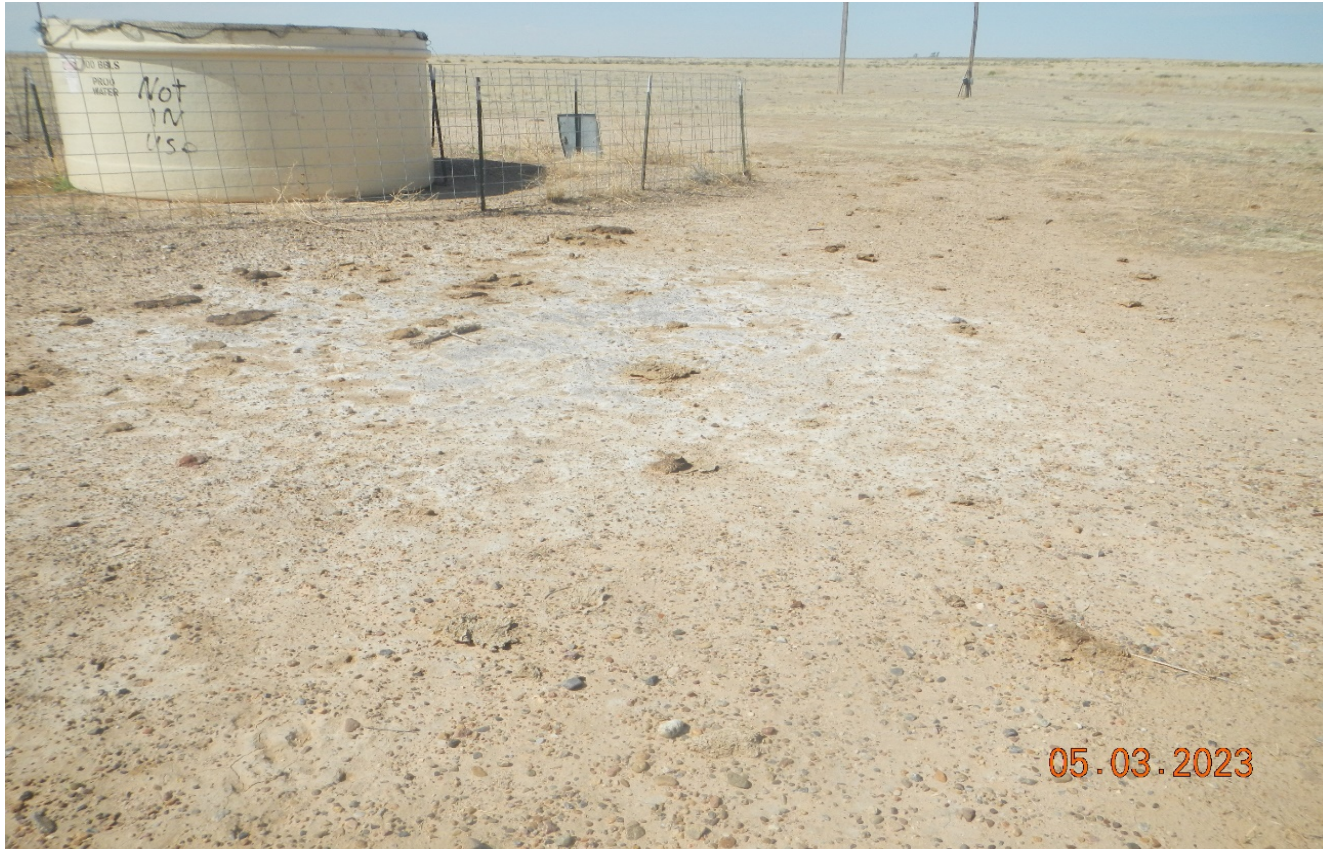
**Photo 5.** This area near the tank at northeast side of the location is bare of vegetation and has a white crusted soil which maybe impacted soils from a historic spill.
