Inspection Photos

API: 009-06176

Operator: DOVER ATWOOD CORPORATION

Inspection Date: 5/3/2023

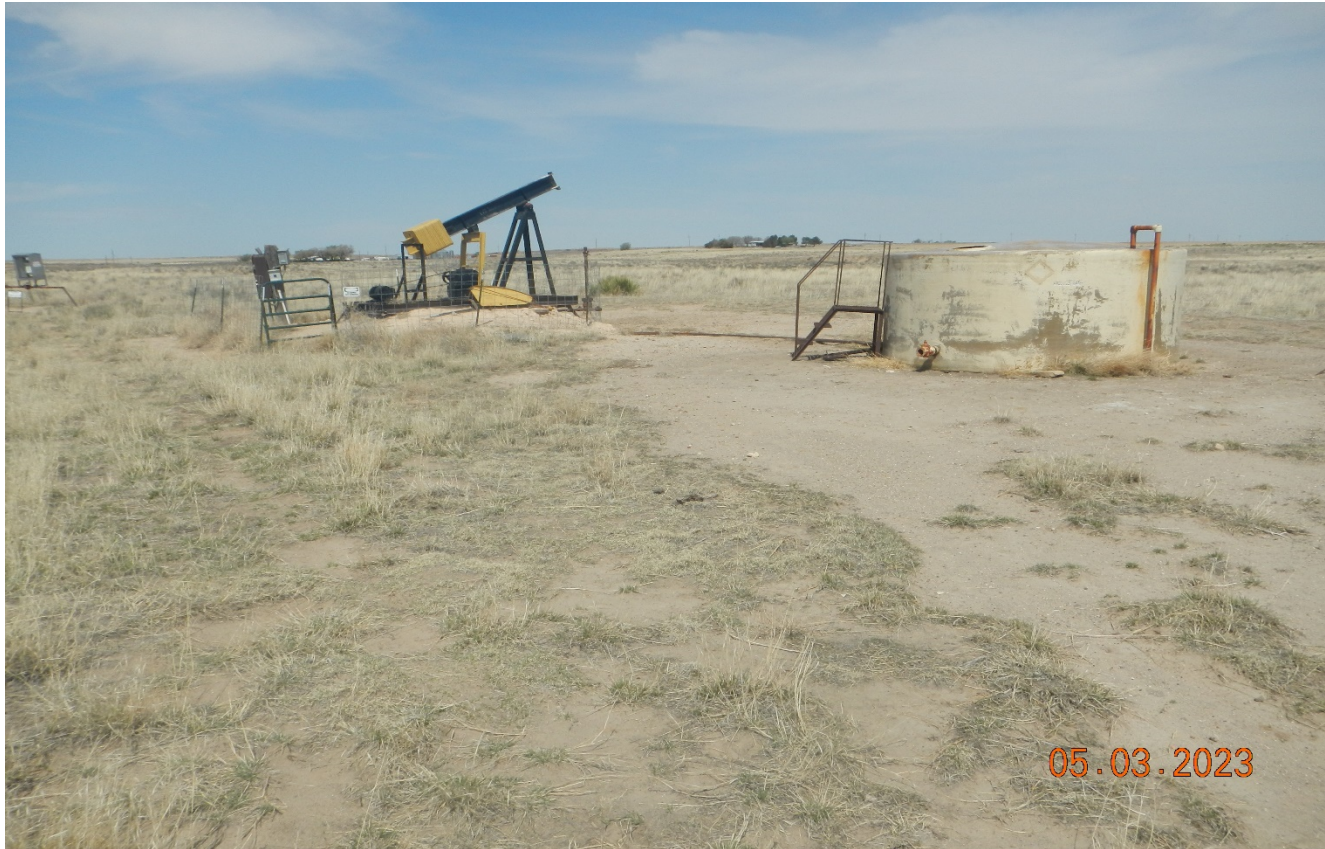
Photo 1. Facing toward the wellsite. There is no well sign posted.

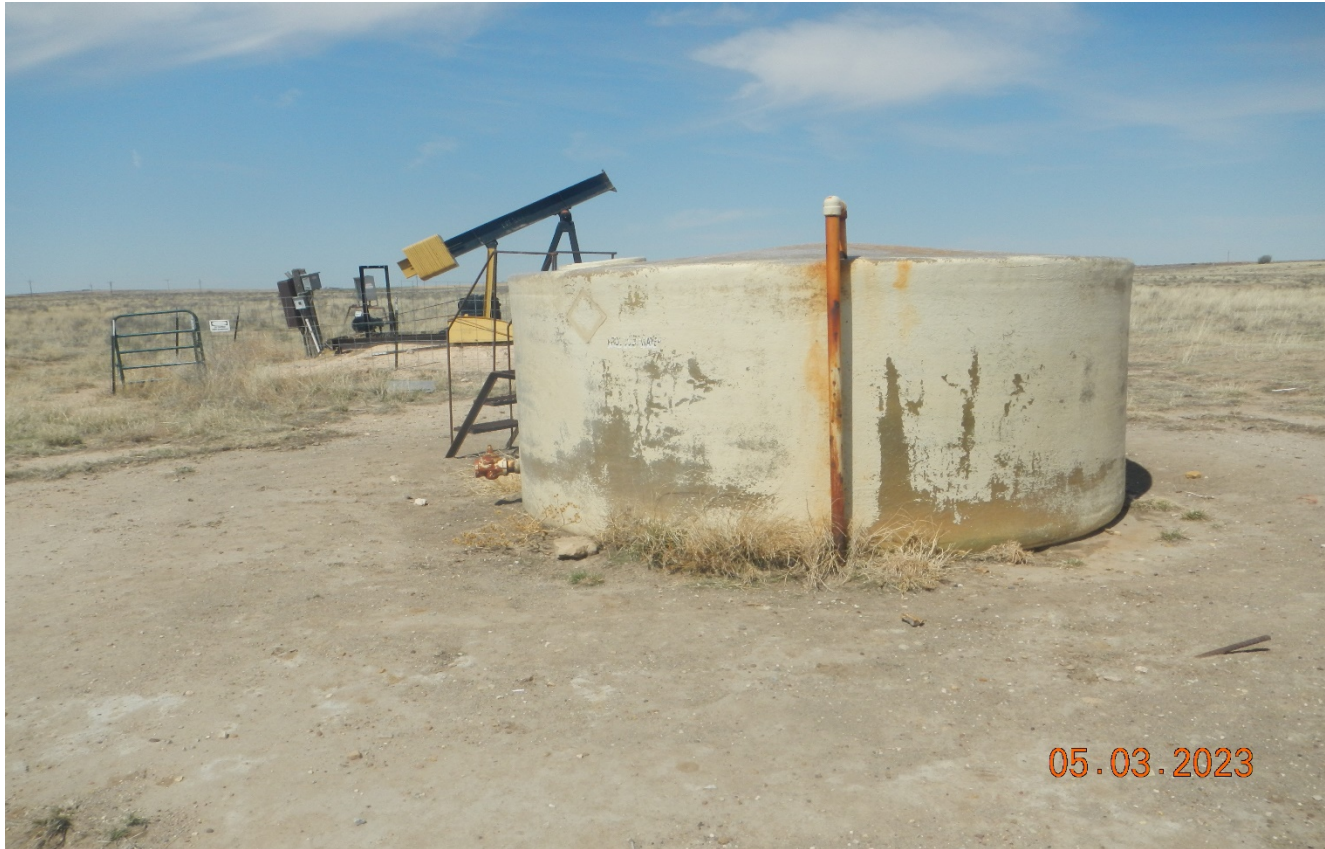
Photo 2. Facing toward the open top tank which still does not have secondary containment and does not have signage.

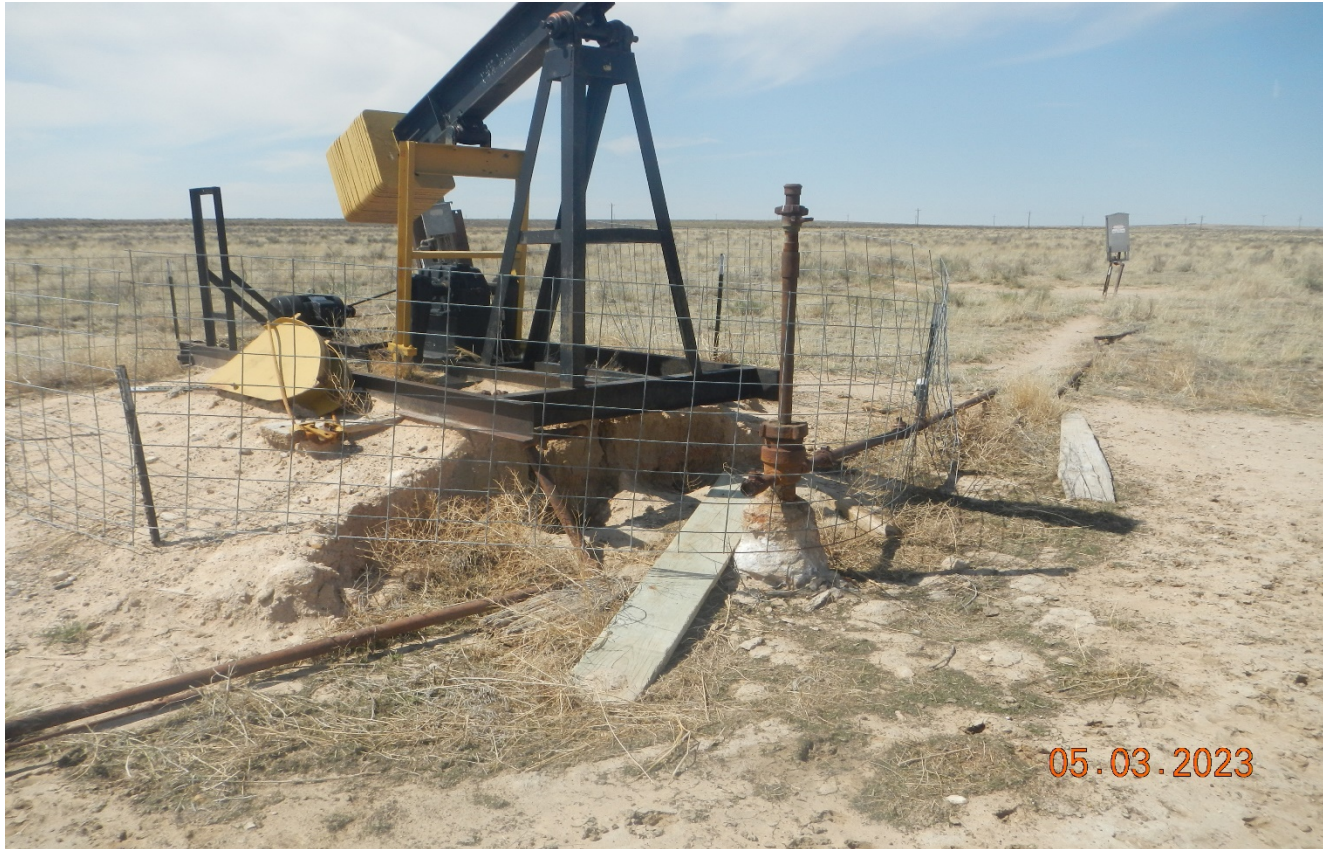
Photo 3. Facing toward the well head which appears inoperable. The base of the pumpjack has eroded and there are boards and debris around wellhead.

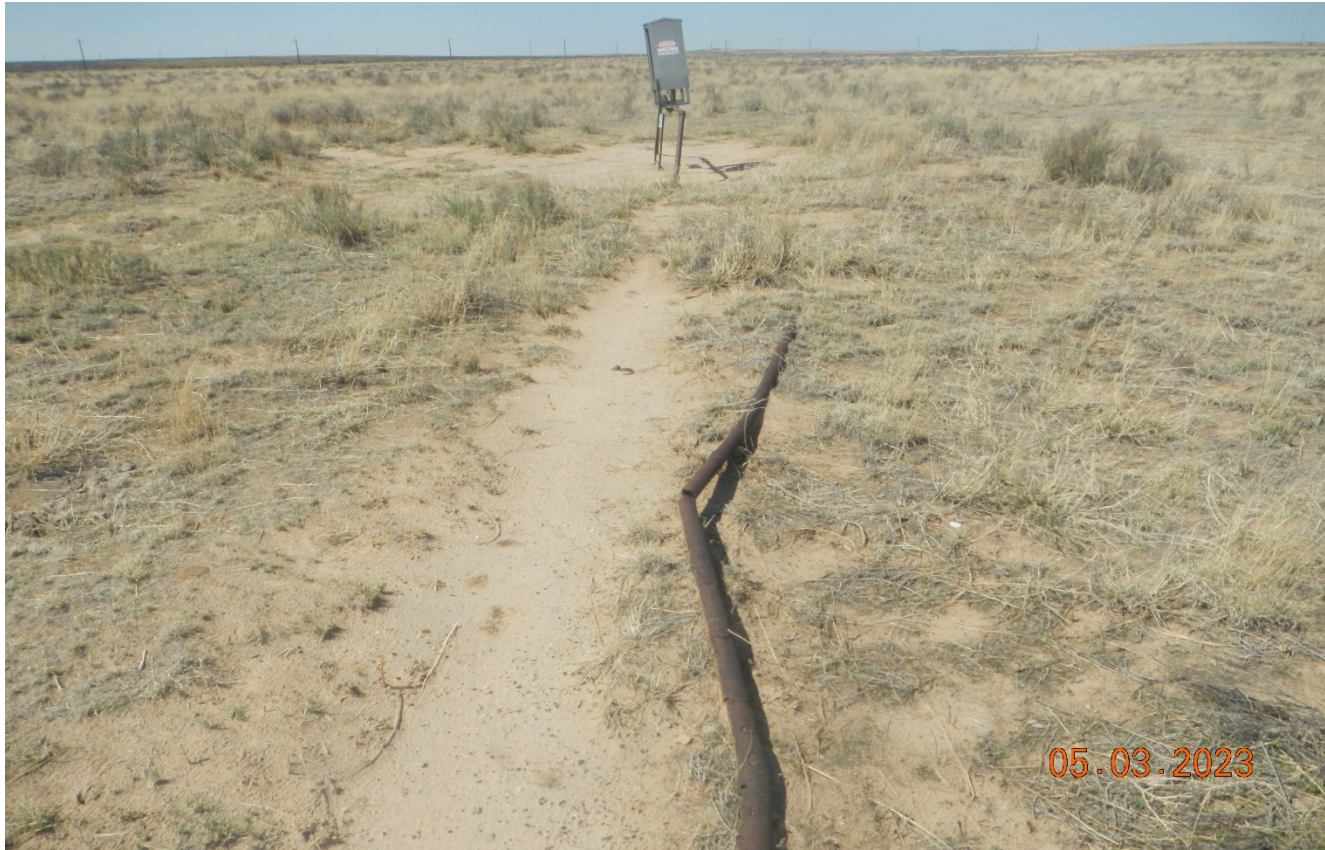
Photo 4. There is a rusted out pipe that needs to be removed.

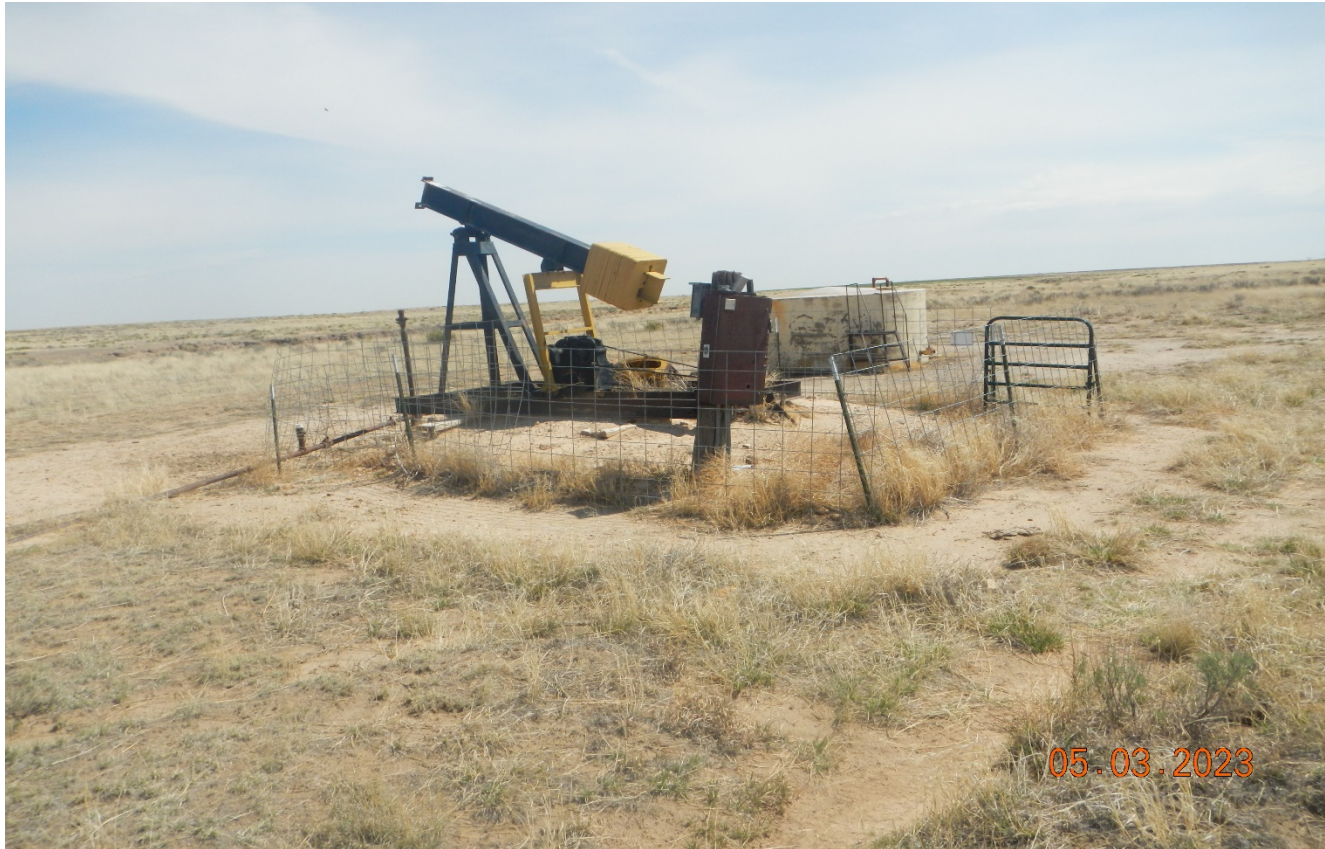
Photo 5. Facing northeast toward the wellsite.
