Inspection Photos

API: 009-05101

Operator: CHACO ENERGY COMPANY

Inspection Date: 5/3/2023

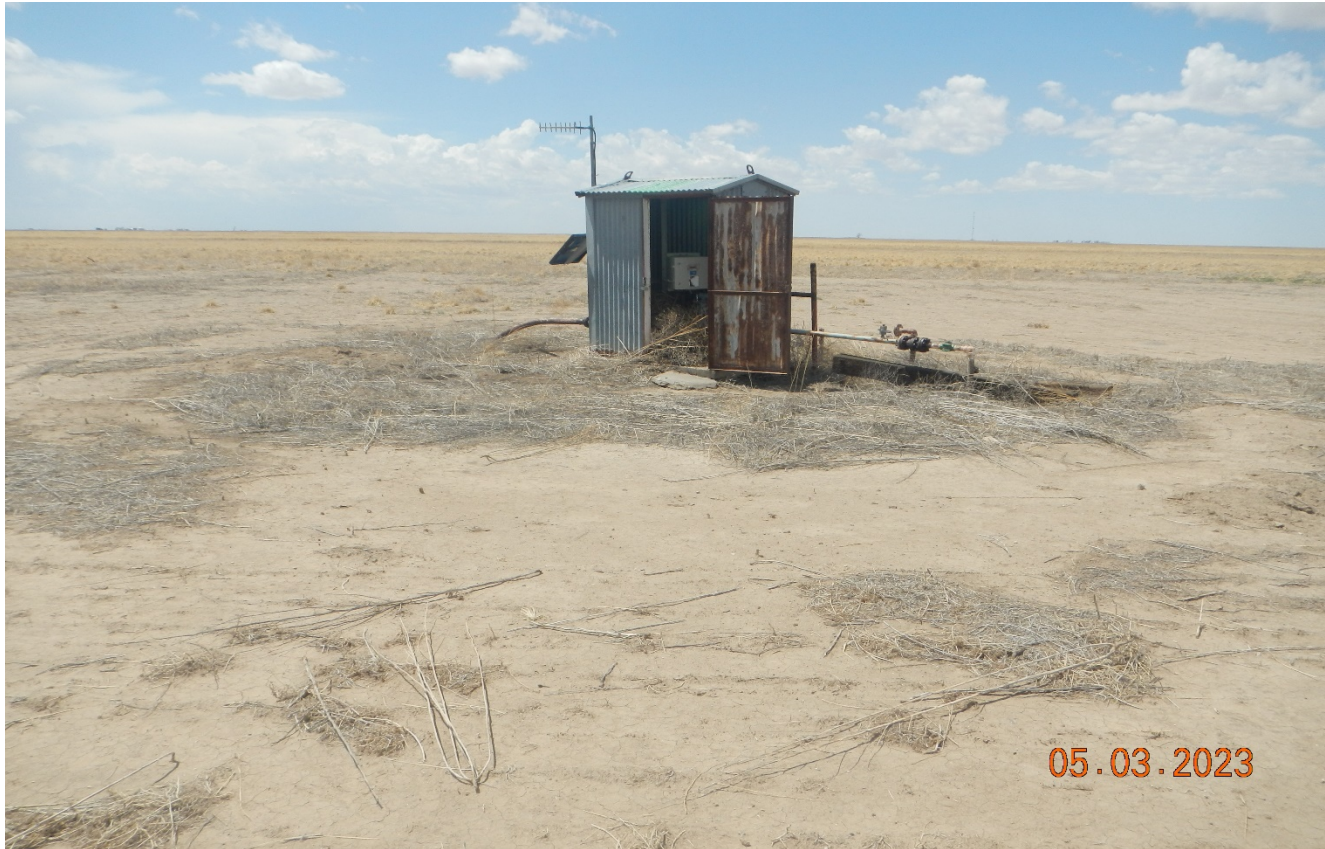
Photo 1. The meter run still remains at the location. All equipment should have been removed within 3 months of abandonment.

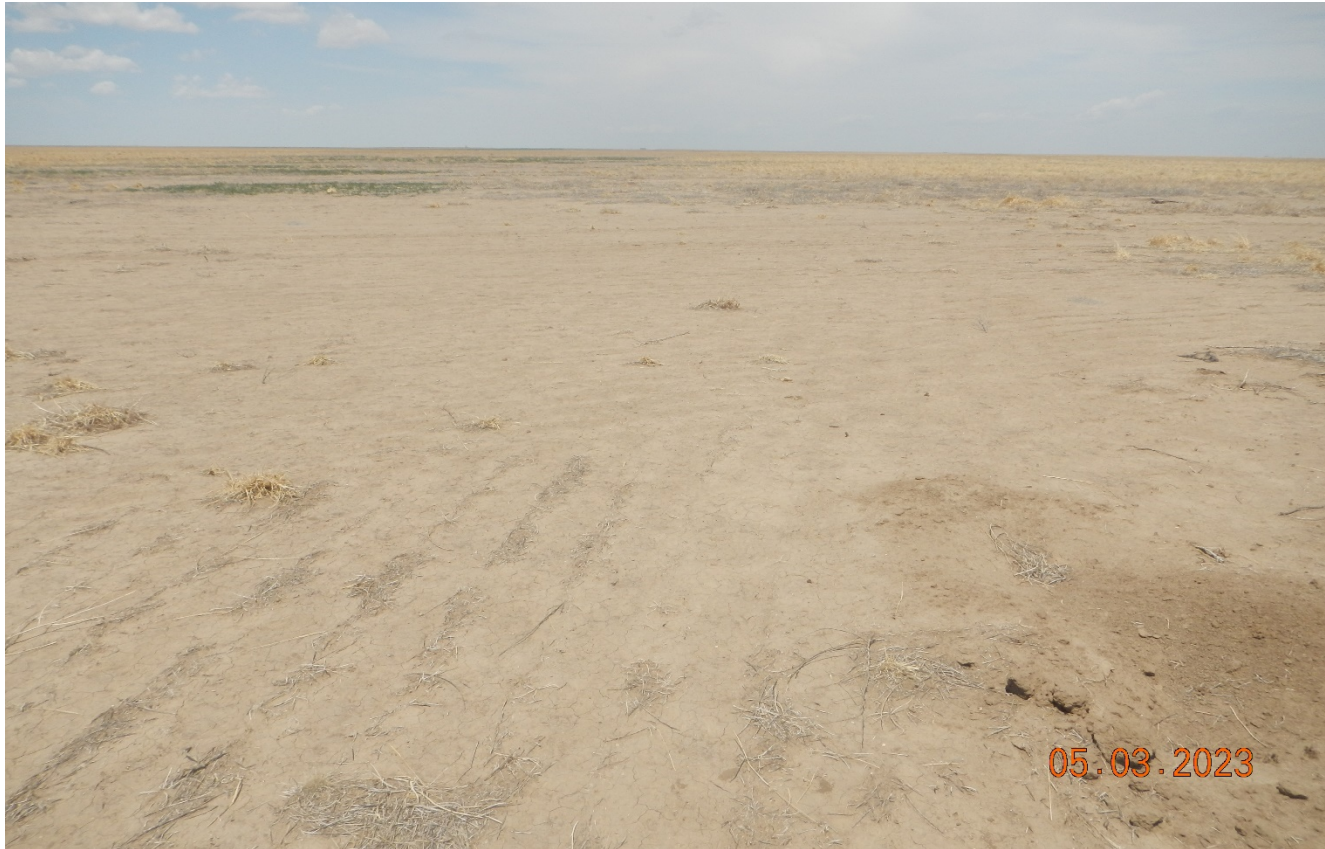
Photo 2. Facing north at the location which does not appear to have been reclaimed. Soils are bare of vegetation.

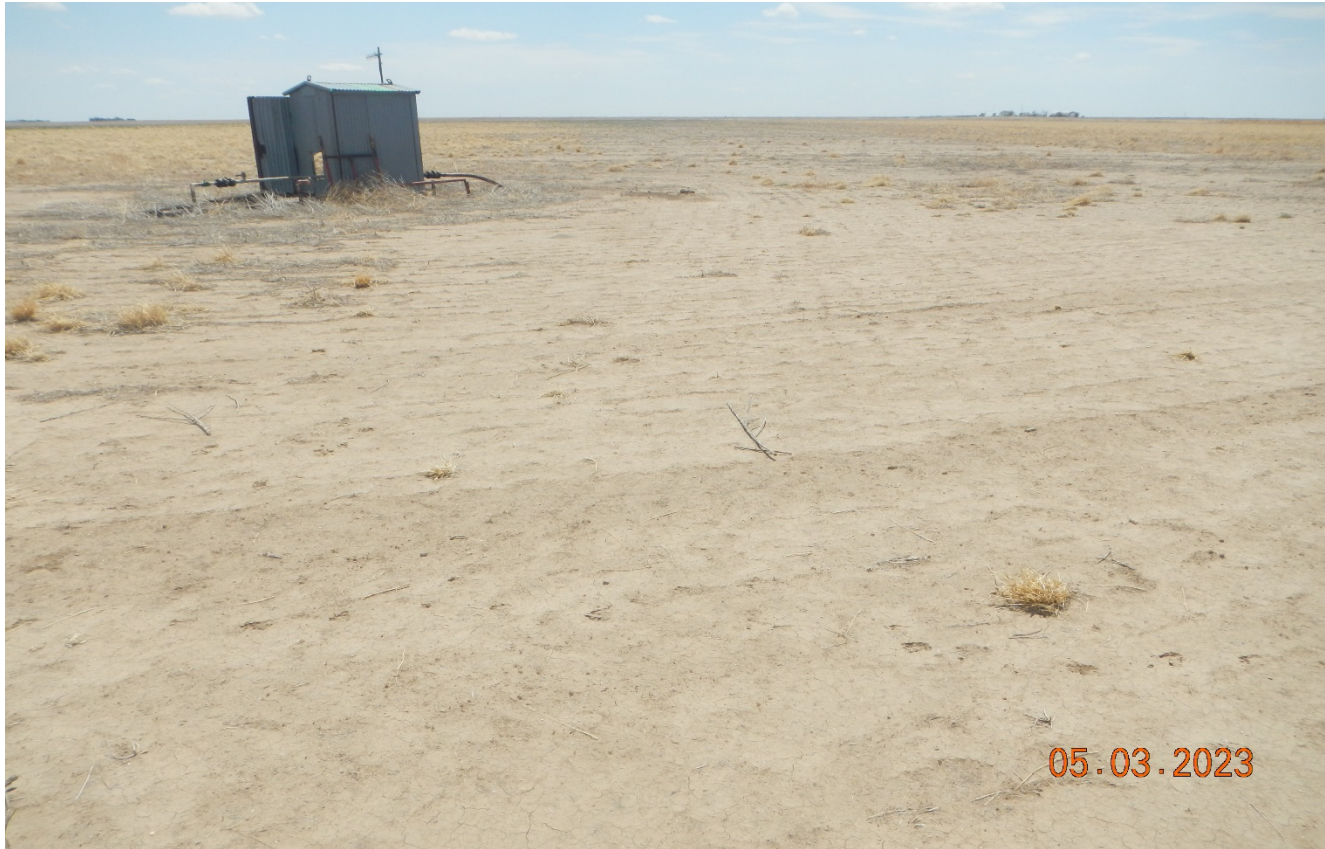
Photo 3. Facing south at the location. Soils are bare of vegetation.

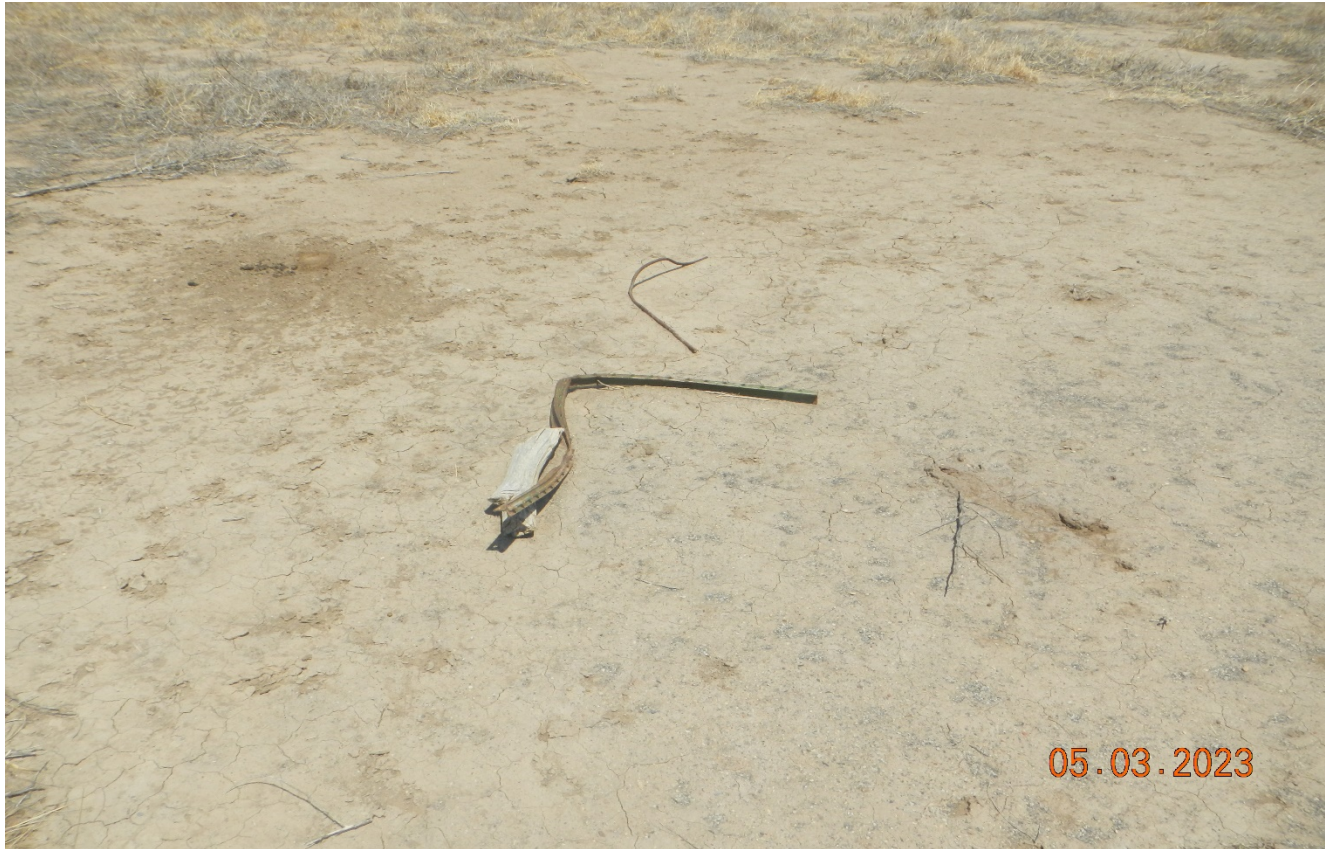
Photo 4. There is metal t-post and wire debris that needs to be removed.
