Inspection Photos
Location Name: CAERUS PICEANCE LLC COUEY J8E Pad
Location ID: 334821

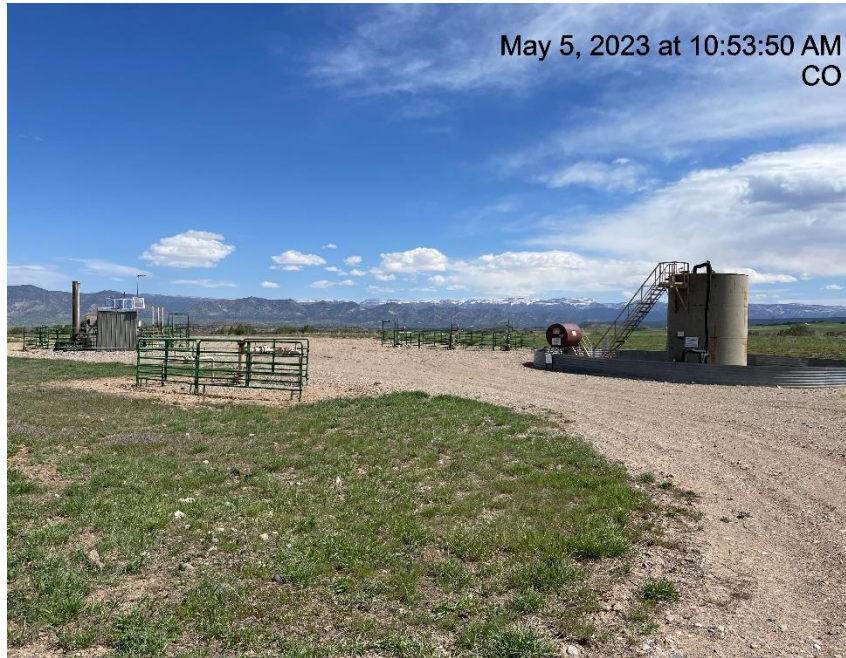
Photo # 7036 From entrance to location

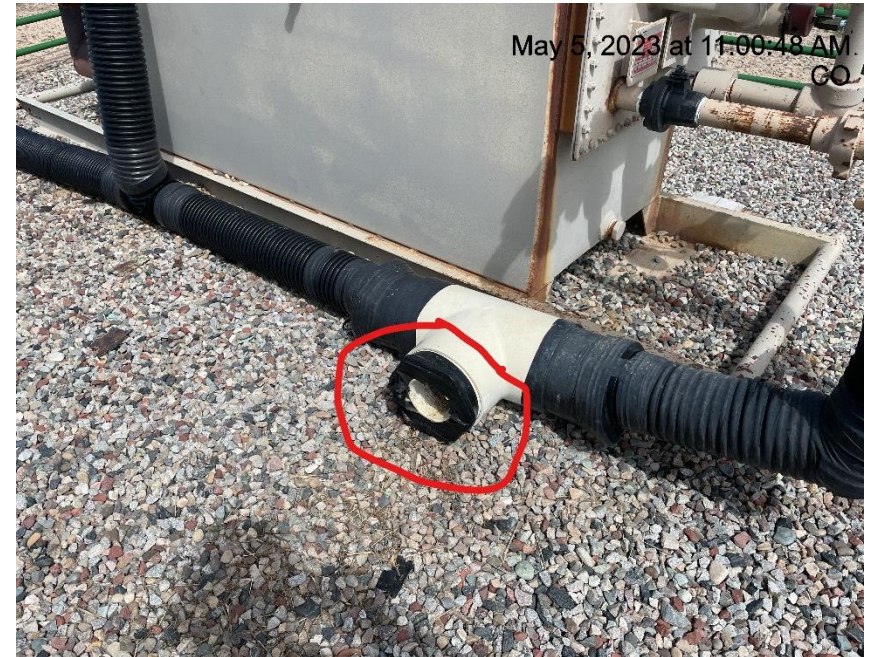
Photo # 7043 Flow line heating insulation open ended/wildlife hazard

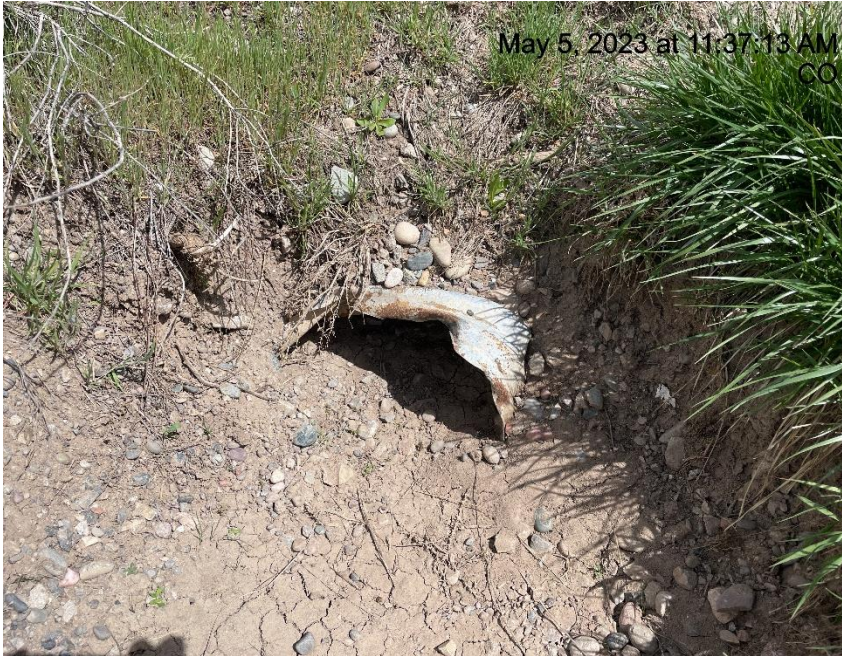
Photo # 7132 Culvert needs maintenance (Culvert is located at the start of the access road right before the gates)
