## Inspection Photos

Location Name: TEP ROCKY MOUNTAIN LLC MV 53-28 /Frac Pad

Location ID: 335327

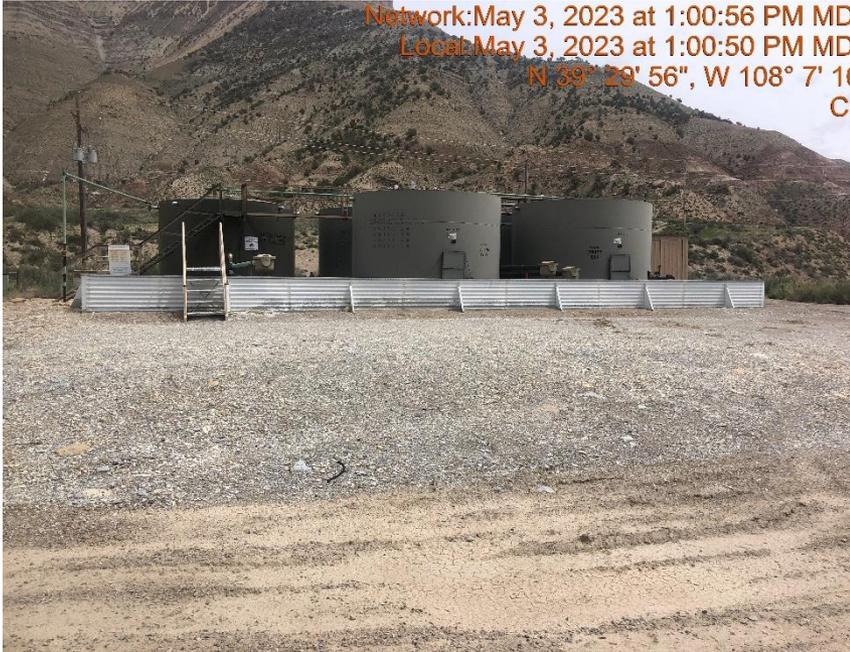
Photo #9867 From entrance to location.

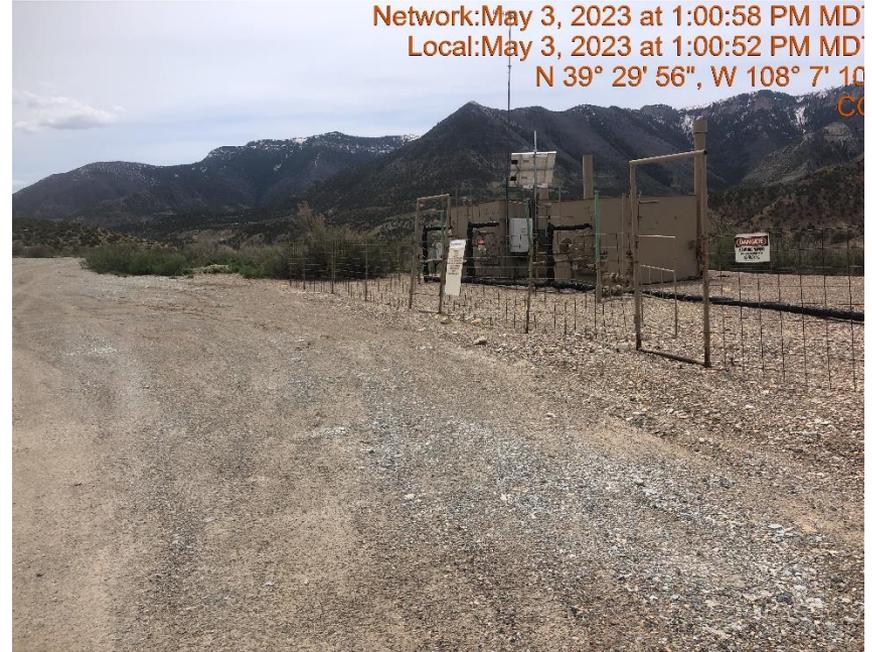
Photo #9868 From entrance to location

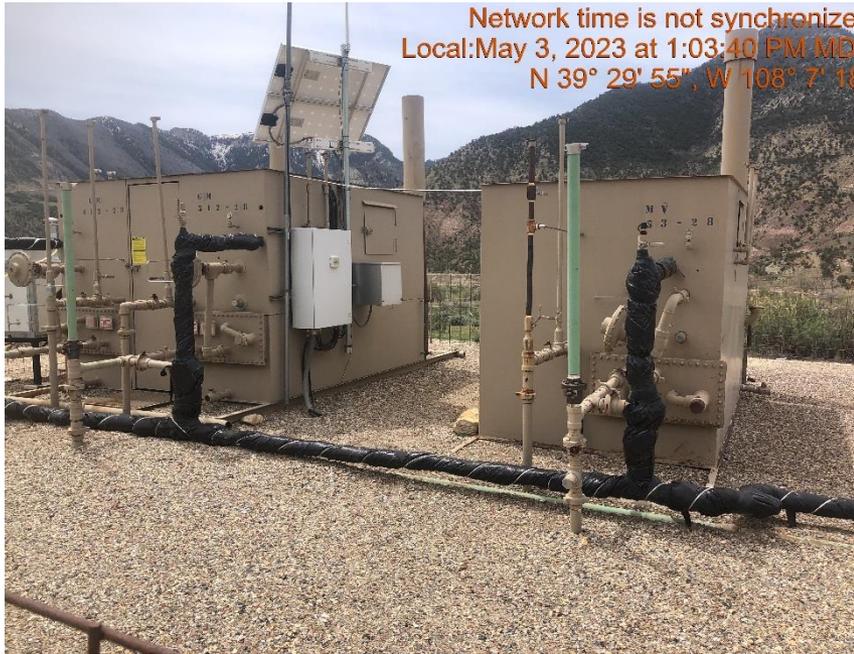
Photo #9870 Calibration cards not conspicuously posted.

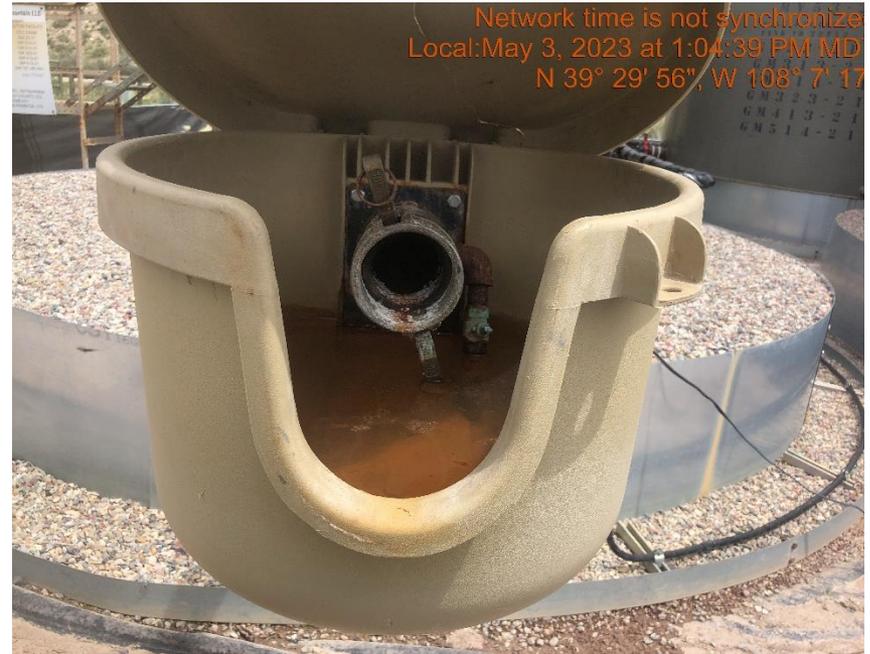
Photo #9872 Loadline open ended.

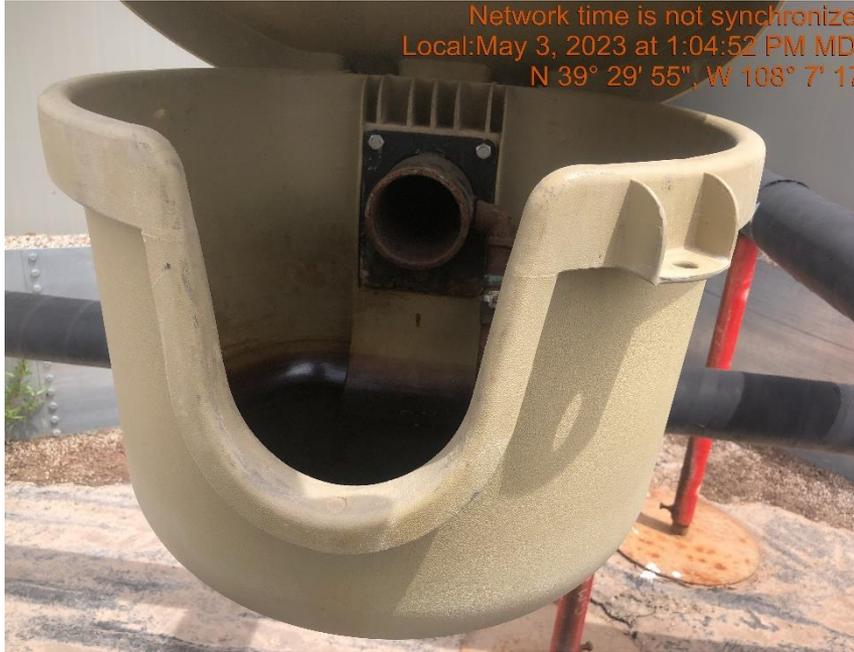
Photo #9873 Loadline open ended.

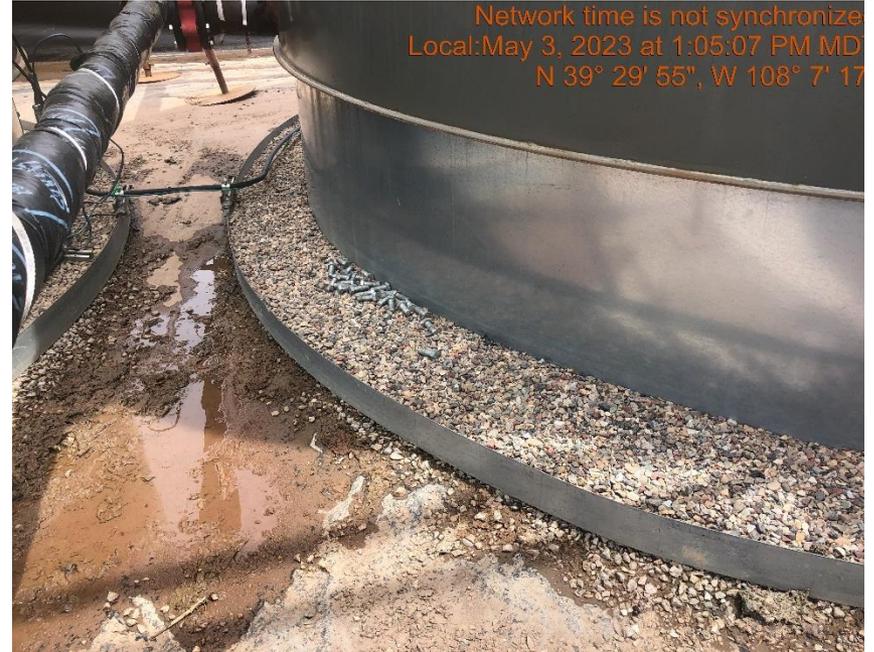
Photo #9874 Unused equipment.

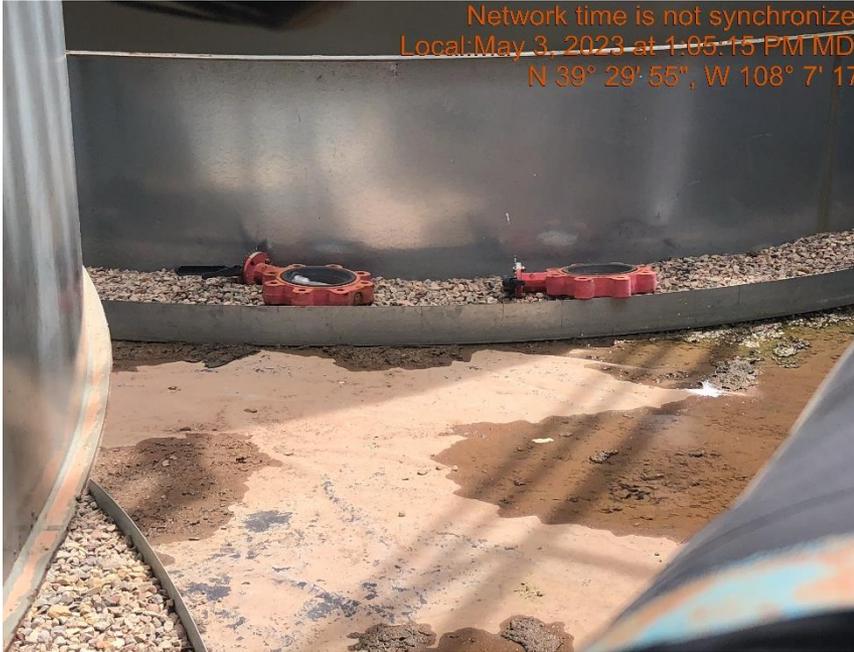
**Photo #9875 Unused equipment.**
