Interim Reclamation and Stormwater Inspection

Operator: FUNDARE RESOURCES OPERATING
COMPANY LLC - 10773

Location ID: 430314

Inspection Photos
Location Name: Razor 30K Pad
Location ID: 430314

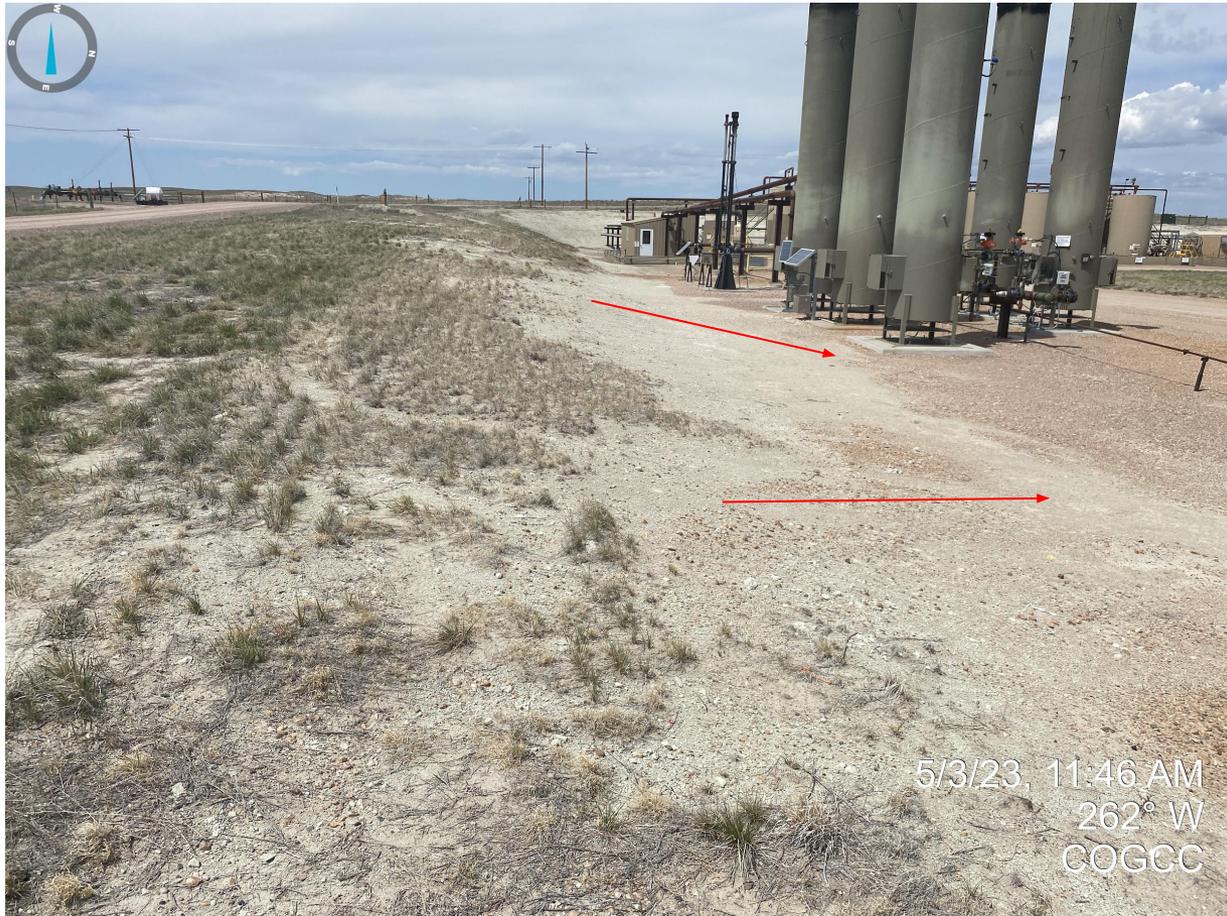
Photo 1. Southern portion of the production area. Photo illustrates that the cut slopes do not appear to be properly stabilized with non-uniform vegetation cover and evidence of sediment deposition into the production area. No apparent stormwater BMPs were observed to be implemented in these unstabilized areas.

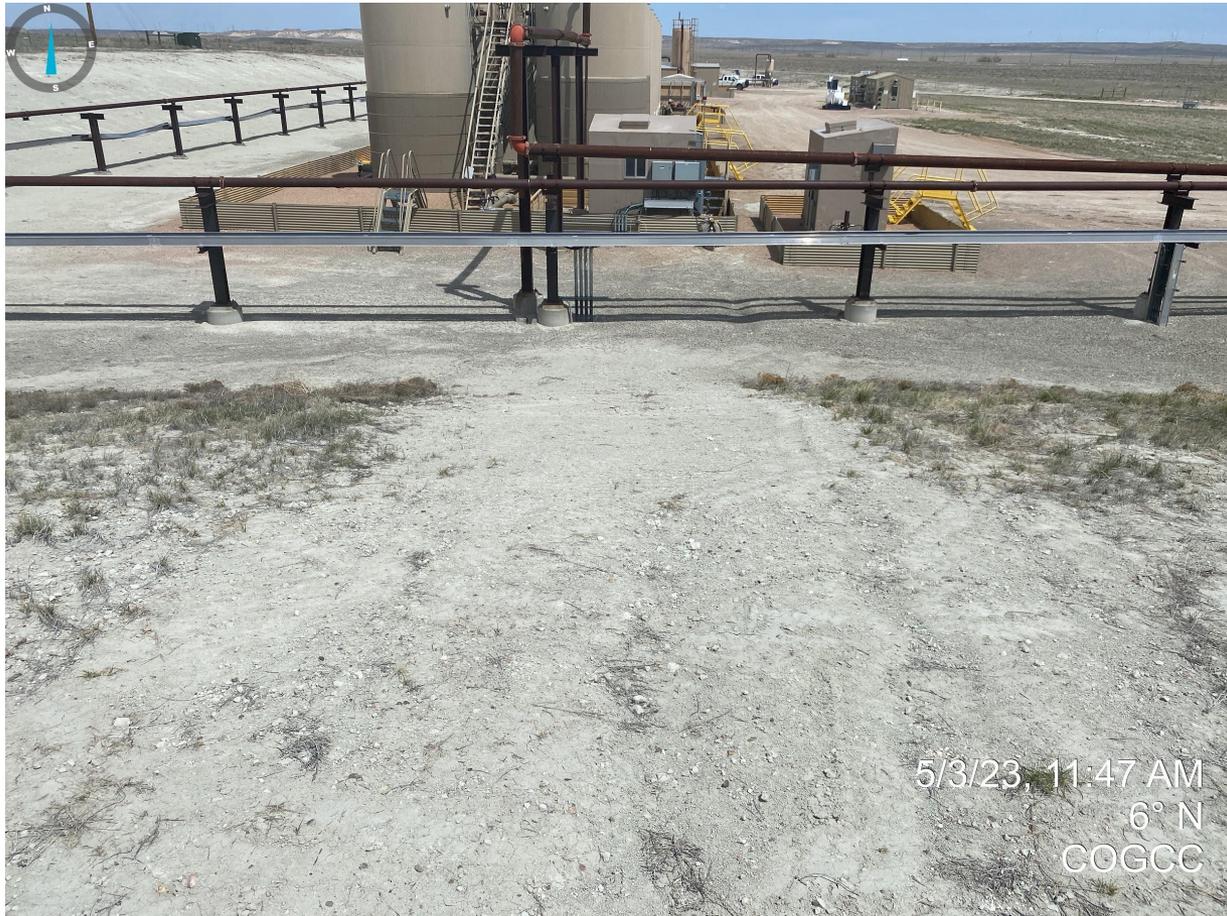
Photo 2. See comments in Photo 1.

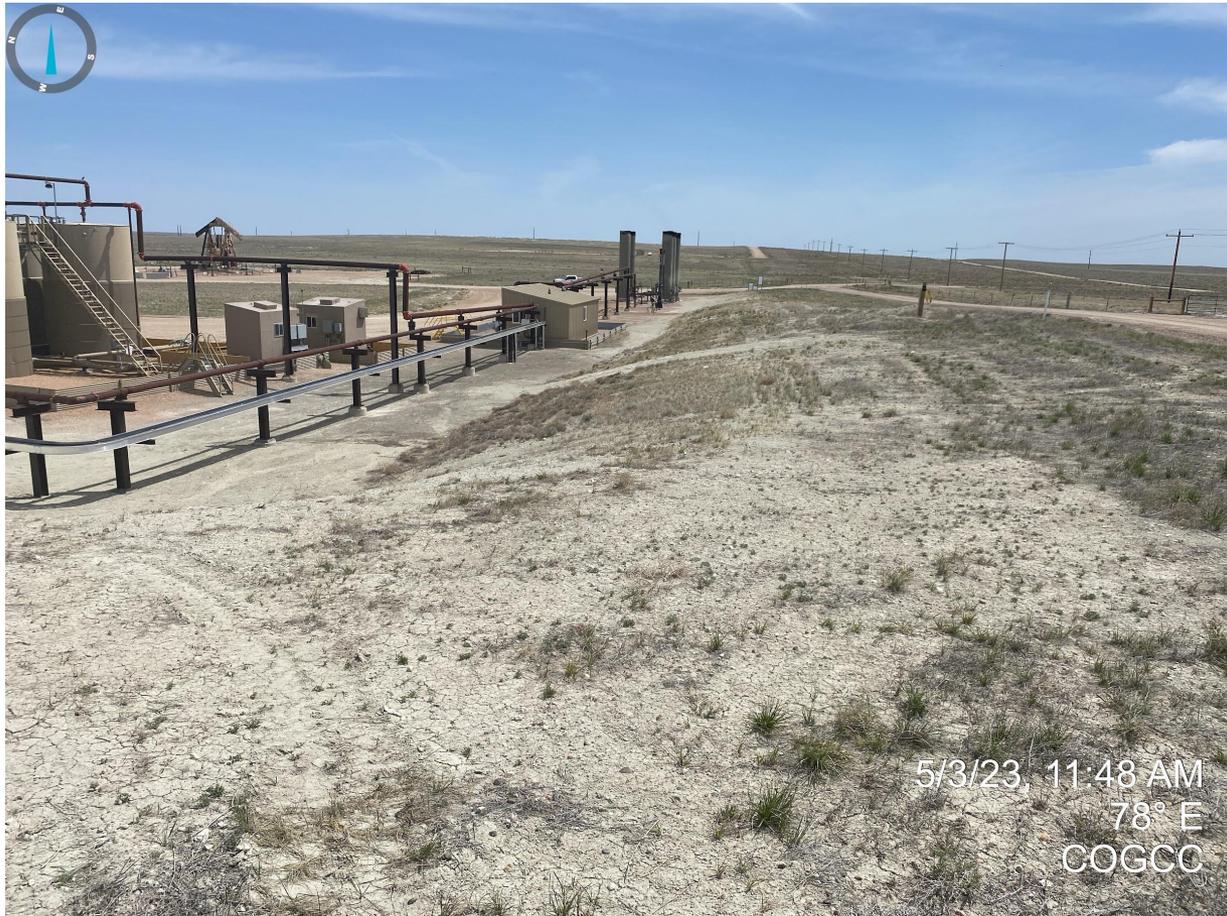
Photo 3. Facing east from the southwestern corner of the location; see comments in Photo 1.

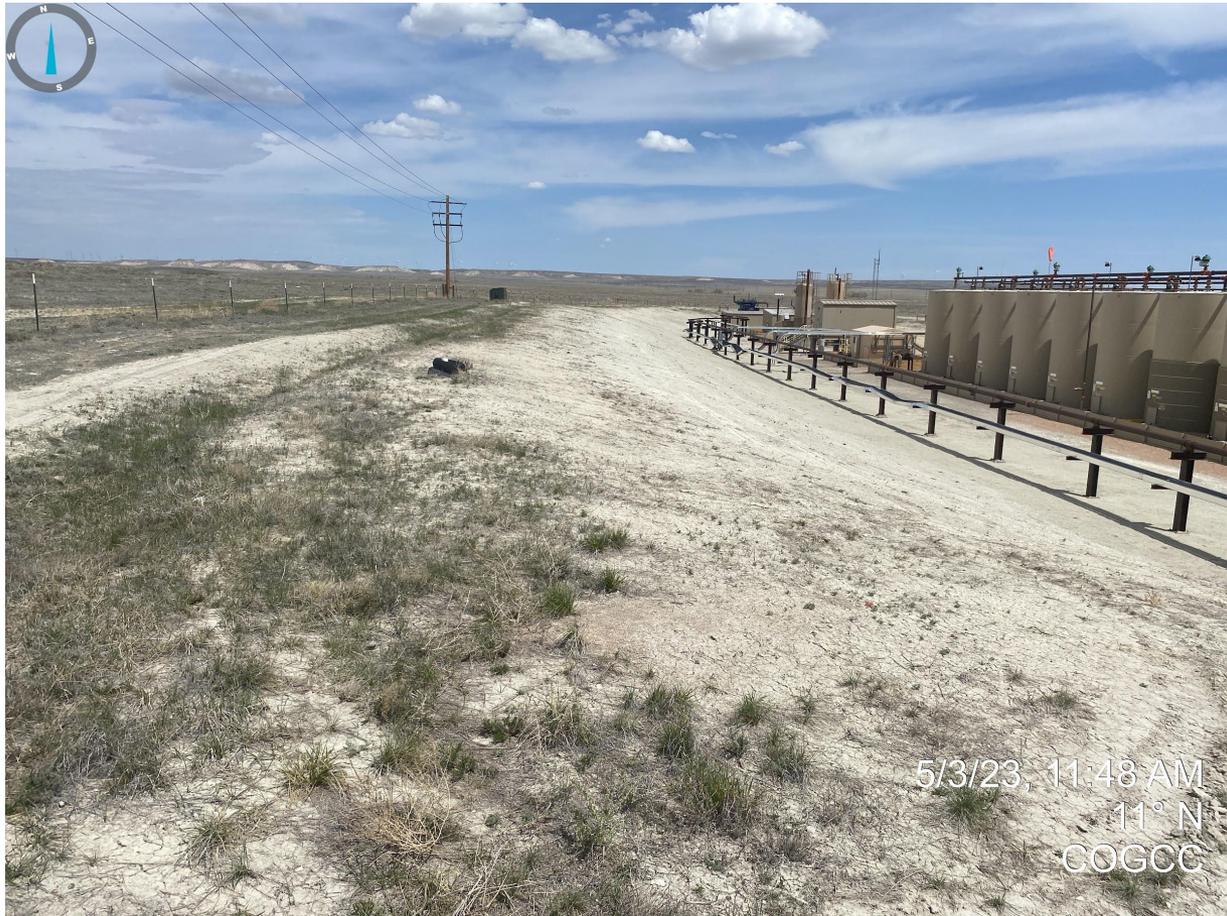
Photo 4. Western portion of the location; see comments in Photo 1.

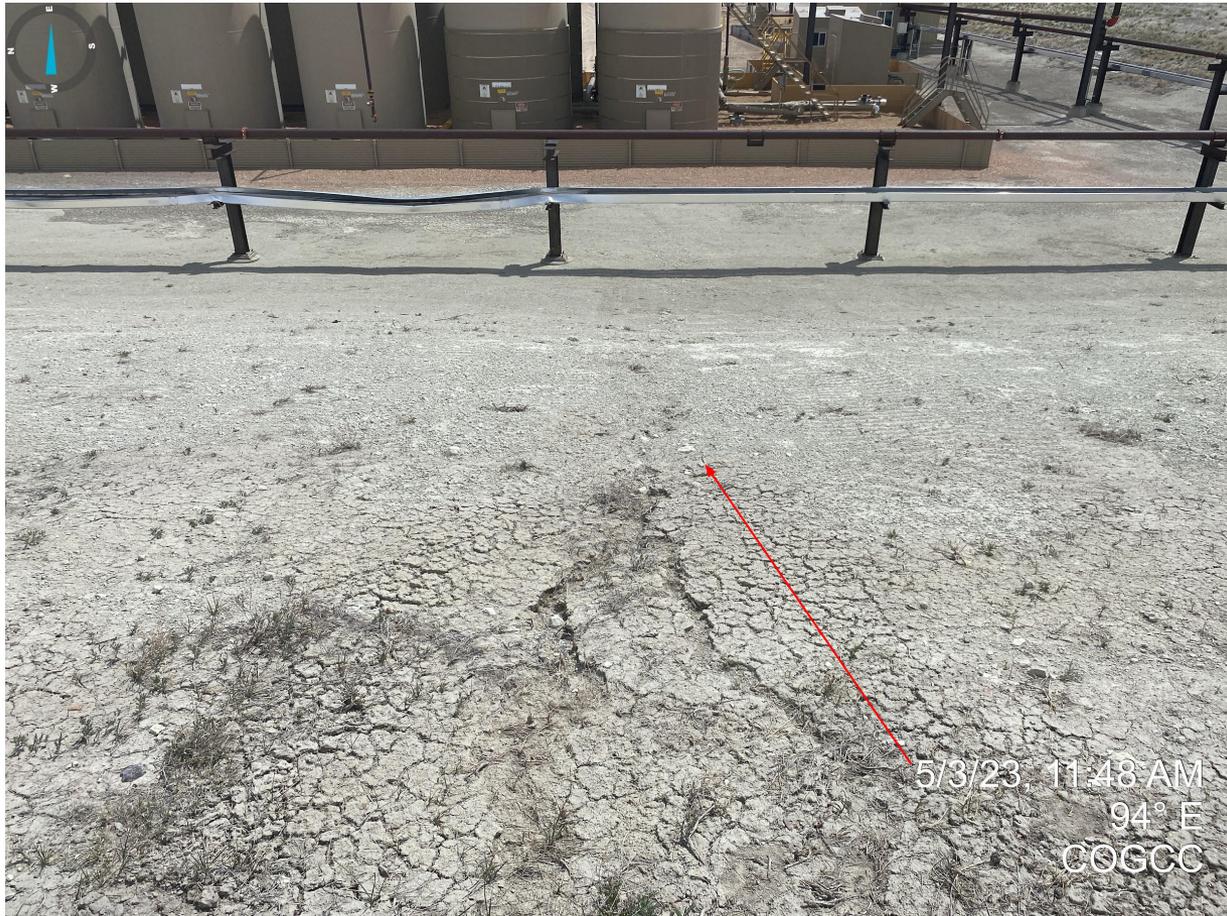
Photo 5. Rill erosion occurring on the unstabilized cut bank. Other than a perimeter stormwater ditch, no other stormwater BMPs were observed in this area.

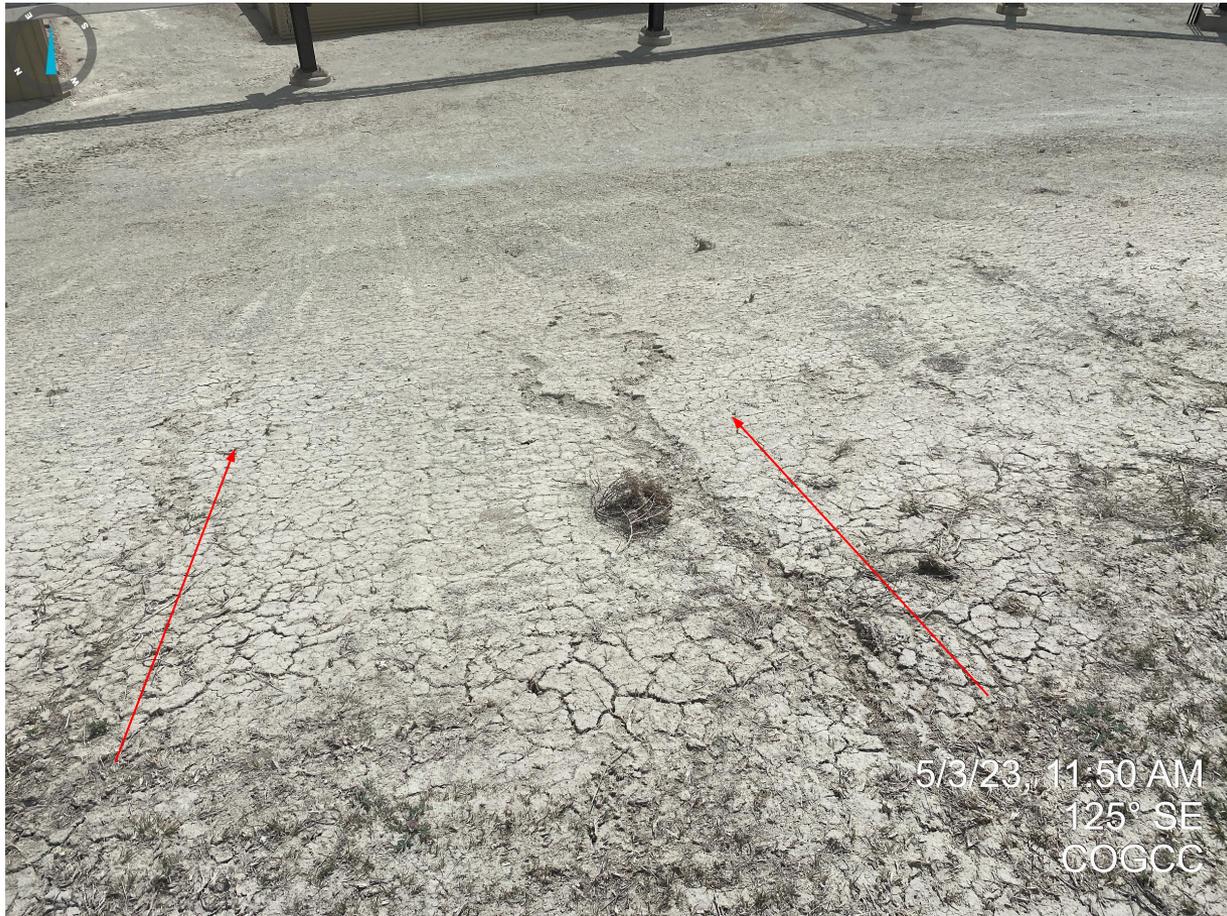
Photo 6. See comments in Photo 5.

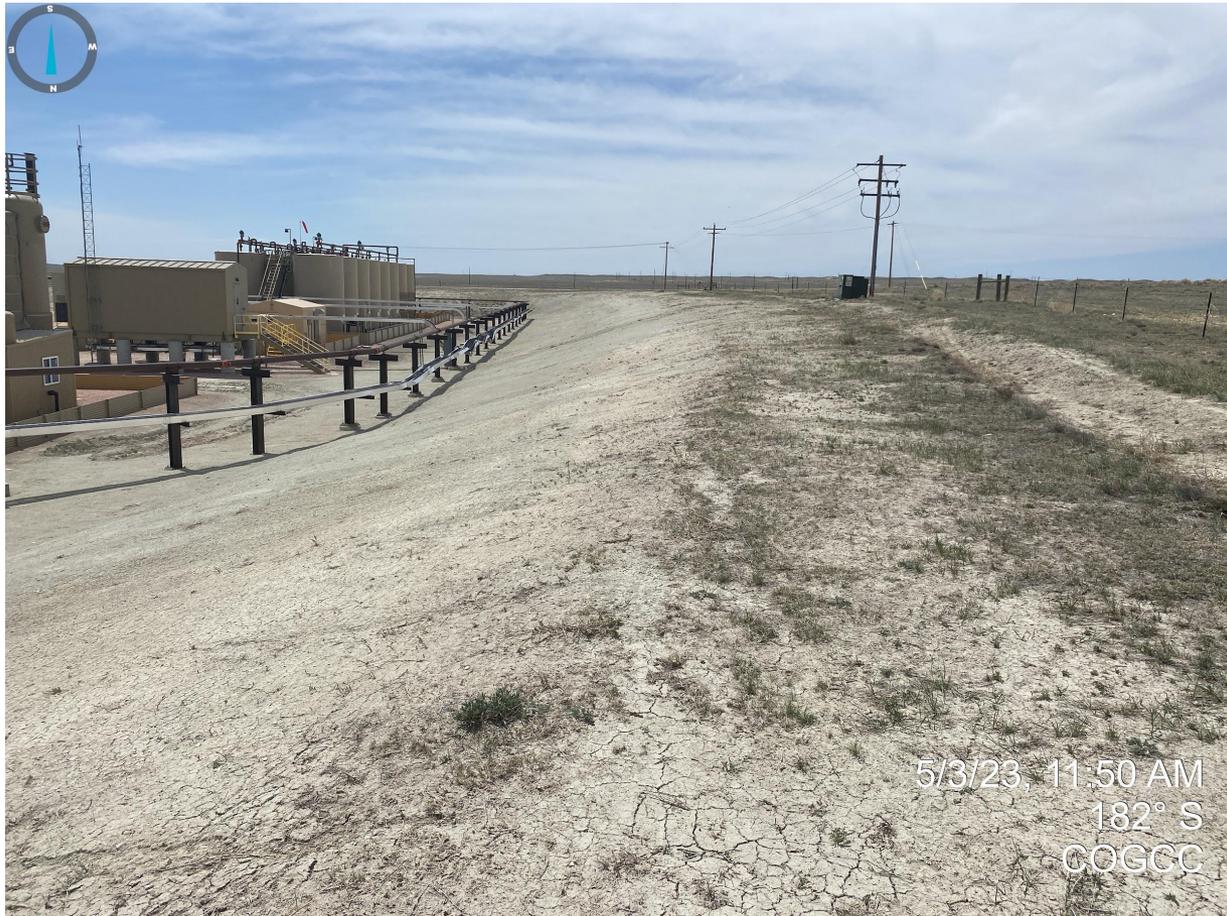
Photo 7. Overview of cut bank on west side of location; see comments in Photo 1.

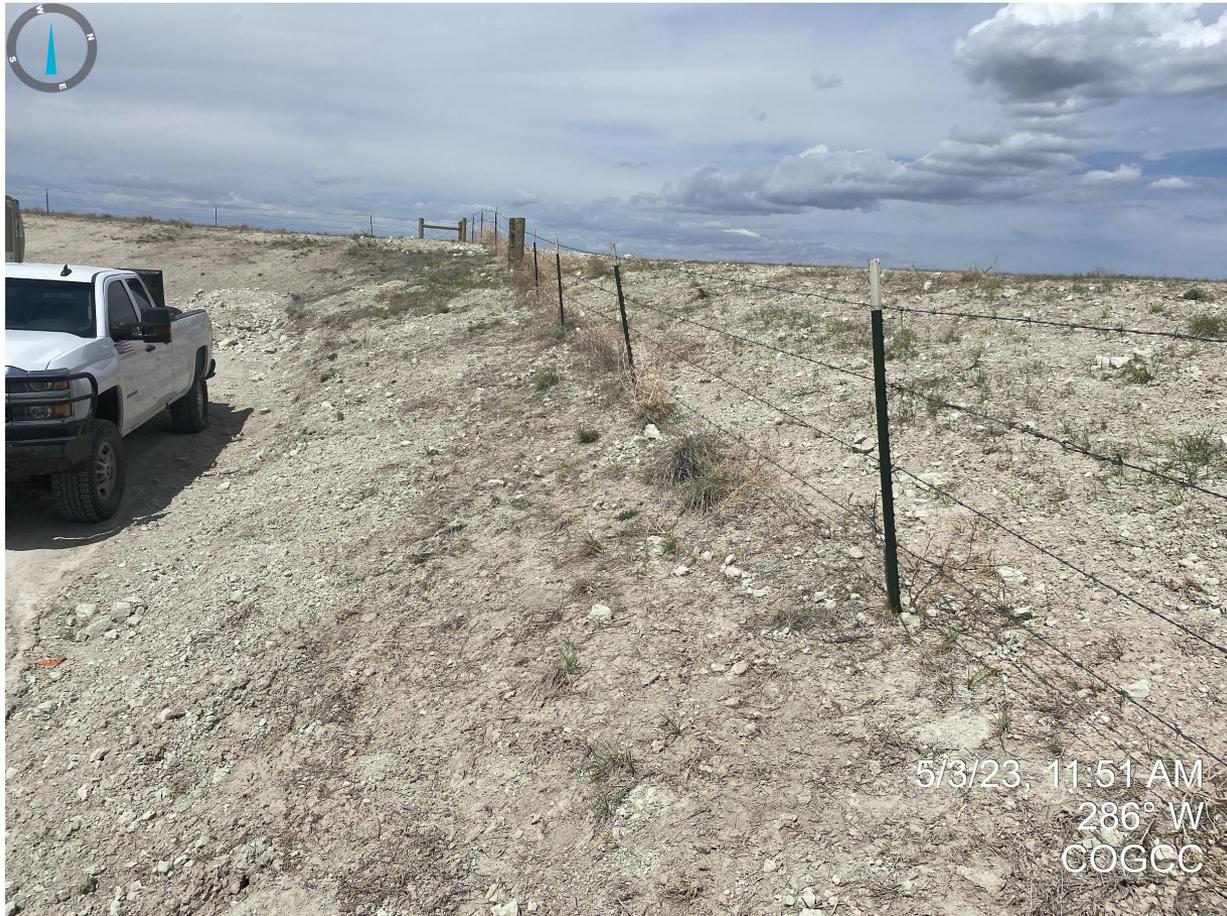
Photo 8. Northwestern corner of the location/production area; see comments in Photo 1.

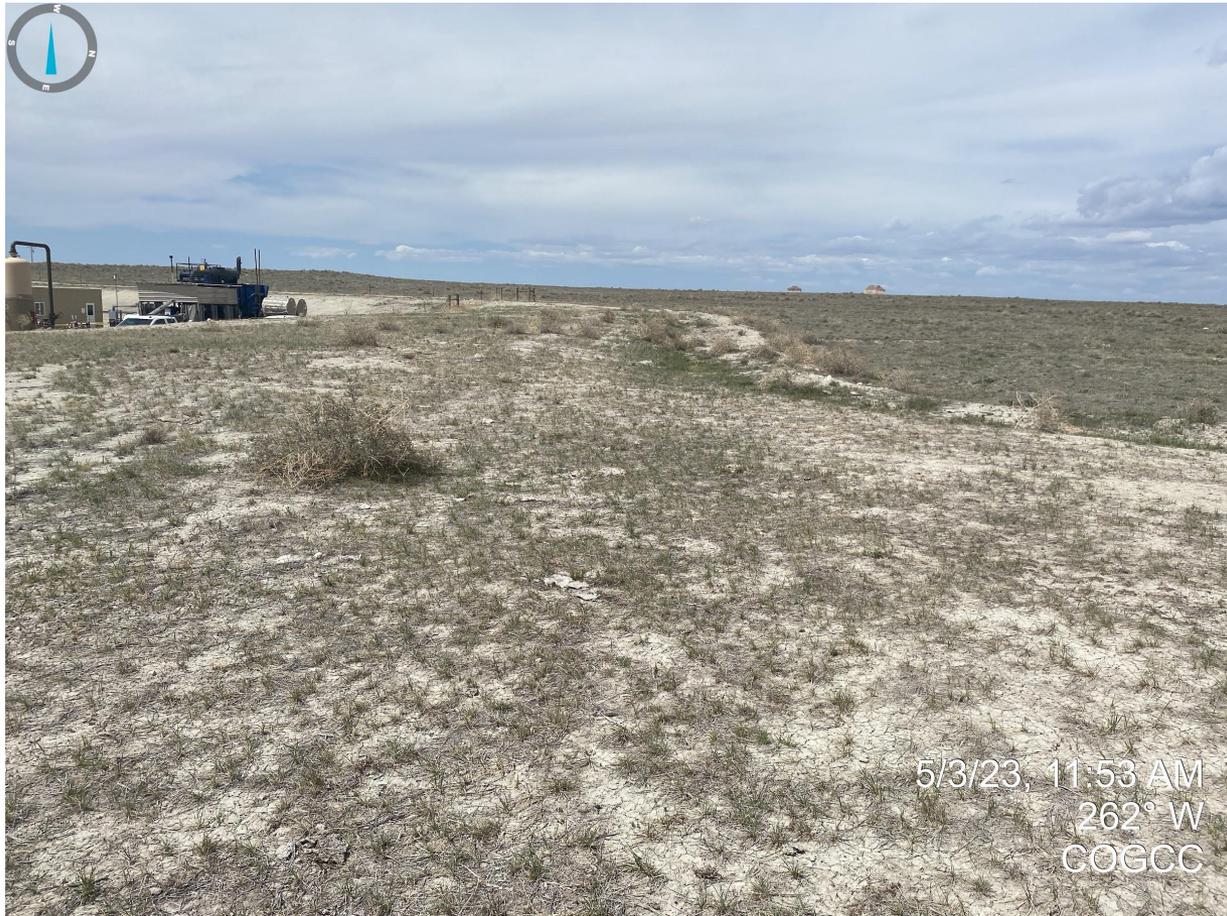
Photo 9. Facing west from the northern interim area. Photo illustrates that the interim areas require additional reclamation activities to meet Rule 1003 standards. Non-uniform vegetative cover resulting in areas of bare soil observed.

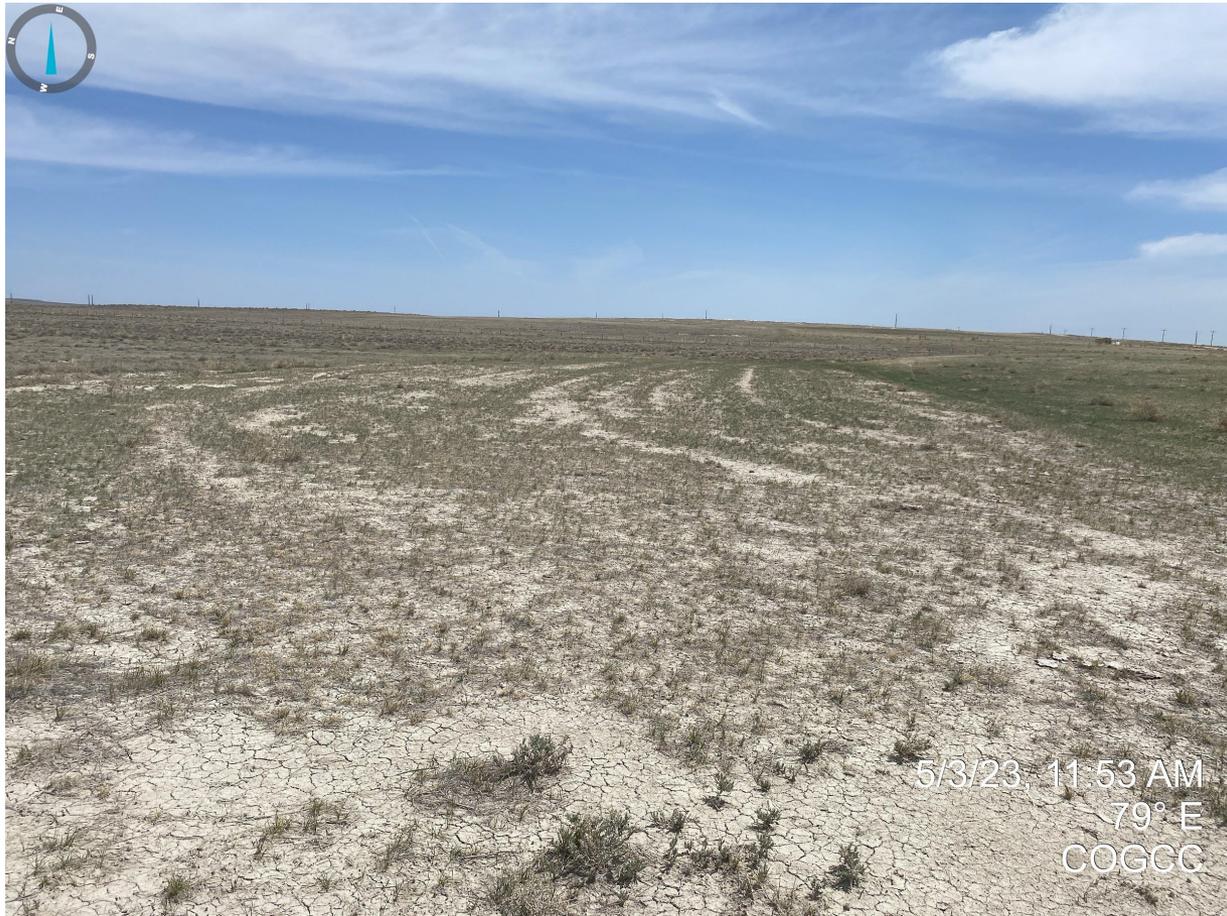
Photo 10. Facing east from the northern interim area; see comments in Photo 9.

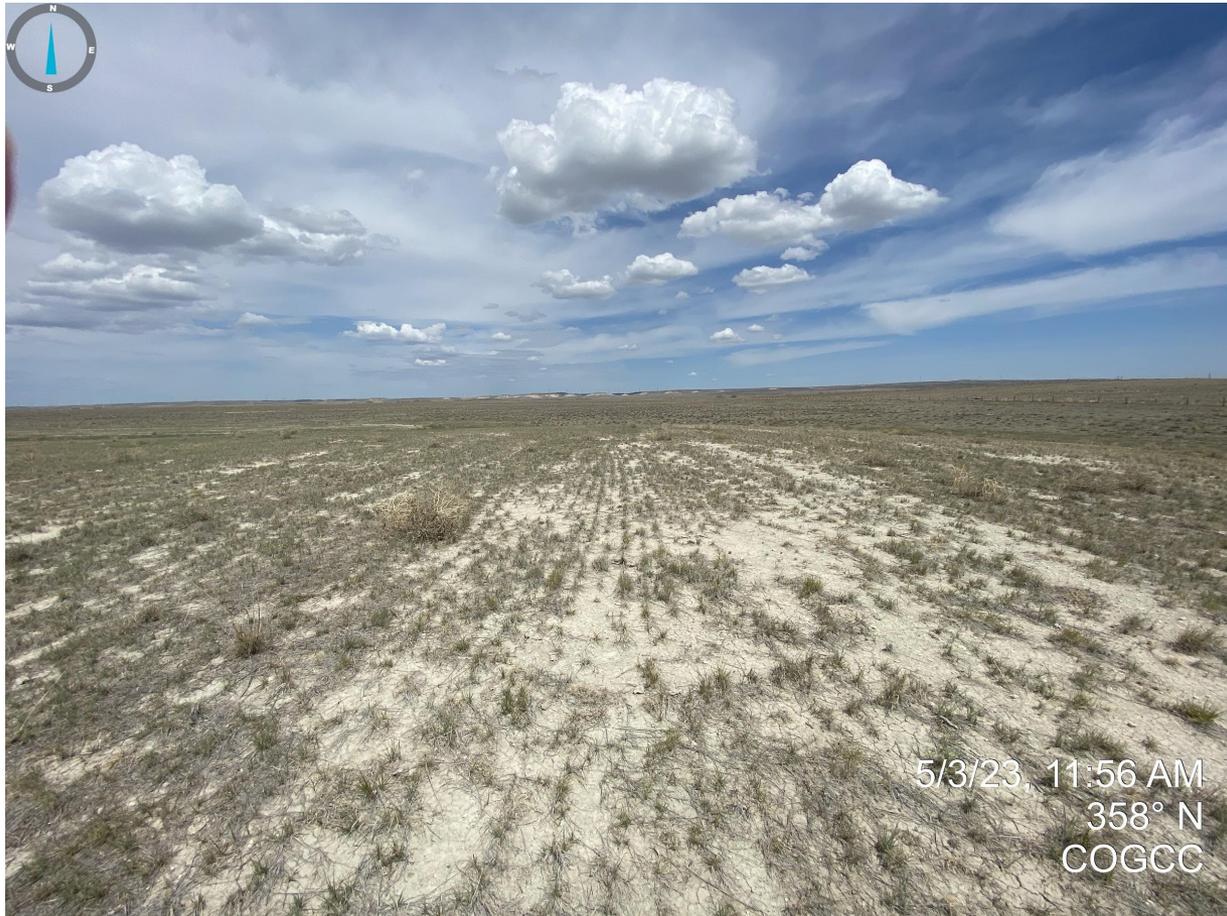
Photo 11. Facing north from the eastern portion of the interim area. See comments in Photo 9.
