Inspection Photos

API: 071-07604

Operator: EVERGREEN NATURAL RESOURCES

Inspection Date: 5/8/2023

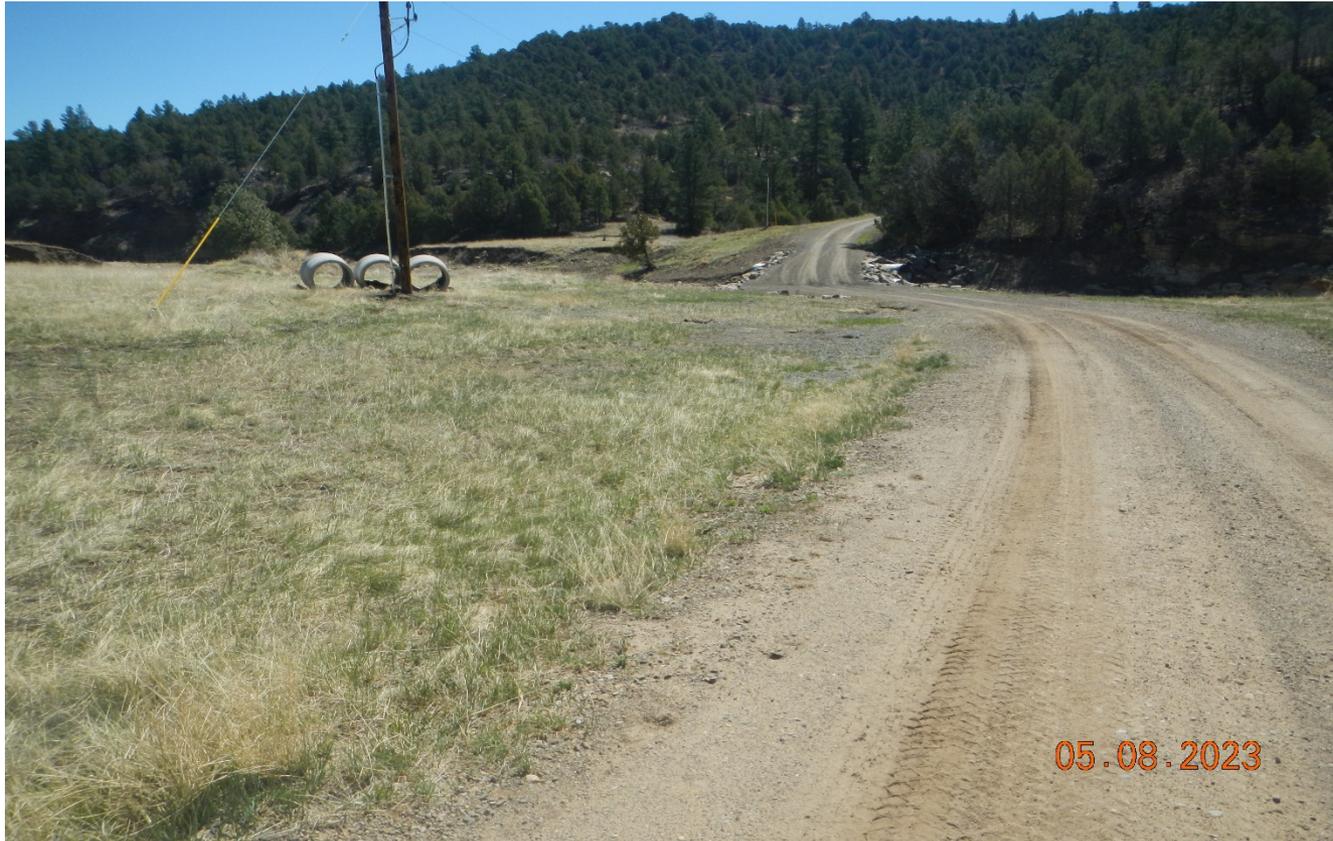
Photo 1. Facing east toward the access road stream crossing. The old cement culverts still remain and need to be removed.

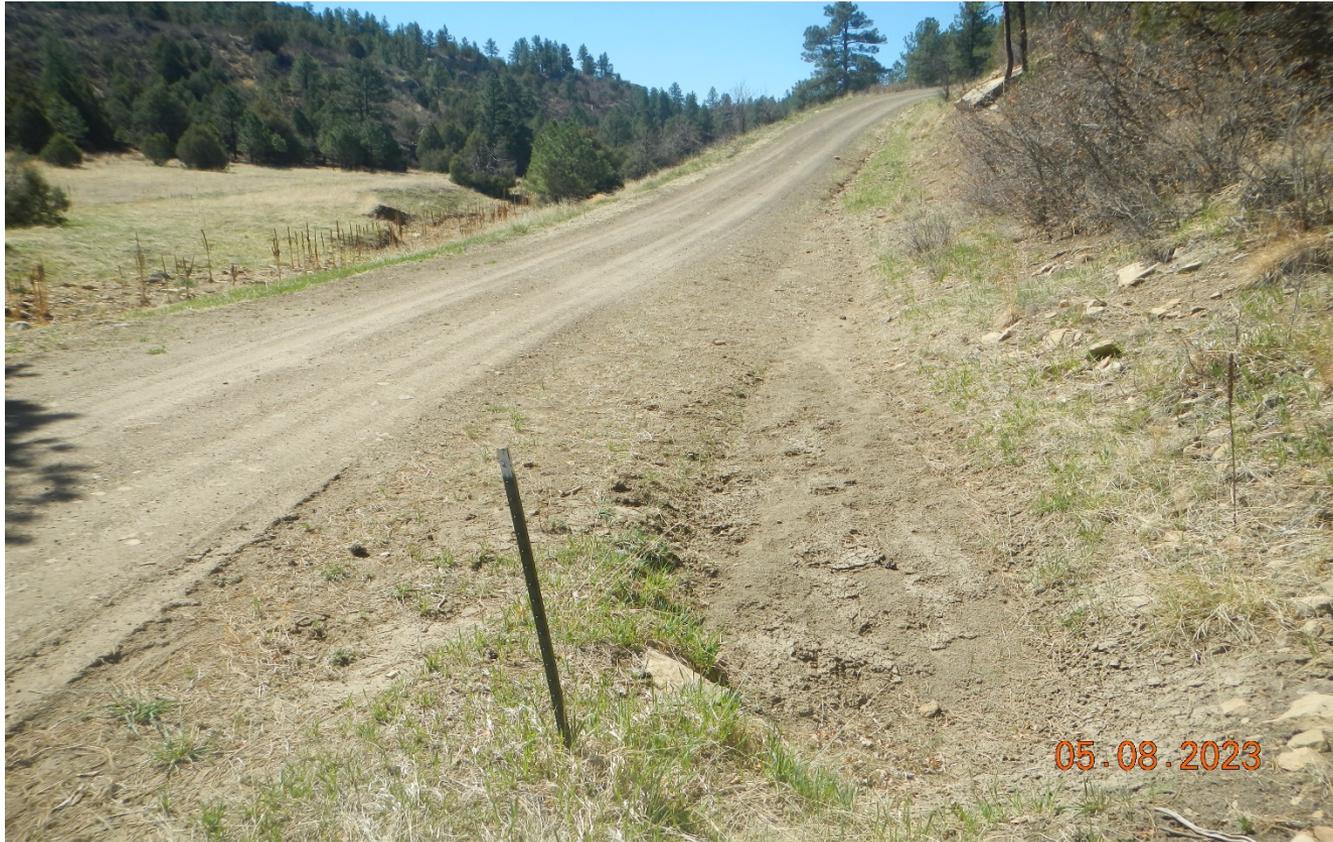
Photo 2. Facing southeast along the access road. This culvert along the access road has filled back in with sediment and needs to be cleaned out.

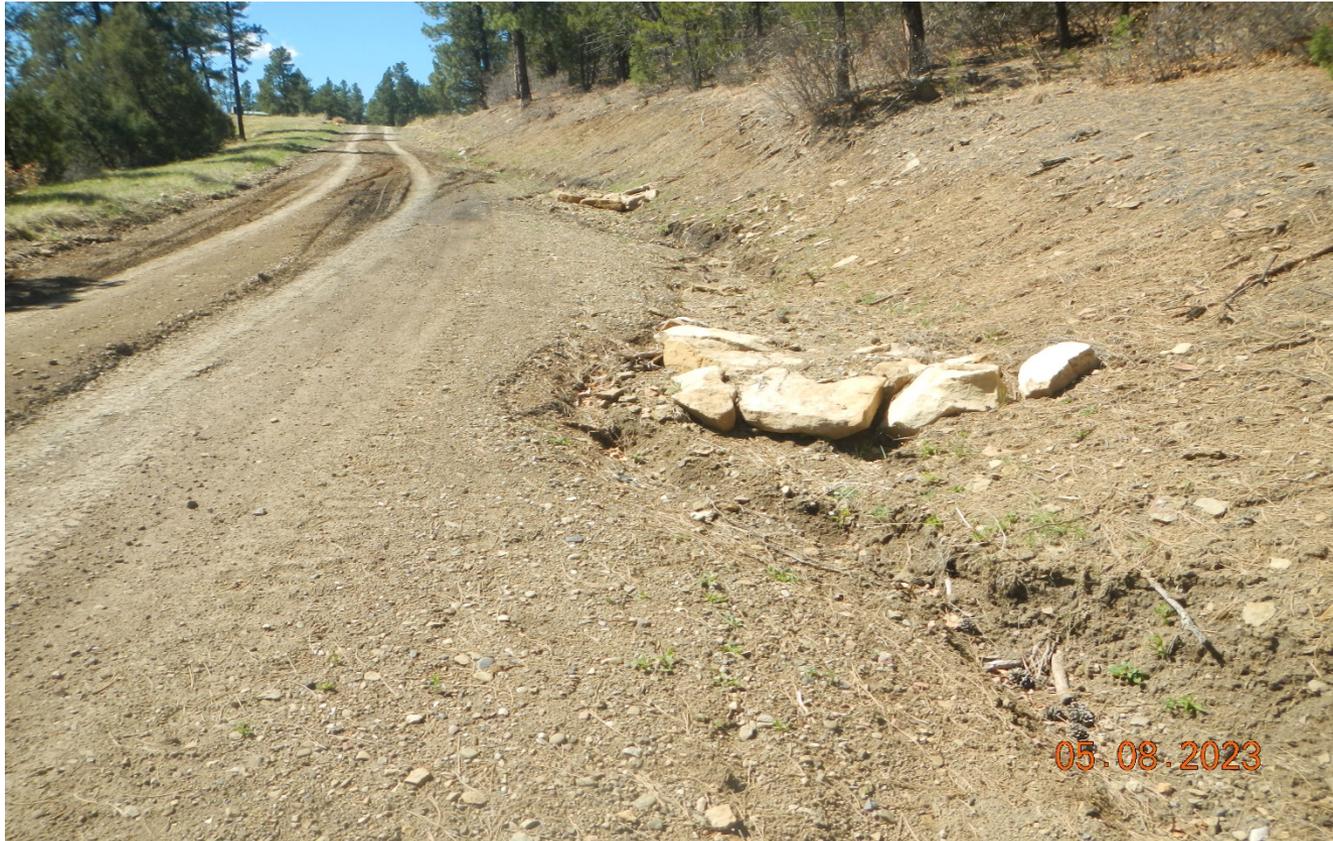
Photo 3. There is erosion is occurring around the rock check dams which has not been repaired since previous inspection.

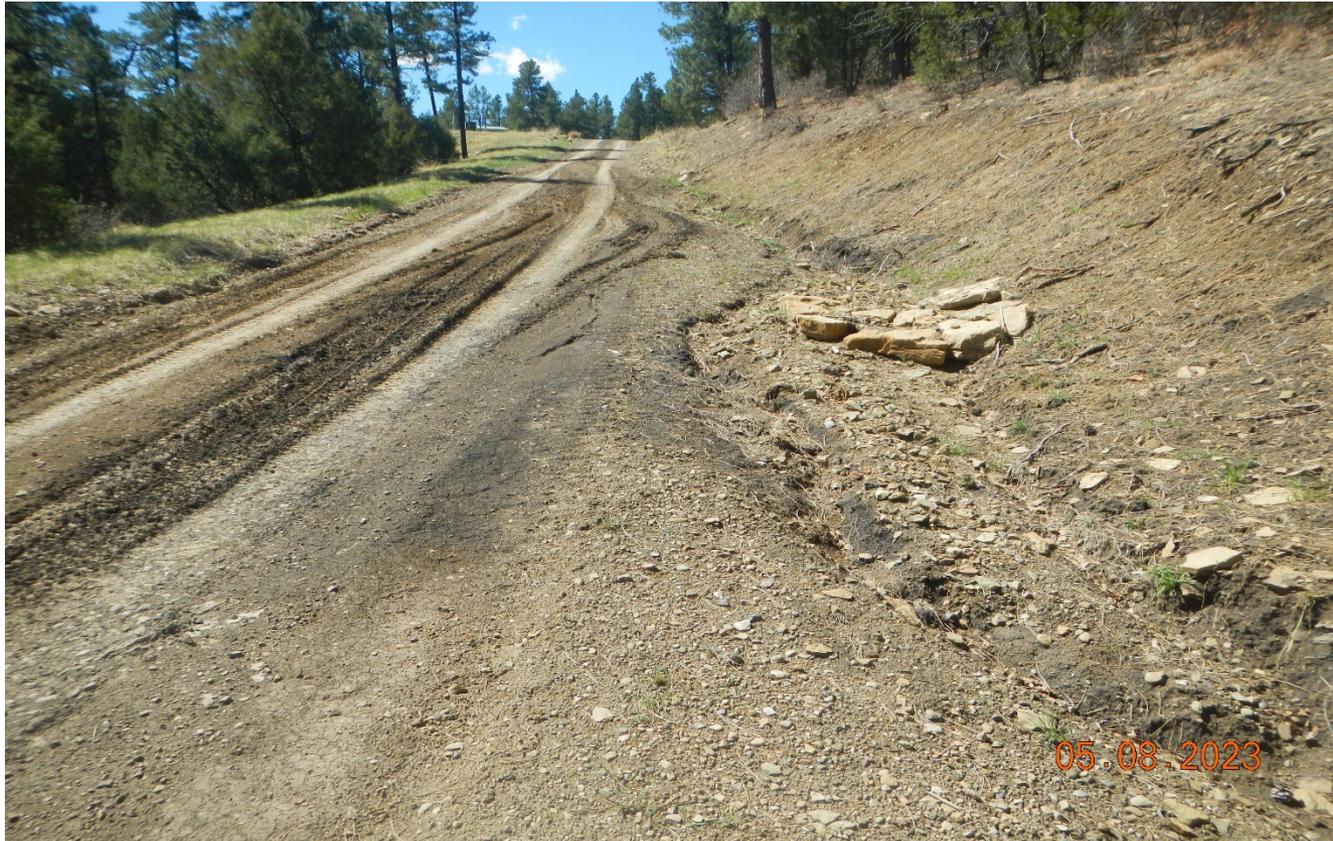
Photo 4. There is erosion is occurring around the rock check dams which has not been repaired since previous inspection.
