# Inspection Photos

API: 009-06495

Operator: OXY USA INC

Inspection Date: 5/3/2023

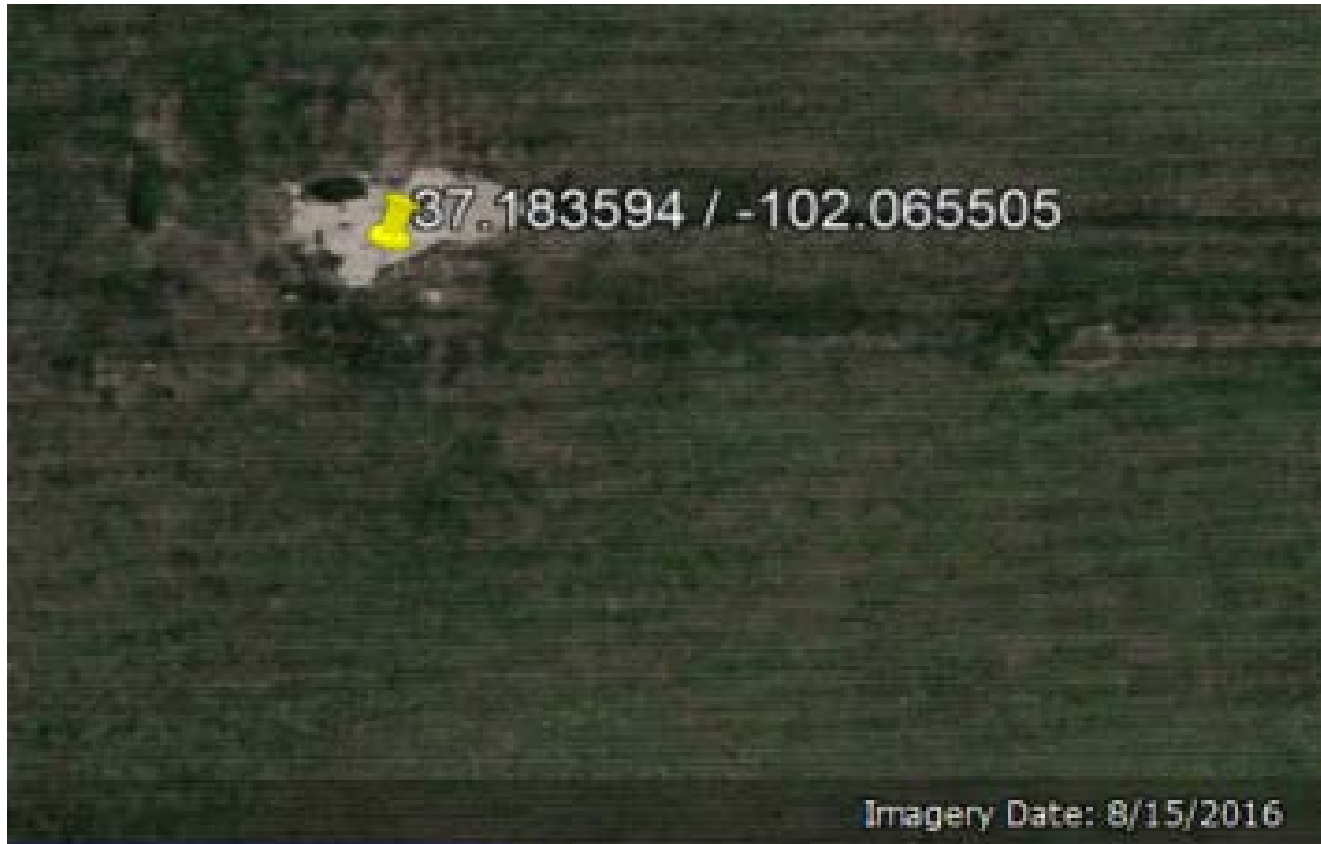
**Photo 1.** Aerial imagery shows wellsite was bare of crop growth.

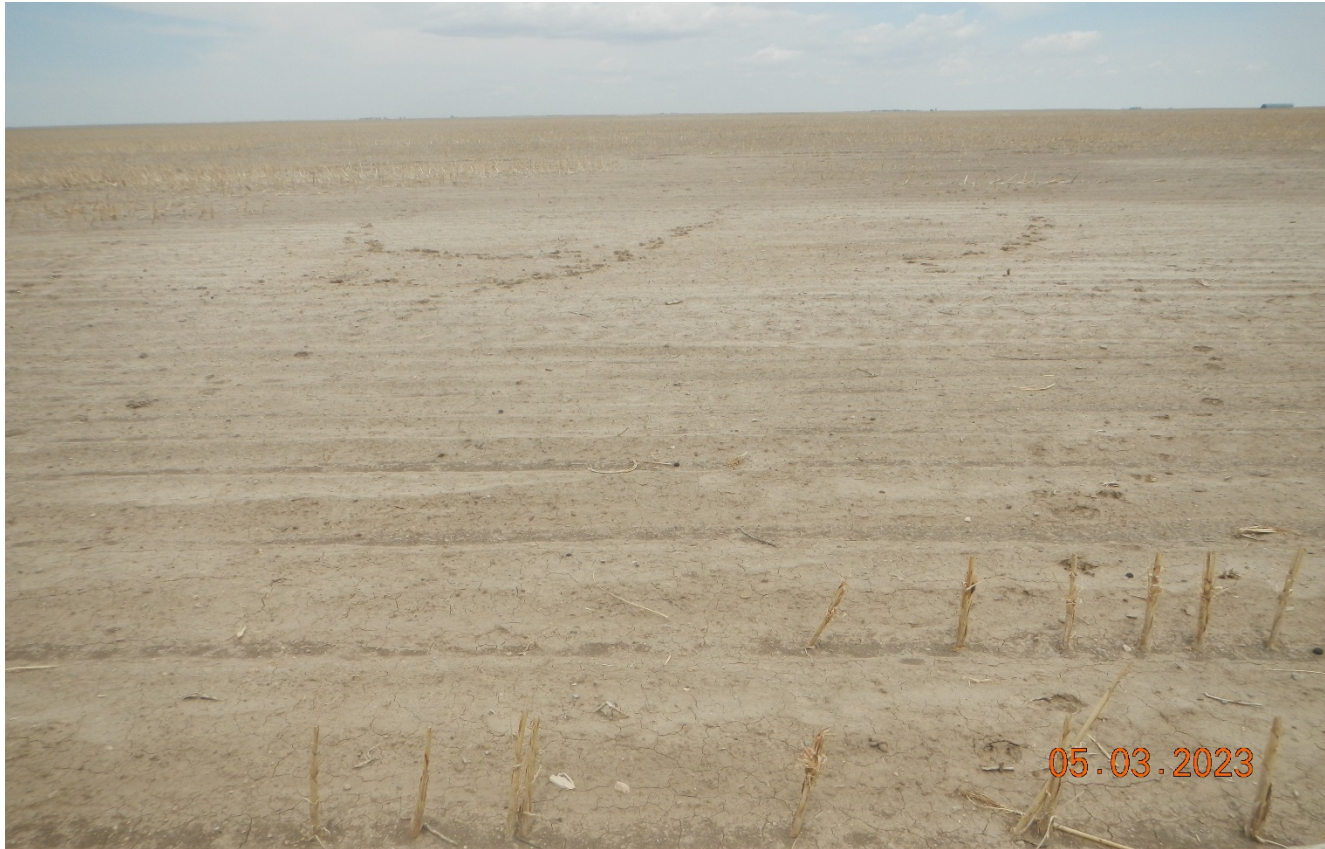
**Photo 2.** Facing north toward the location. The location does not have any stubble from previous years crop.

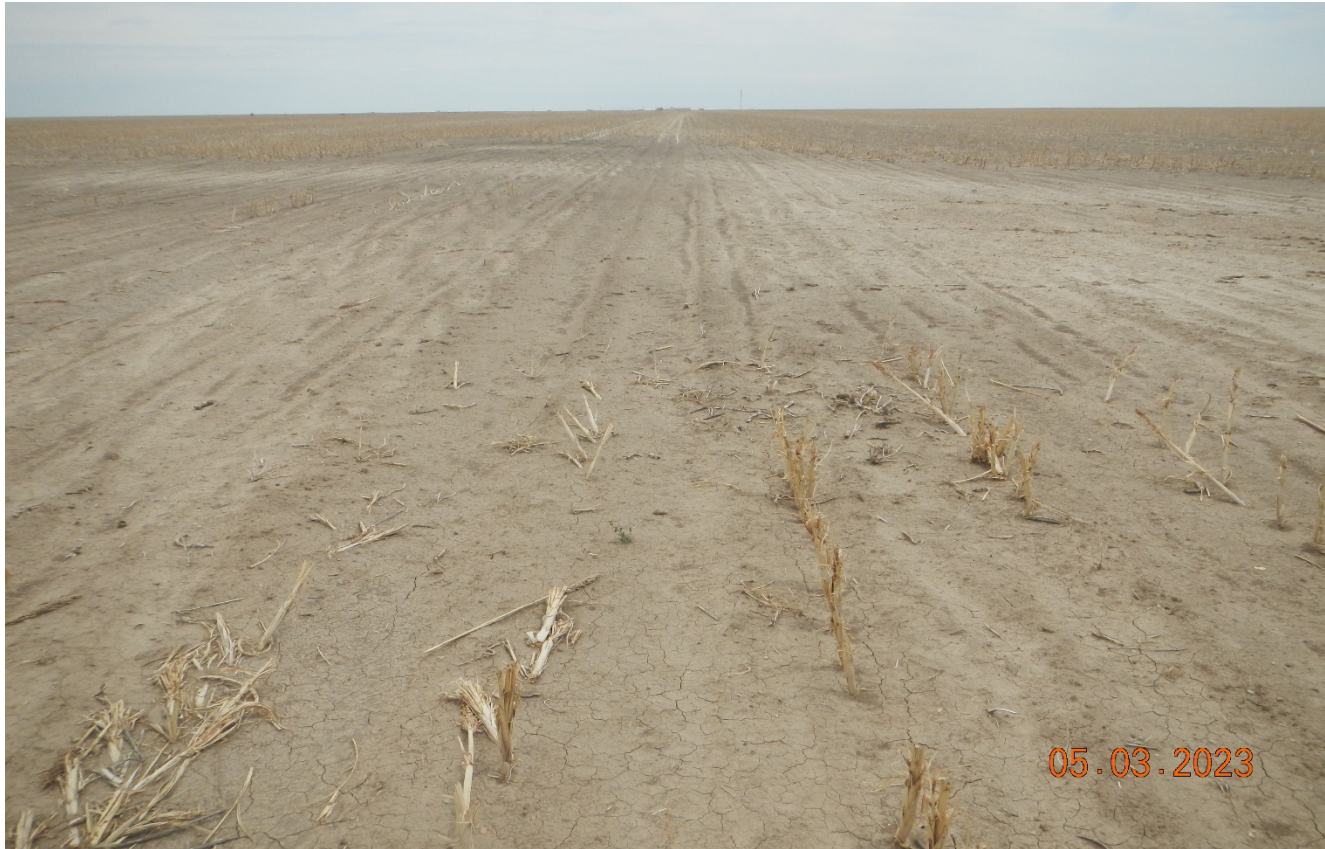
**Photo 3.** Facing east toward the location. The location does not have any stubble from previous years crop.

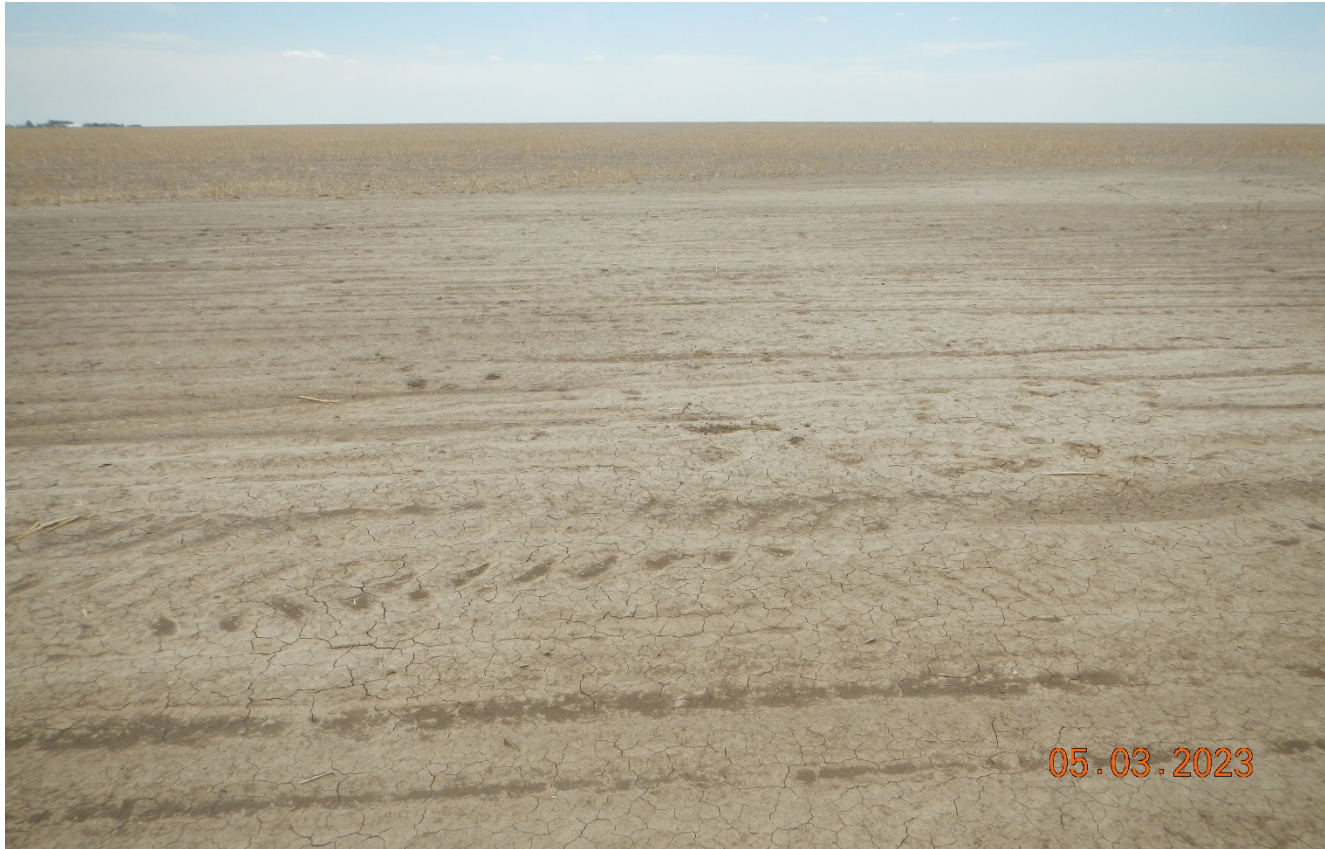
**Photo 4.** Facing south toward the location. The location does not have any stubble from previous years crop.

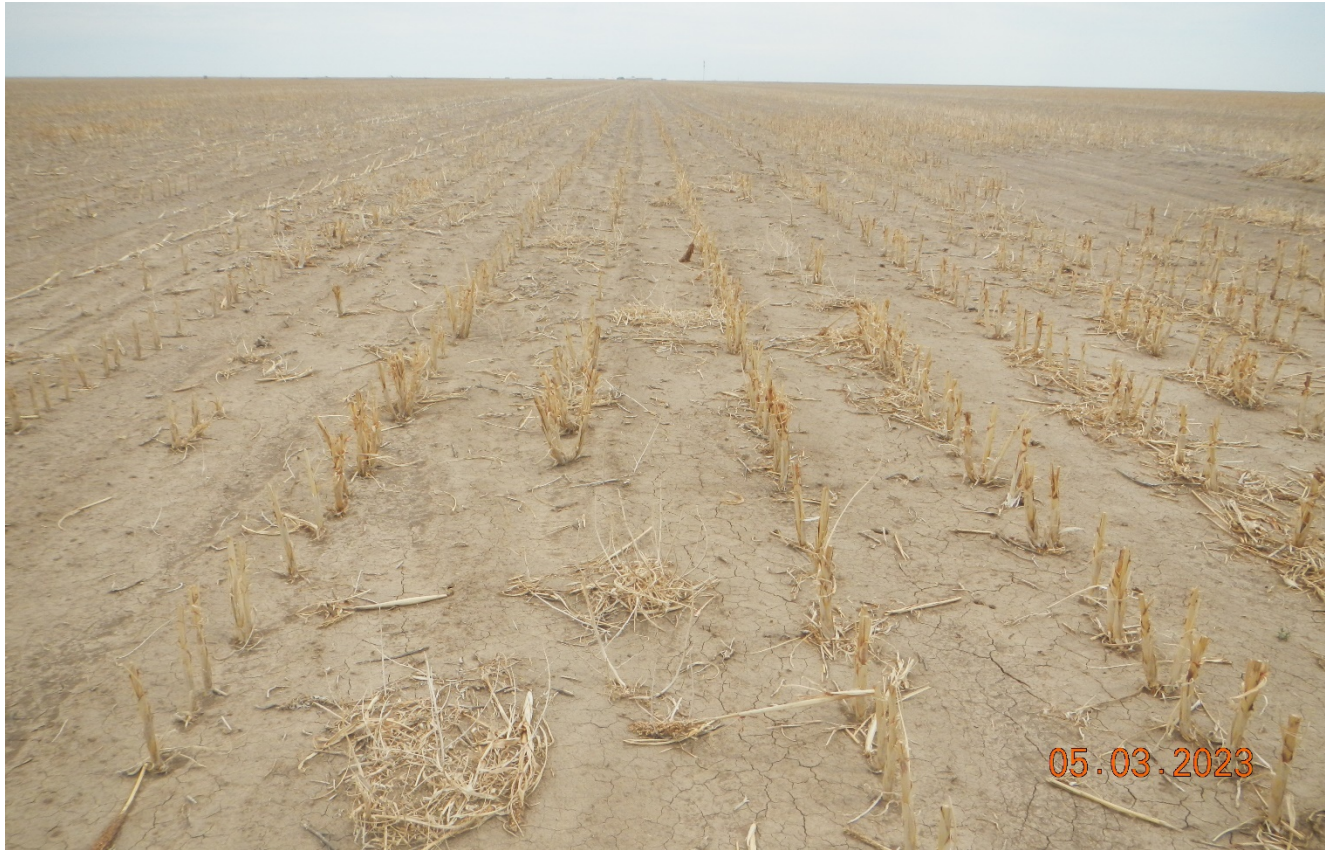
**Photo 5.** Facing east toward the undisturbed reference area which has uniform crop stubble from previous year..
