Construction and Stormwater Inspection

Operator: VERDAD RESOURCES LLC -10651

Location ID: 468727

Inspection Document #: 708200223

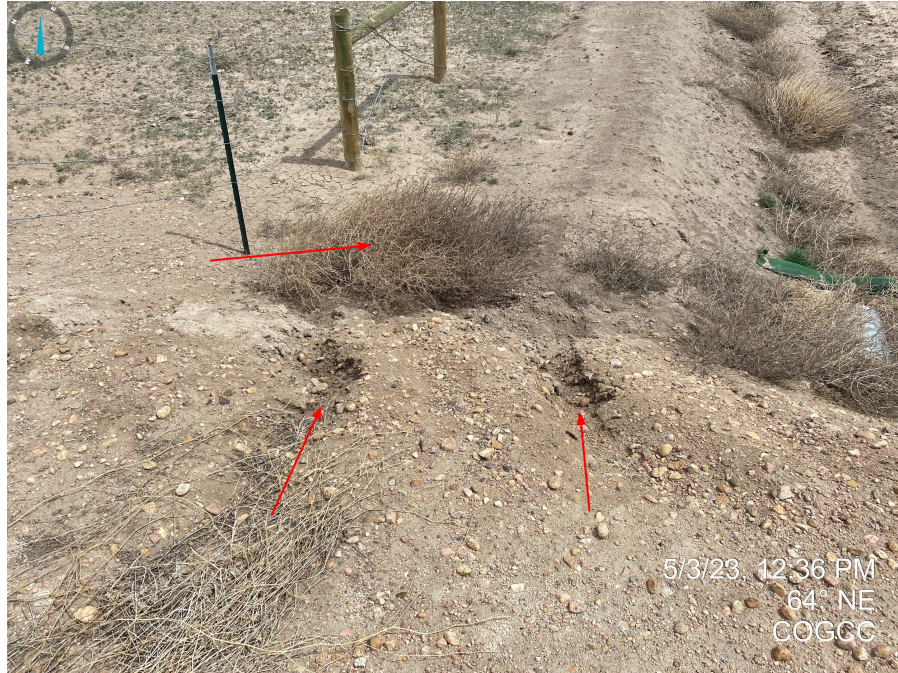
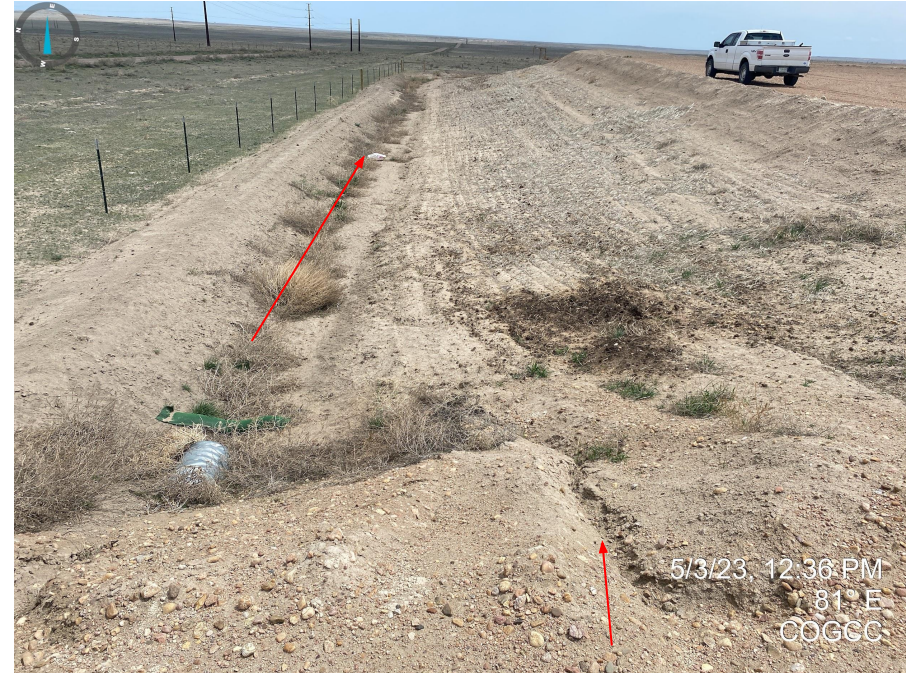
Photos 1 & 2. Rill erosion is evident at the entrance to the location. The inlet/outlets of the culvert will need to be properly stabilized/protected to prevent further erosion from occurring. Also pictured, undesirable plant debris that will need to be removed and managed for during the next local growing season.

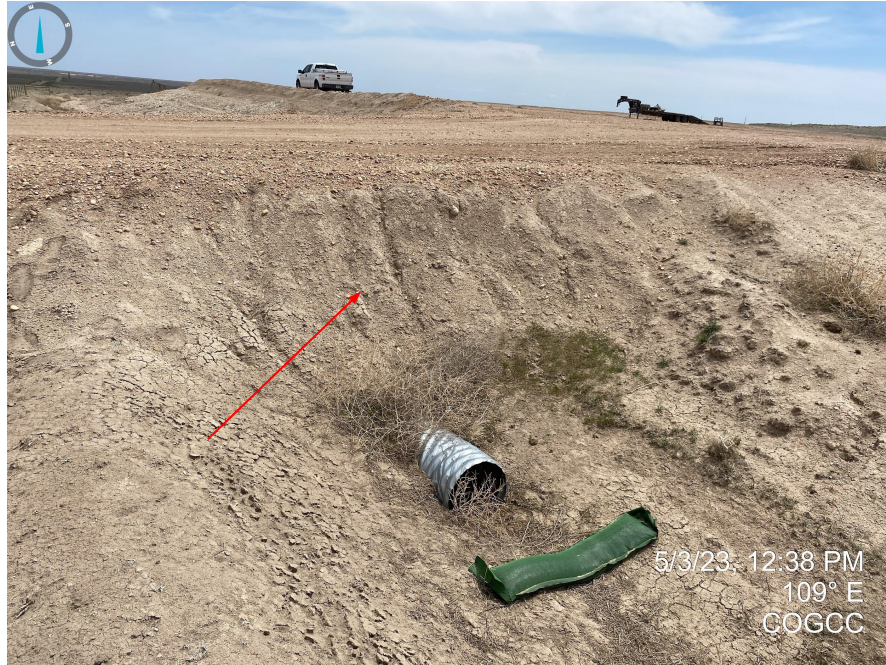
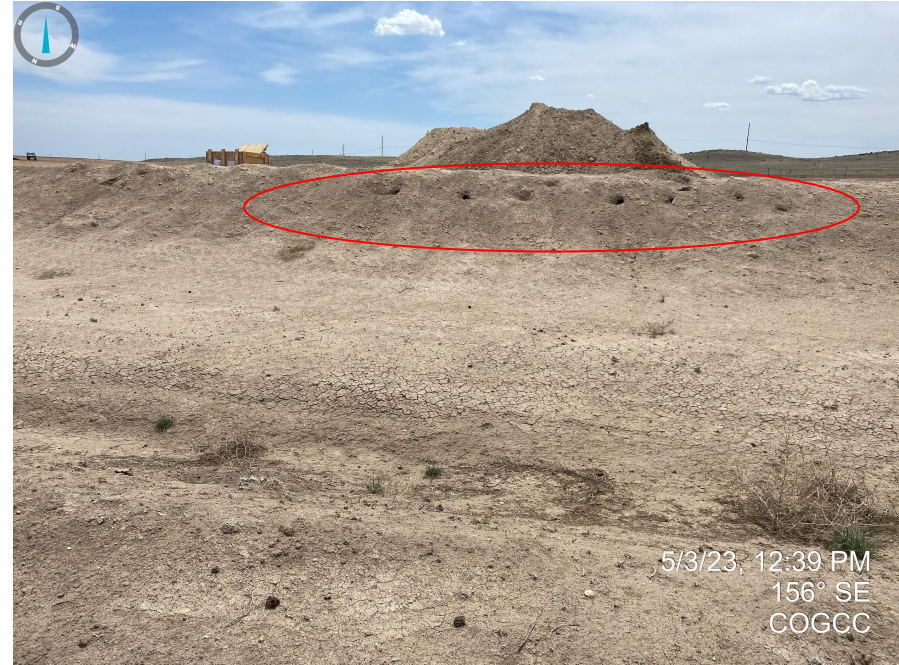
Photos 3 & 4. Rill erosion at culvert (left) and animal burrows in the interior stormwater berm (right); see comments in Photos 1 & 2 for additional information.

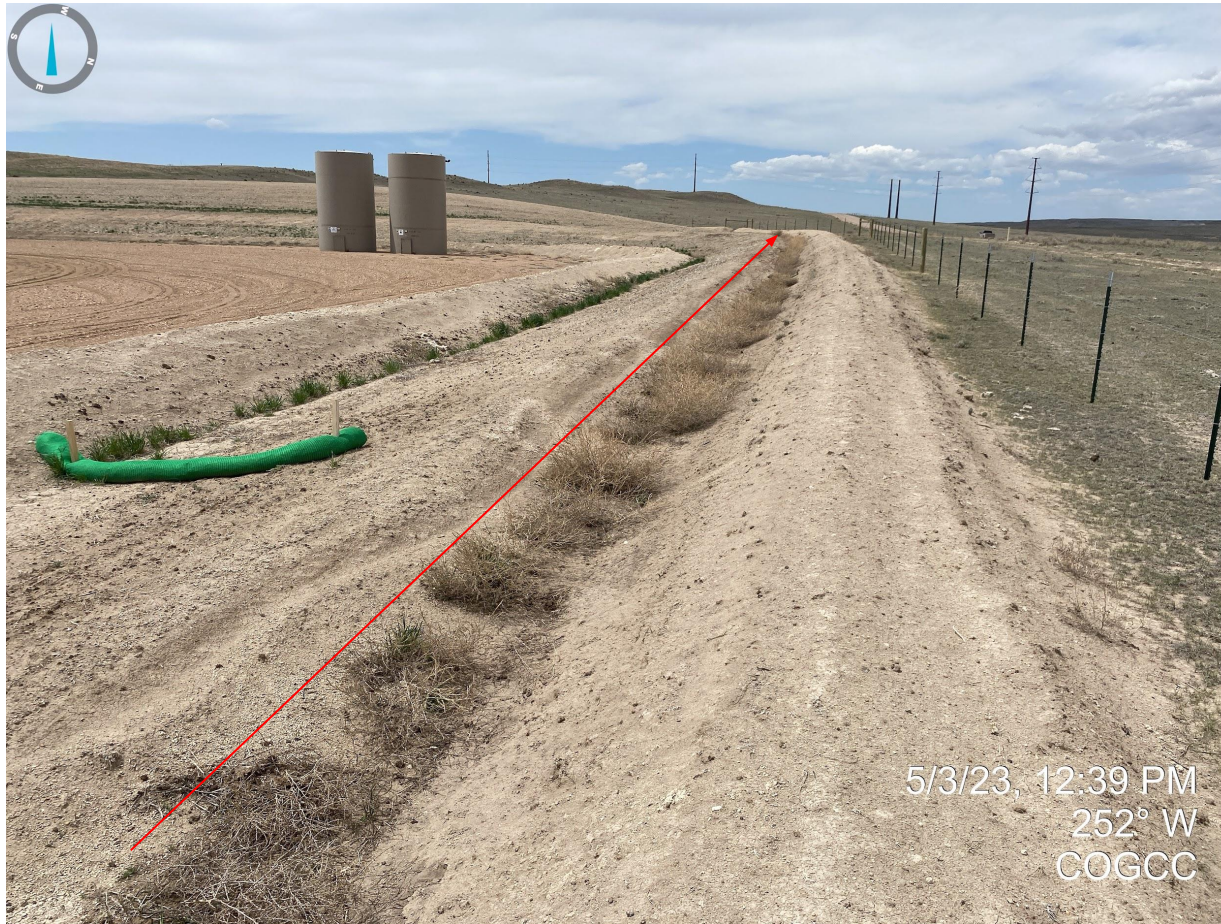
Photo 5. Undesirable vegetation in the ditch that does not appear to have been managed during the previous growing season.

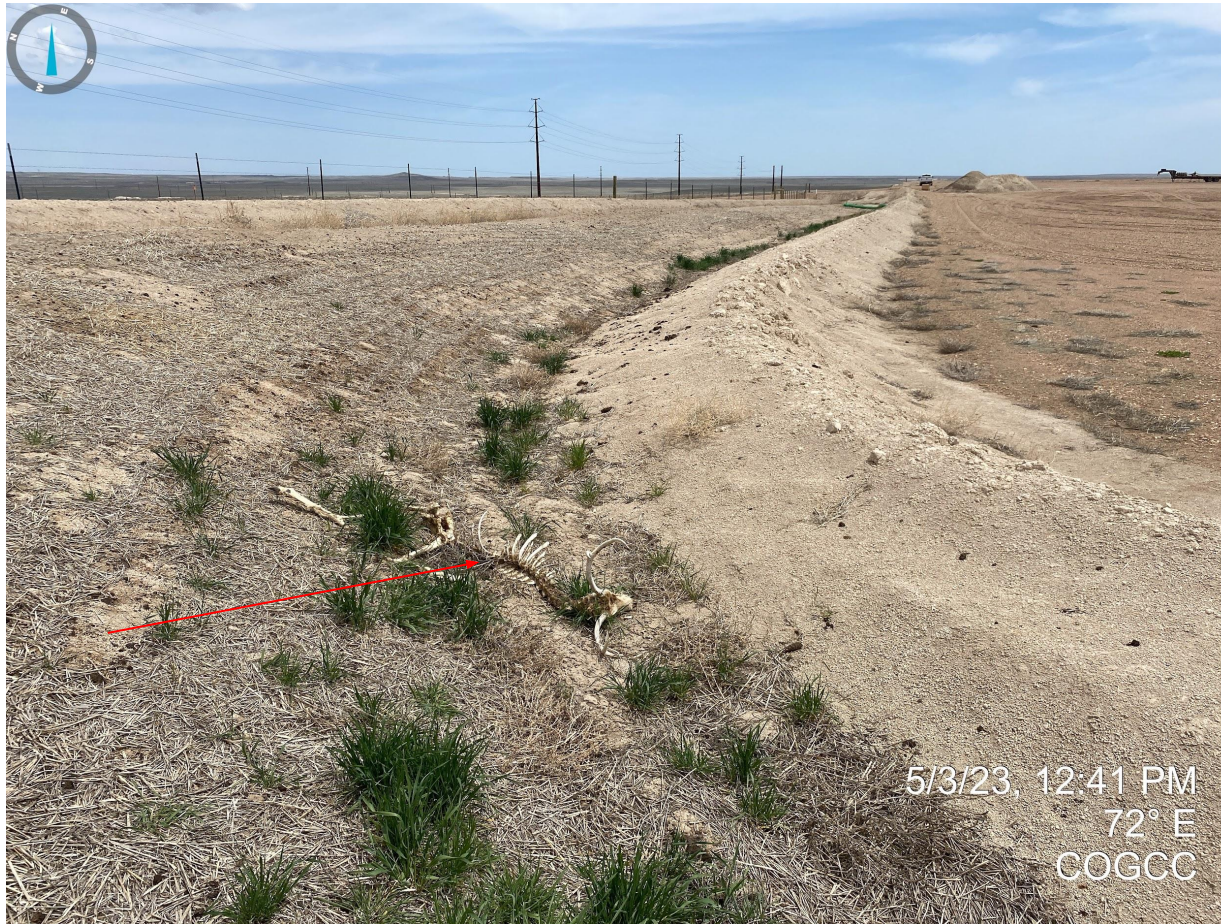
Photo 6. Animal carcass found on location will need to be properly disposed of/removed from location.

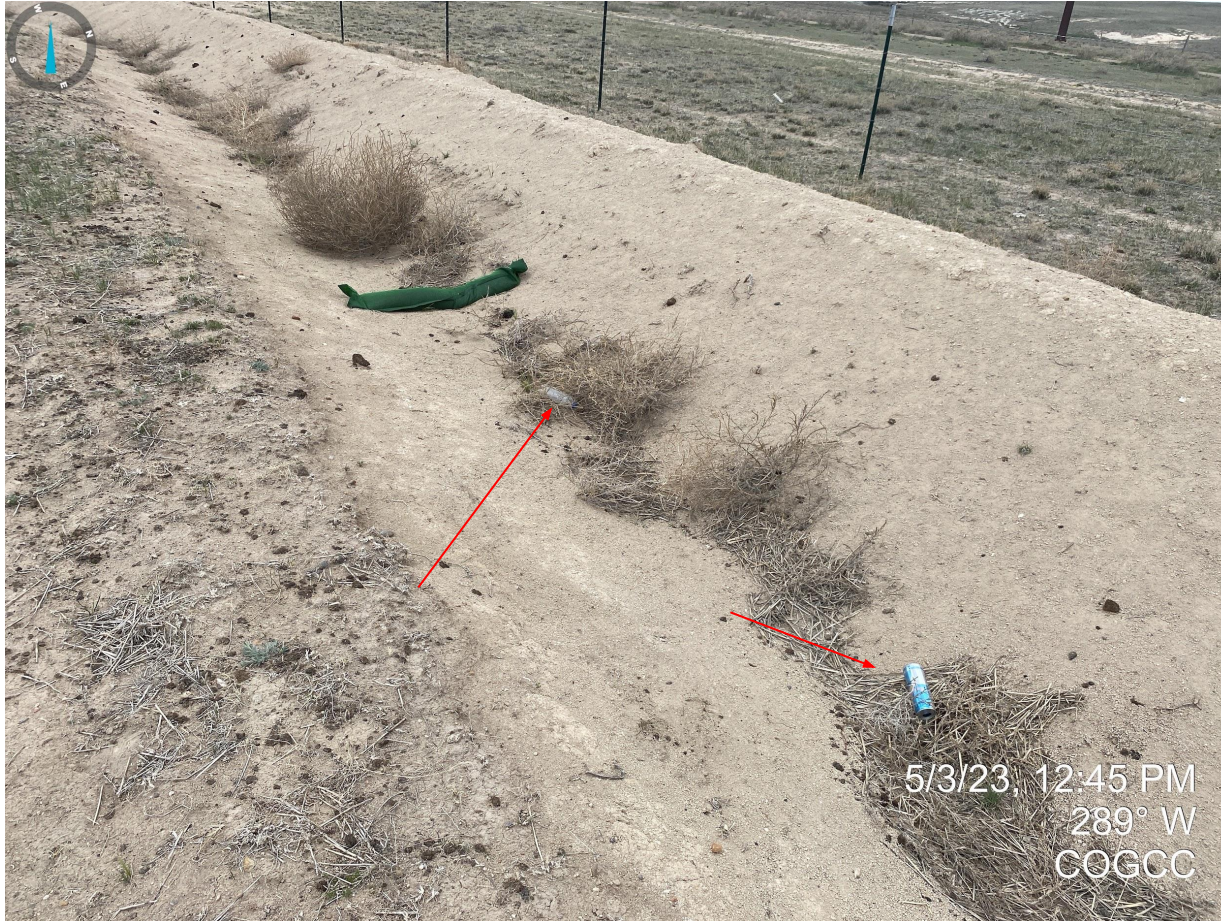
Photo 7. Examples of trash observed on location. The Operator shall self inspect the entire location and remove any trash in compliance with Rule 606.

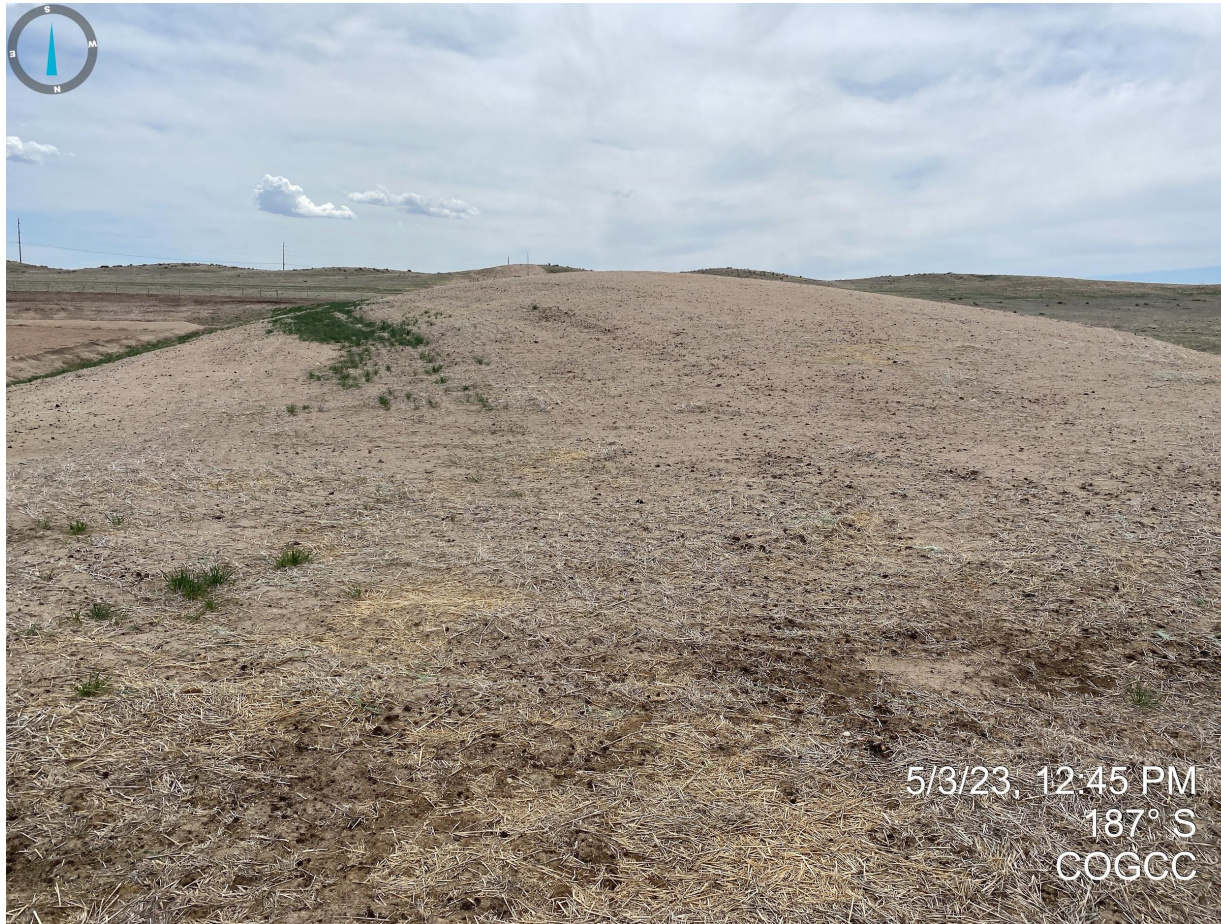
Photo 8. Topsoil stockpile does not appear to be properly stabilized per Rule 1002.c. Additional BMPs will need to be implemented to stabilize the topsoil.

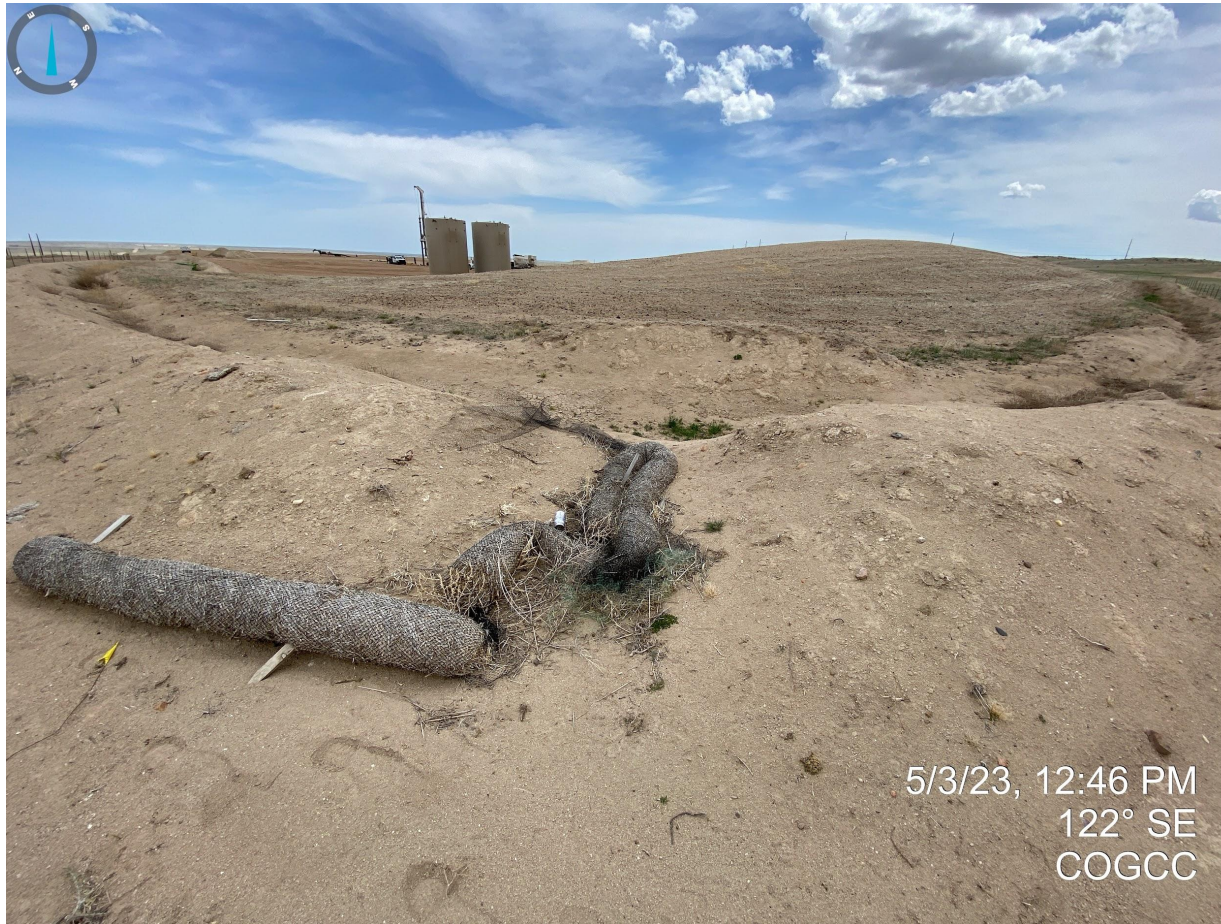
Photo 9. Northwest corner of the location. Degraded straw wattles are no longer properly functioning or installed per good engineering practices and are now considered trash/debris. Inlet/outlets do not appear to be stabilized and the berm material needs additional work to ensure the soil is protected against wind and water erosion as bare soil is not adequate.

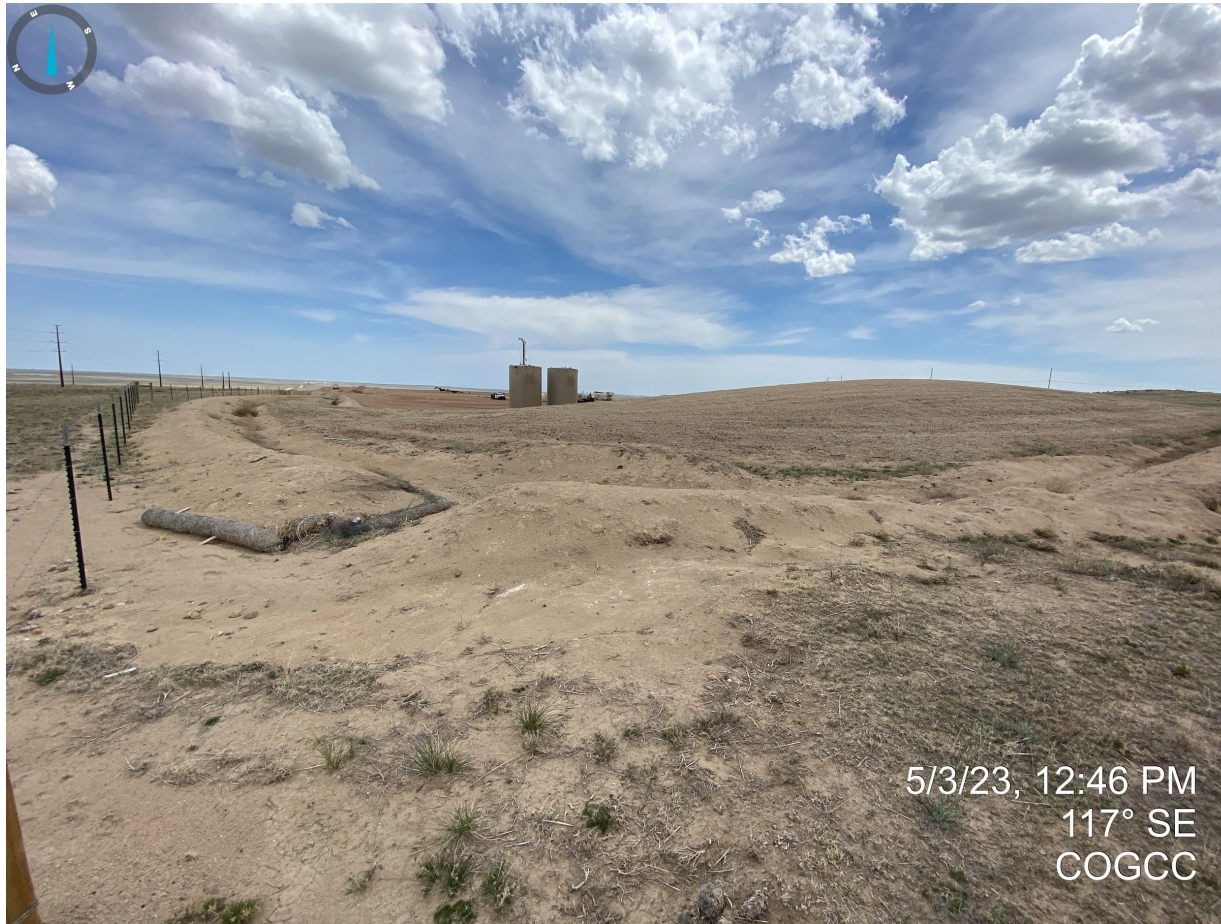
Photo 10. See comments in Photo 9.

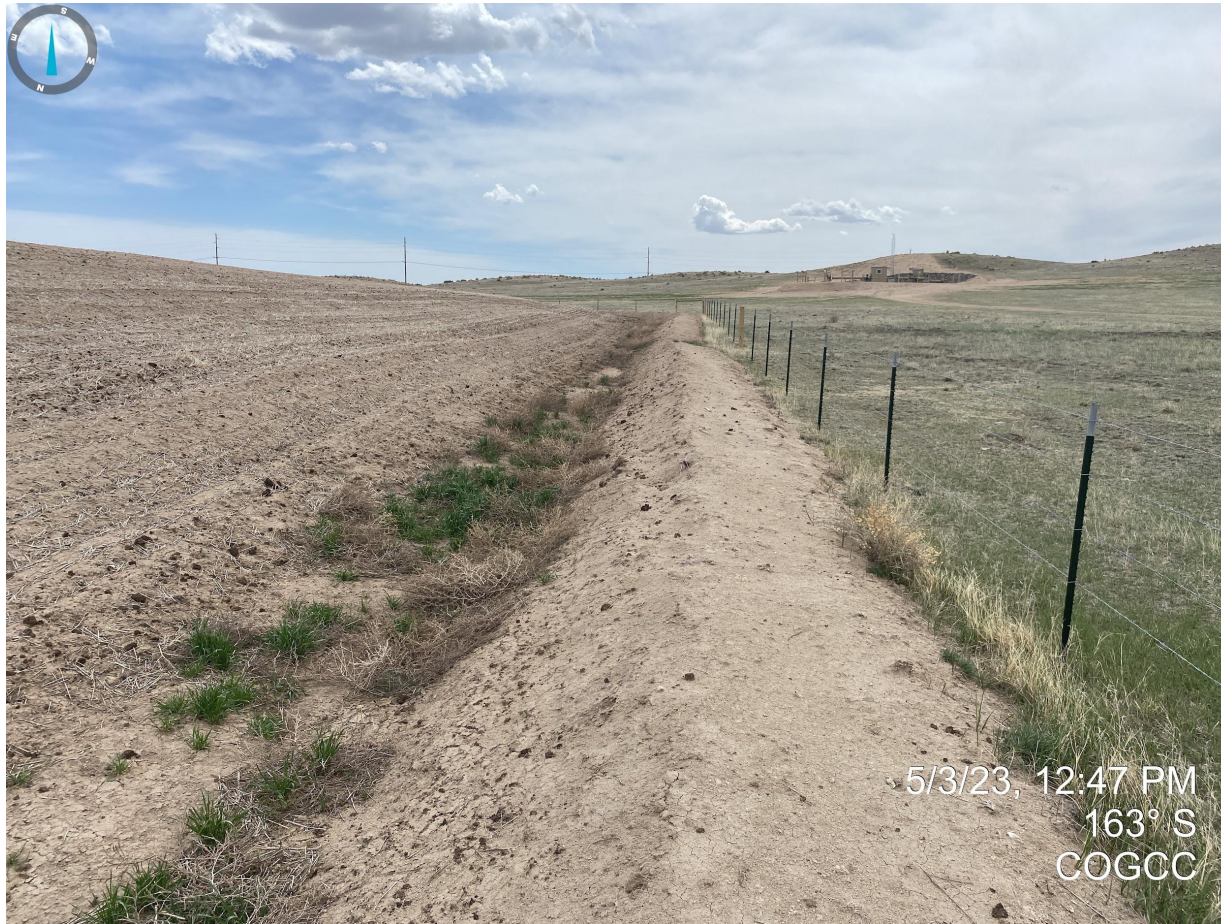
Photo 11. Topsoil stockpile void of any protections and/or vegetation and undesirable plant species observed in the stormwater ditch.

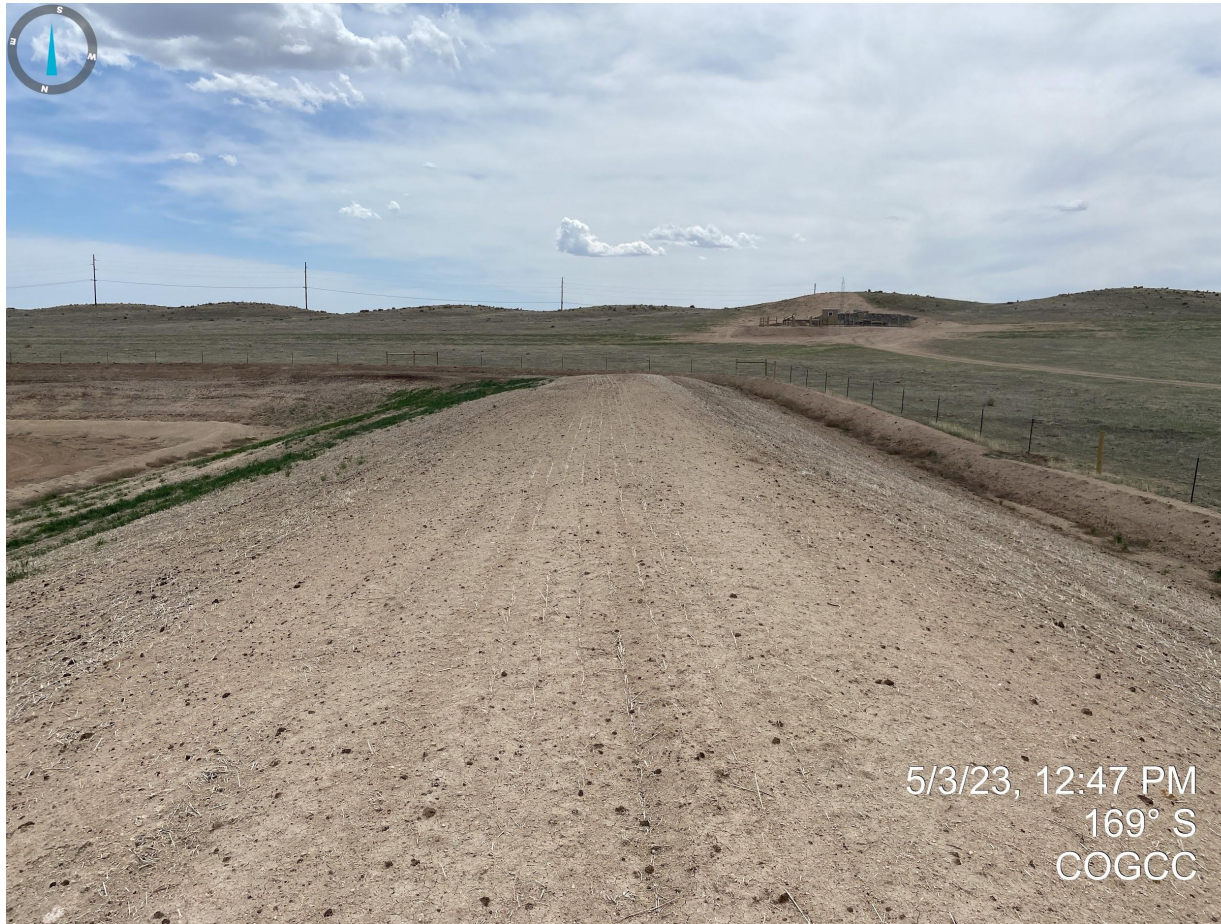
Photo 12. From top of stockpile; see comments in Photo 8.

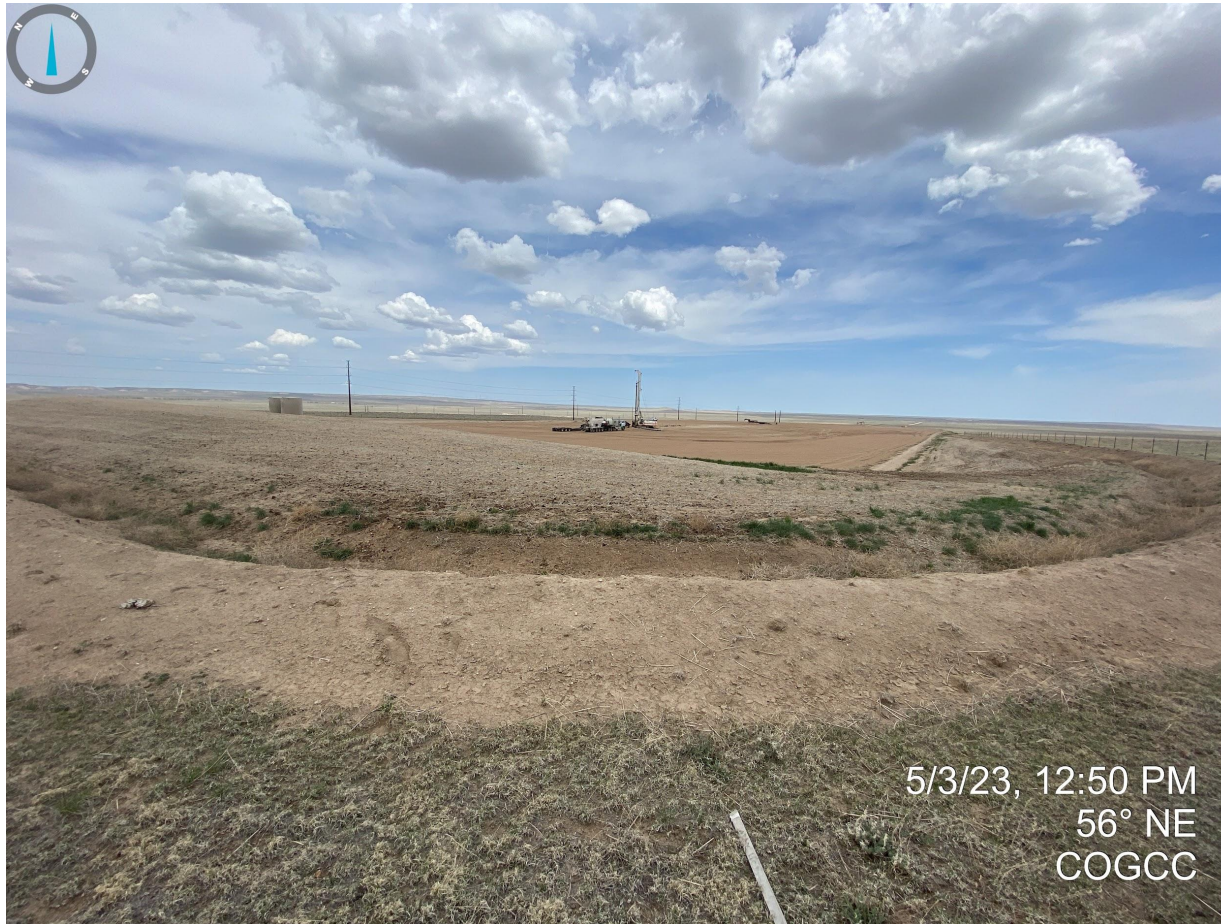
Photo 13. See comments in Photo 8.

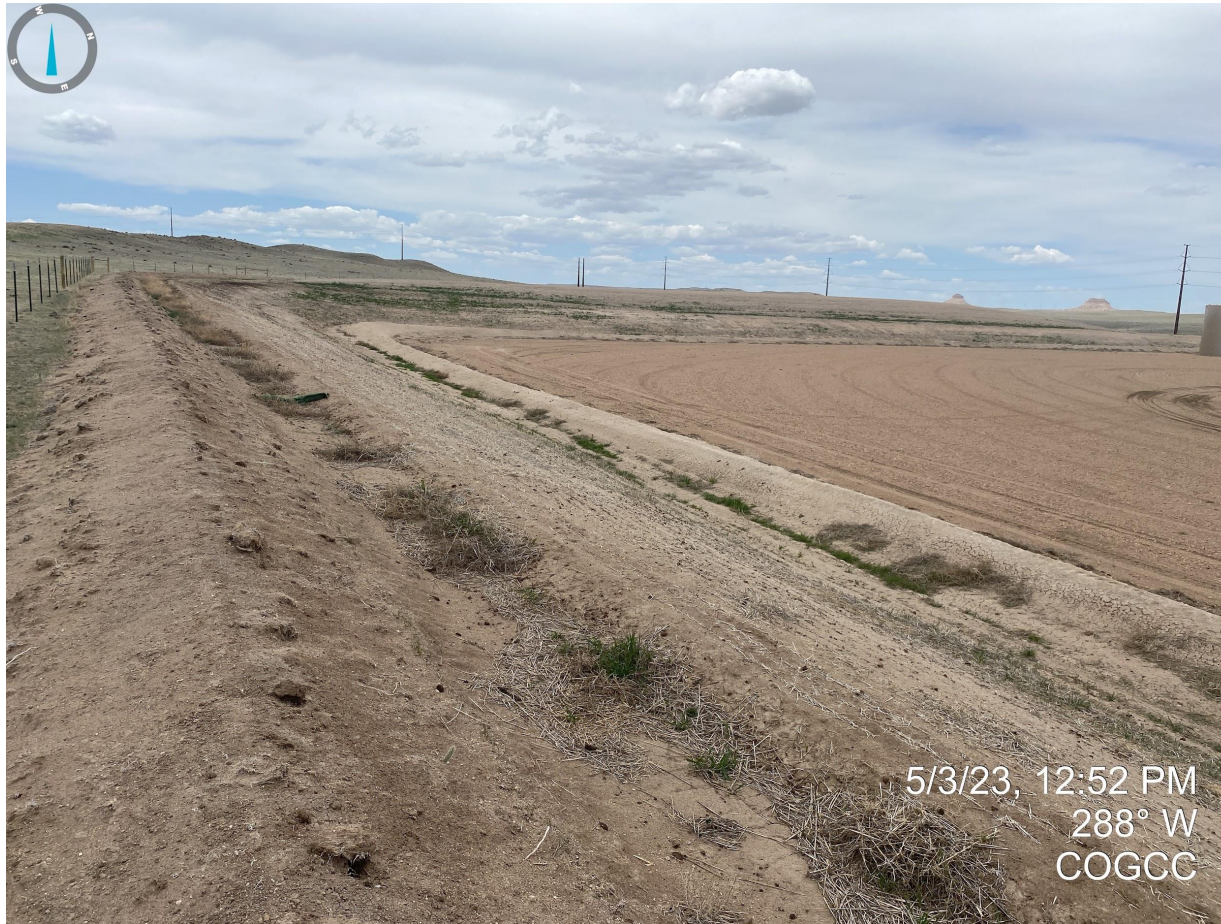
Photo 14. Cut slopes and perimeter stormwater controls will need to be properly stabilized and undesirable vegetation will need to be managed during the next growing season.

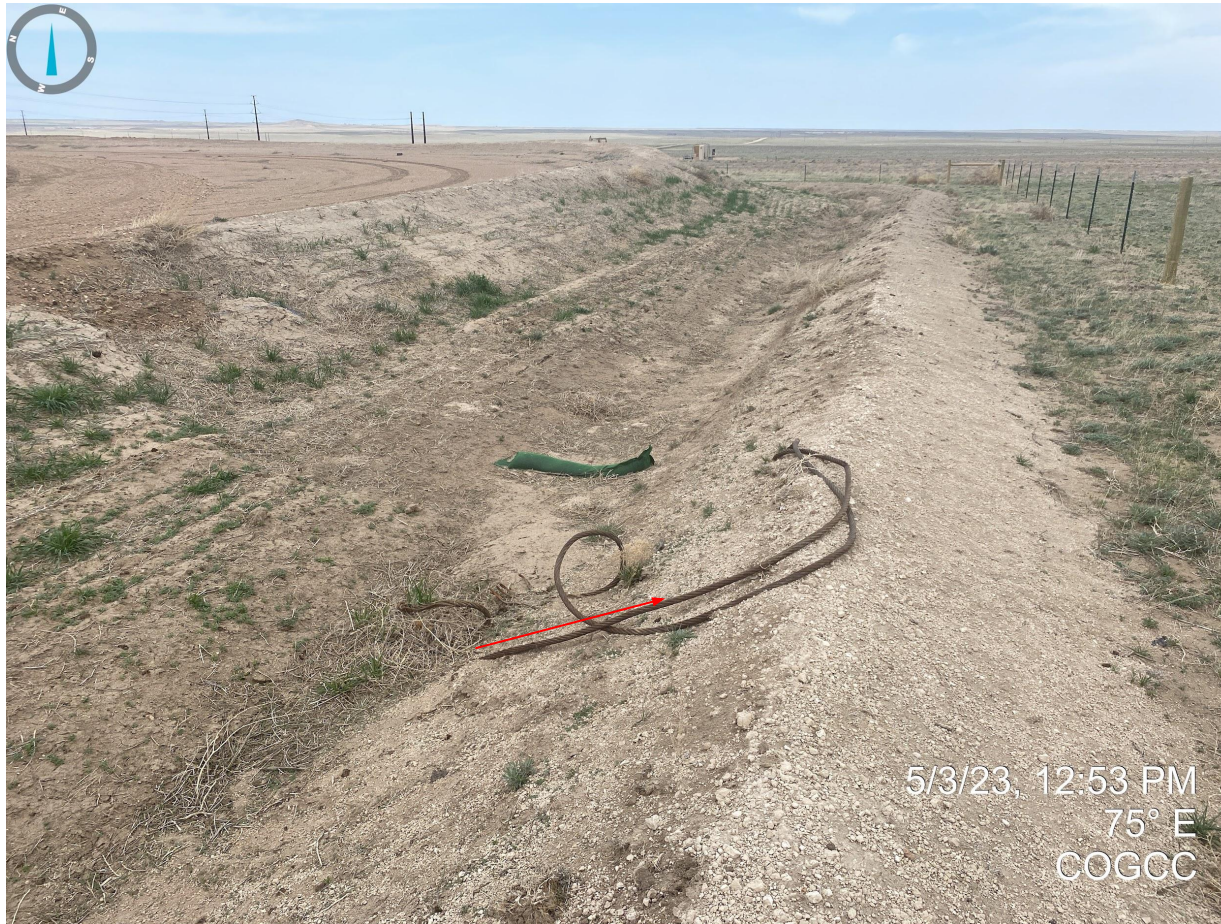
Photo 15. Trash found in ditch.

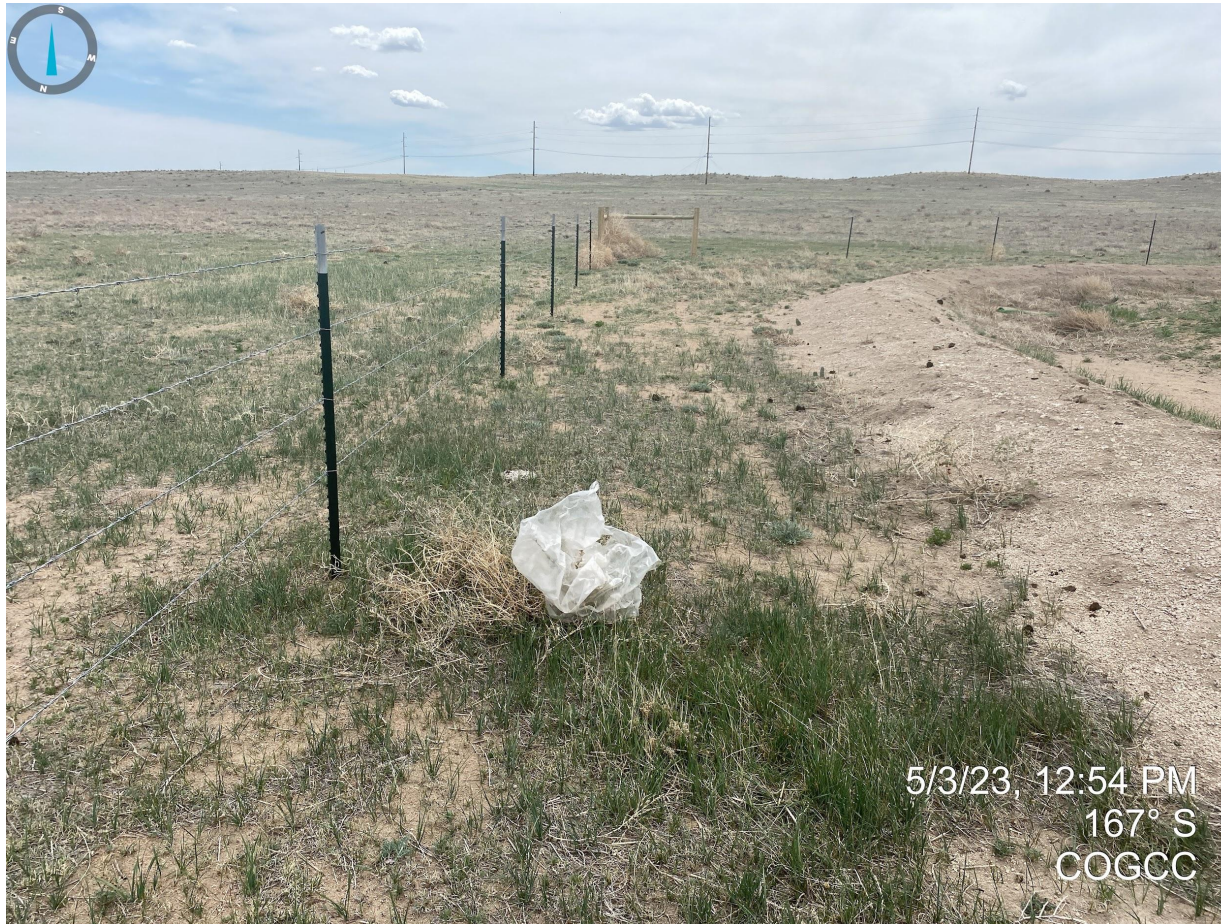
Photo 16. See comments in Photo 15.

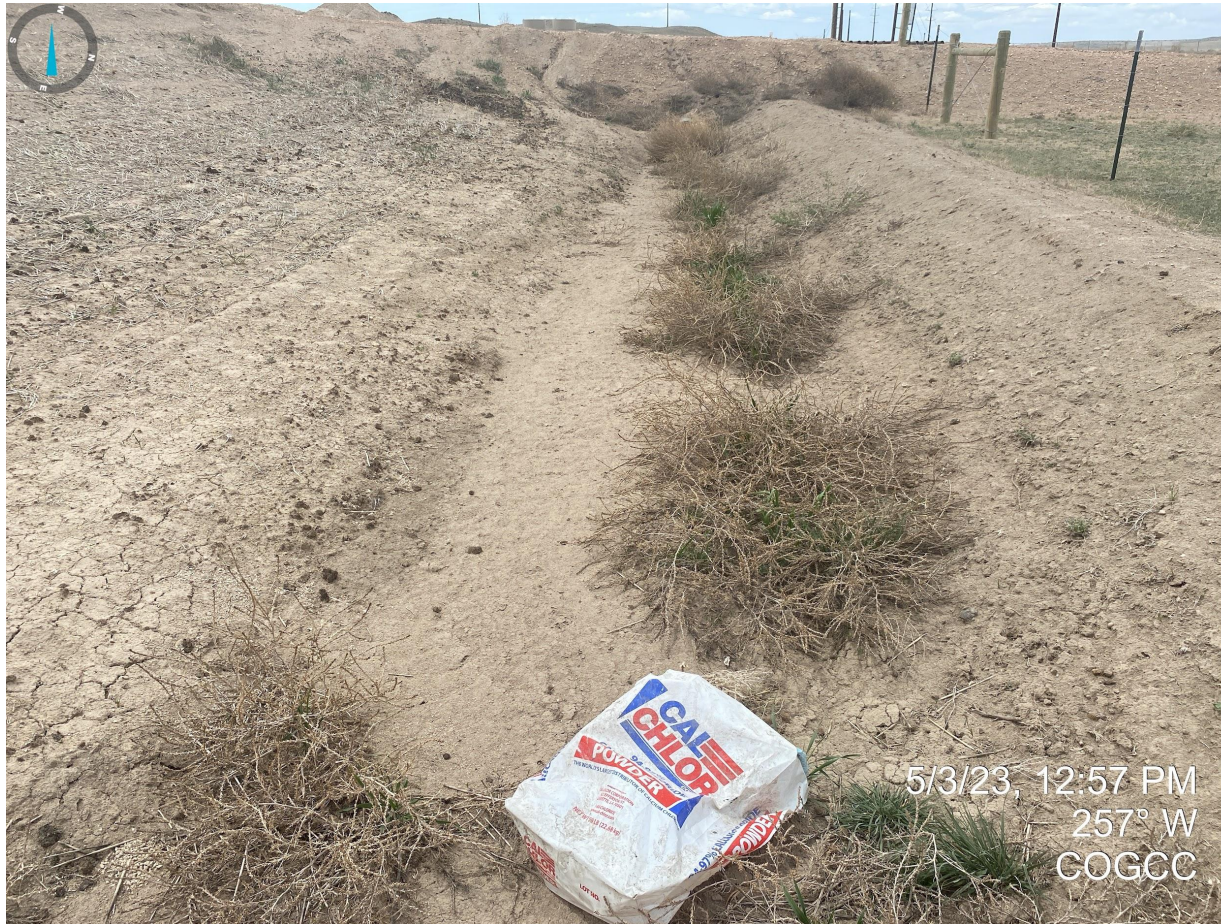
Photo 17. See comments in Photo 15.

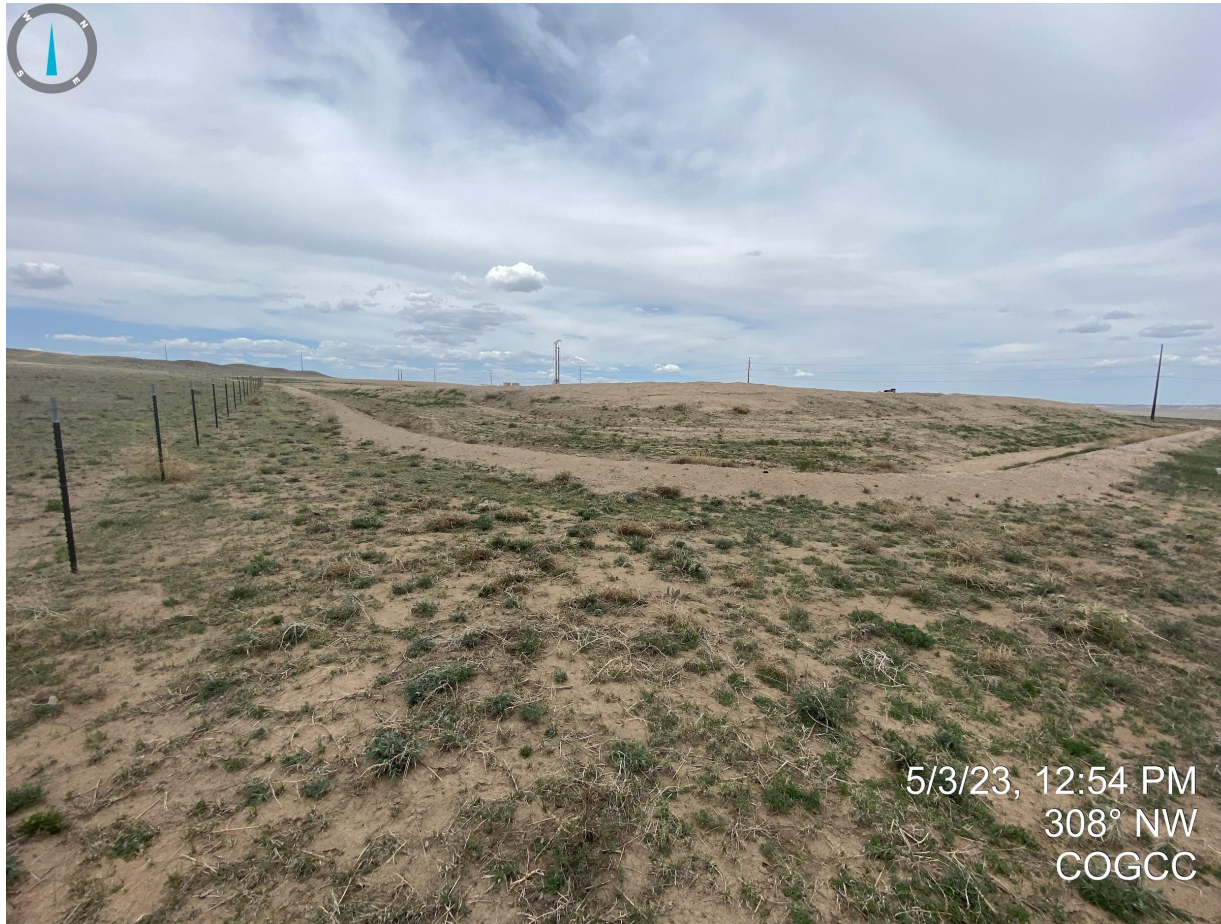
Photo 18. See comments in Photo 14.

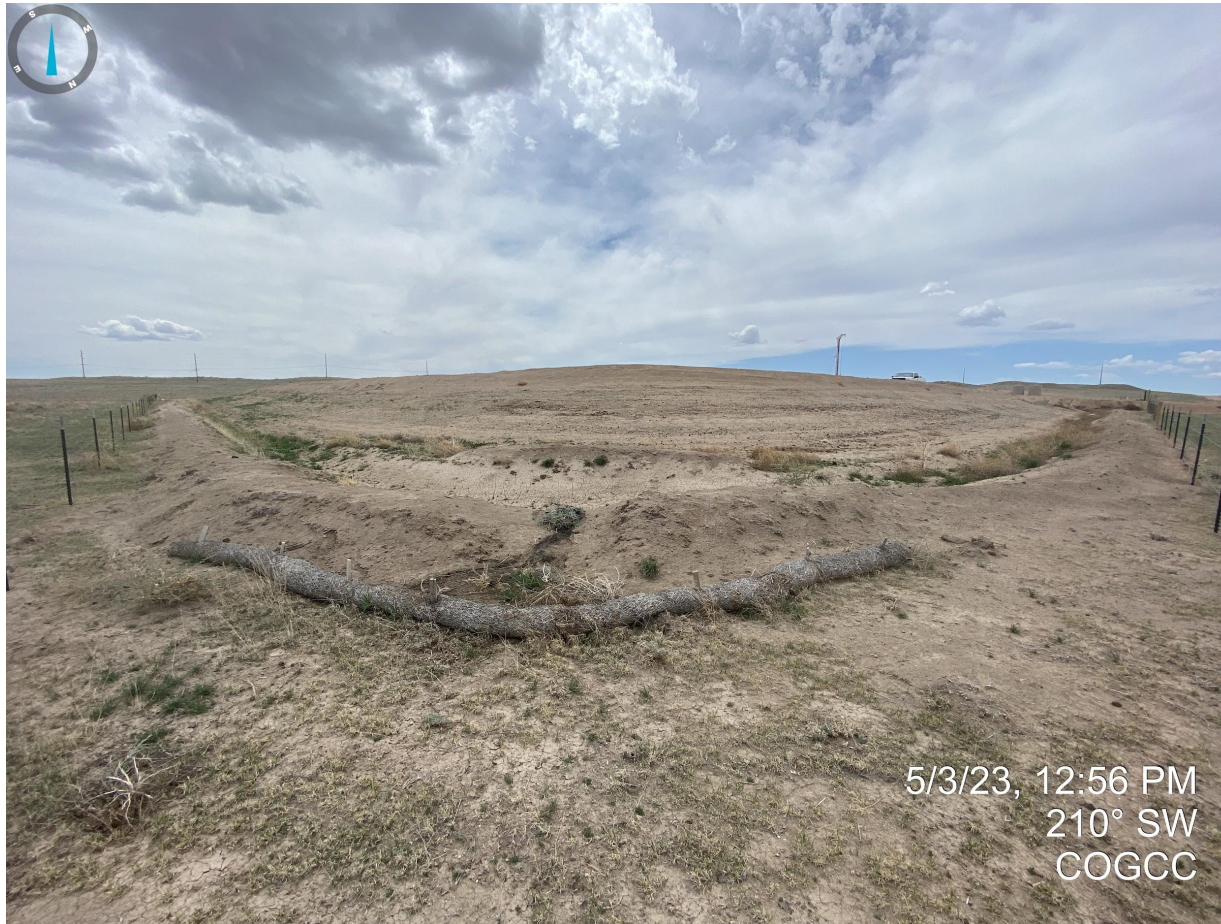
Photo 19. Cut slopes and stormwater BMPs will need to be properly stabilized to protect against wind and water erosion. Degraded straw wattles do not appear adequate and will require maintenance, repairs, or replacements.

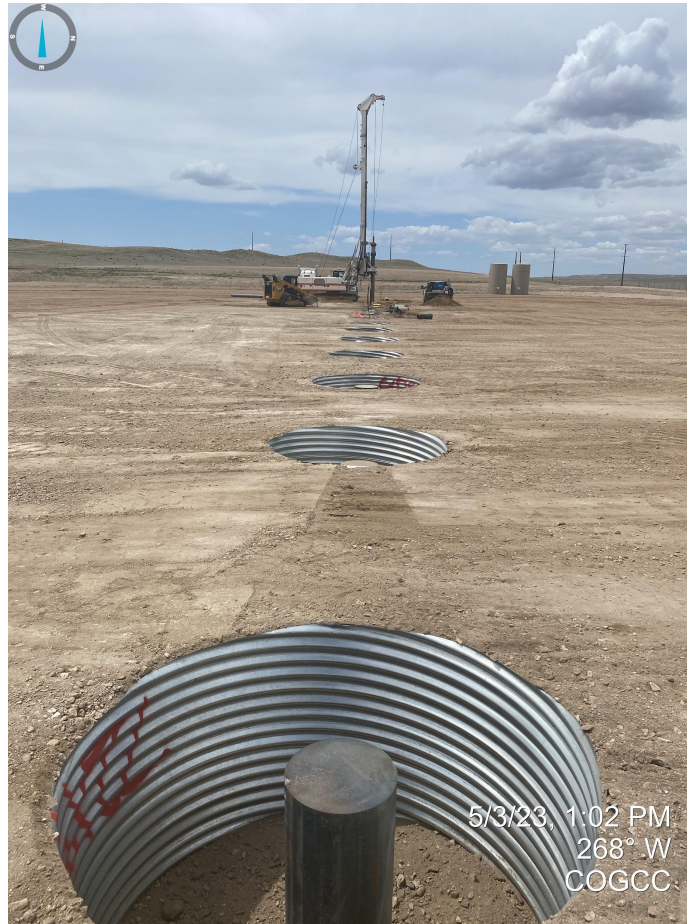
Photo 20. At the time of this inspection, cellars did not have any wildlife exclusion devices installed.
