Inspection Photos

Location Name: TEP ROCKY MOUNTAIN LLC CLOUGH RMV 217-21 pad

Location ID: 335213

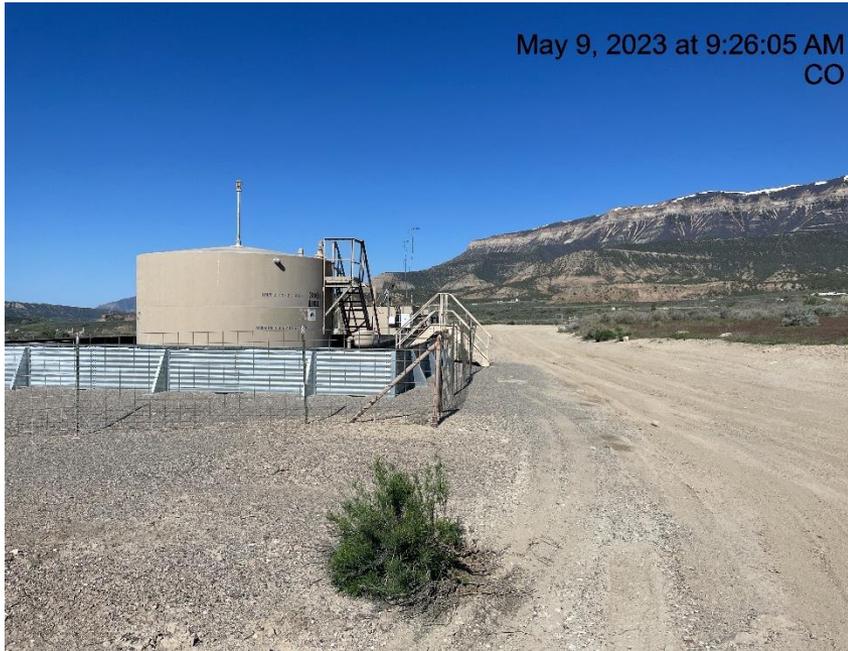
Photo # 7234 From entrance to location

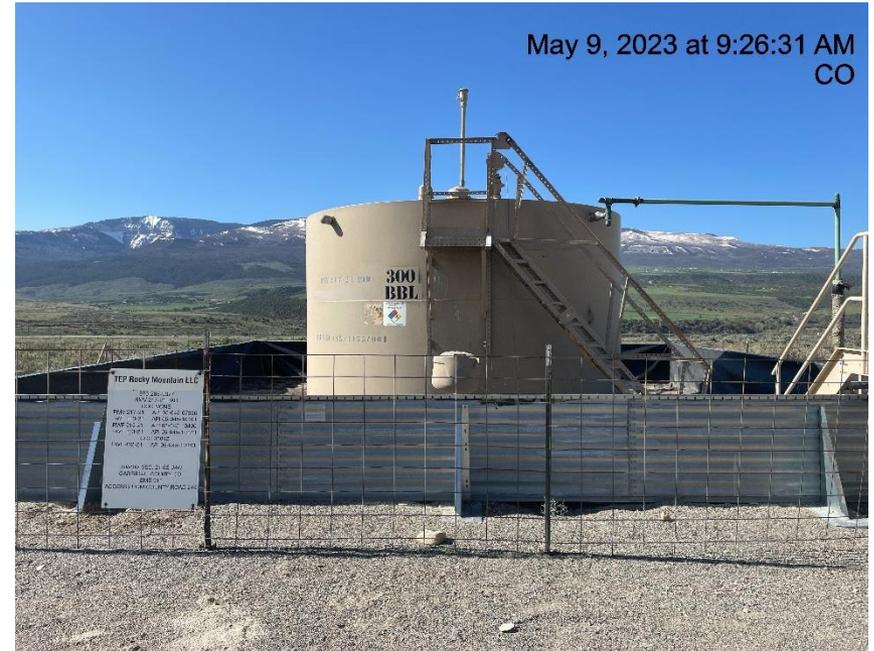
Photo # 7235 Location

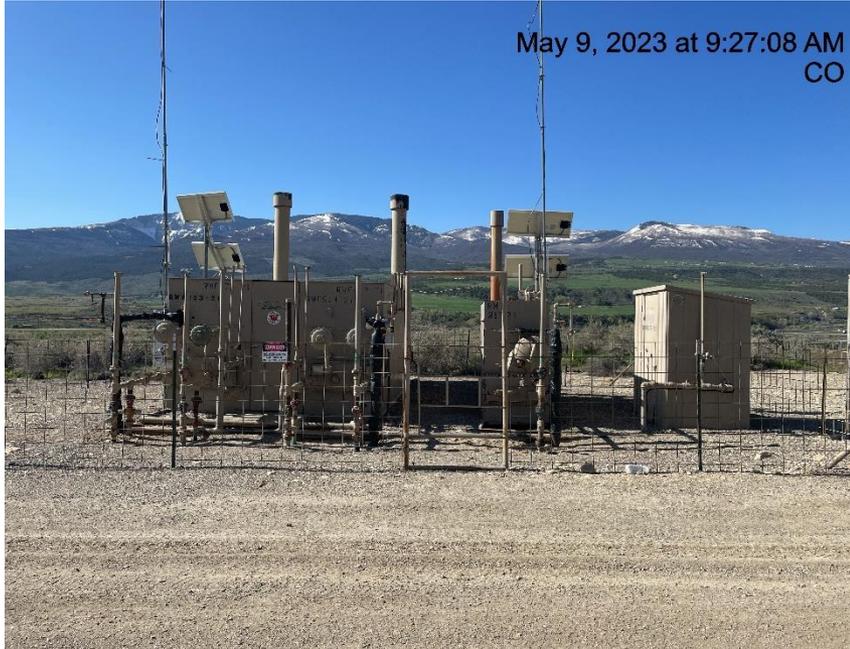
Photo # 7236 Location

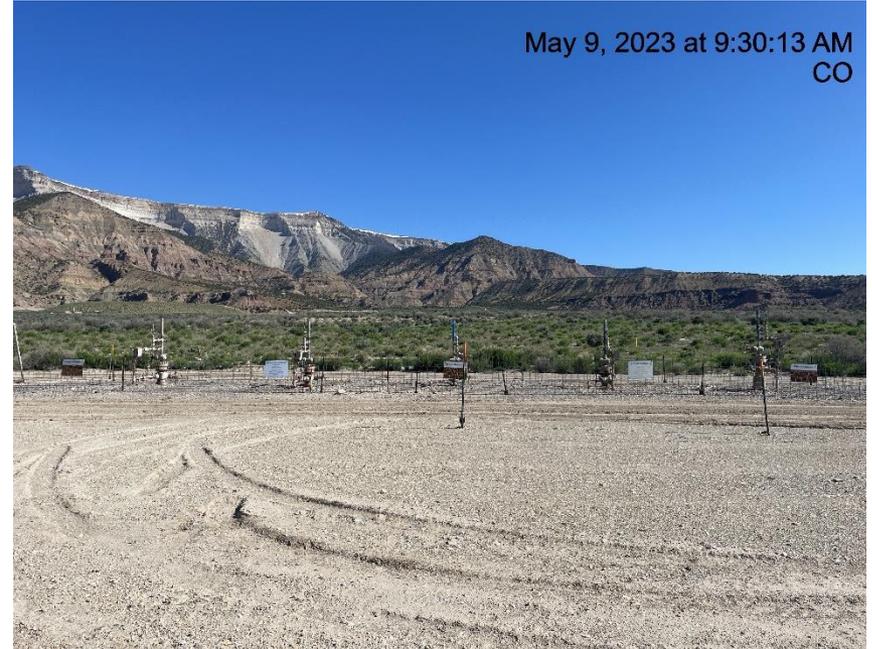
Photo # 7237 Location

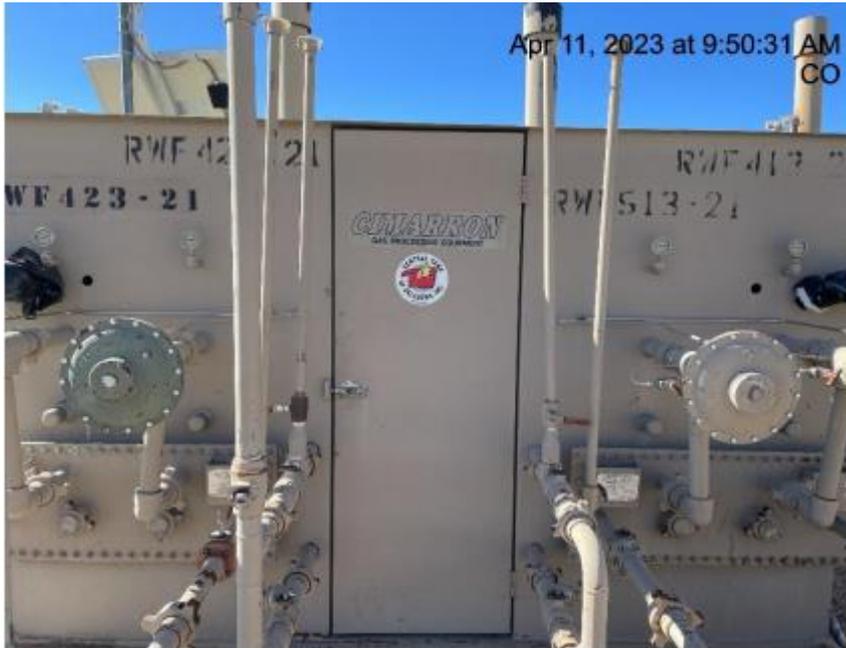
Photo # 4959 From Inspection 708900261 conducted on 04/11/2023 Meter calibration info not conspicuously posted

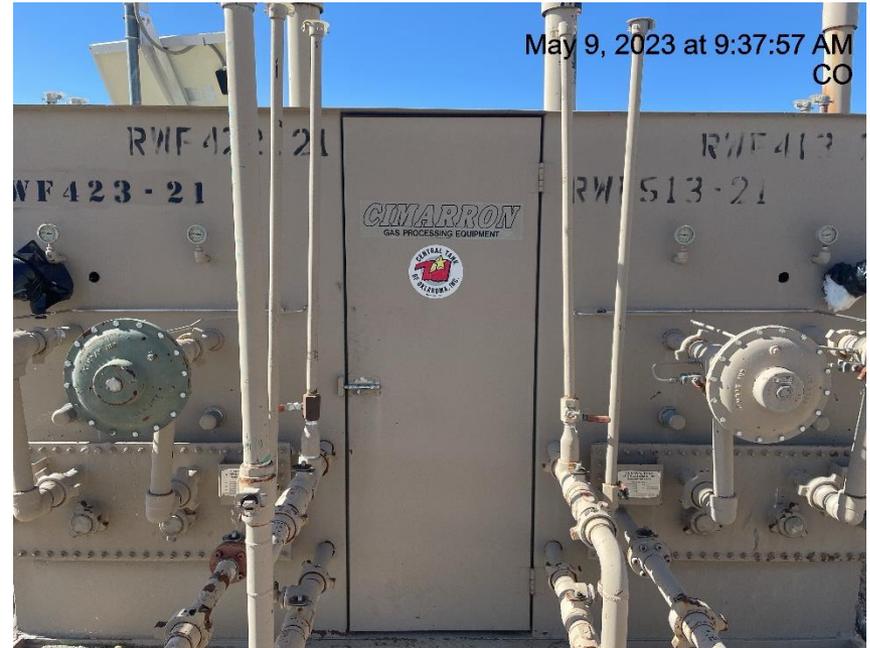
Photo # 7241 Meter calibration info not conspicuously posted

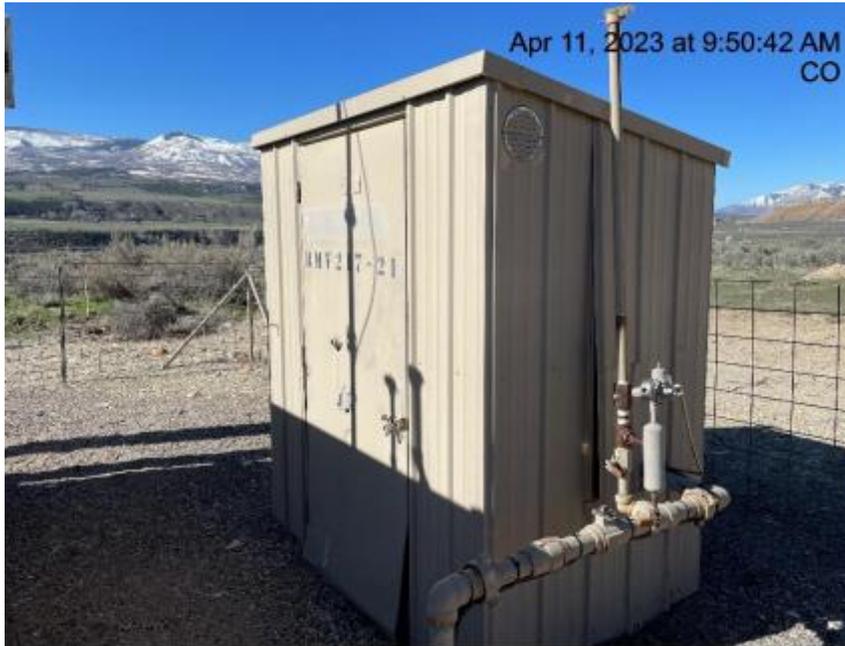
Photo # 4960 From Inspection 708900261 conducted on 04/11/2023 Meter calibration info not conspicuously posted

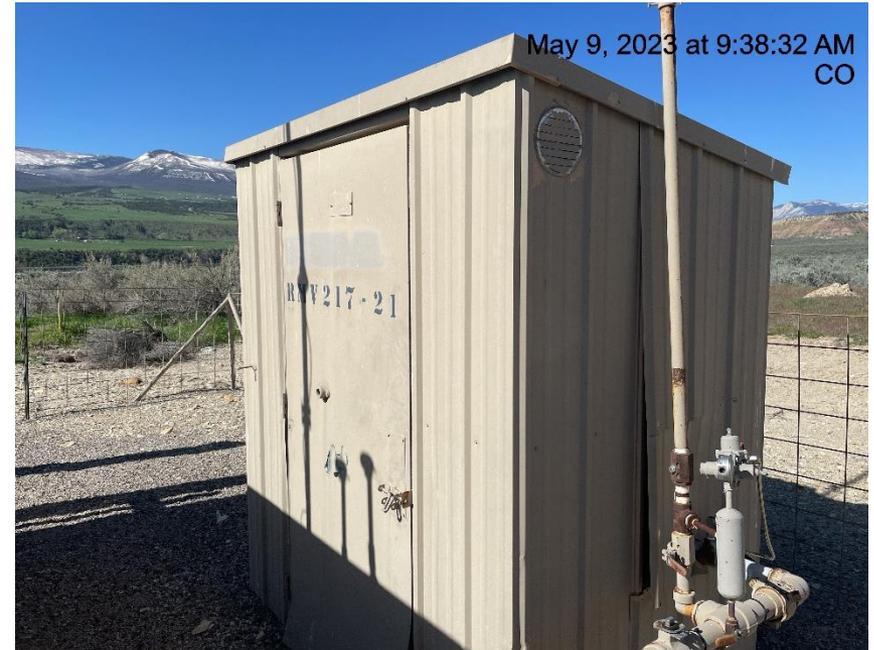
Photo # 7243 Meter calibration info not conspicuously posted

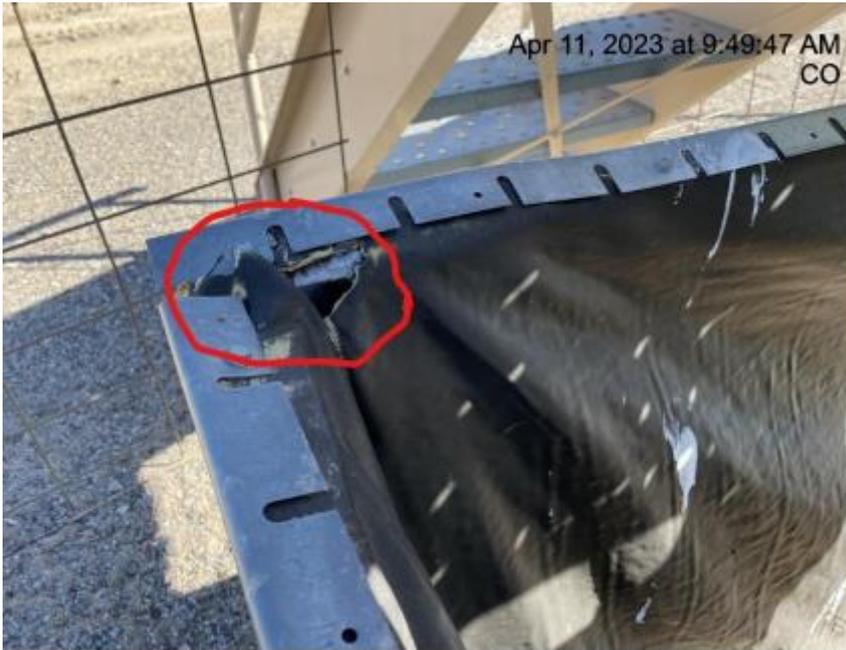
Photo # 4958 From Inspection 708900261 conducted on 04/11/2023 Containment liner needs maintenance

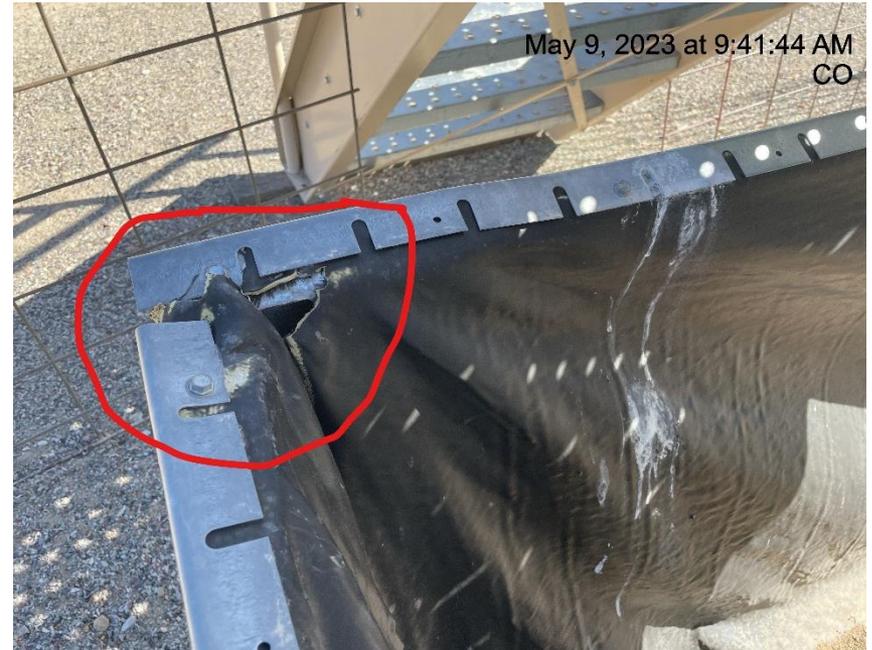
Photo # 7247 Containment liner needs maintenance
