# Final Reclamation and Stormwater Inspection

Operator: MAGPIE OPERATING INC - 52530

Location ID: 312143

Inspection Photos  
Location Name: Warnecke 68N53W 30SESE  
Location ID: 312143

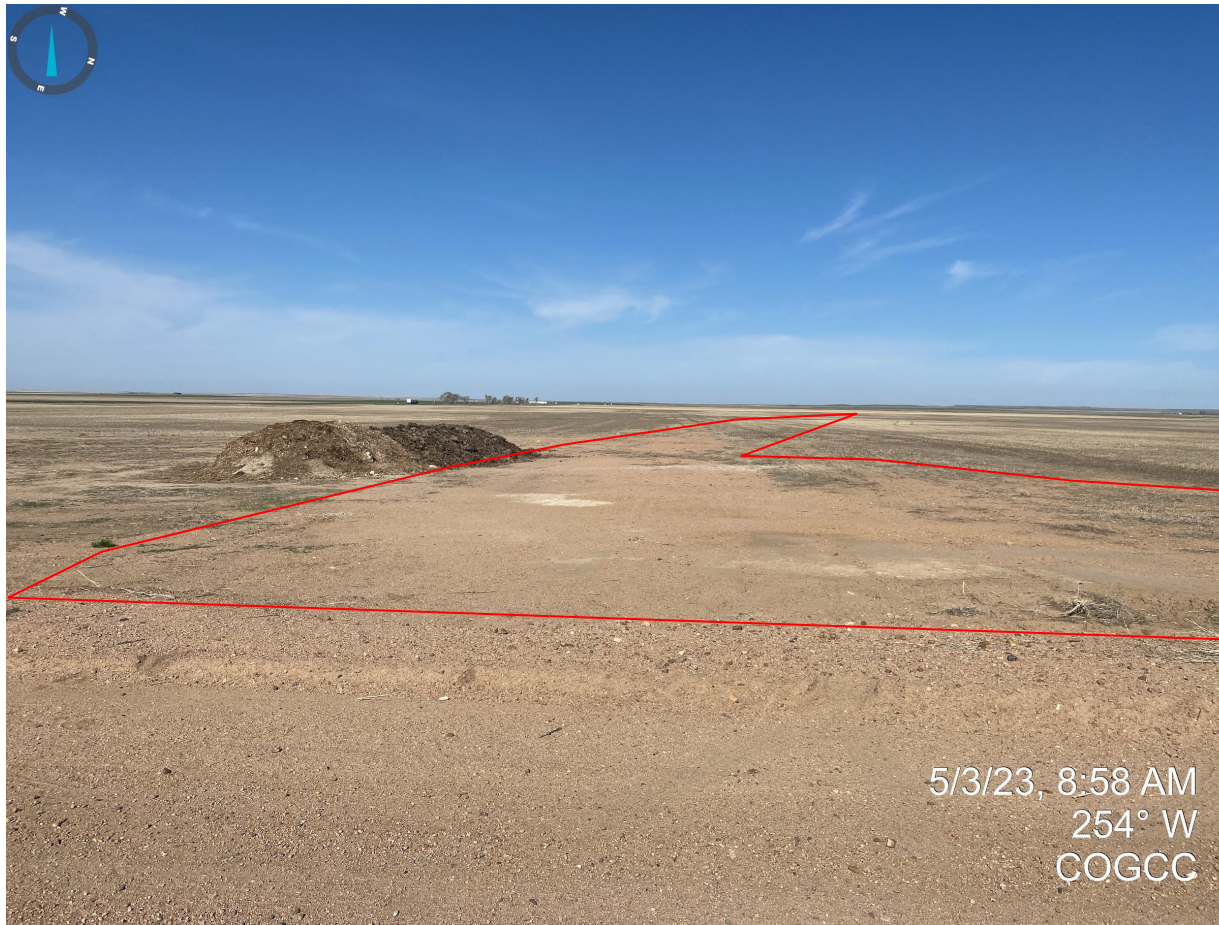
**Photo 1.** Facing west from adjacent county road. Photo illustrates that the former production areas and access road do not appear to have been reclaimed (highlighted in red) with evidence of road base material and lack of vegetation reflective of reference areas (millet stubble at time of this inspection).

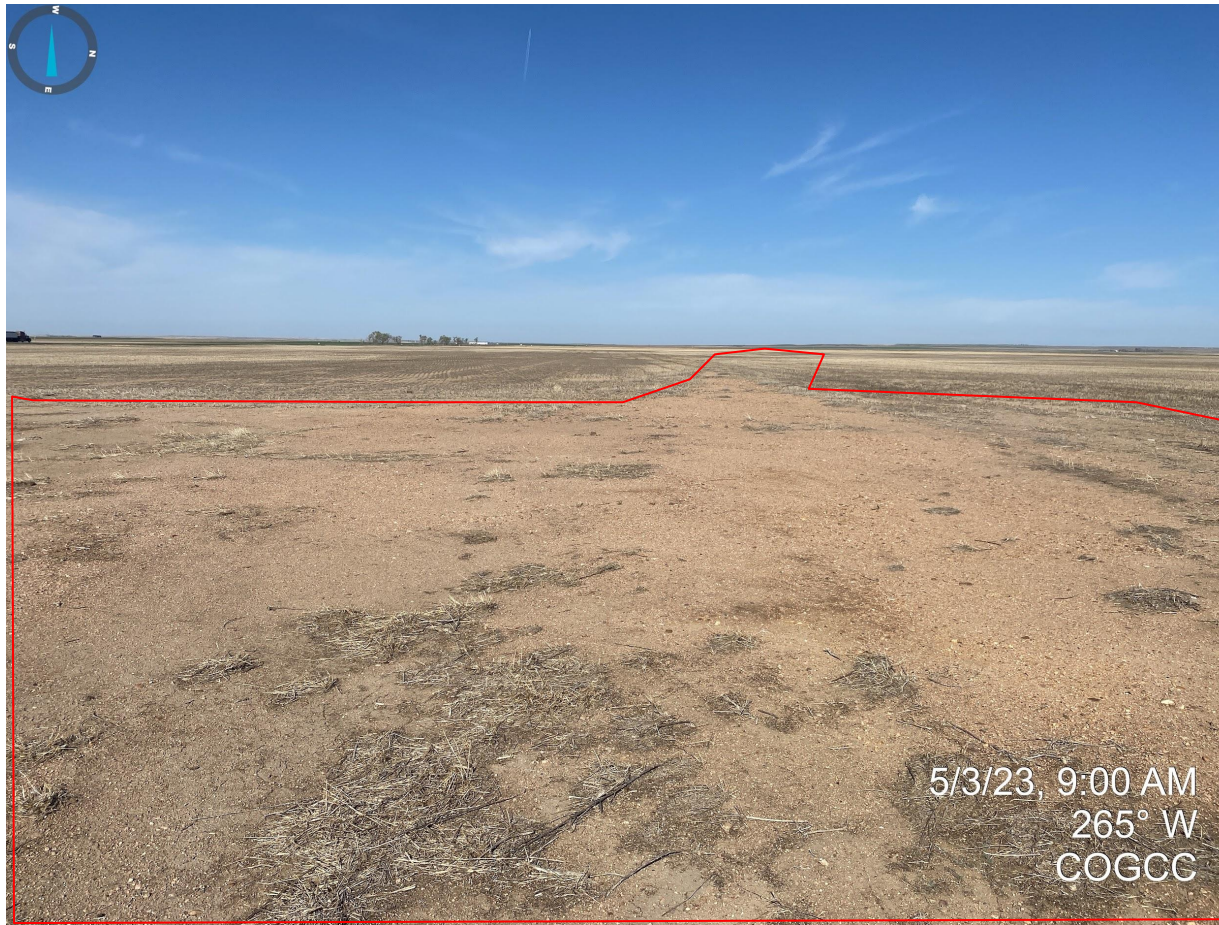
**Photo 2.** Facing west from former production areas. Active remediation (not pictured; off to the left (South) of photo) should not preclude the commencement of final reclamation activities. Road base material still evident in this photo; does not appear the location has been reclaimed.

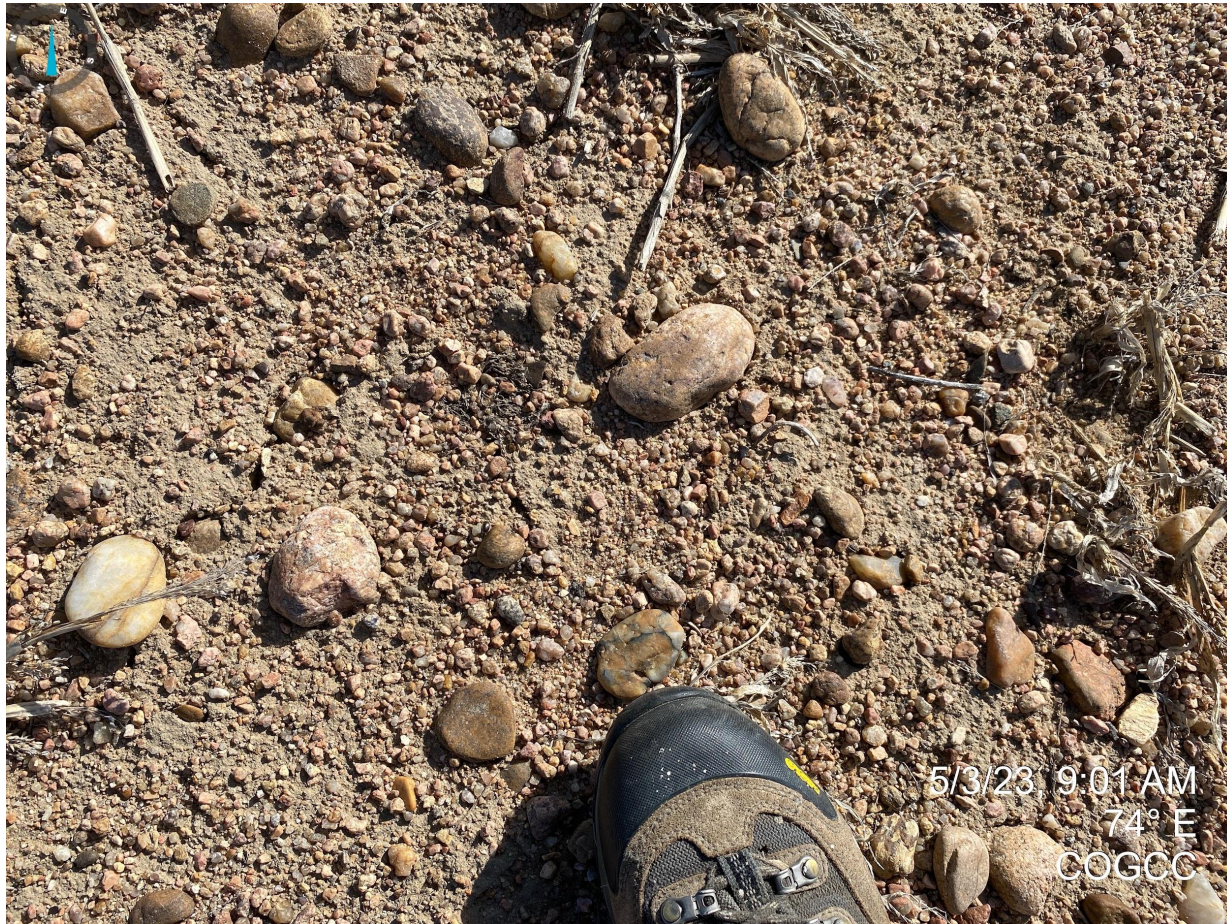
**Photo 3.** Close up photo of road base material left on the former production area and access road to well API# 075-05621.

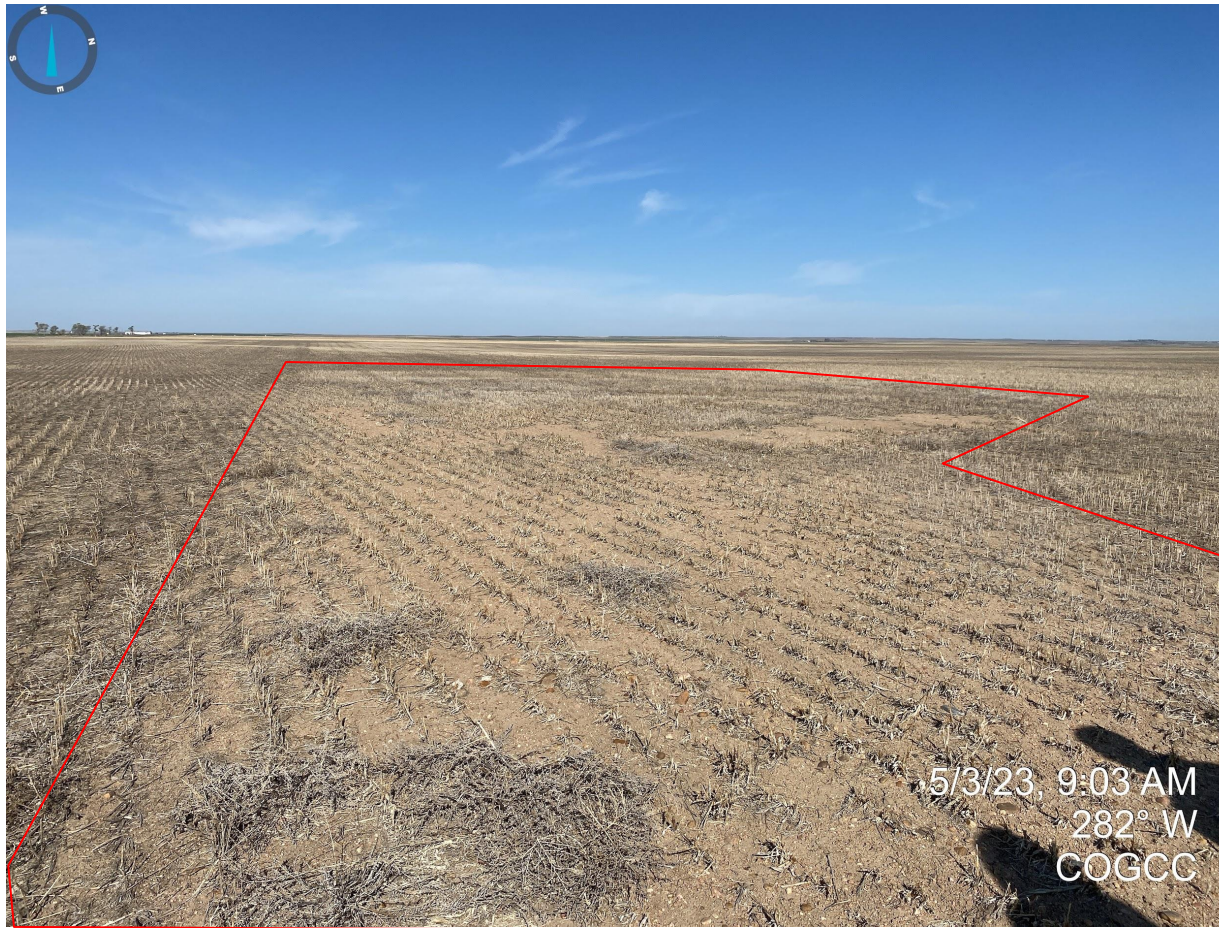
**Photo 4.** Facing west towards the former well location. Presence of road base material was observed throughout. All road base will need to be removed before the location can be decompacted, contoured and graded.

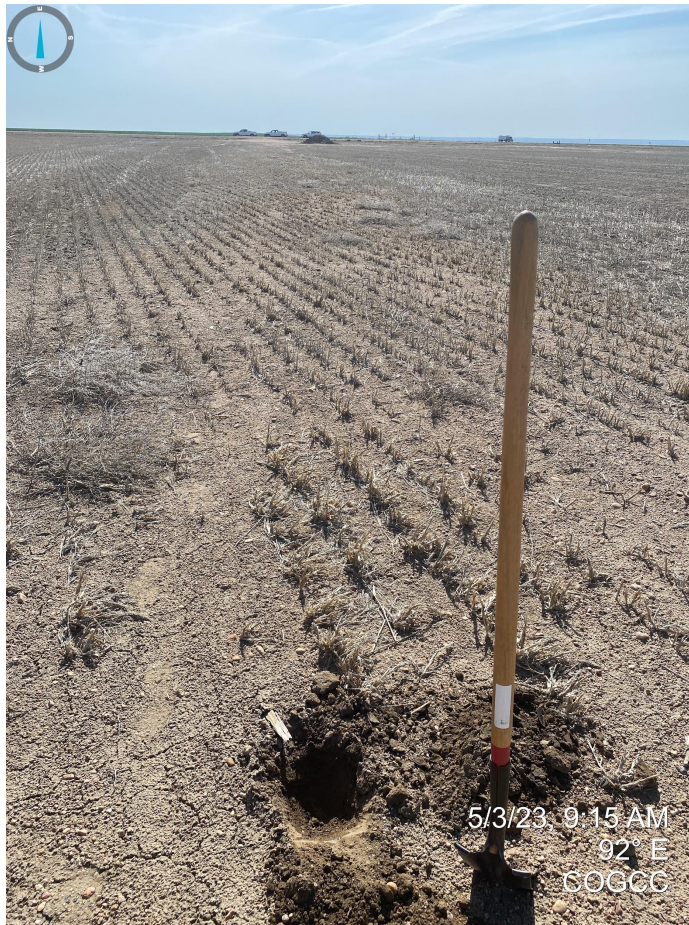
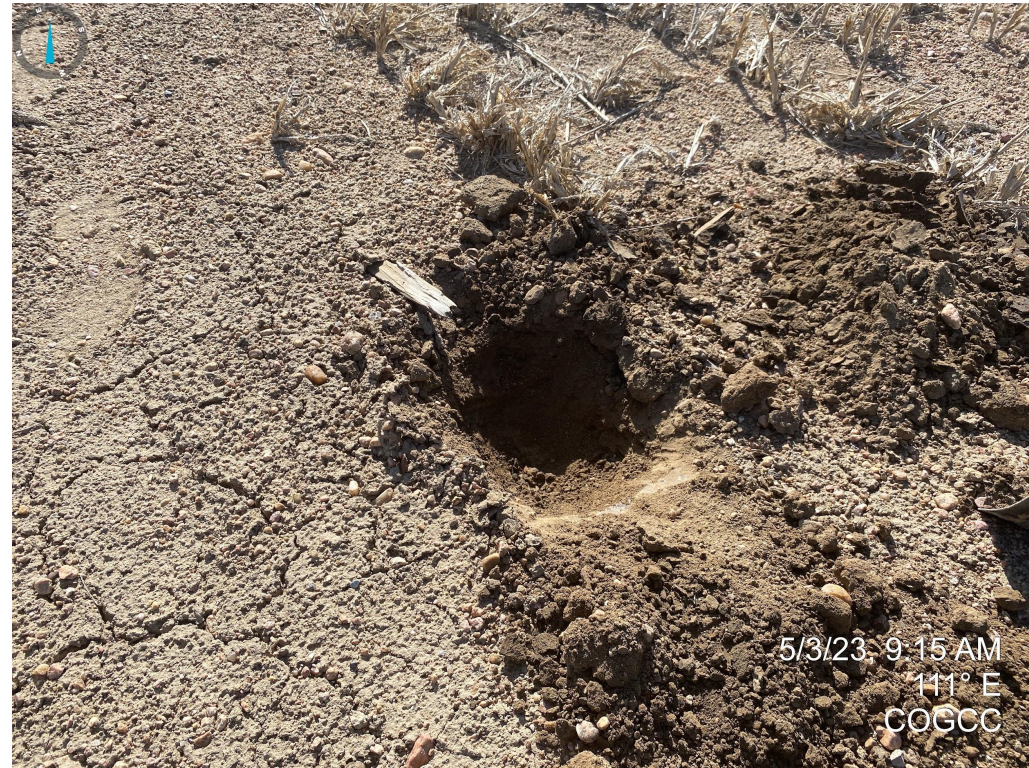
**Photos 5 & 6.** Staff conducted a compaction test around the former wellhead location. Soil pothole was only dug approximately 3-4" bsg before encountering compacted soil.

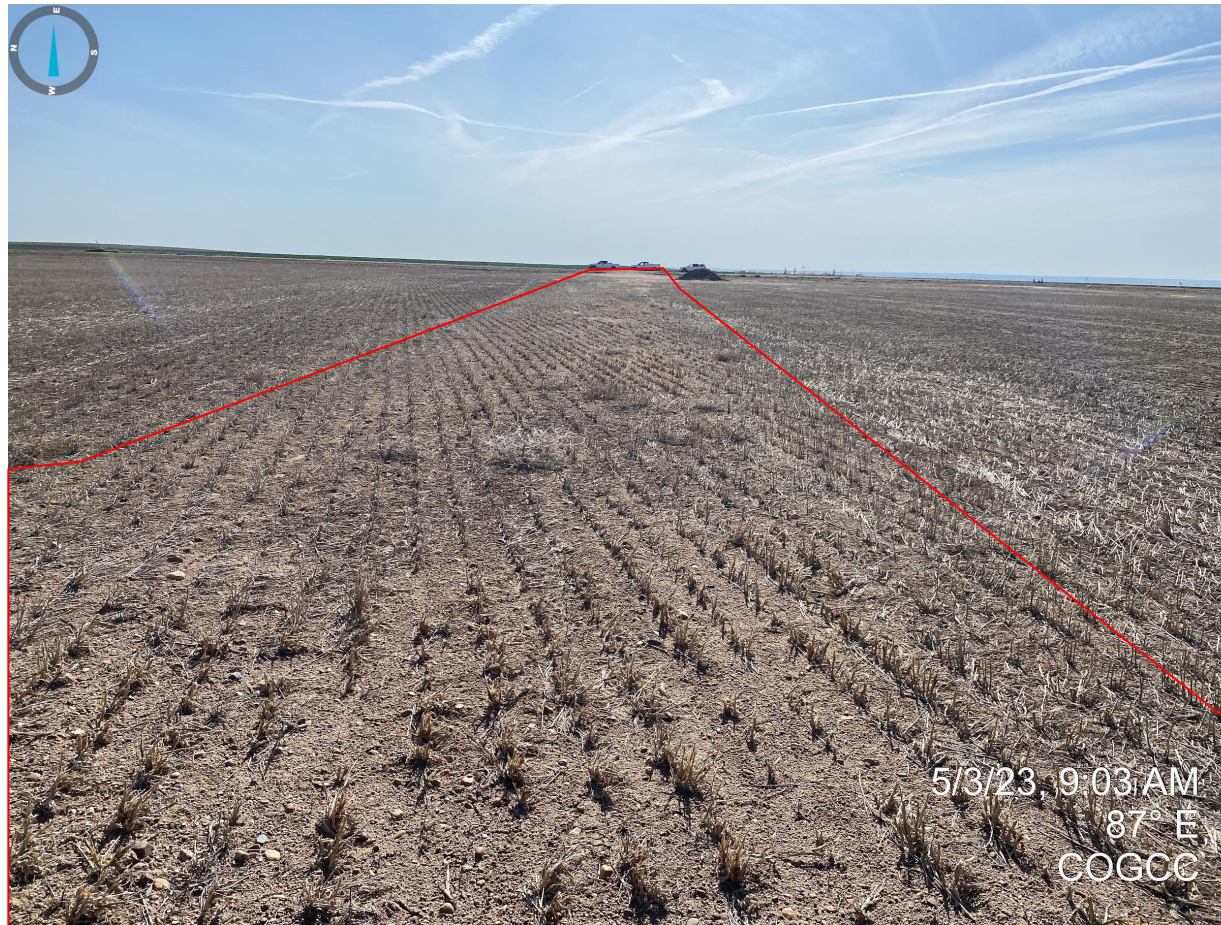
**Photo 7.** Facing east from the access road to the well location. Red outline illustrates the access road that will require further reclamation activities to meet Rule 1004 standards.

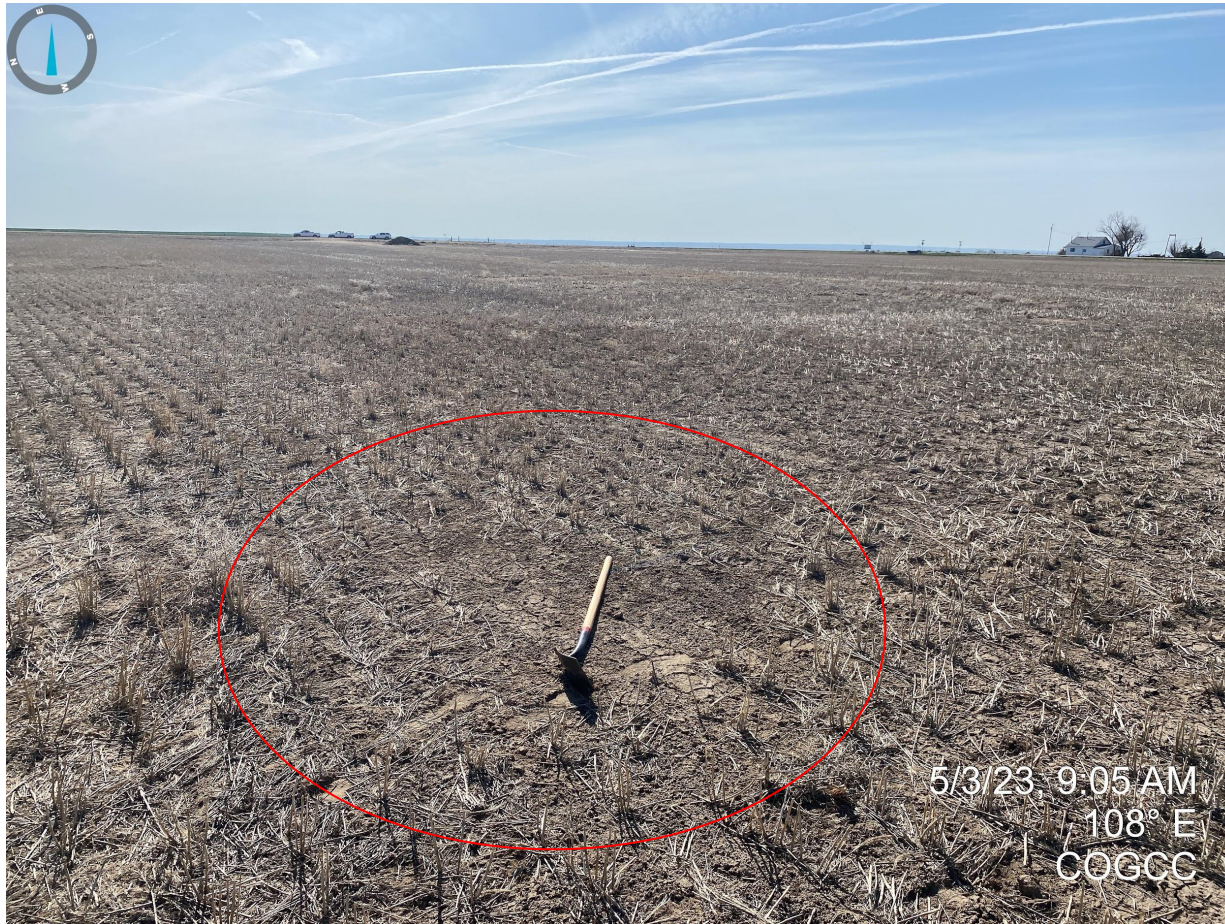
**Photo 8.** Northwest guy line anchor highlighted in red. No visible stubble from recent crop, possibly a result of compaction issues. This area will also require additional reclamation activities. Note: these are only examples as all four guyline anchors have poor or little to no growth (see Photo 10 for further).

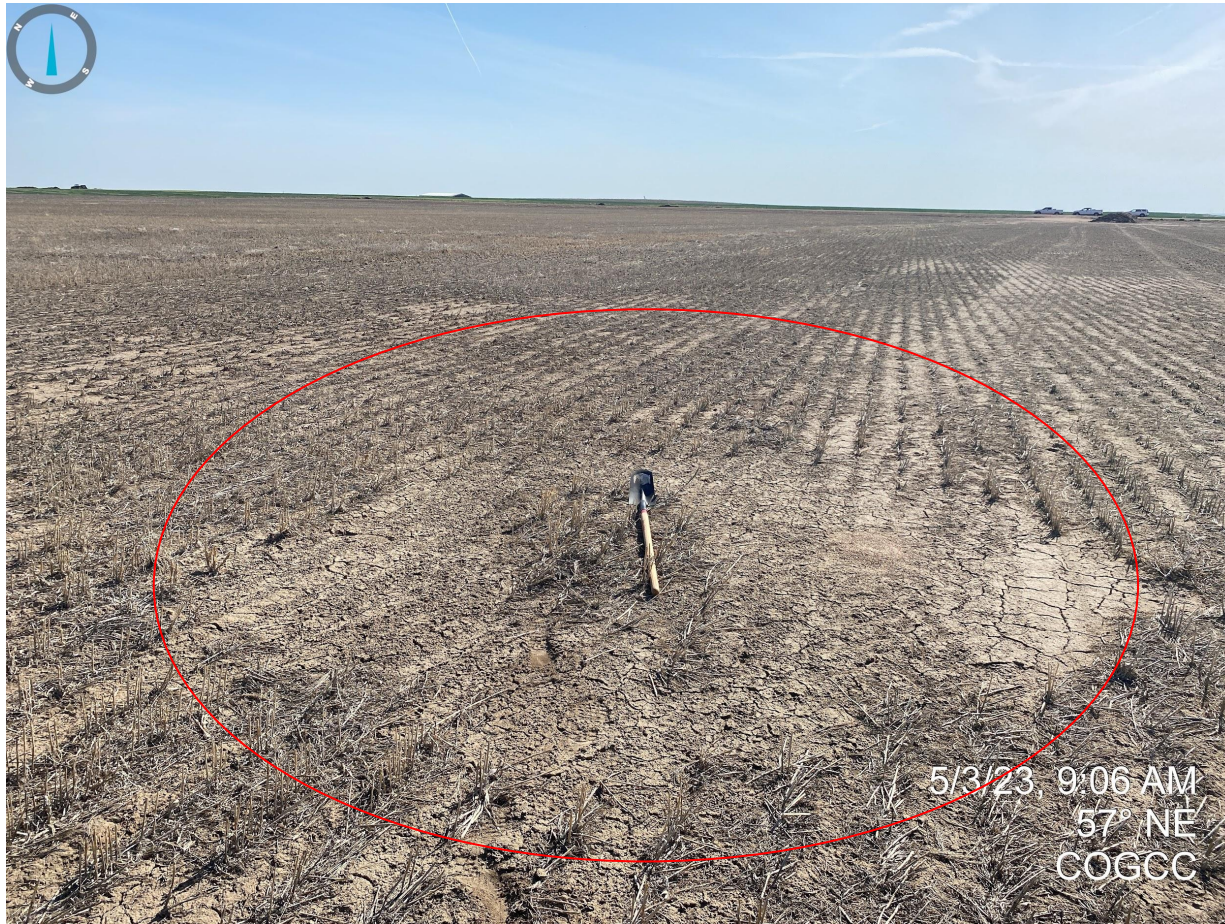
**Photo 9.** Southeast guyline anchor; see comments in Photo 8.

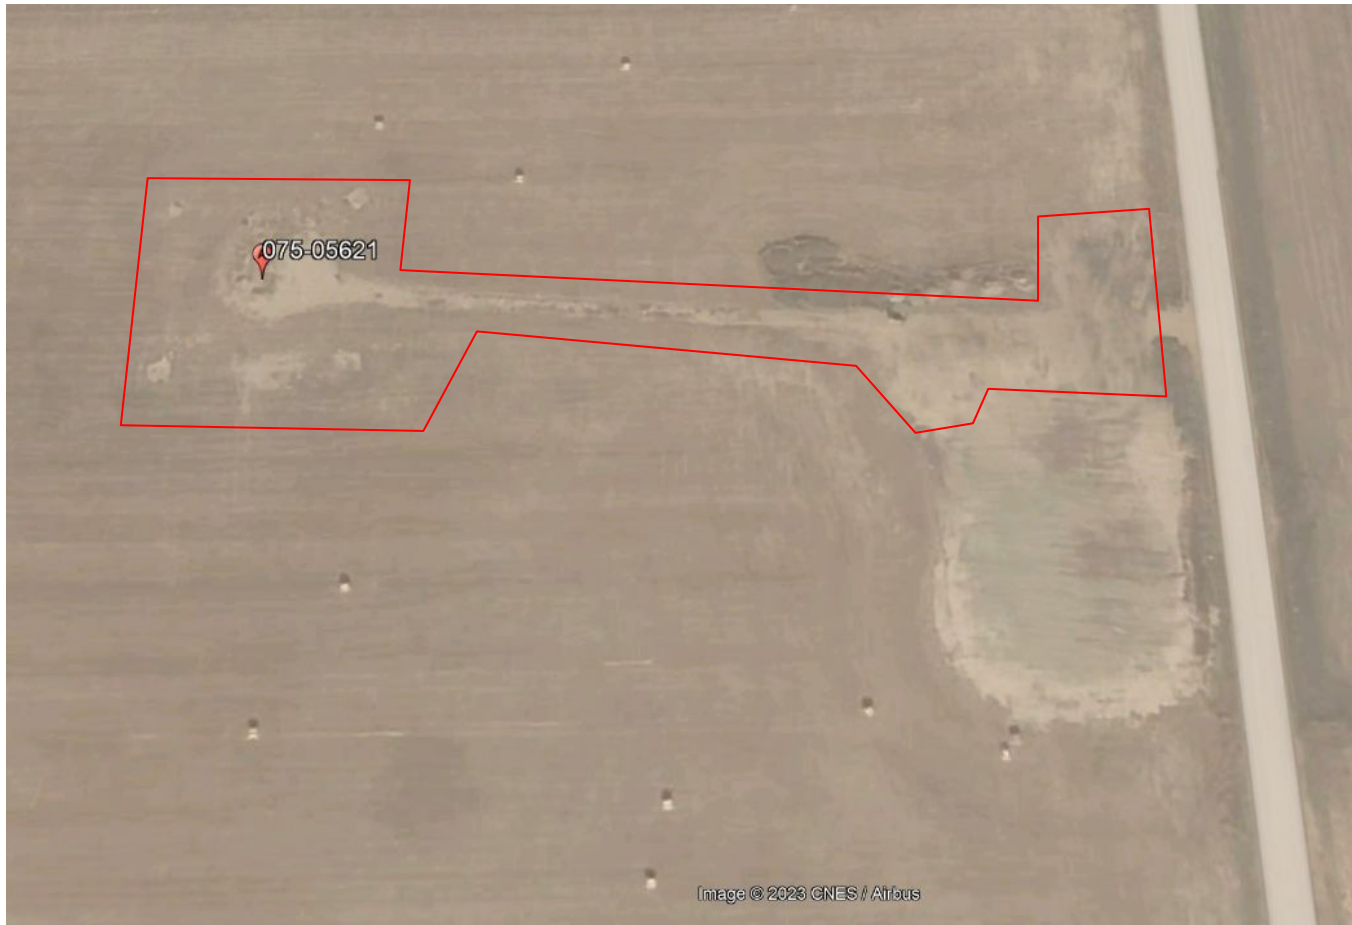
**Photo 10.** Google Earth aerial imagery (circa 10/2020) illustrating red outline of former access road, well location, and production area disturbances that will require final reclamation activities ASAP. Active remediation should not preclude the commencement of final reclamation activities on the above identified areas. Final reclamation should have been completed by 07/22/2019, per 1004 Rules.
