Inspection Photos
Location Name: Pace-Connelly #2
Location ID: 318512

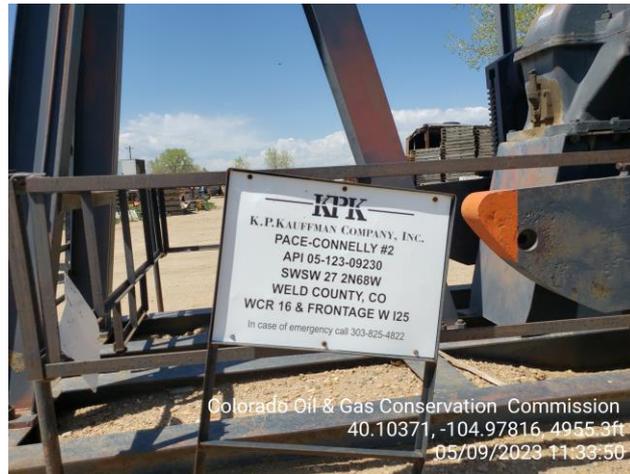
Photo 1 WH sign.

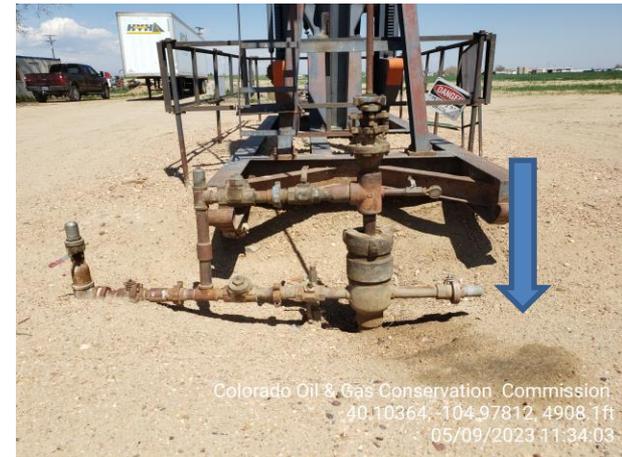
Photo 2 Stained soil by the WH.

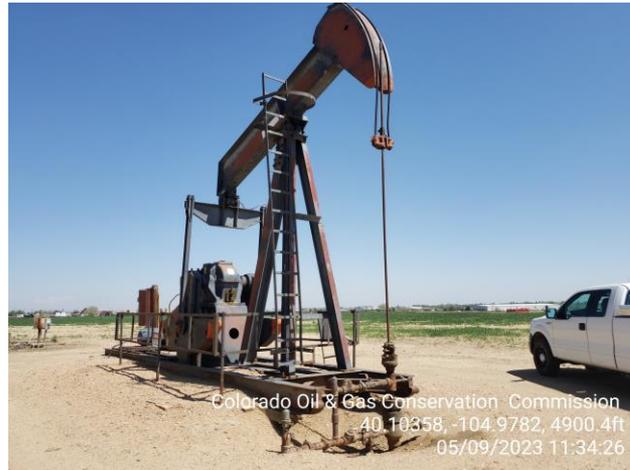
Photo 3 pump jack.

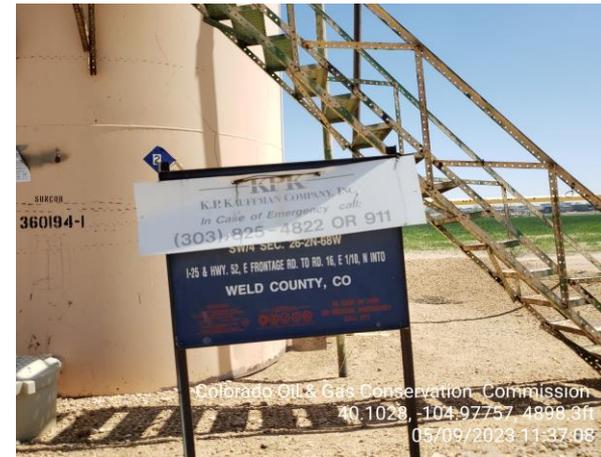
Photo 4 TB sign.

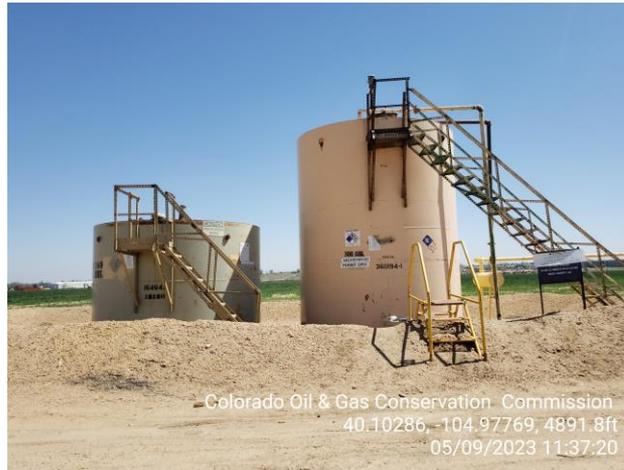
Photo 5 TB.

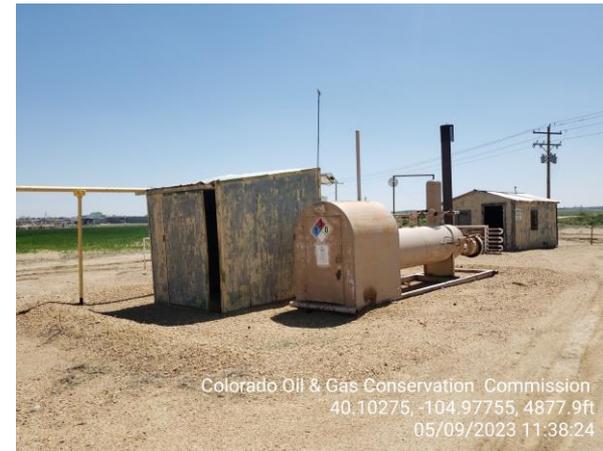
Photo 6 Horizontal Heated Separator and Flow line manifold house.

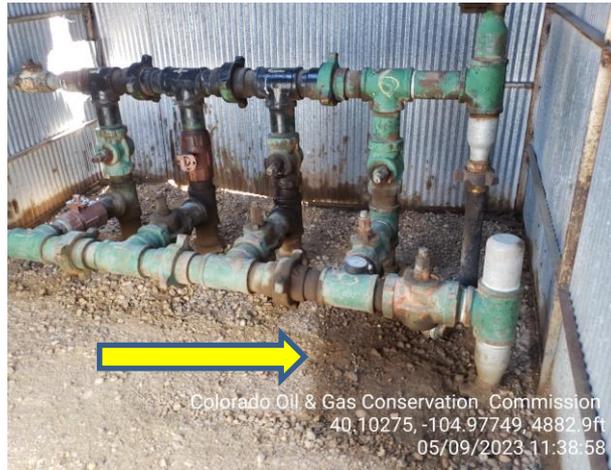
Photo 7 Stained soil under flow line manifold.

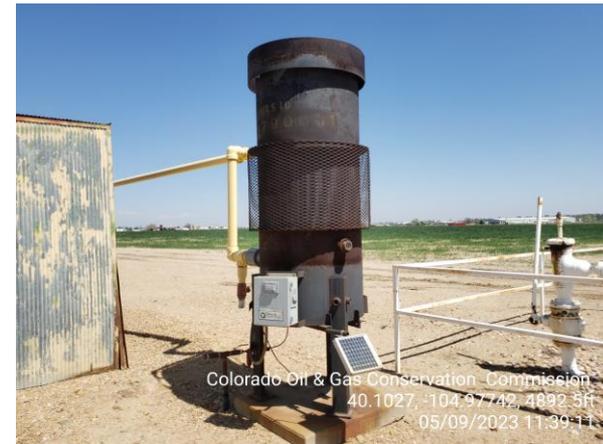
Photo 8 ECD.

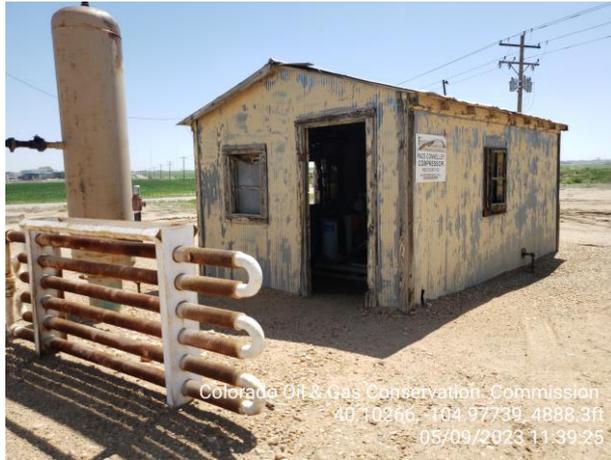
Photo 9 Compressor house.

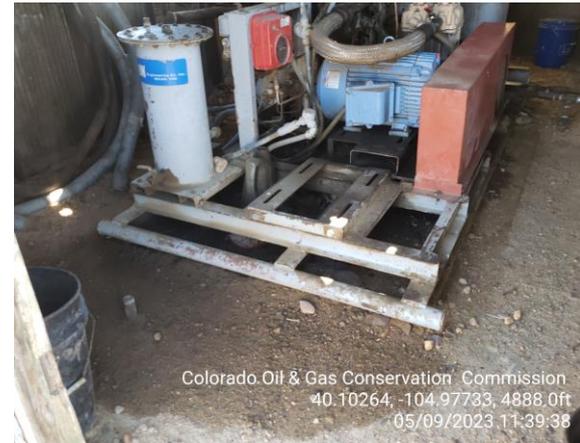
Photo 10 Stained soil under skid in compressor house.

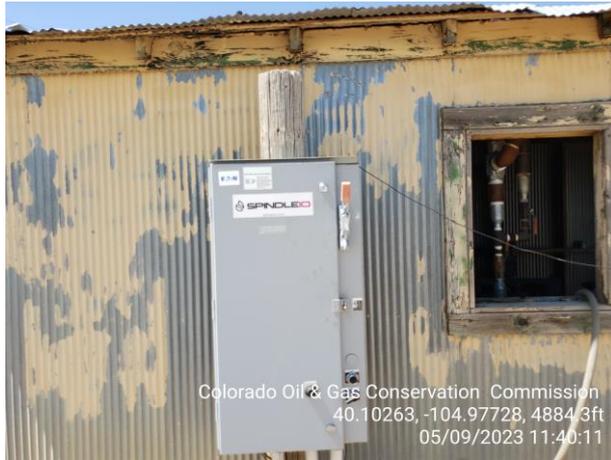
Photo 11 Electric panel at Compressor house is on.

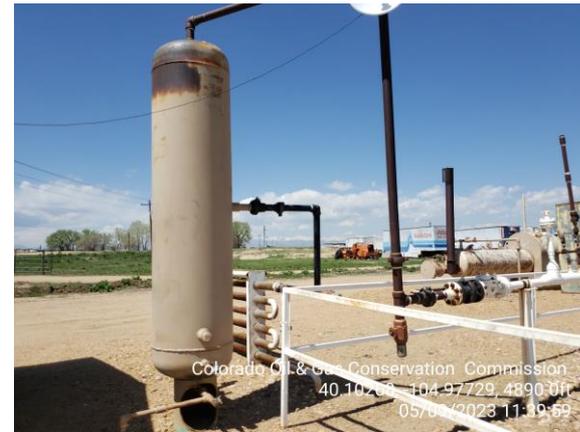
Photo 12 Vertical Separator.

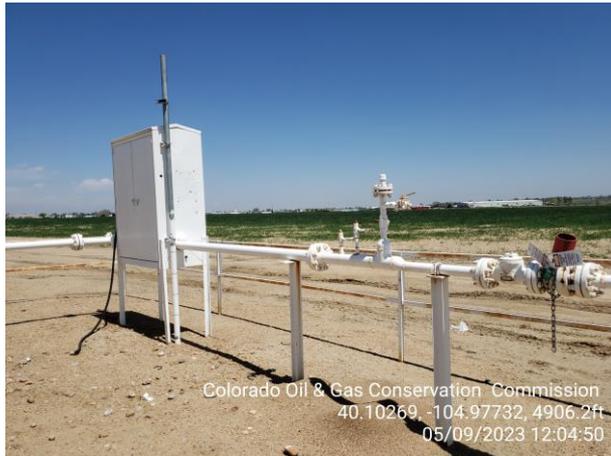
Photo 13 Gas Meter Run LOTO.

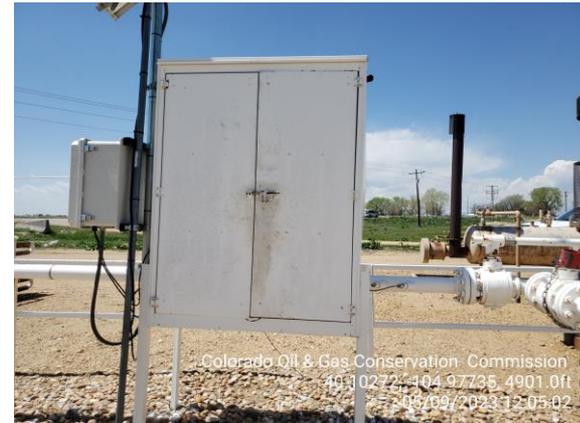
Photo 14 Gas Meter Run.

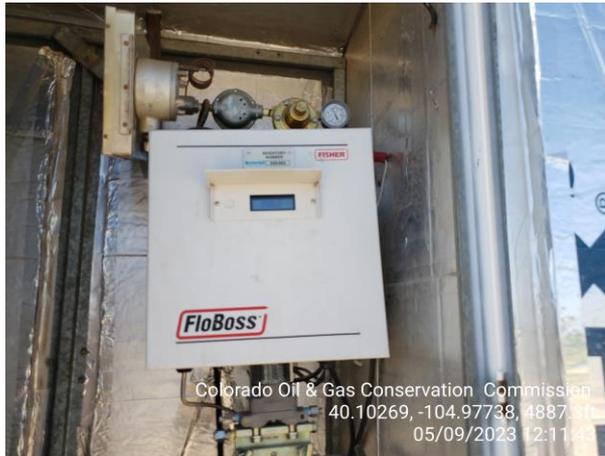
Photo 15 Anadarko Gas Meter inventory # 295482.

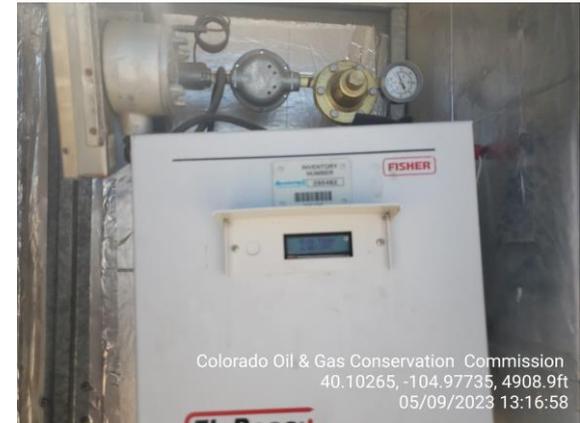
Photo 16 Gas Meter Run shows yesterdays flow at 3.579175 and a monthly flow at 39.91647 .
