# Inspection Photos

Operator: Beeman Oil & Gas Inc- #7125

Location Name: Bulldog /17-11H-893

Inspection Document #: 702801506

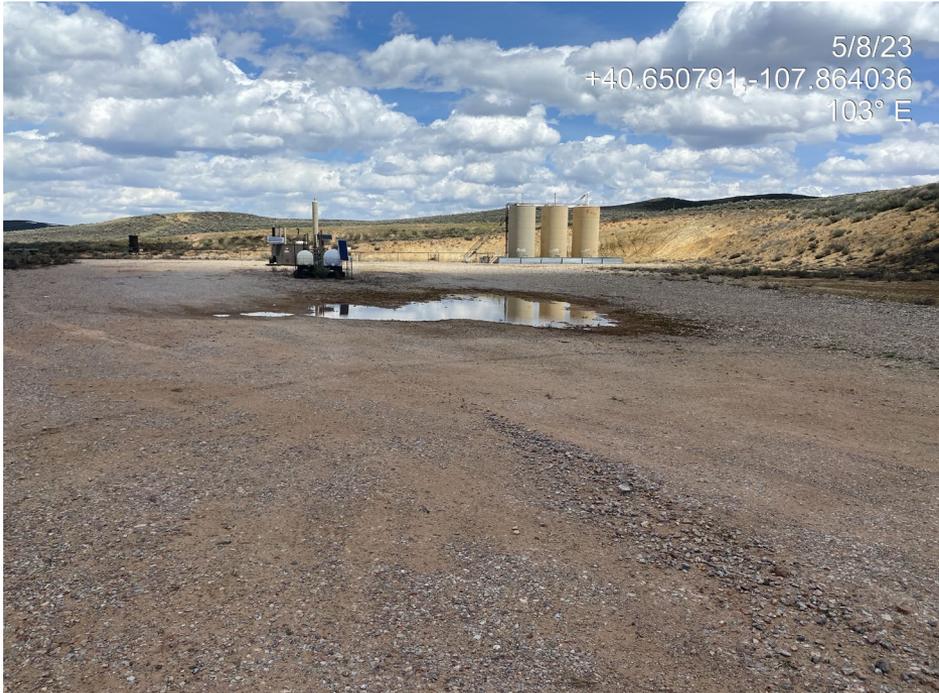
**Photo 1.** Photo taken from the Location entrance shows an overview of the eastern portion of the Location.

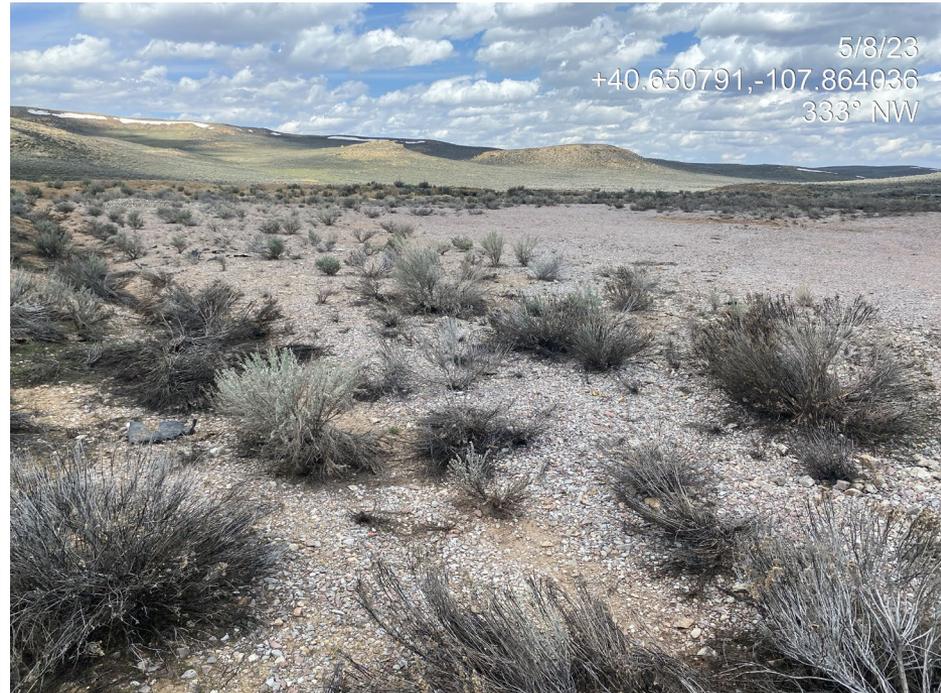
**Photo 2.** Photo taken from the Location entrance shows an overview of the western portion of the Location.

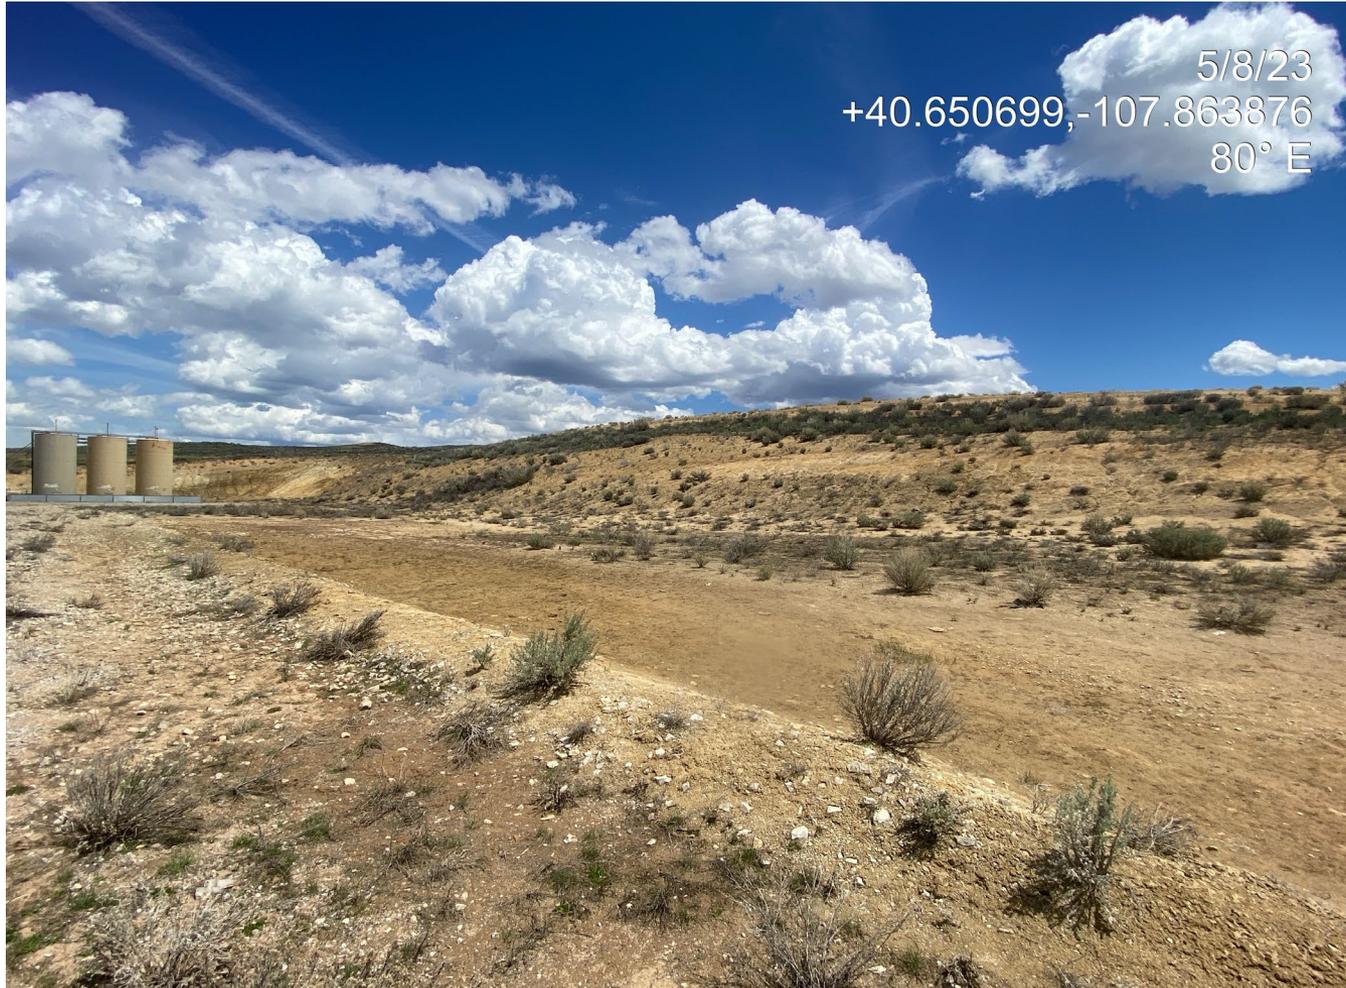
**Photo 3.** Photo shows an overview of the unstabilized cut slope at the east of the location.

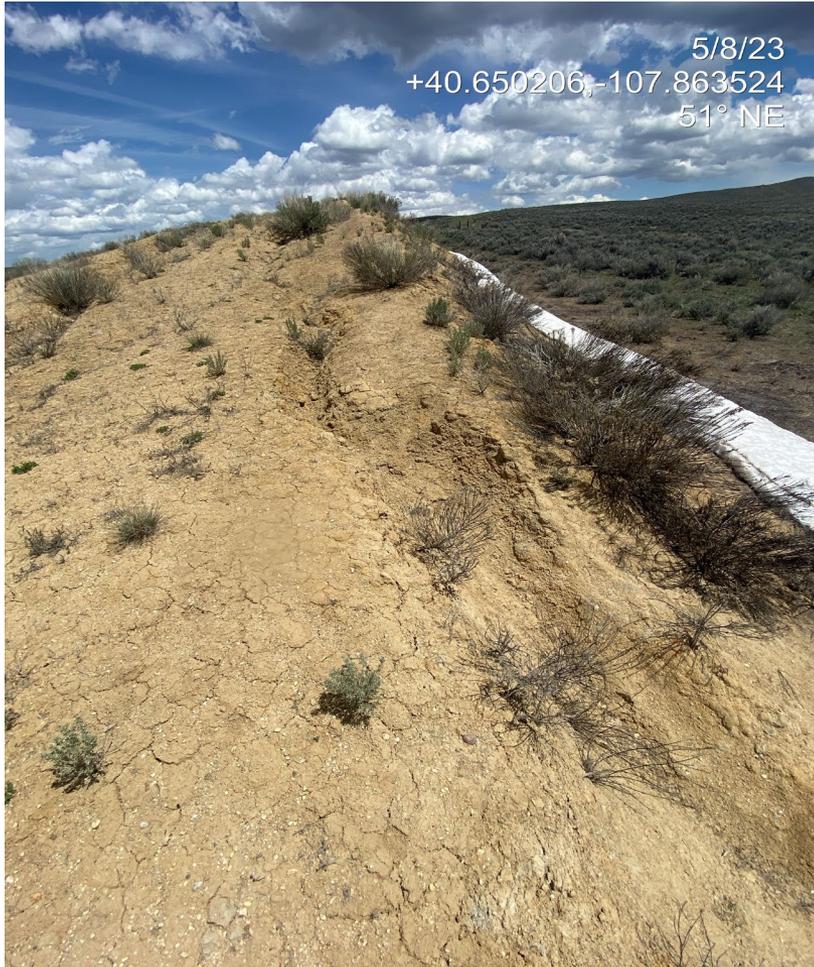
**Photo 4.** Photo taken from the south of the Location shows gully erosion occurring on unstabilized slopes.

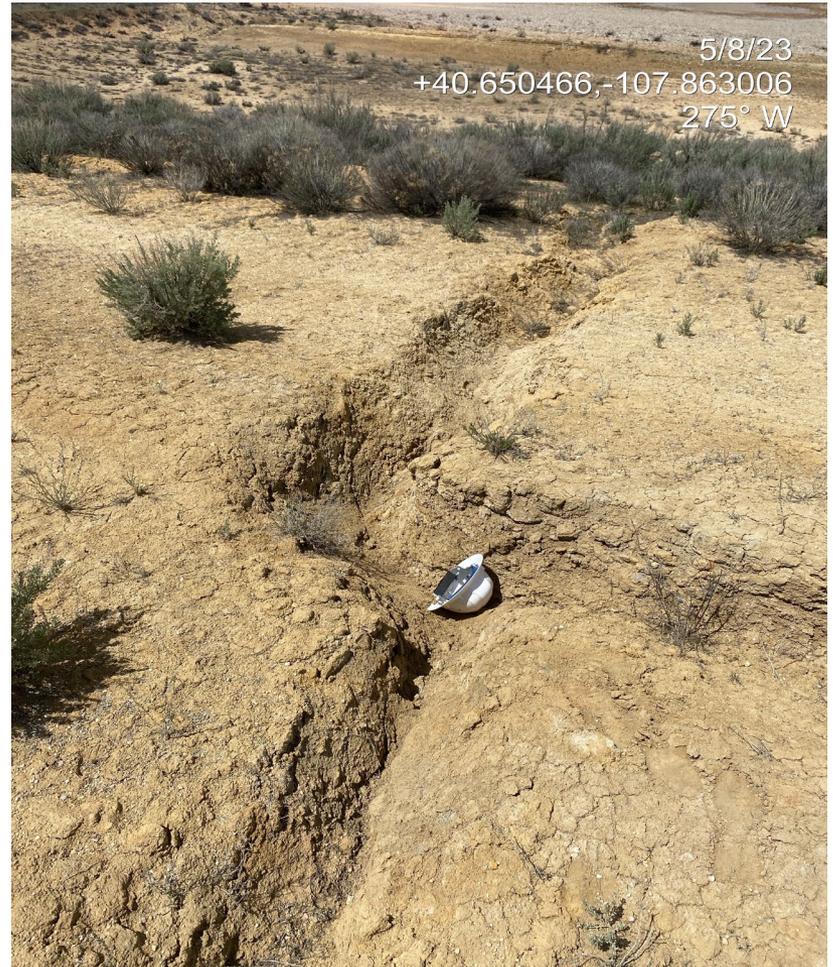
**Photo 5.** Photo shows gully erosion on the cut slope to the east.

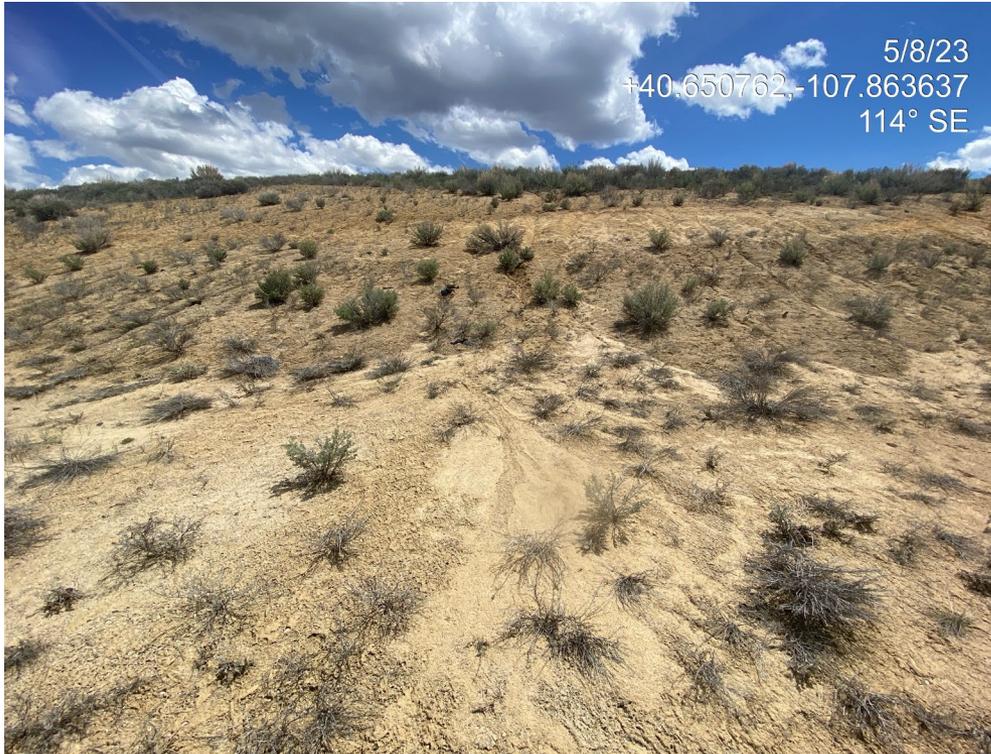
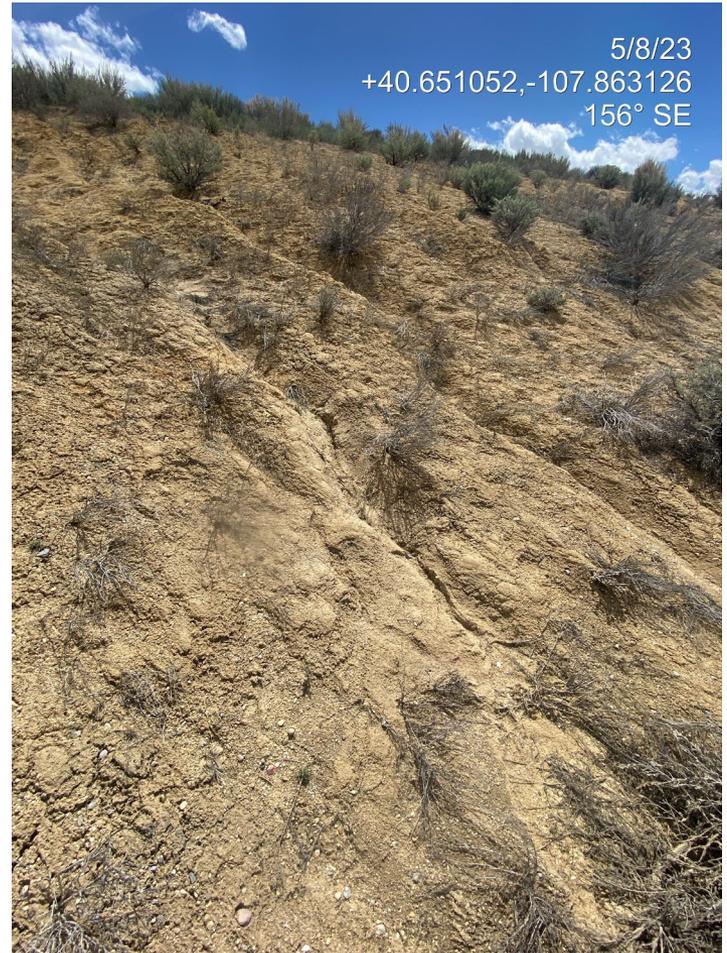
**Photo 6.** Photos show rill erosion on the unstabilized cut slope.

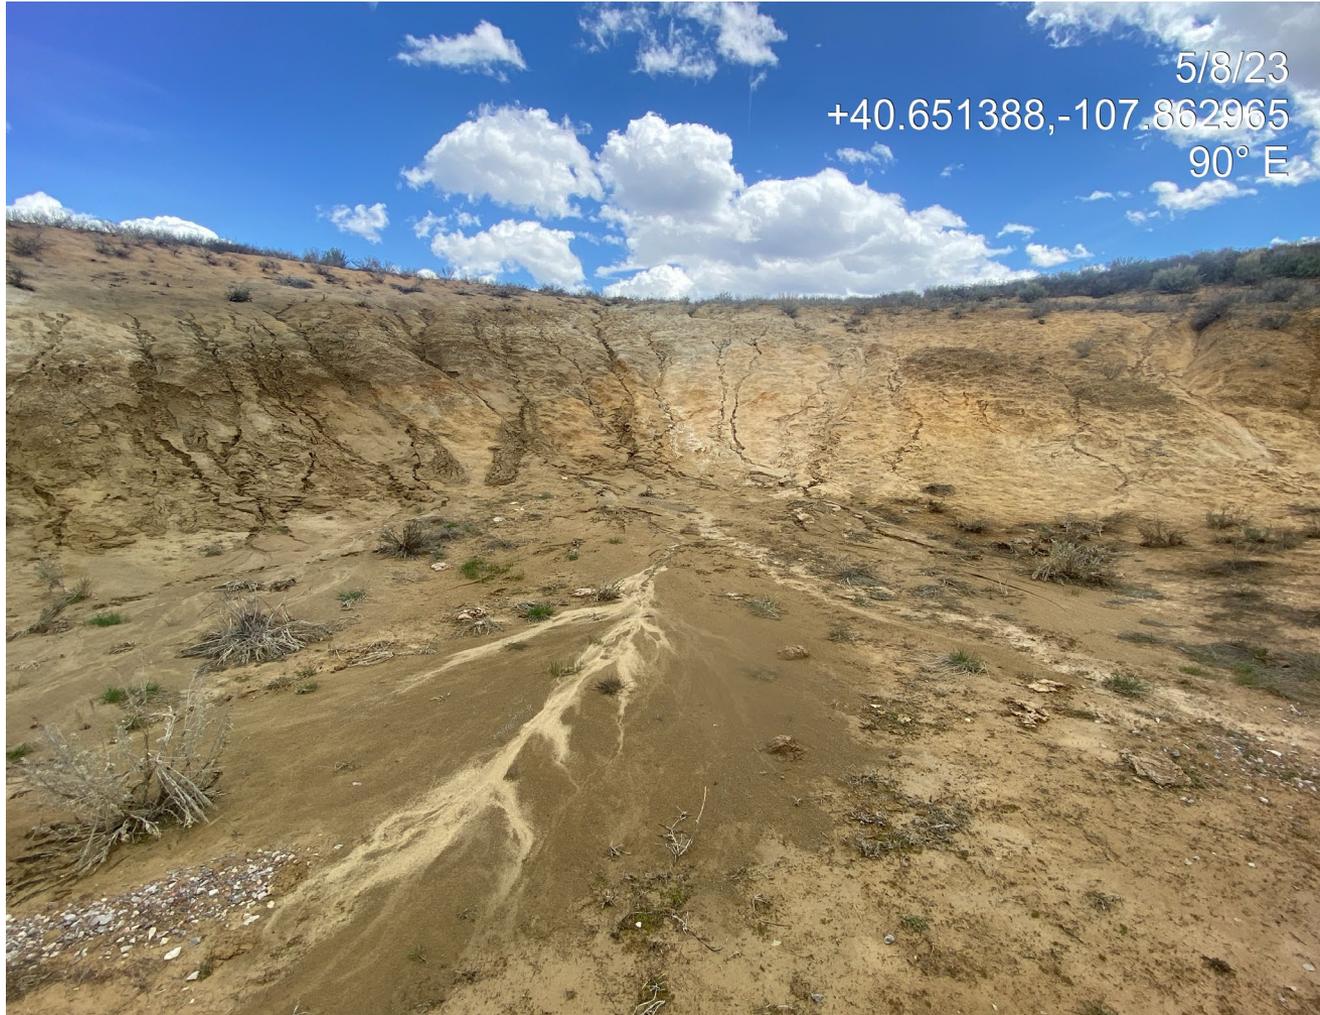
**Photo 7.** Photo shows rill erosion on the unstabilized cut slope to the northeast.

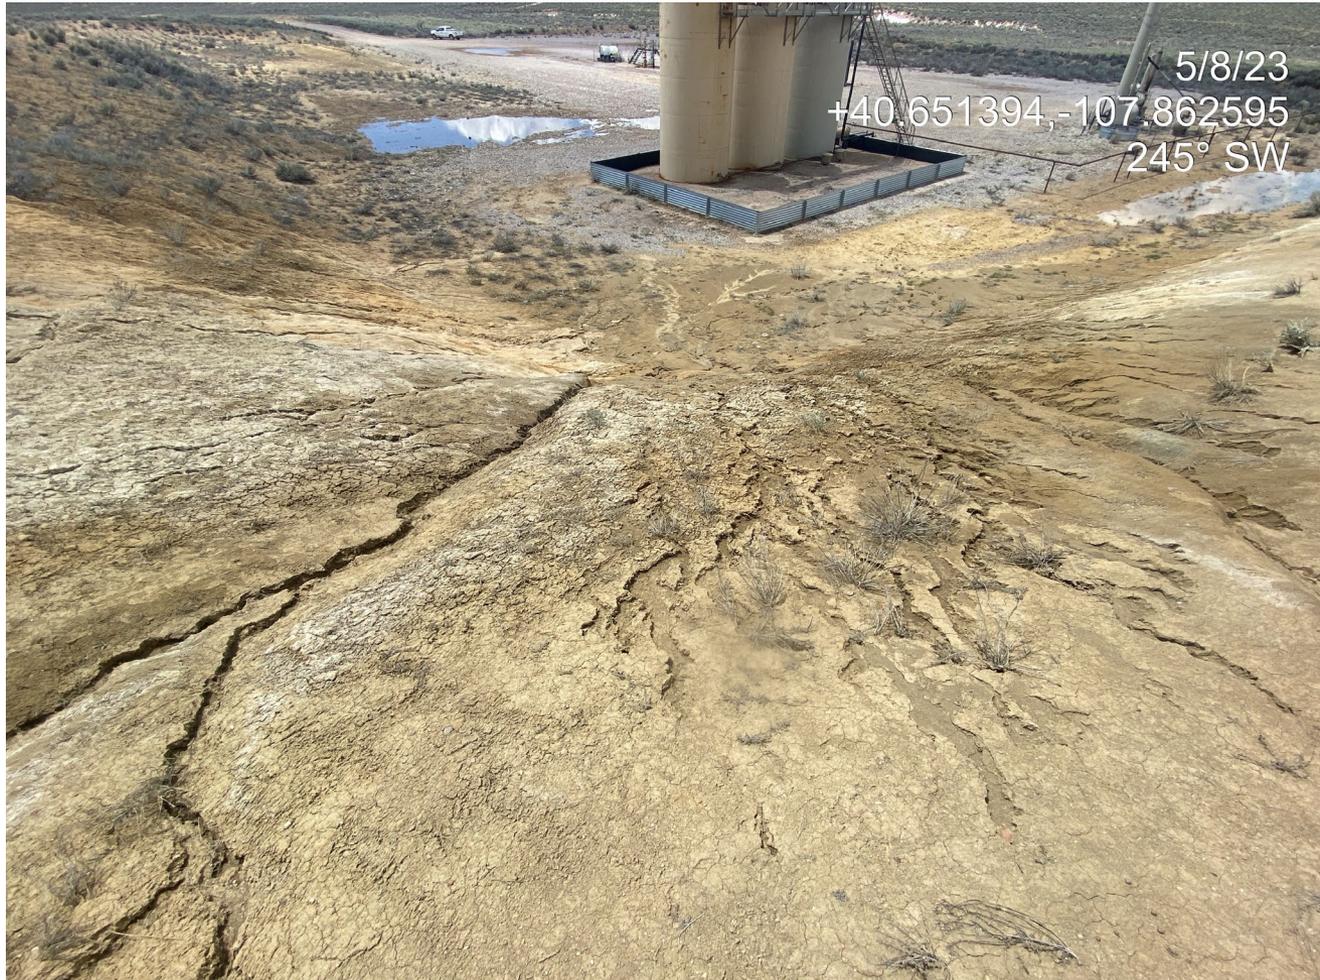
**Photo 8.** Photo shows rill erosion on the unstabilized cut slope to the northeast.

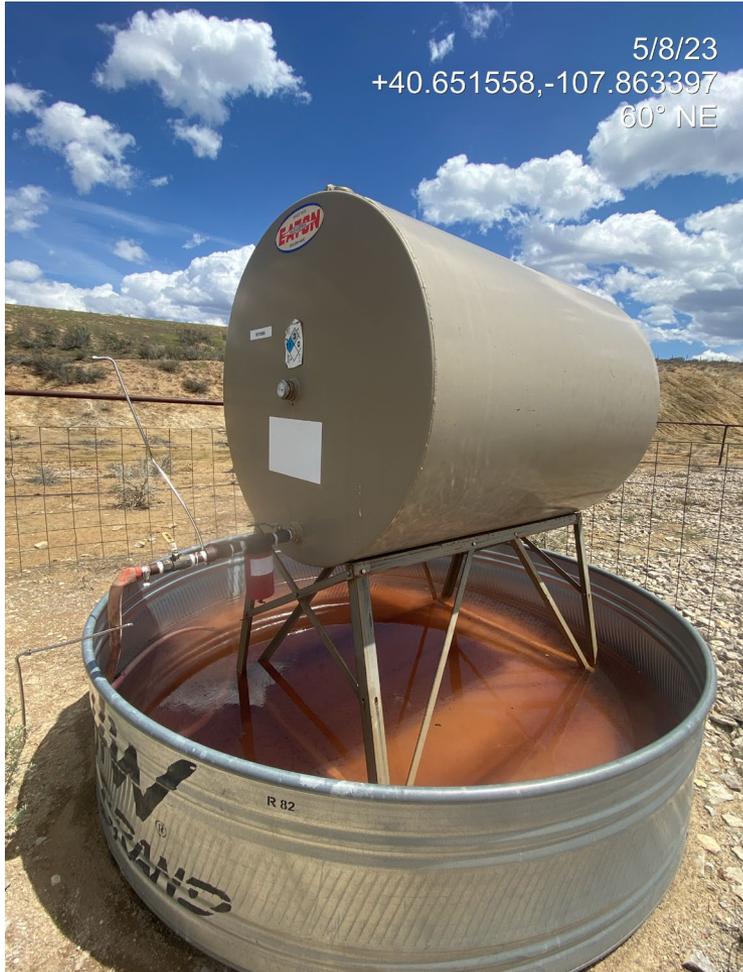
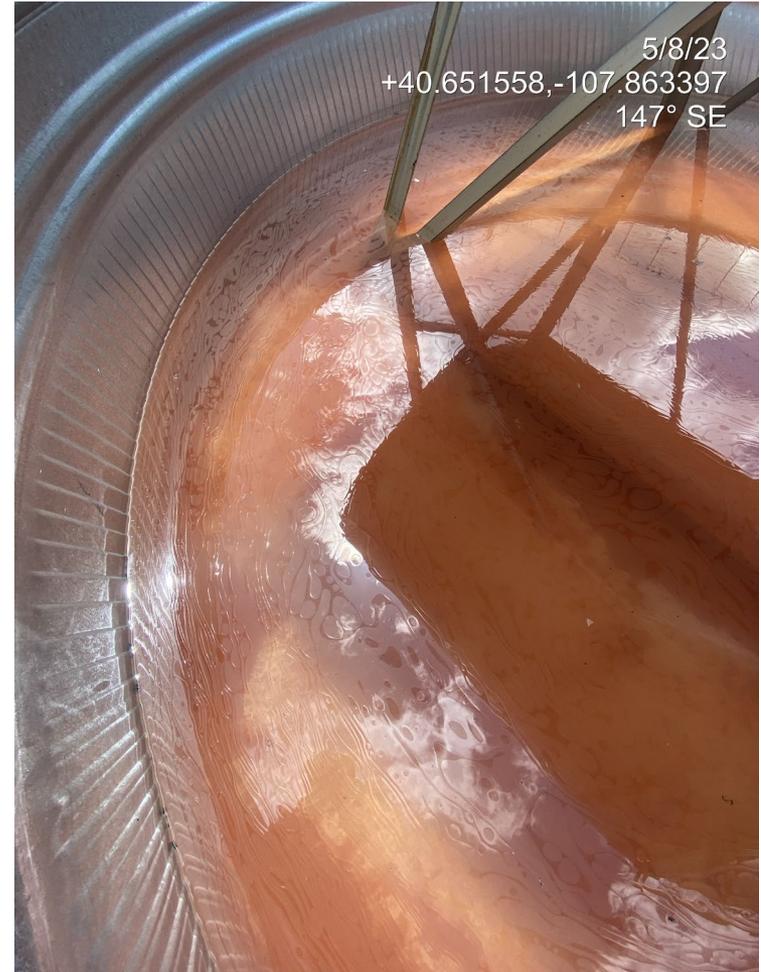
**Photo 9.** Photos show a methanol tank at the north of the Location lacks wildlife protection BMPs on the secondary containment stock tank. Photos also shows impacted fluid within secondary containment.

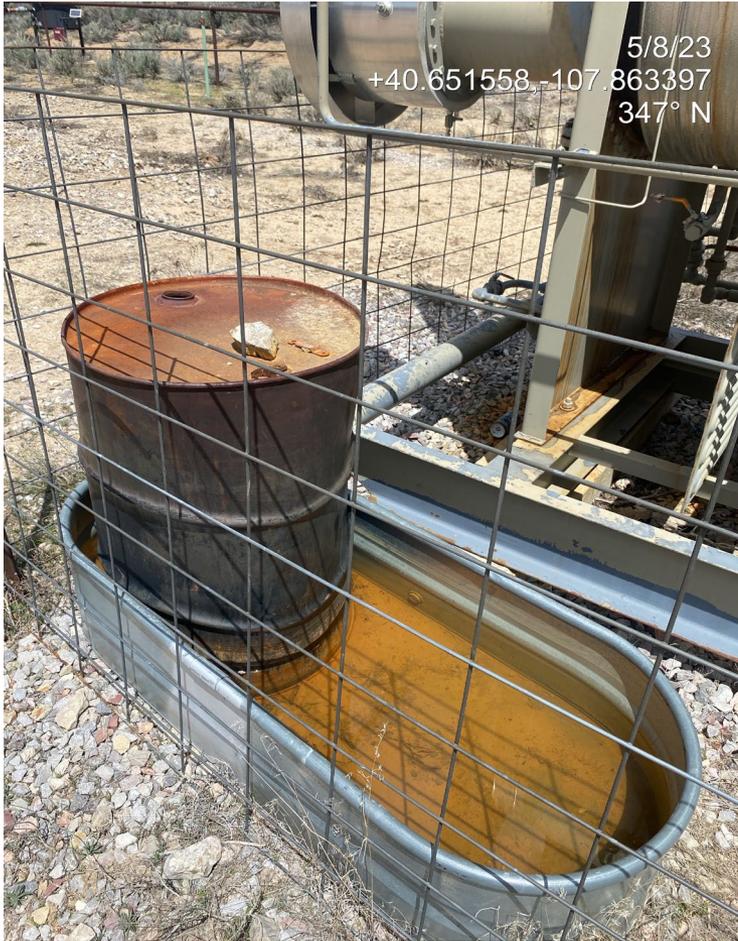
**Photo 10.** Photo taken to the north shows inadequate wildlife protection BMPs on the secondary containment stock tank.

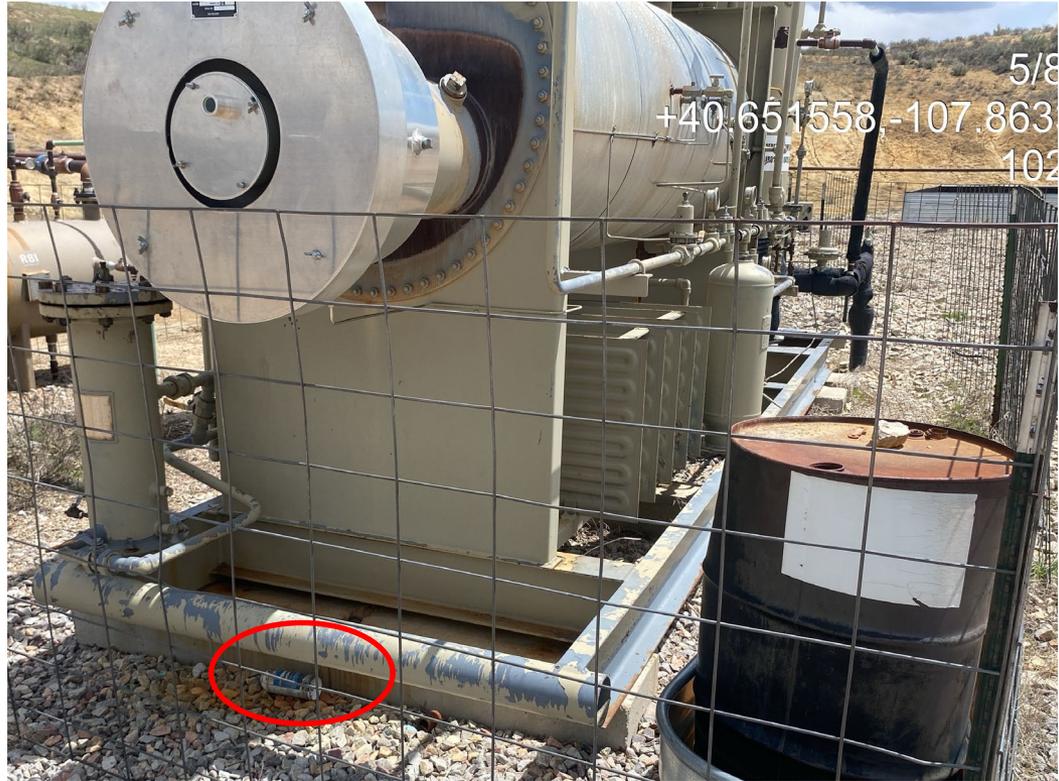
**Photo 11.** Photo taken to the north shows trash (aerosol can).

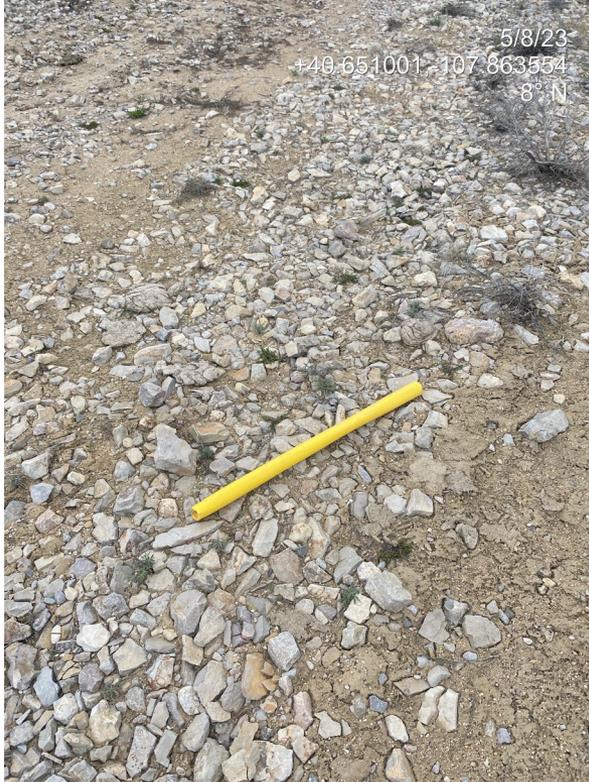
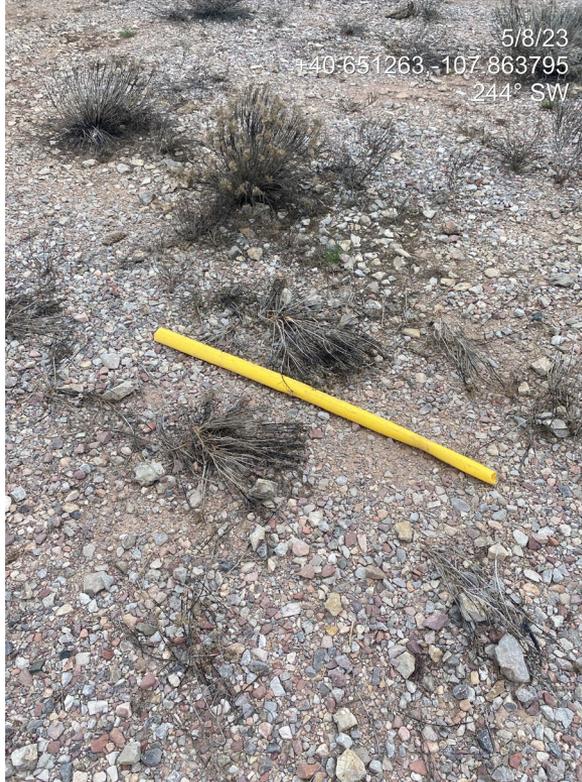
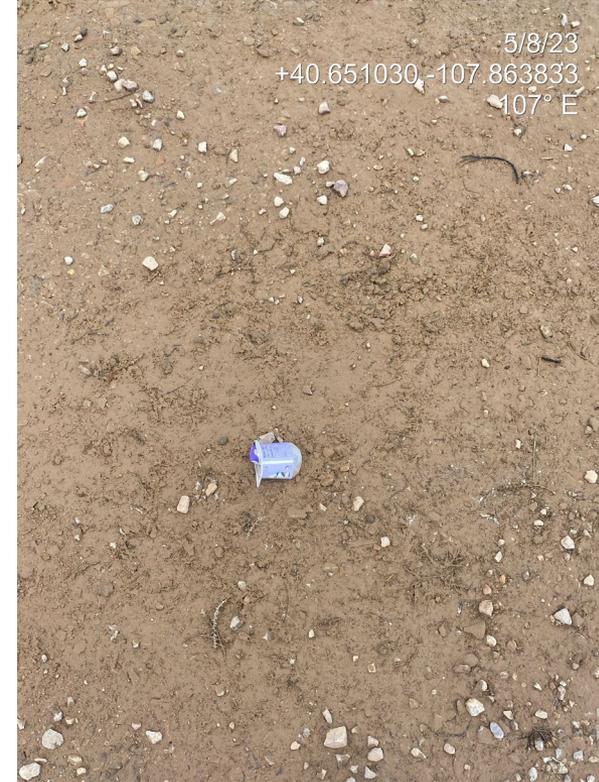
**Photo 12.** Photos show trash.

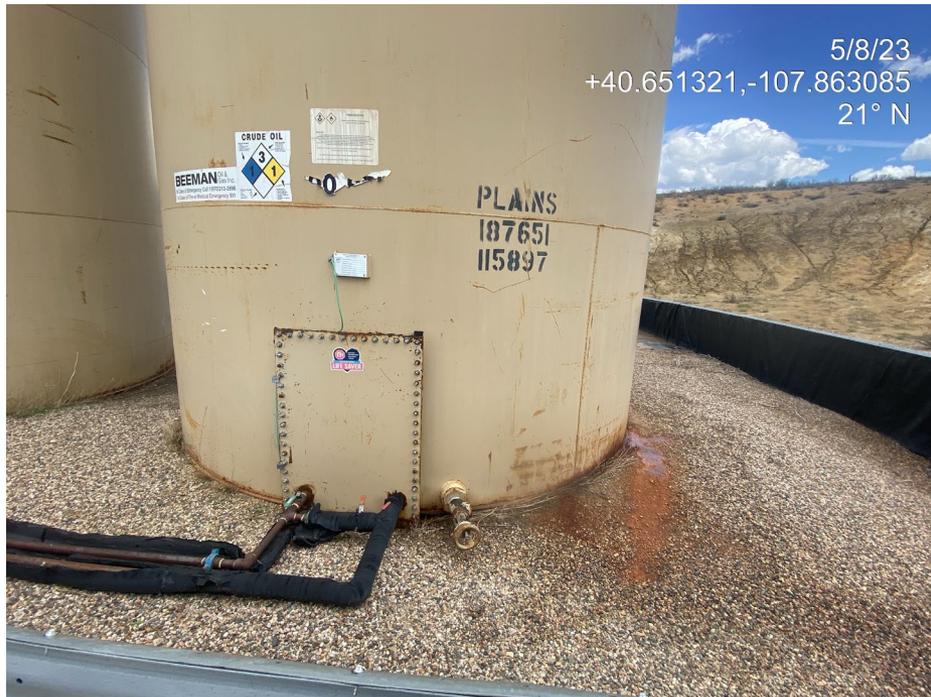
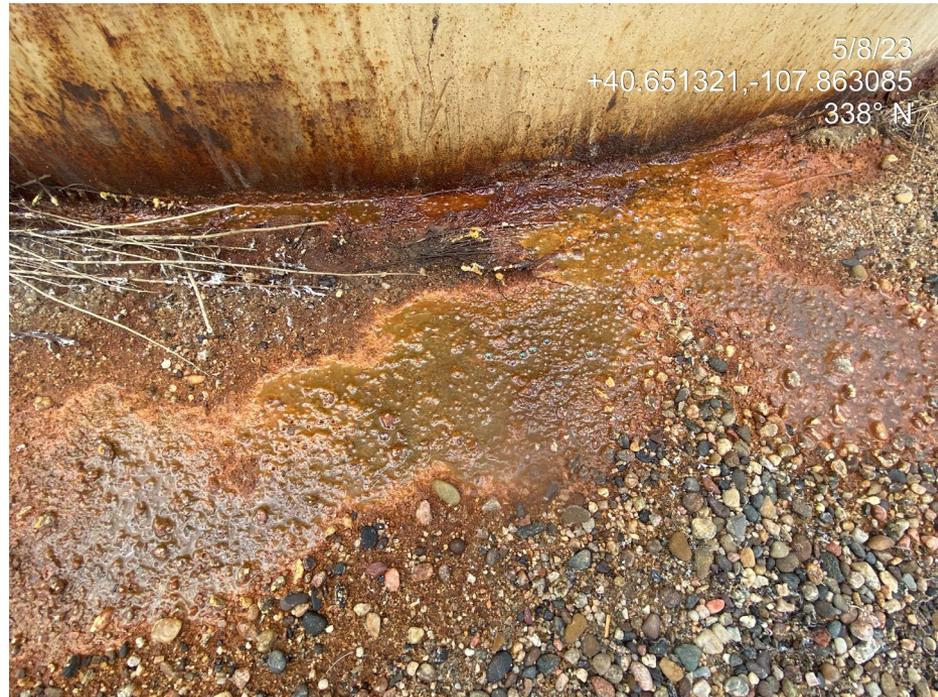
**Photo 13.** Photos show staining below a crude oil tank, which appears to be leaking.

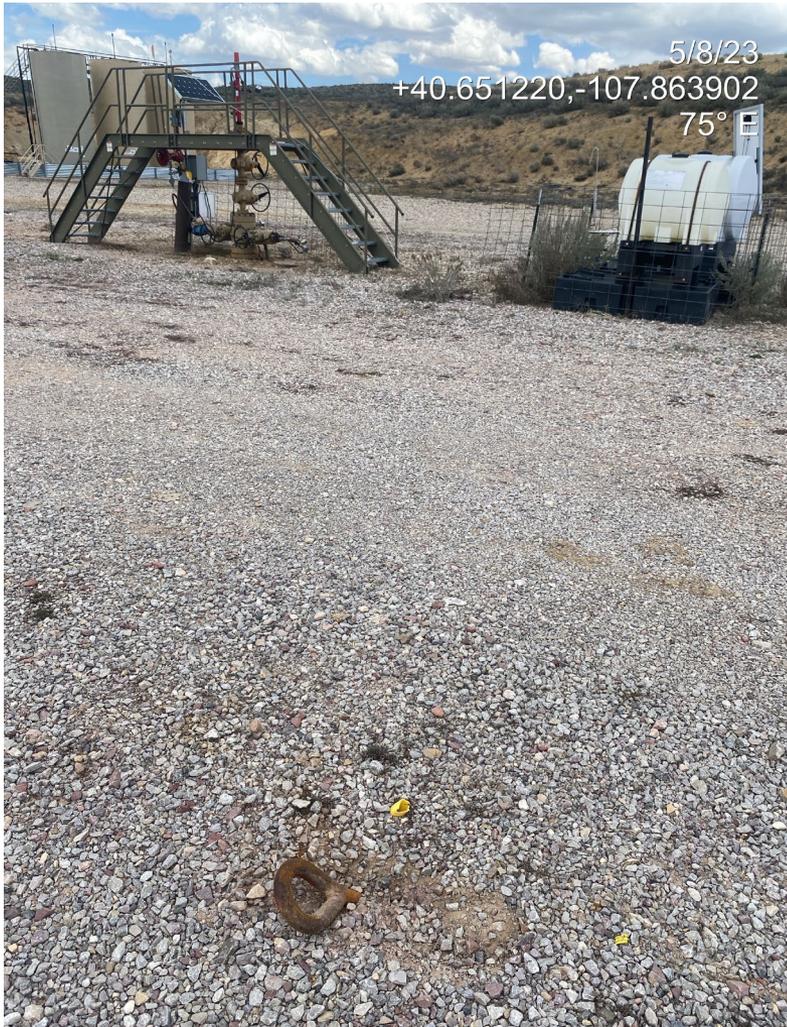
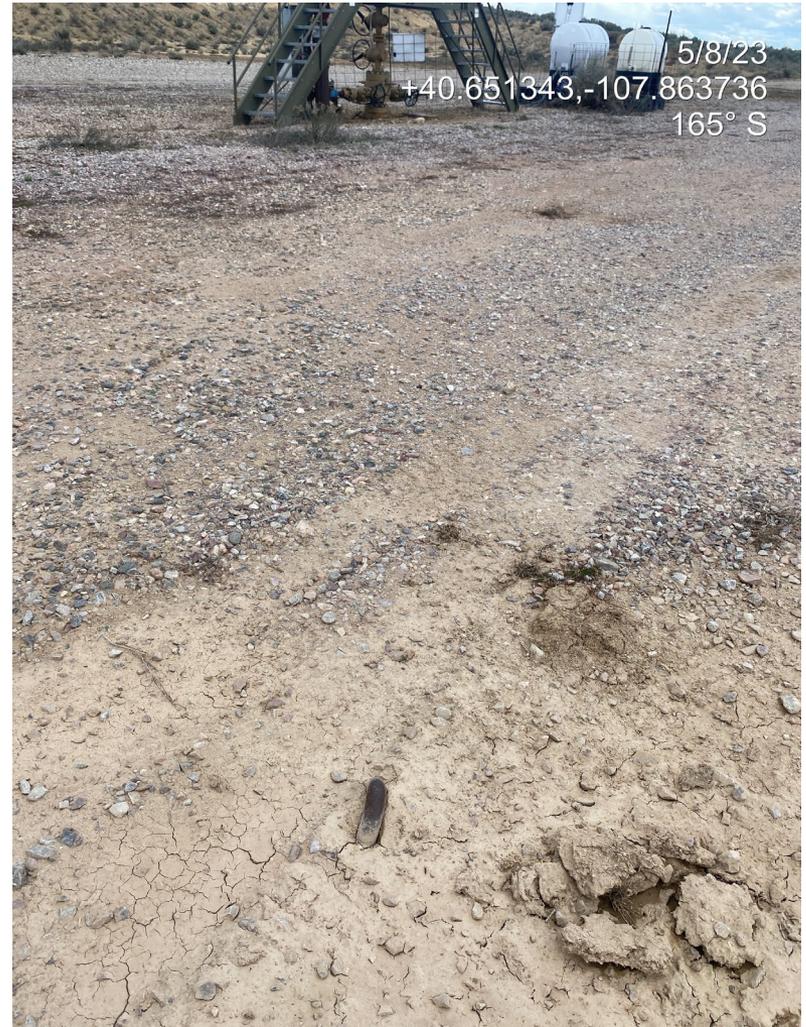
Photo 14. Photos show two (2) unmarked anchors.

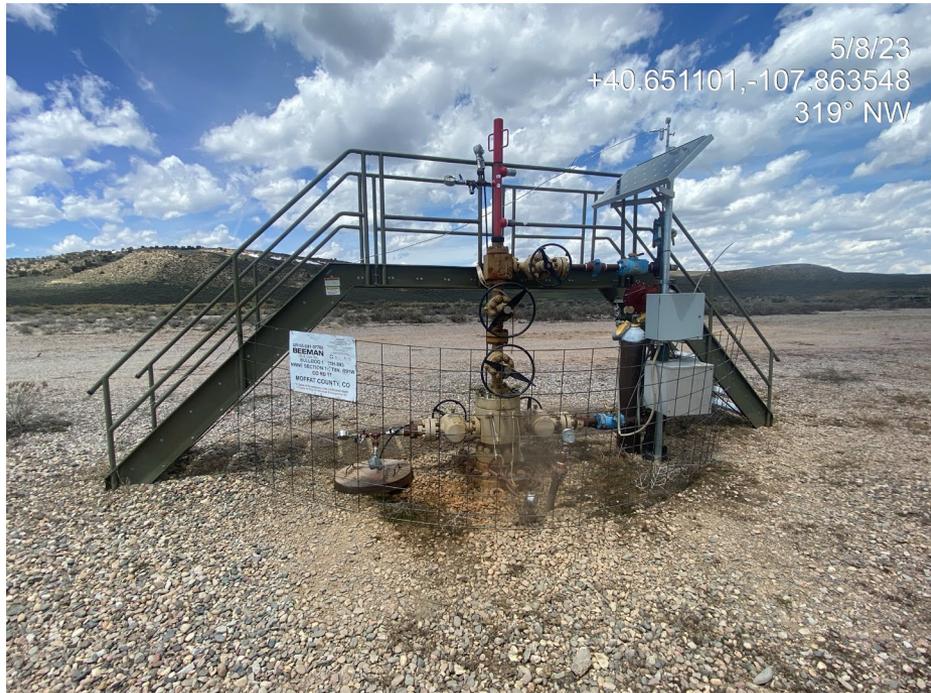
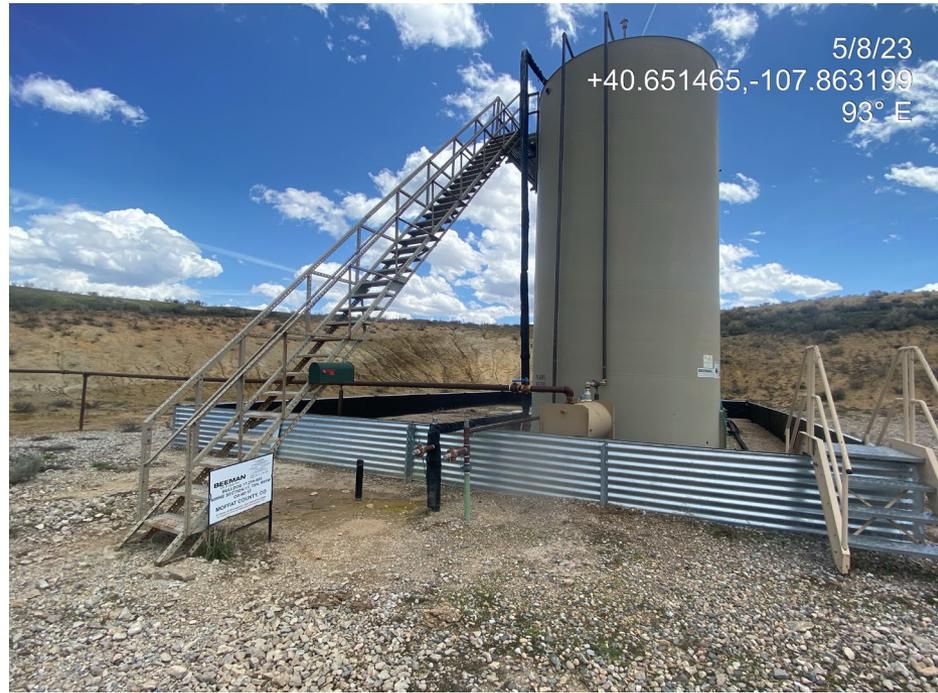
Photo 15. Photos show production areas.

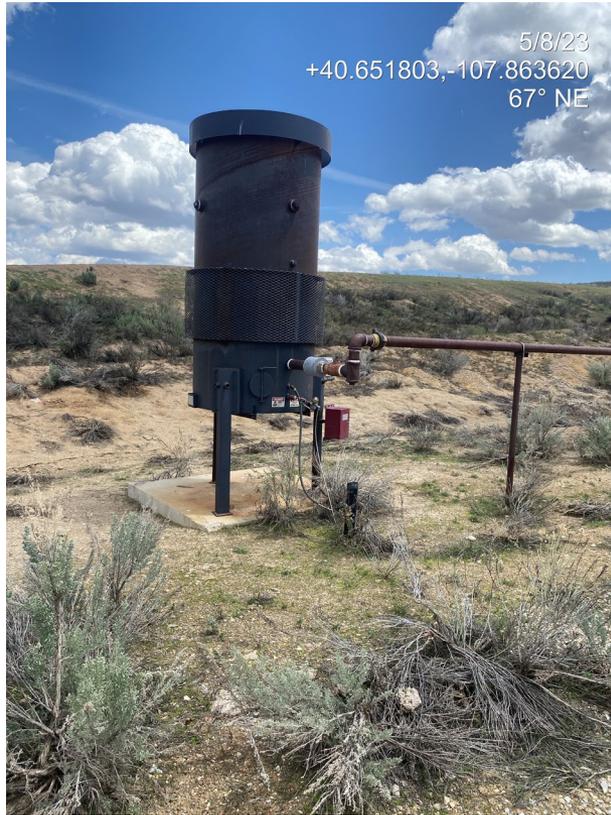
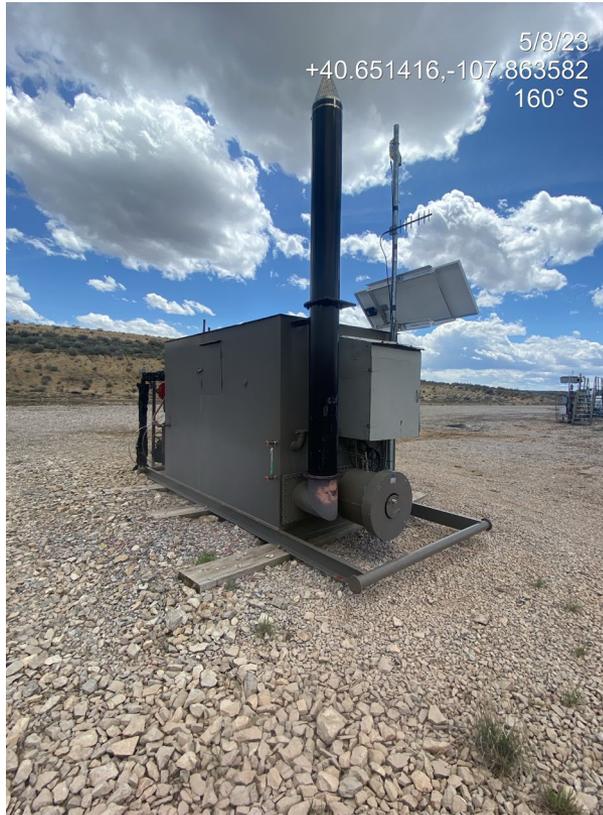
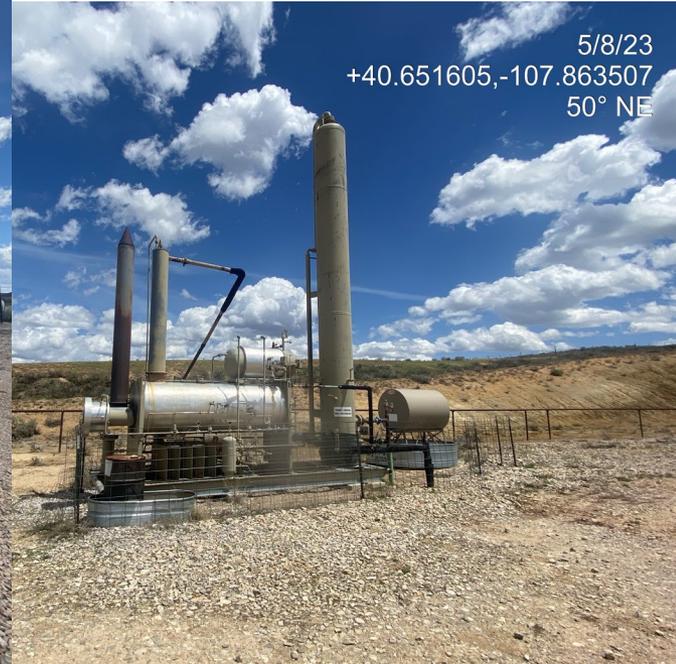
Photo 16. Photos show production areas.
