**KT Resources LLC
Ant Hill Unit 18-43
Location #316341**

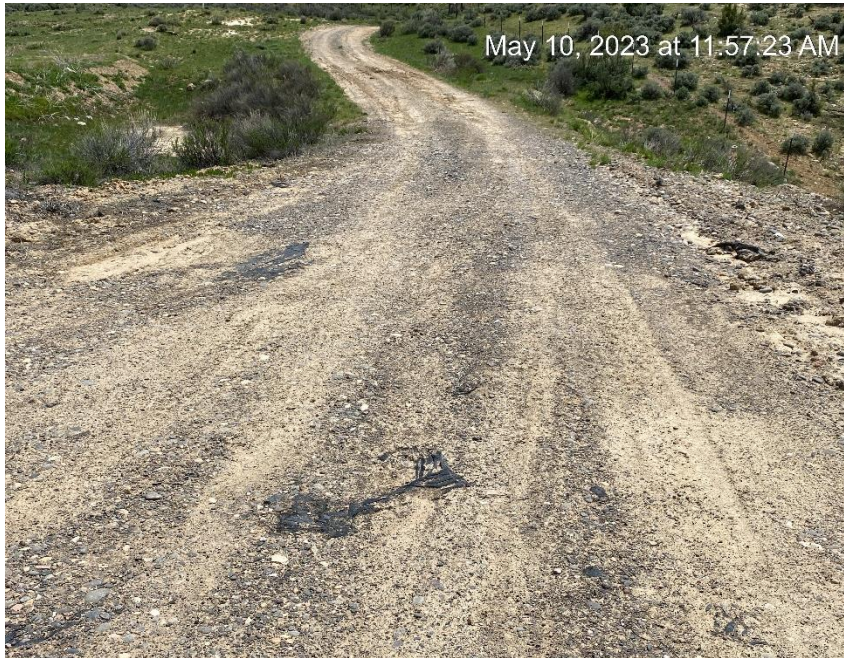
Access road at location

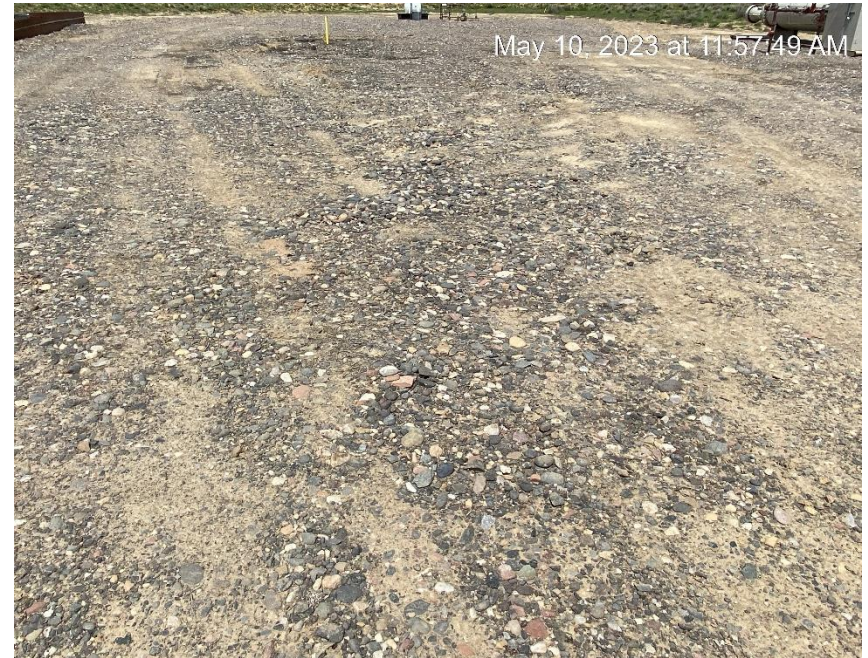
Entrance to location

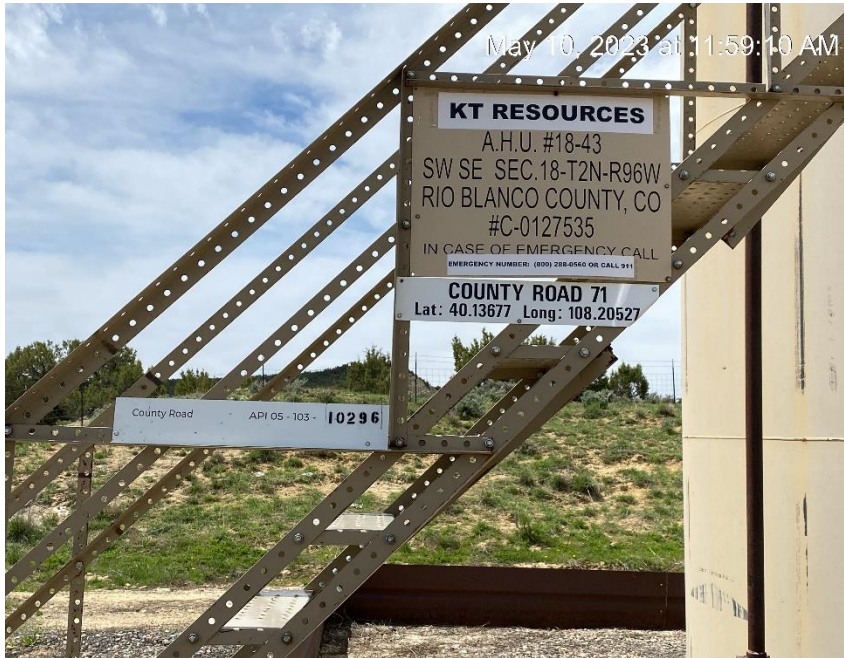
Tank battery signs

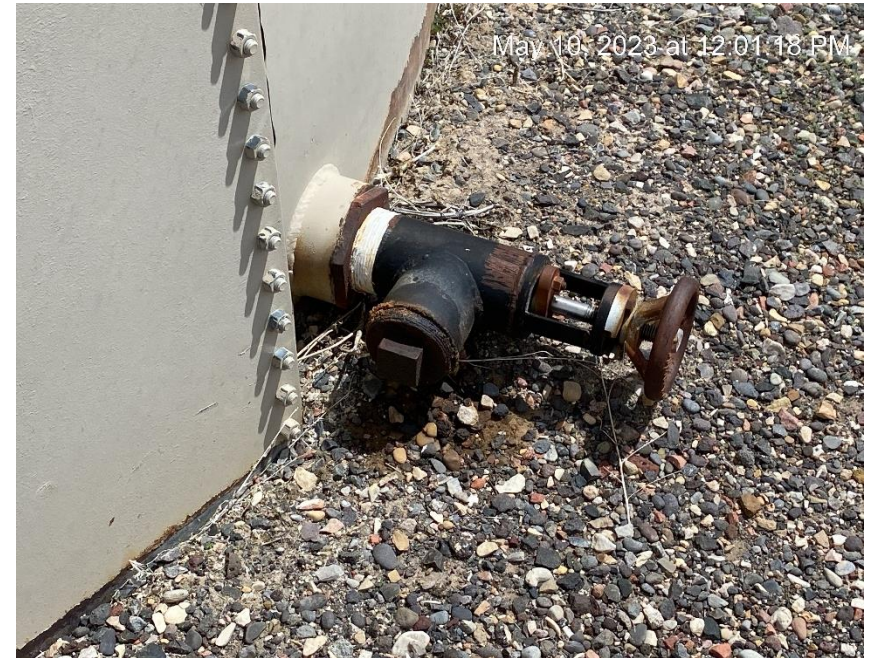
Stained soil behind produced water tank

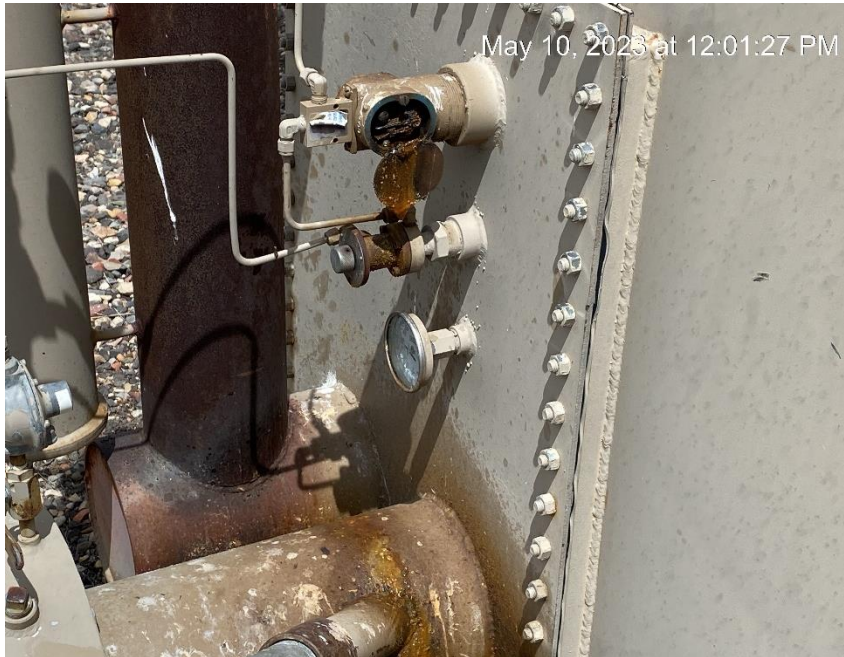
Oil leak on crude oil tank

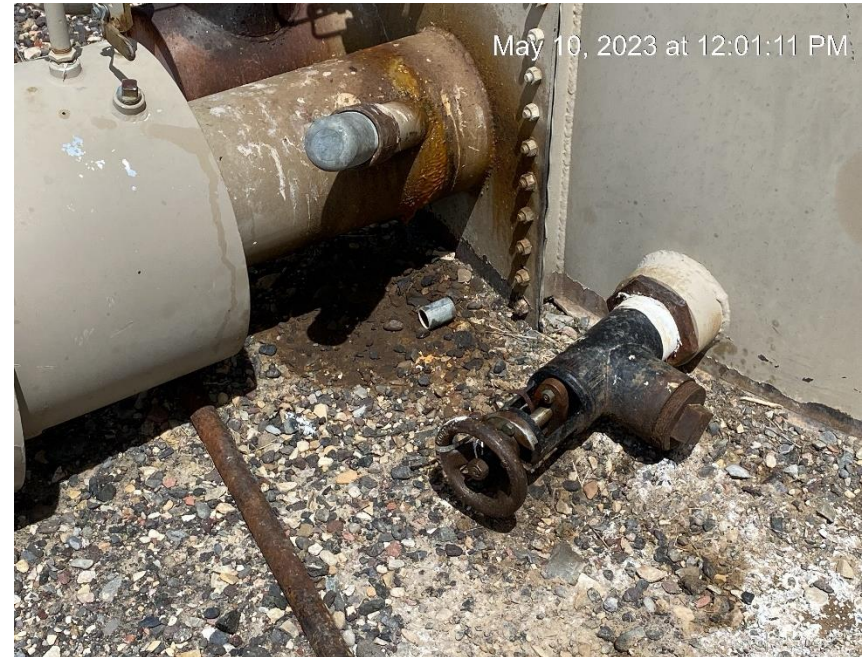
Soil staining from leak on crude oil tank

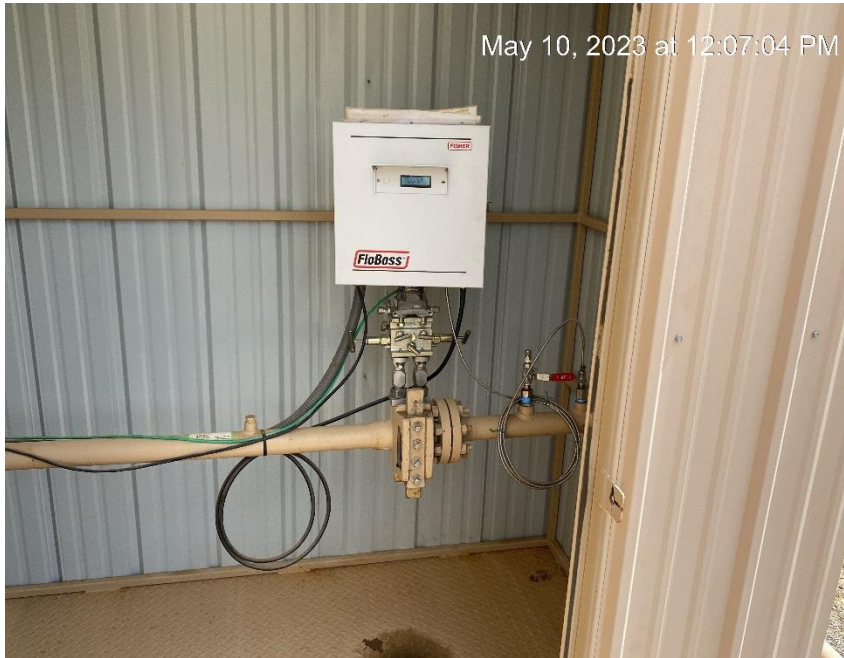
No visible display of gas meter calibration

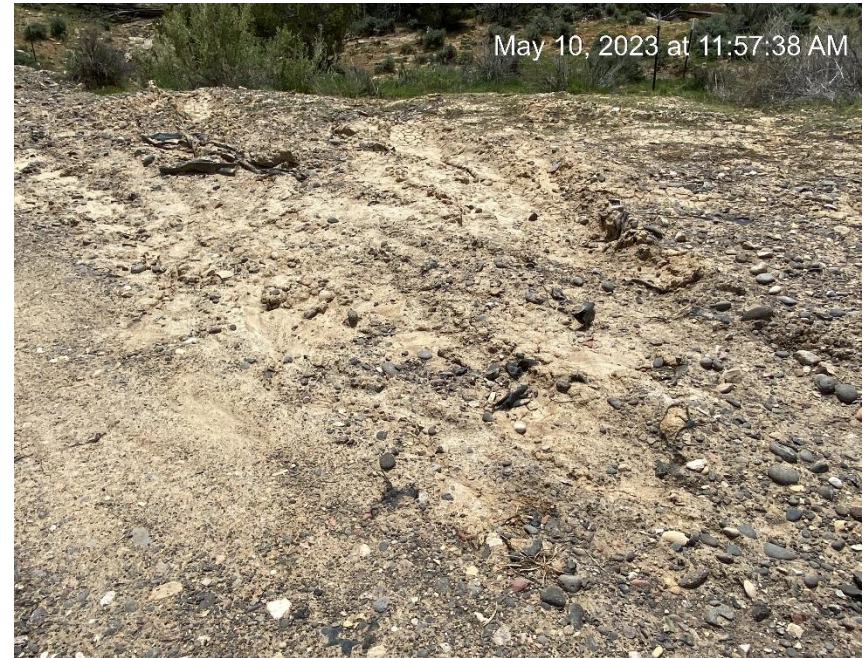
Erosion and sediment along access road at location

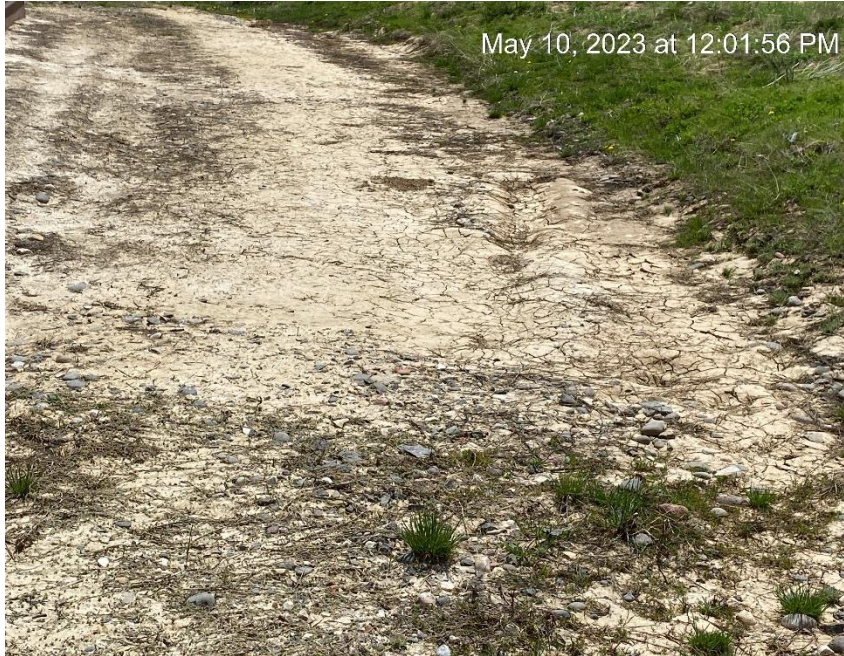
Bare slope and sediment migration off location

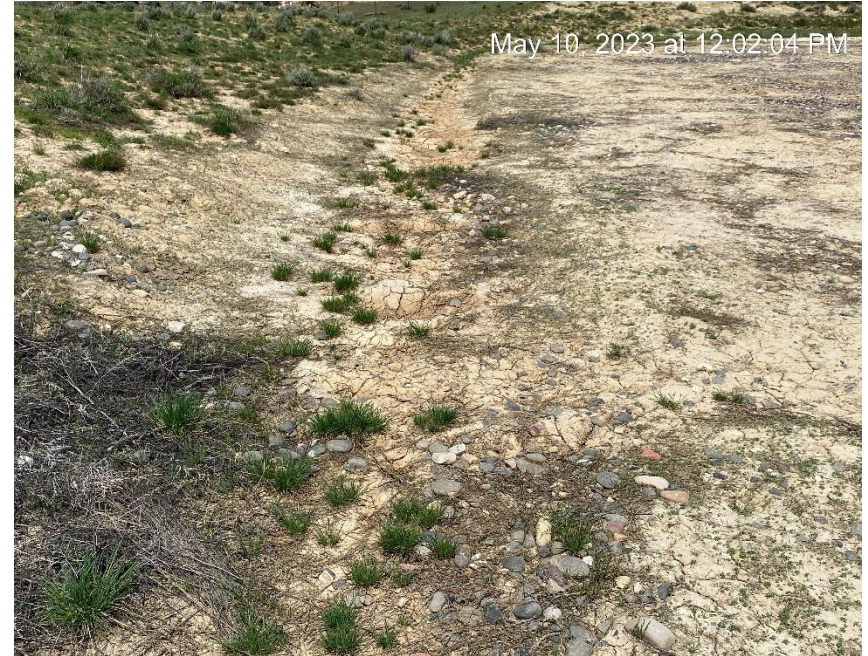
Diversion ditch full of sediment

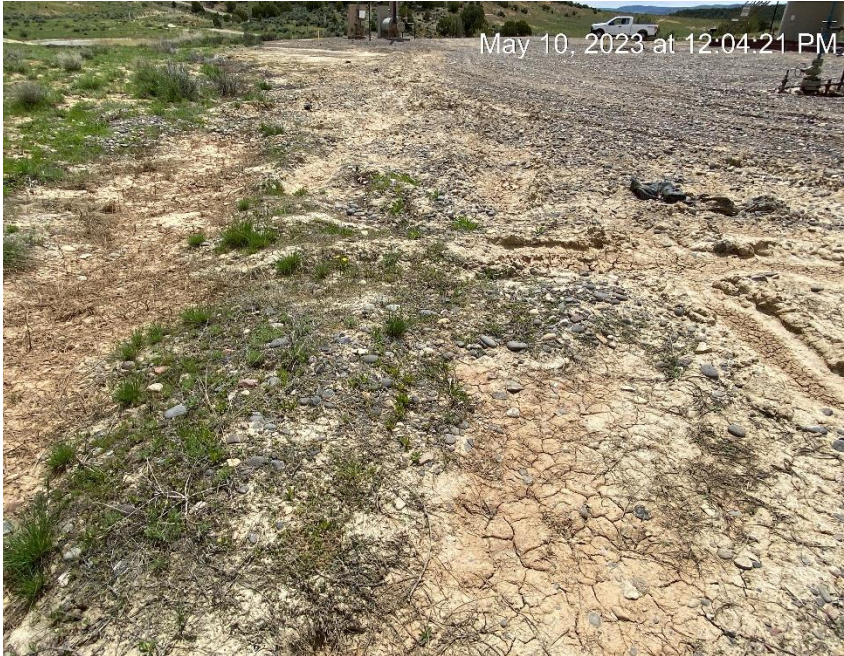
Diversion ditch damage and full of sediment

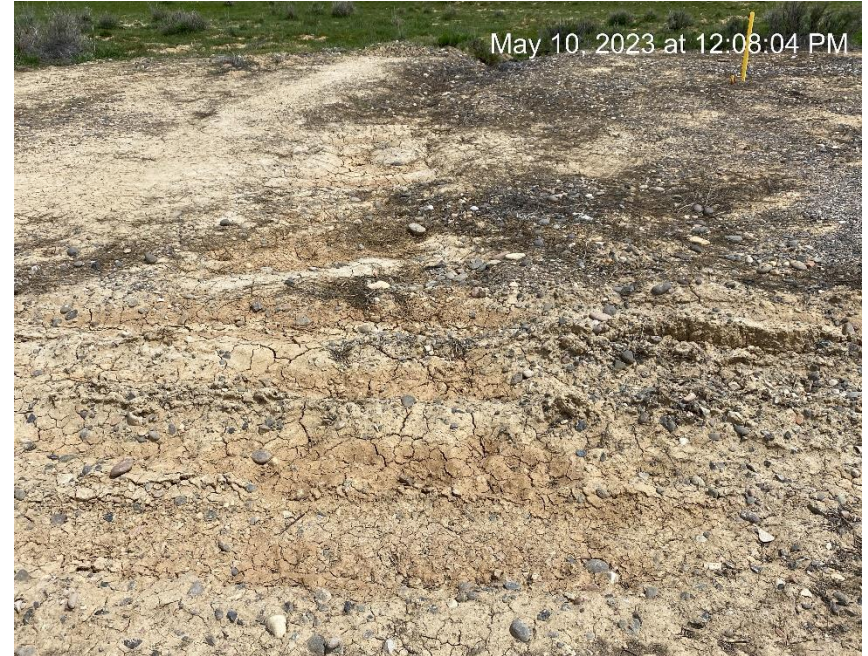
Erosion and sediment off location

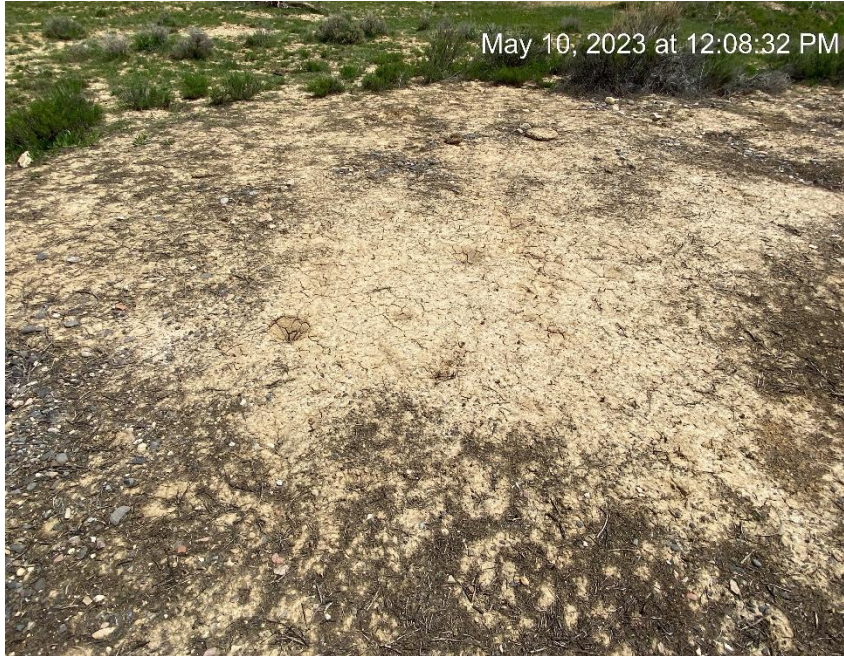
Sediment migration leaving location

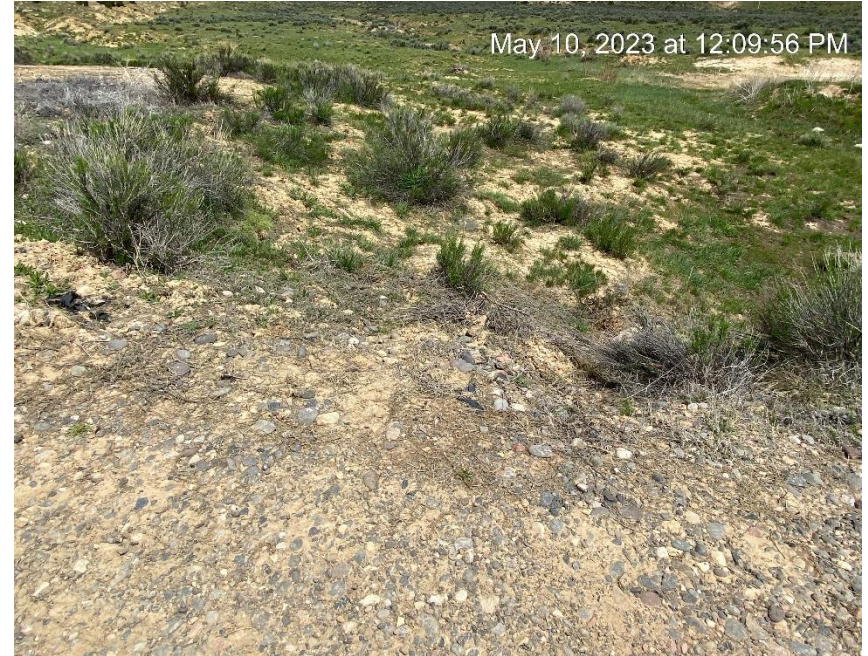
Road erosion. Sediment migration off location
