**KT Resources LLC  
Ant Hill Unit 18-42  
Location #316308**

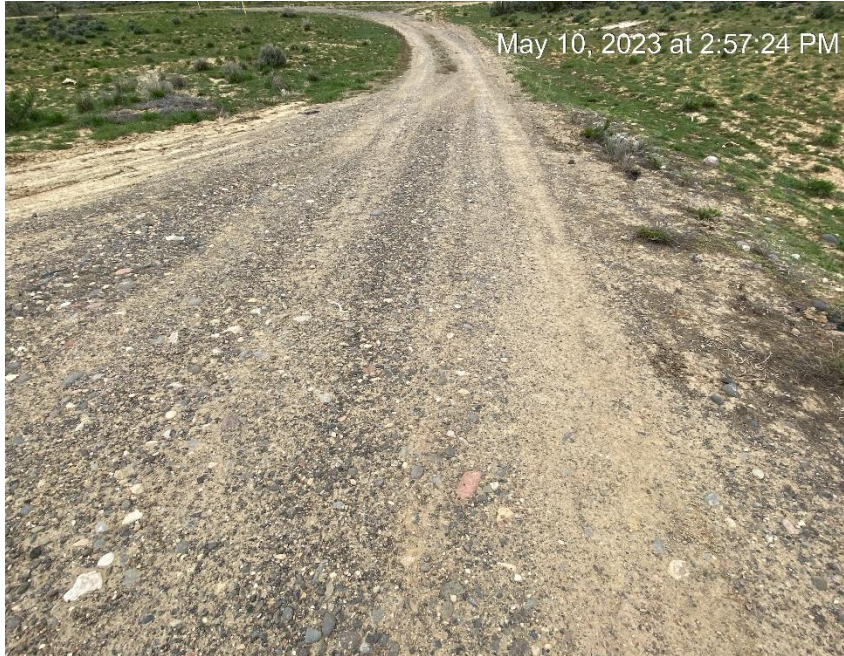
**Access road at location entrance**

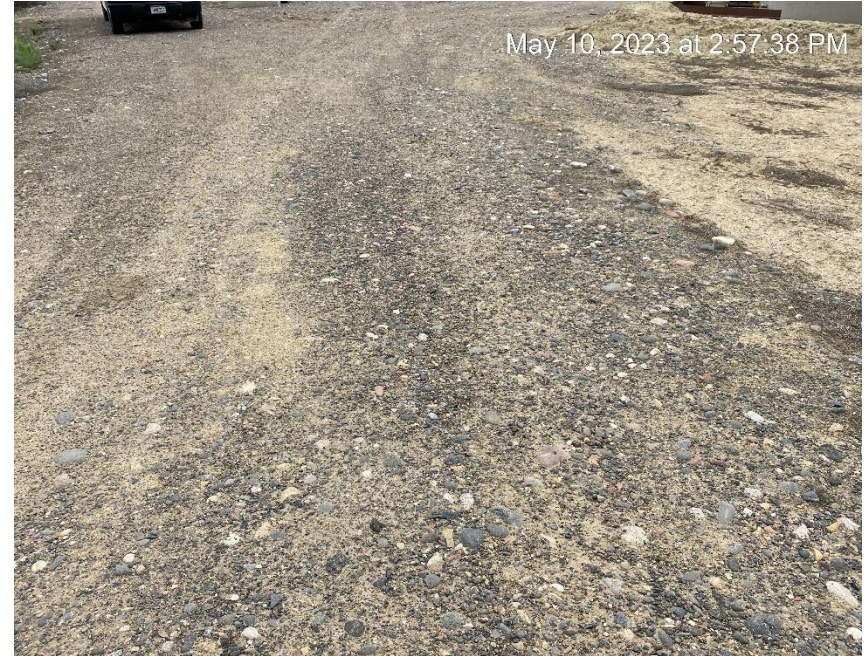
**Entrance to location**

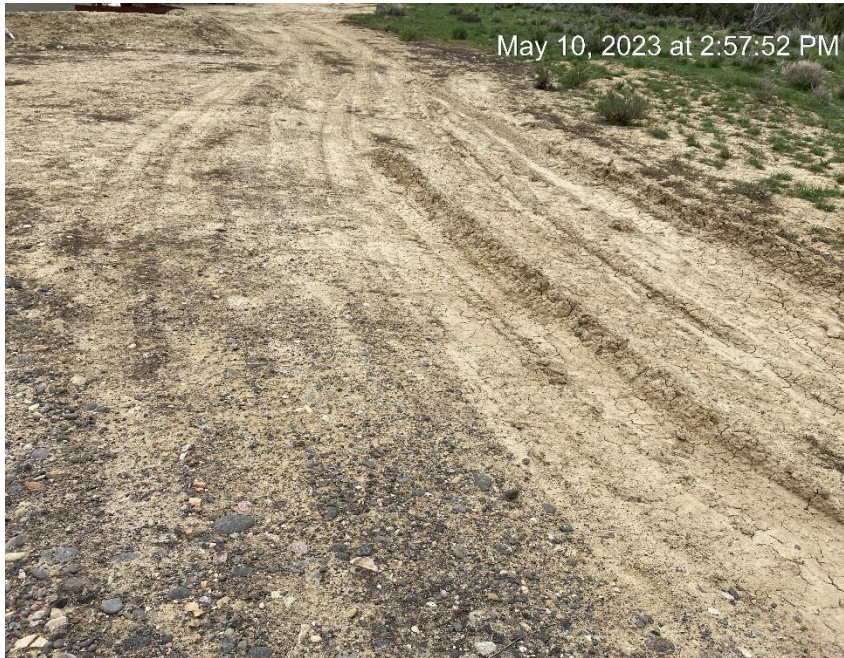
**Alternate entrance to location**

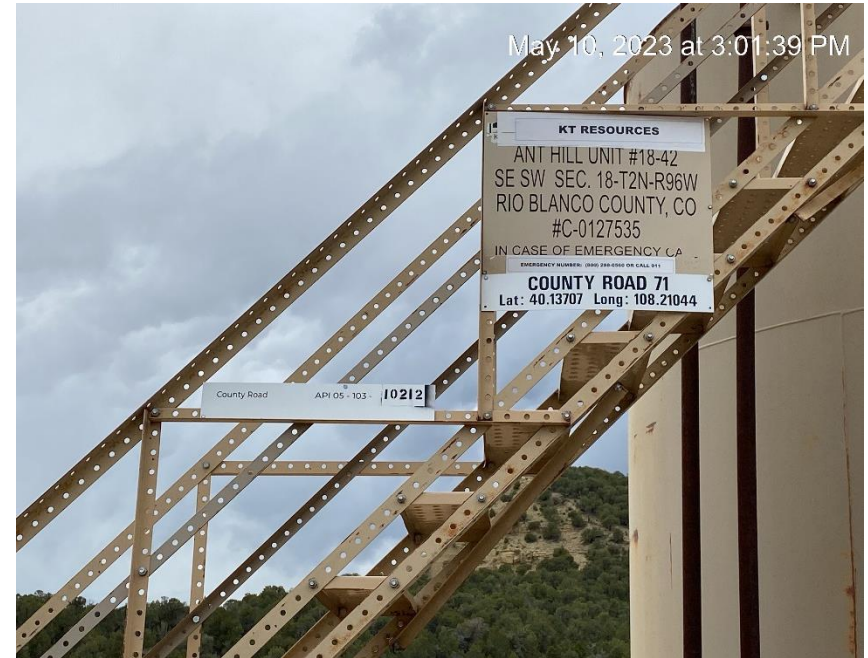
**Signs at tank battery**

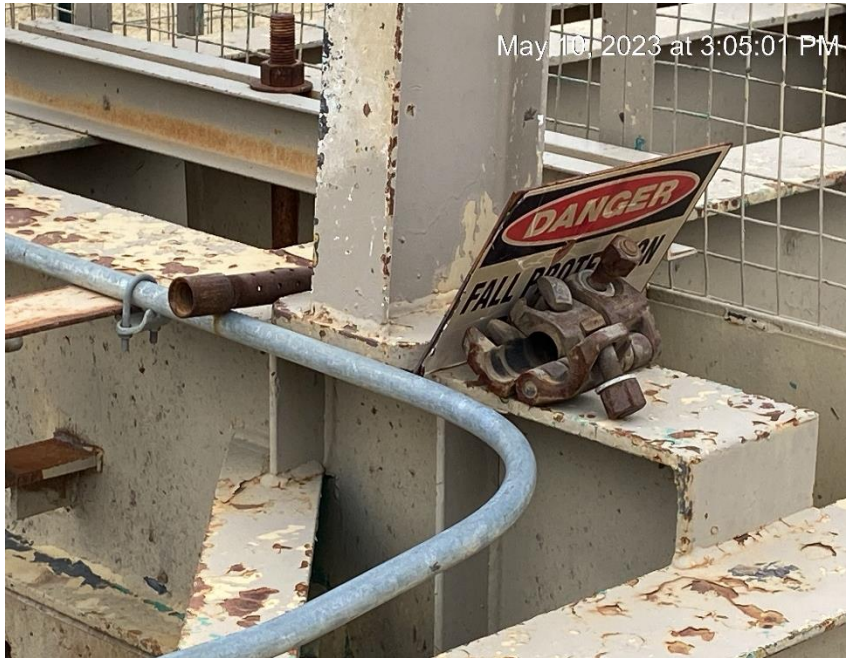
Debris

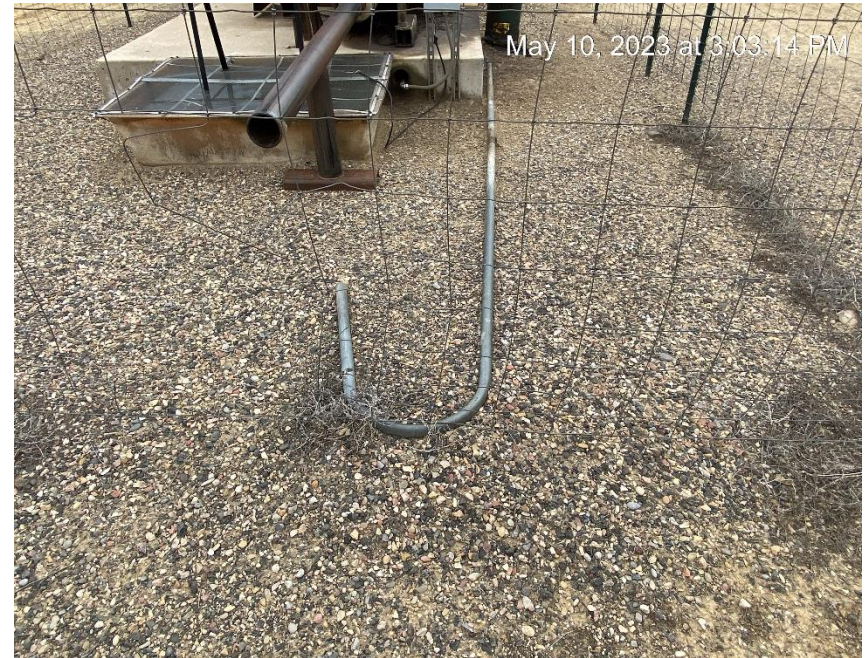
Debris

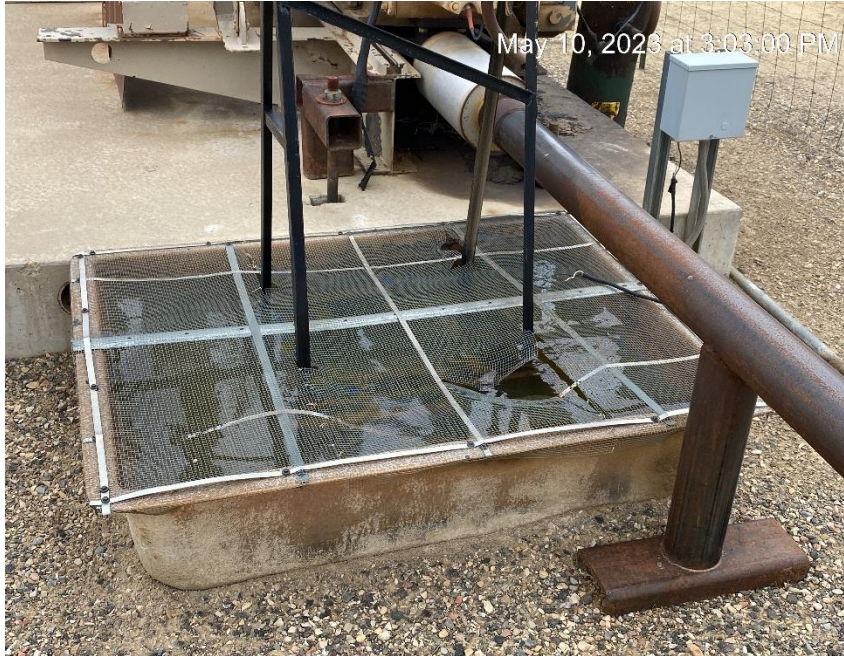
**Inadequate wildlife protection**

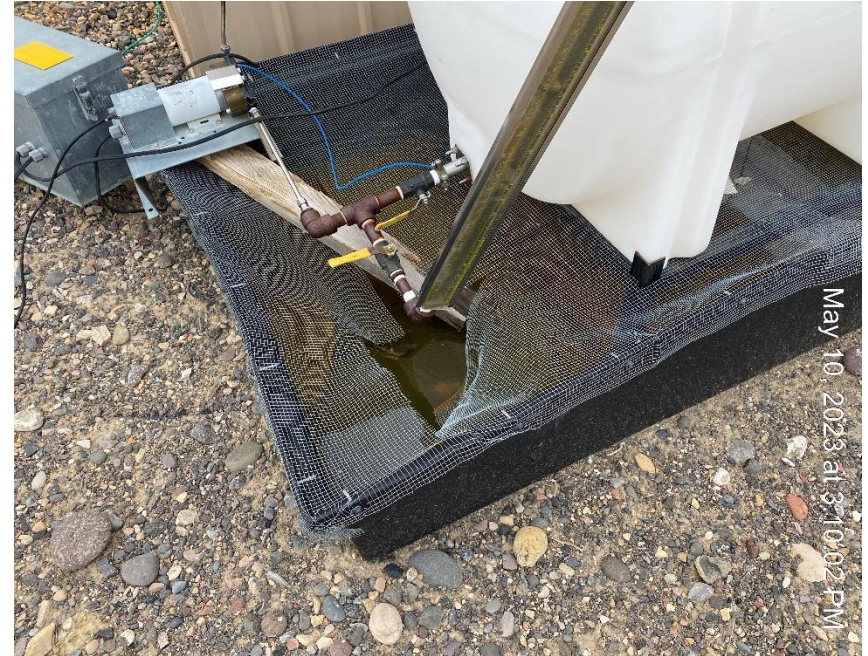
**Inadequate wildlife protection**

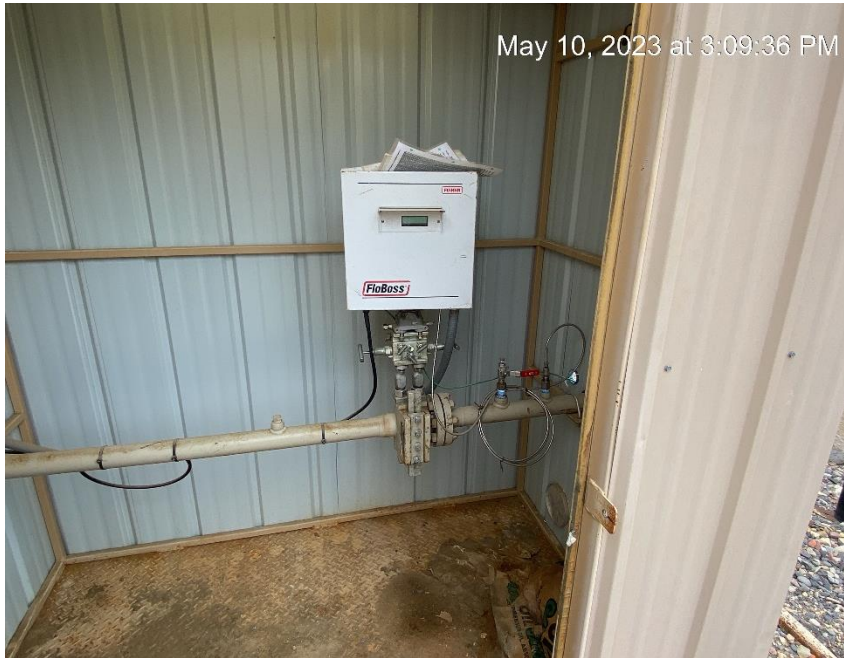
**Gas meter calibration card not visibly displayed**

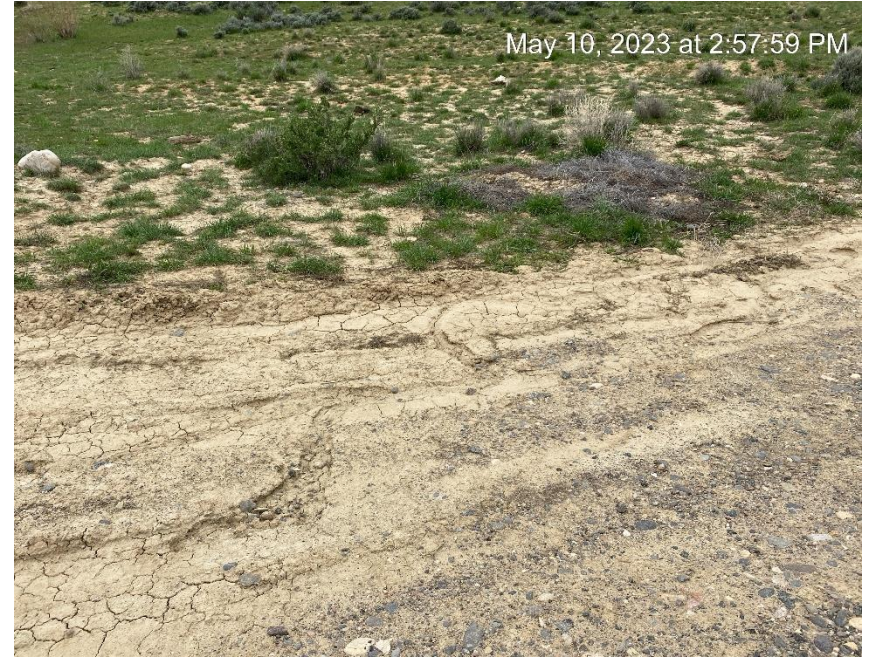
**Erosion and sediment migration from alternate entrance to location**

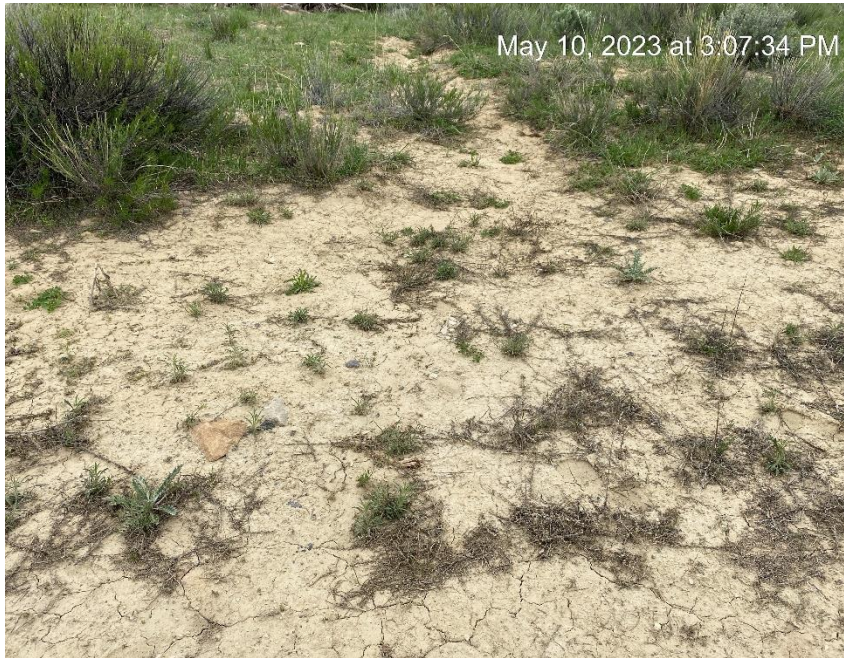
**Sediment migration from location**

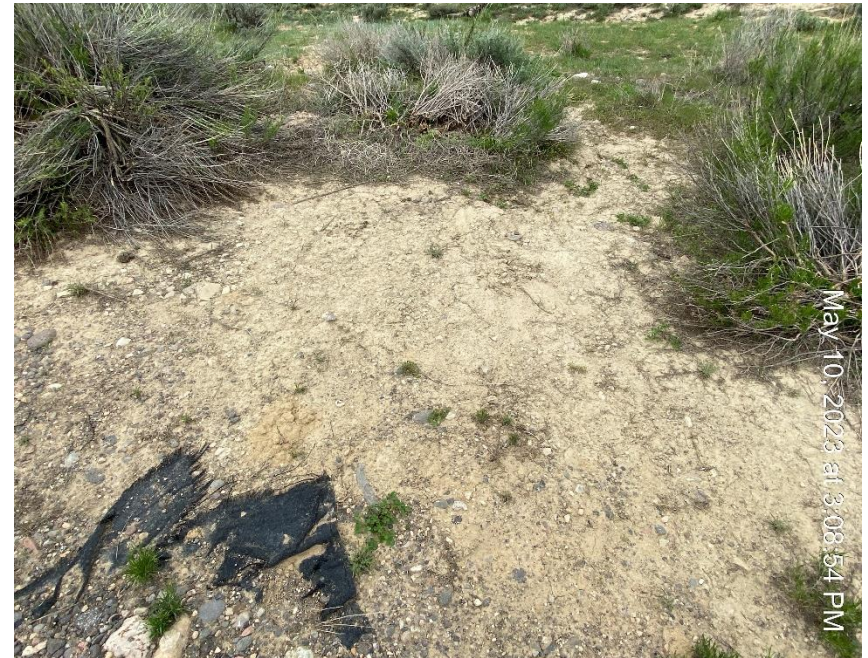
**Sediment migration from location**
