# Inspection Photos

Operator: Beeman Oil & Gas Inc- #7125

Location Name: Bulldog /20-12H-892

Inspection Document #: 702801512

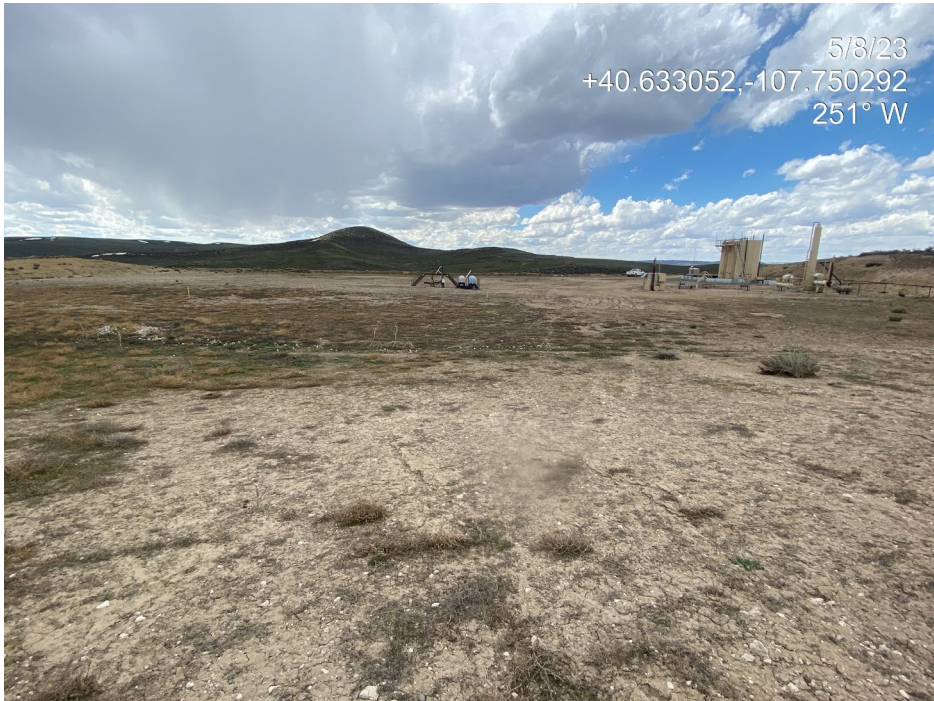
**Photo 1.** Photo taken from the northeast shows an overview of the northern portion of the Location. Photo also shows dense cover of cheatgrass (List C Noxious) and Russian thistle (undesirable plant species).

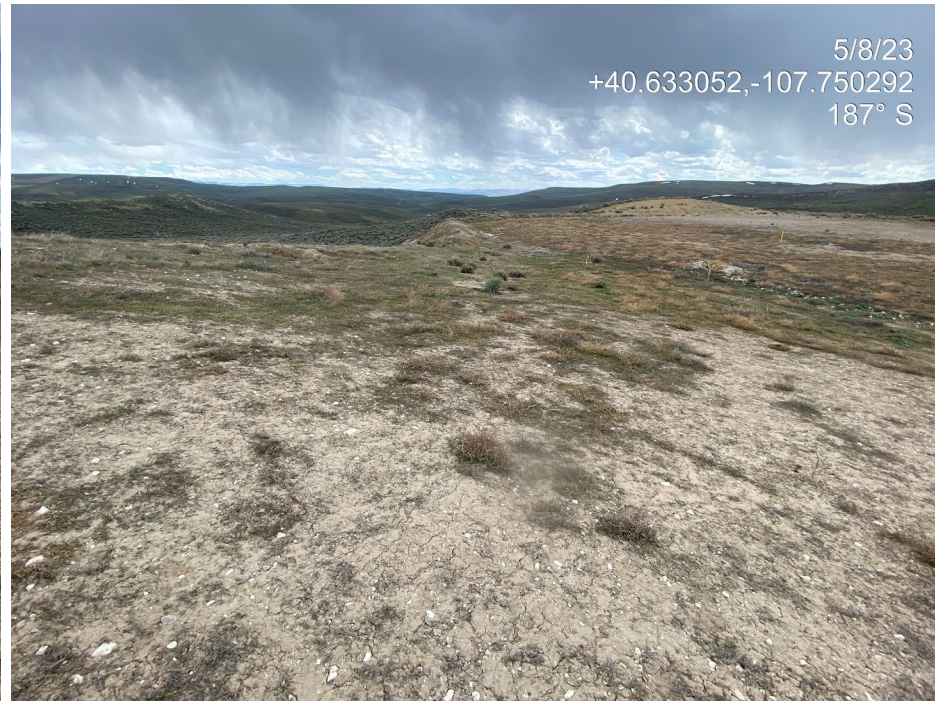
**Photo 2.** Photo taken from the northeast shows an overview of the southern portion of the Location. Refer to additional Photo 1 comments.

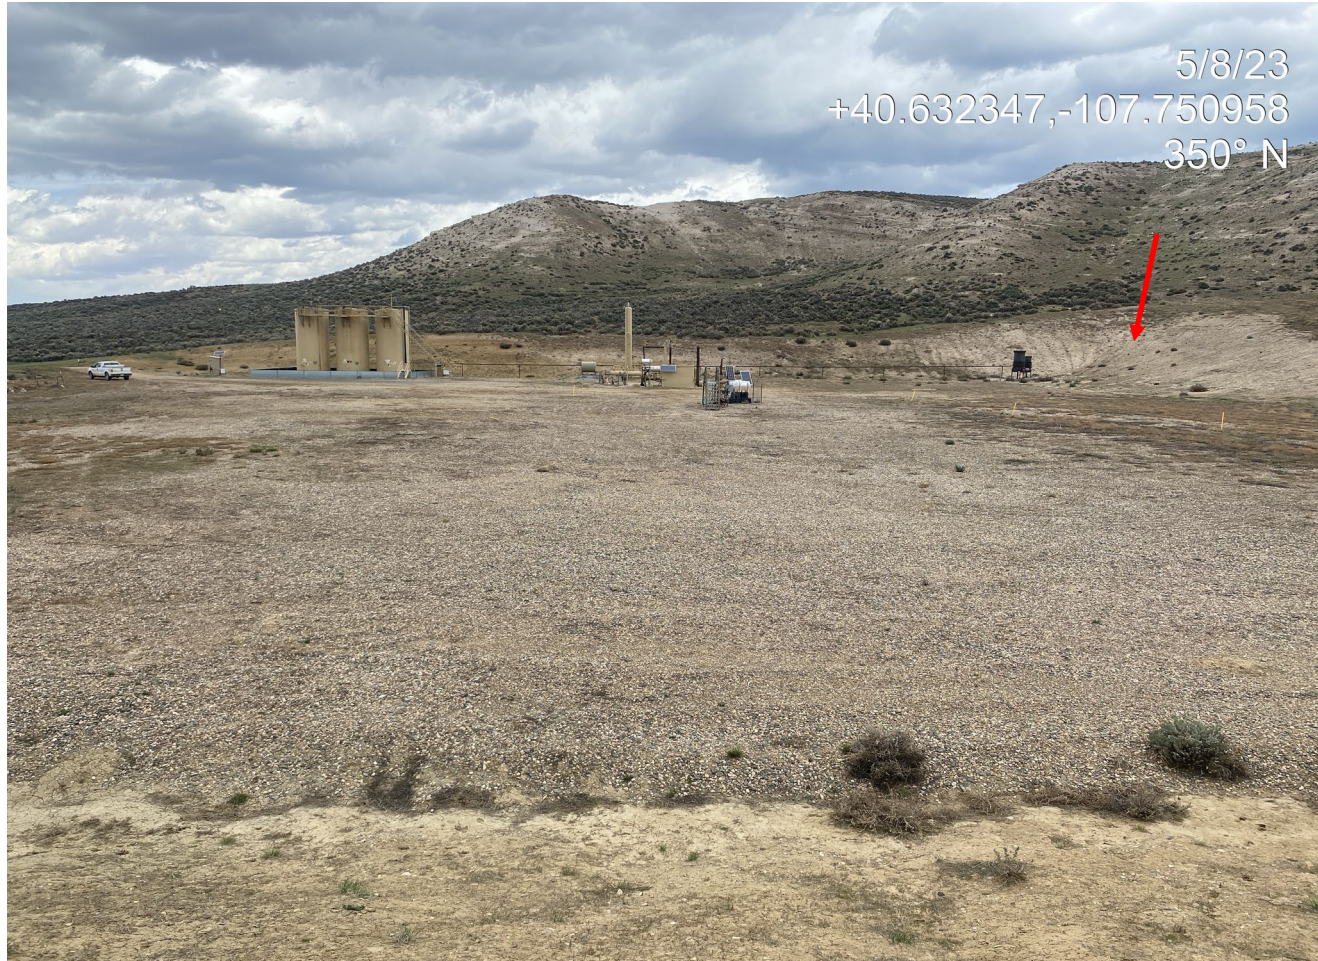
**Photo 3.** Photo taken from the south shows an overview of the location. Note the eroding cut slope (arrow).

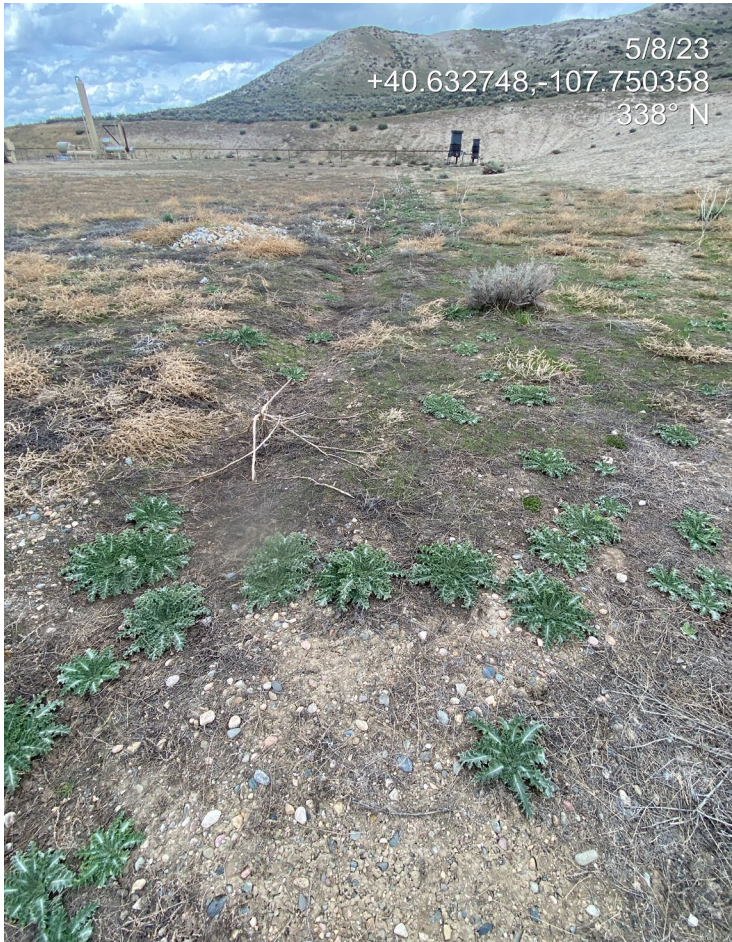
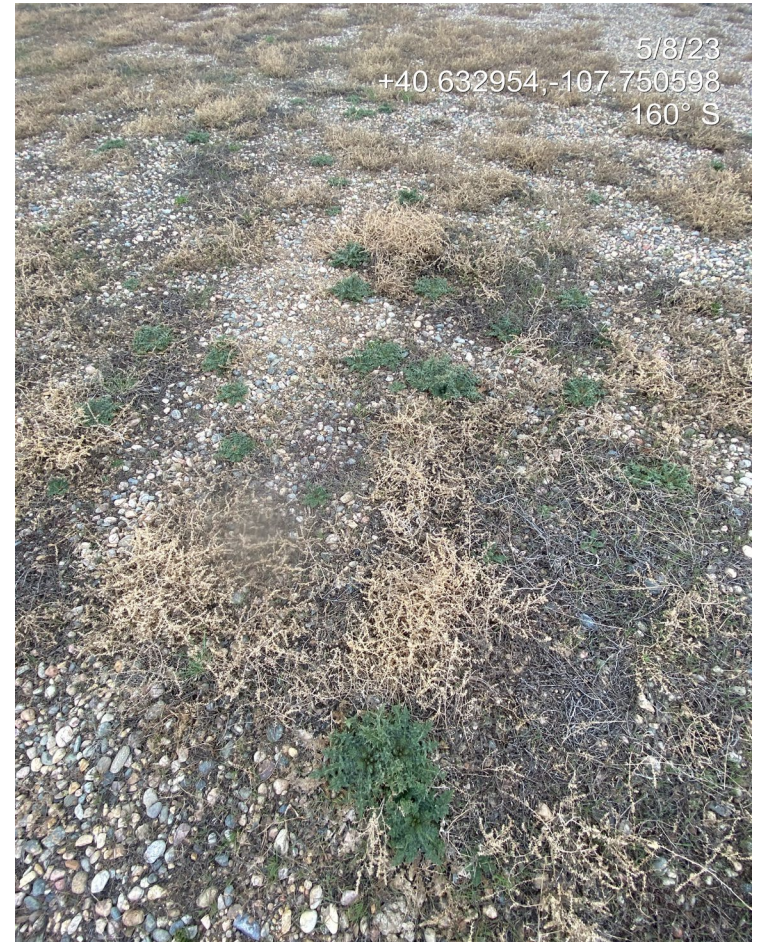
**Photo 4.** Photos show a examples of Scotch thistle (left) and bull thistle (right), CO List B Noxious Weeds which are widespread on Location.

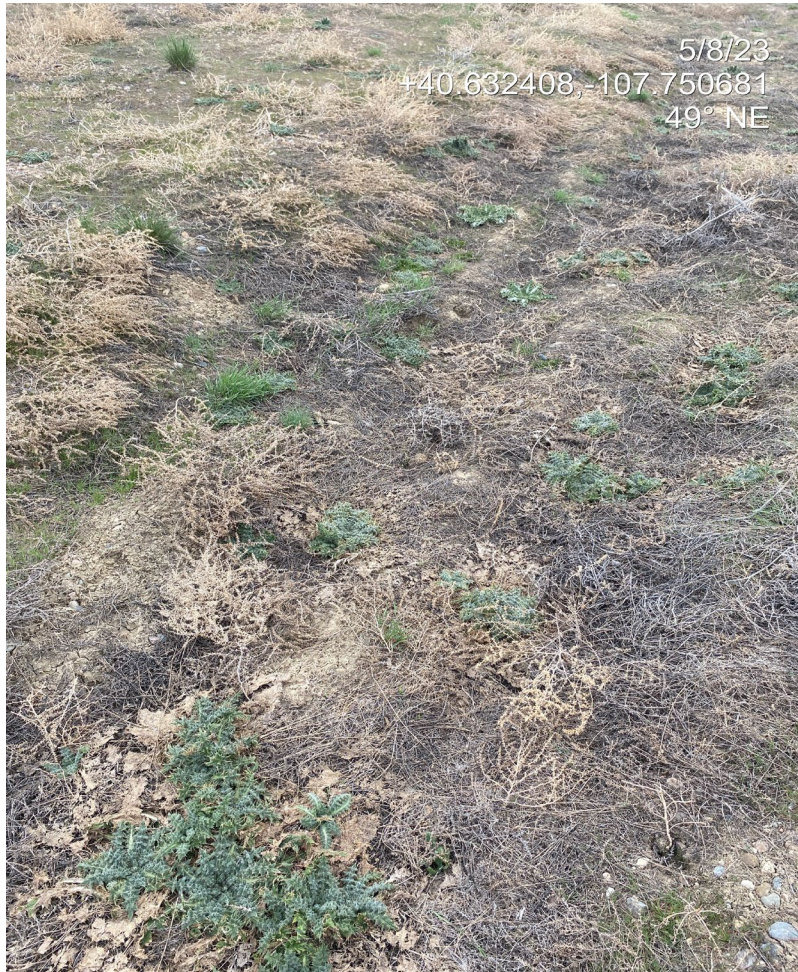
**Photo 5.** Photo shows bull and Scotch thistle and dense coverage of emerging Russian thistle and cheatgrass.

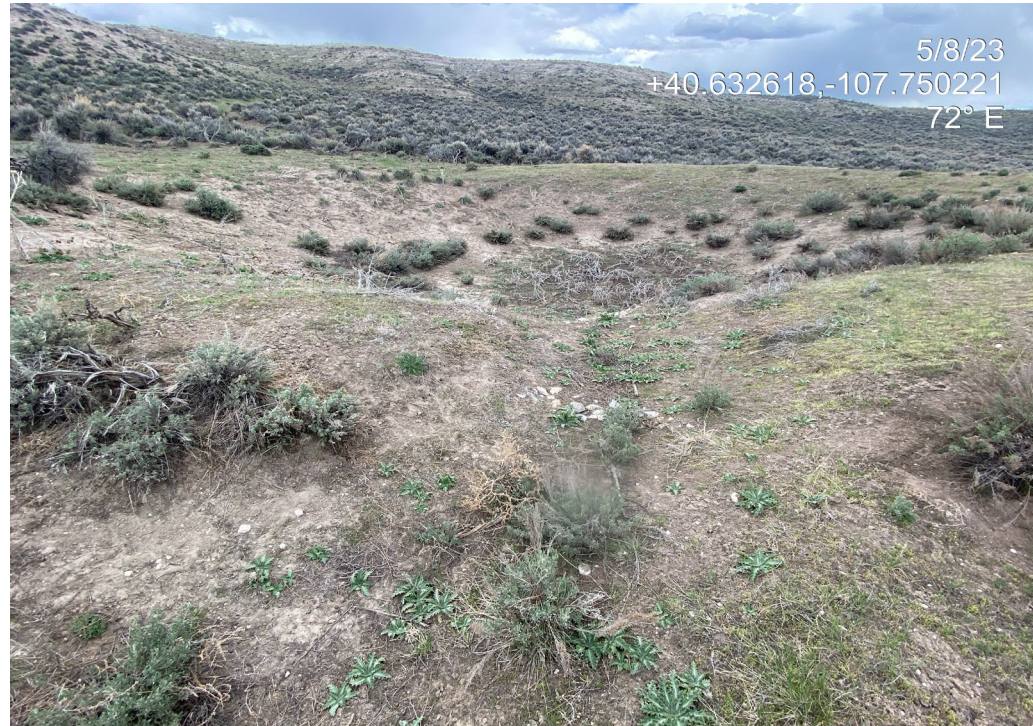
**Photo 6.** Photo taken at the stock pond to the east of the Location shows an example of Scotch thistle, a CO List B Noxious Weed on Location. Note also extensive native rangeland in the background which is free of noxious weeds. Thistle on location is acting as a weed source in habitat otherwise free of list B noxious weeds.

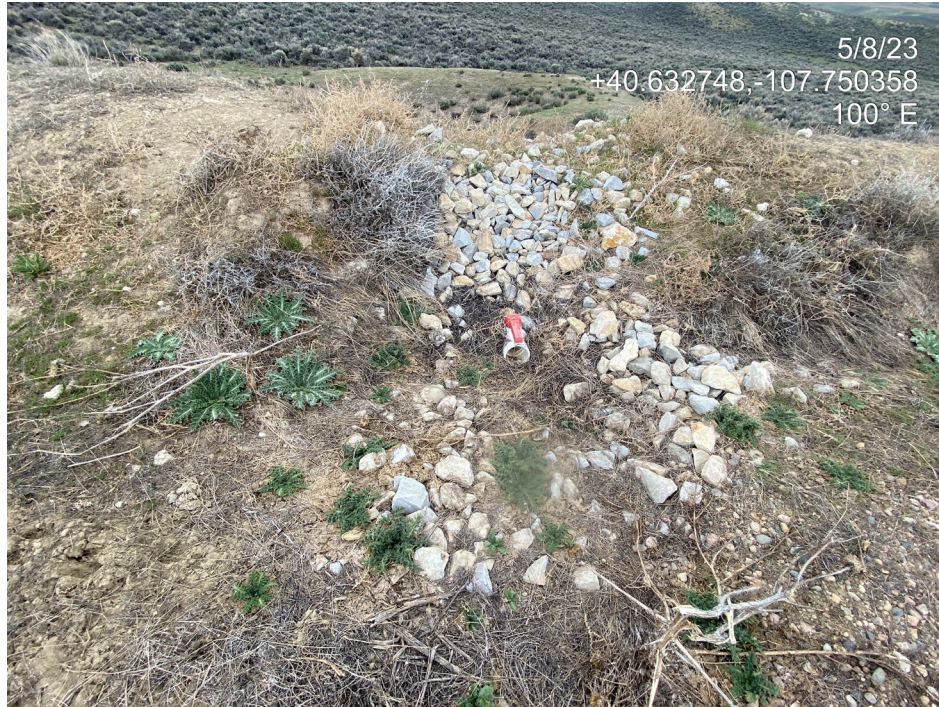
**Photo 7.** Photo taken from the east of the Location shows a drain pipe which leads through the fill slope. Stormwater is bypassing the drain and eroding the fill slope. Note also scotch and bull thistles.

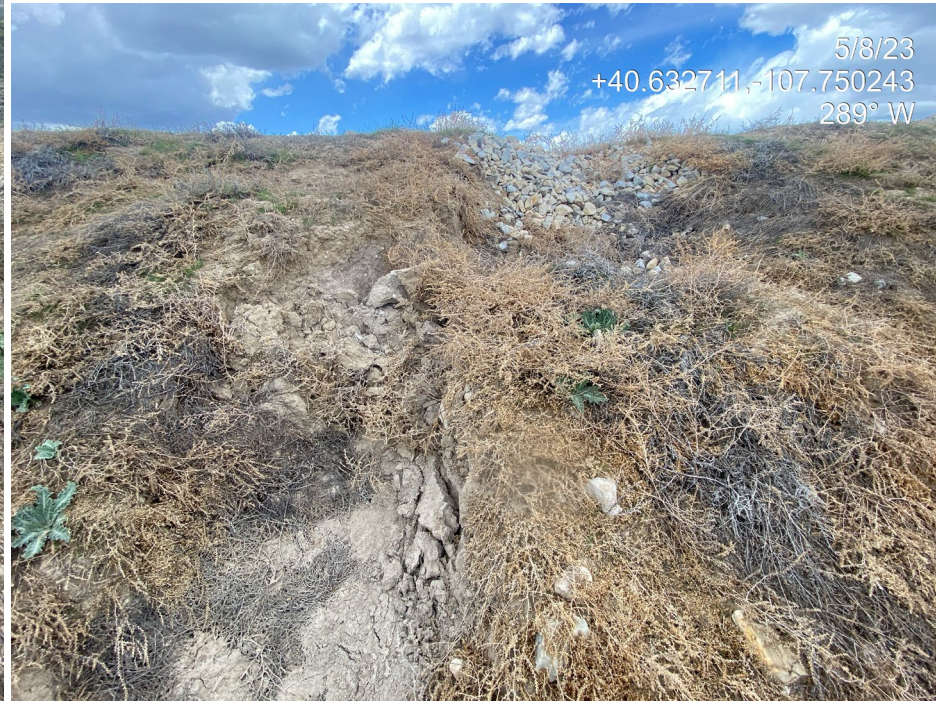
**Photo 8.** Photo taken from the east of the location shows where stormwater is bypassing a drain pipe and eroding the fill slope. Note the slope is densely colonized by noxious weeds and undesirable plant species.

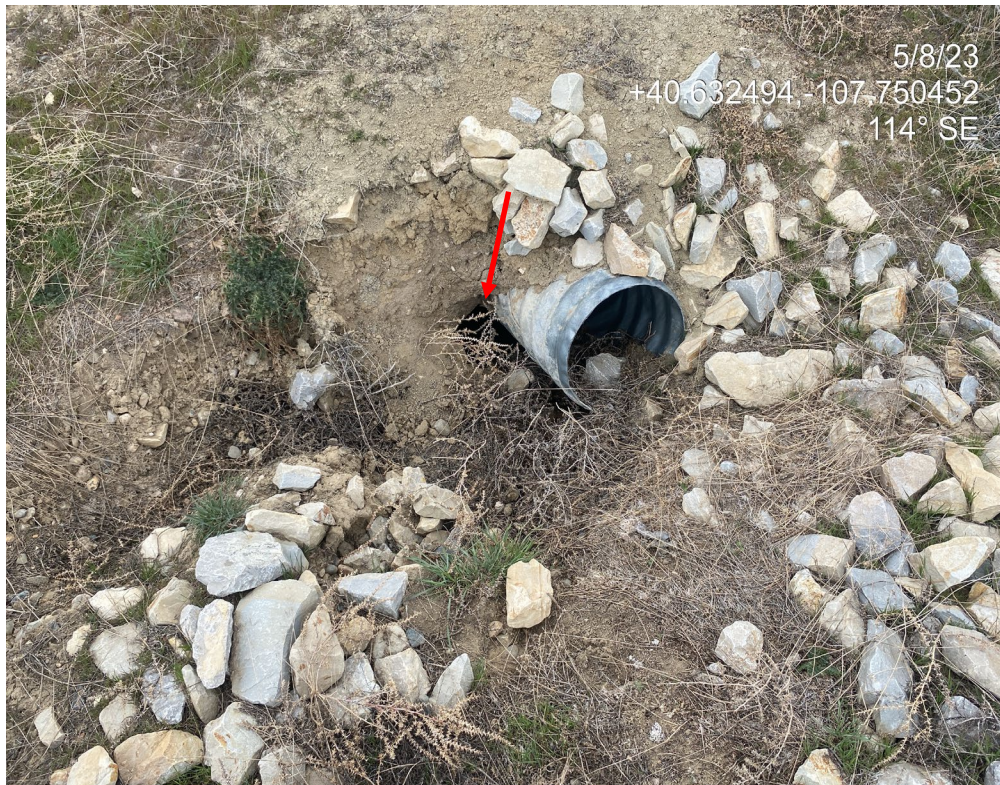
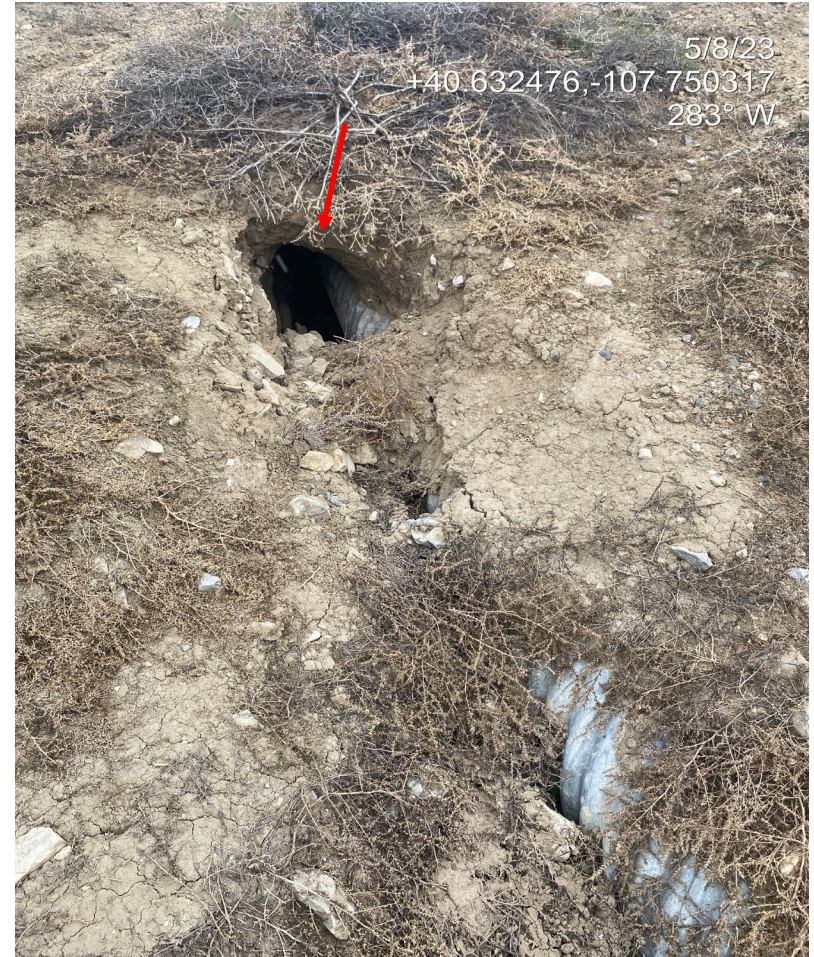
**Photo 9.** Photo taken from the fill slope at the southeast shows a fill slope drain. Stormwater is bypassing the drain and causing erosion. Photo left shows the inlet, right shows the outlet.

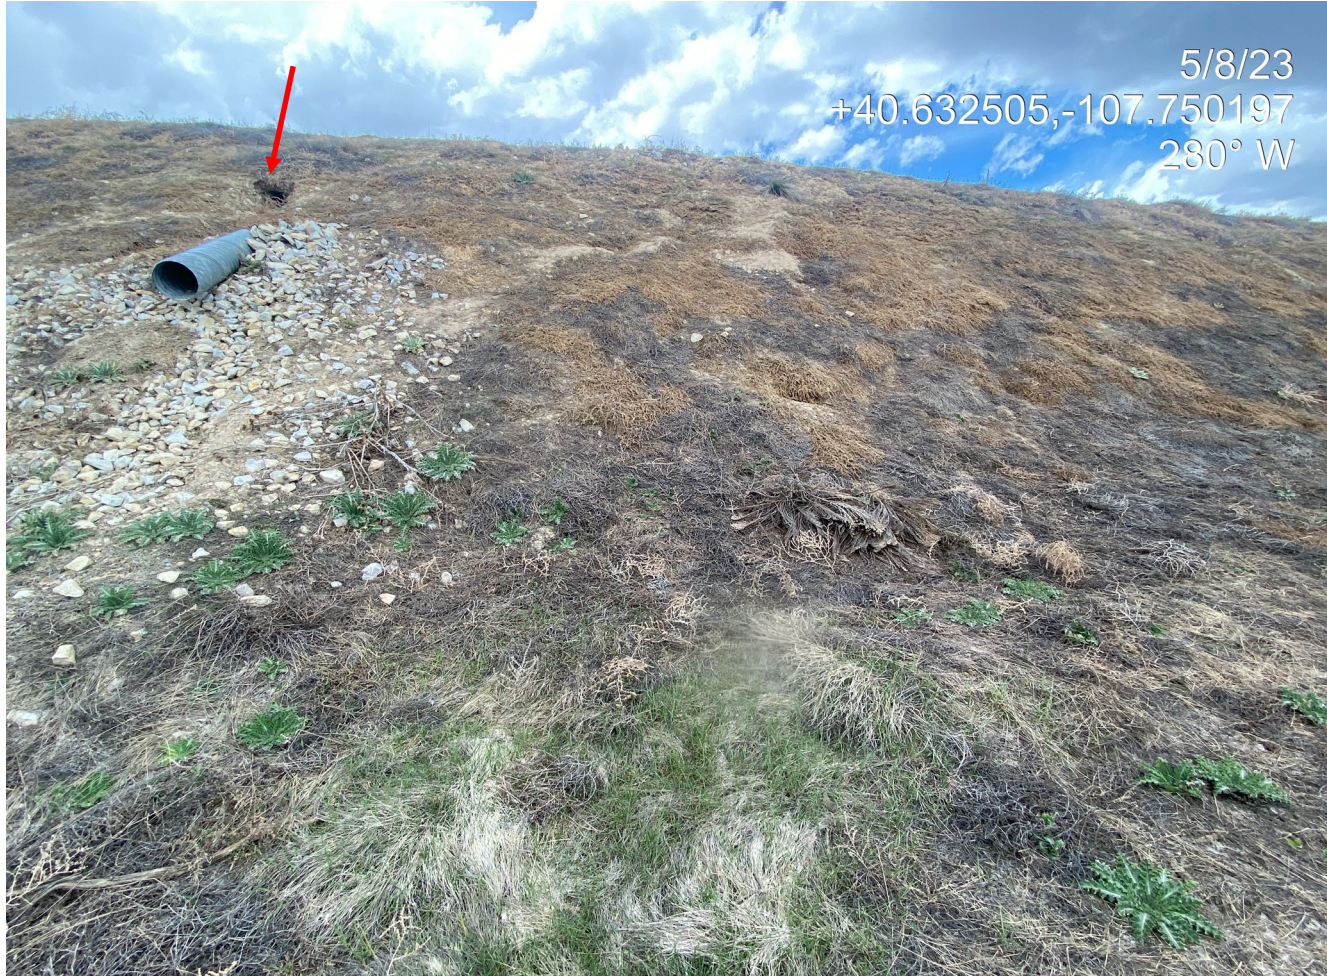
**Photo 10.** Refer to Photo 9 comments. Note also noxious weeds and undesirable plant species.

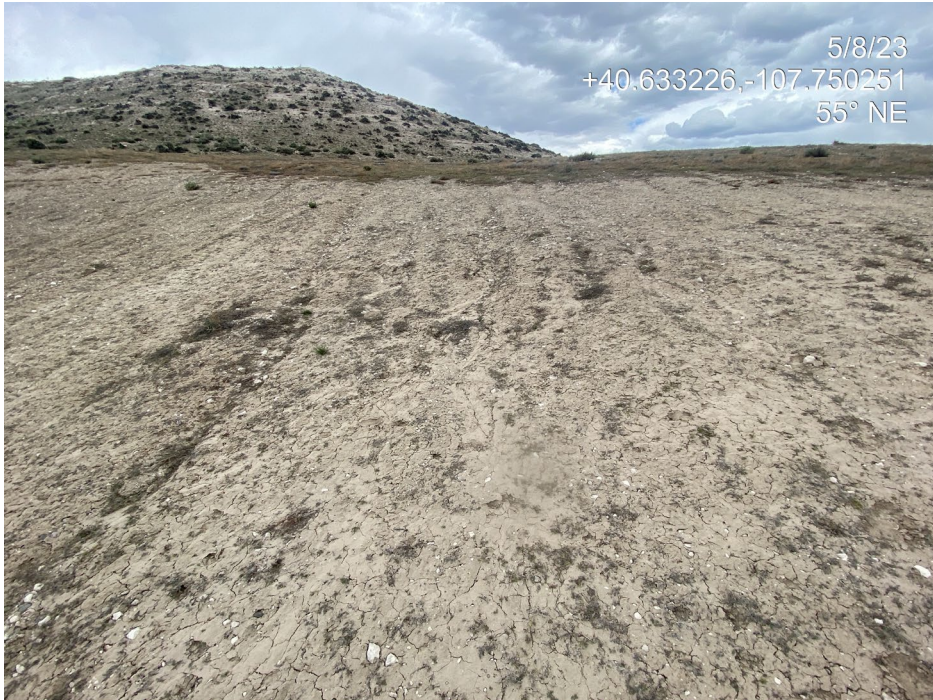
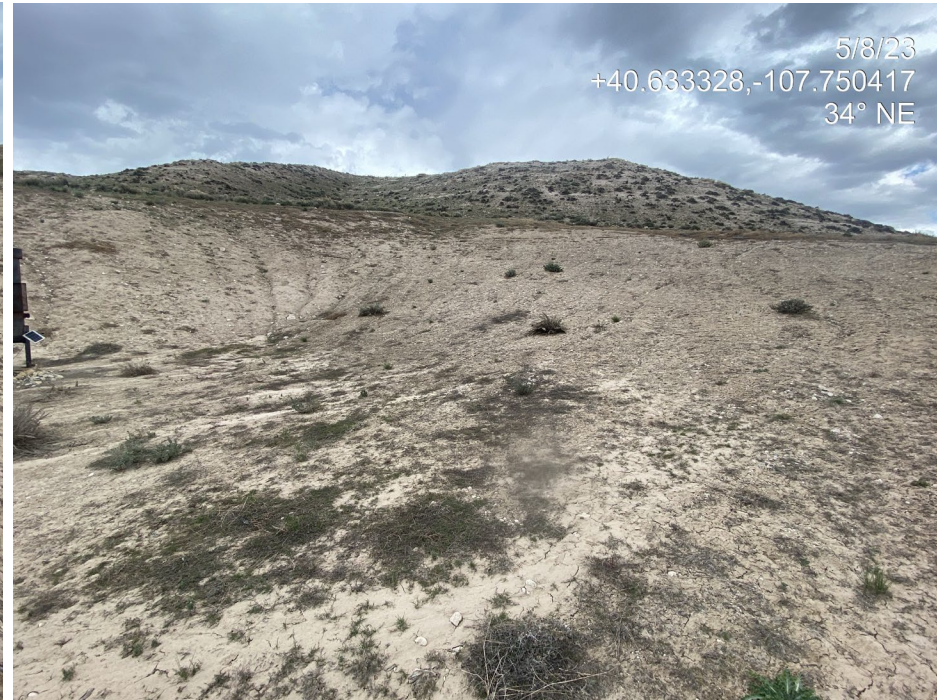
**Photo 11.** Photos taken at the northeast of the Location show rill erosion occurring on the unstabilized and unprotected cut slope. Photos also show Russian thistle, an undesirable plant species emerging.

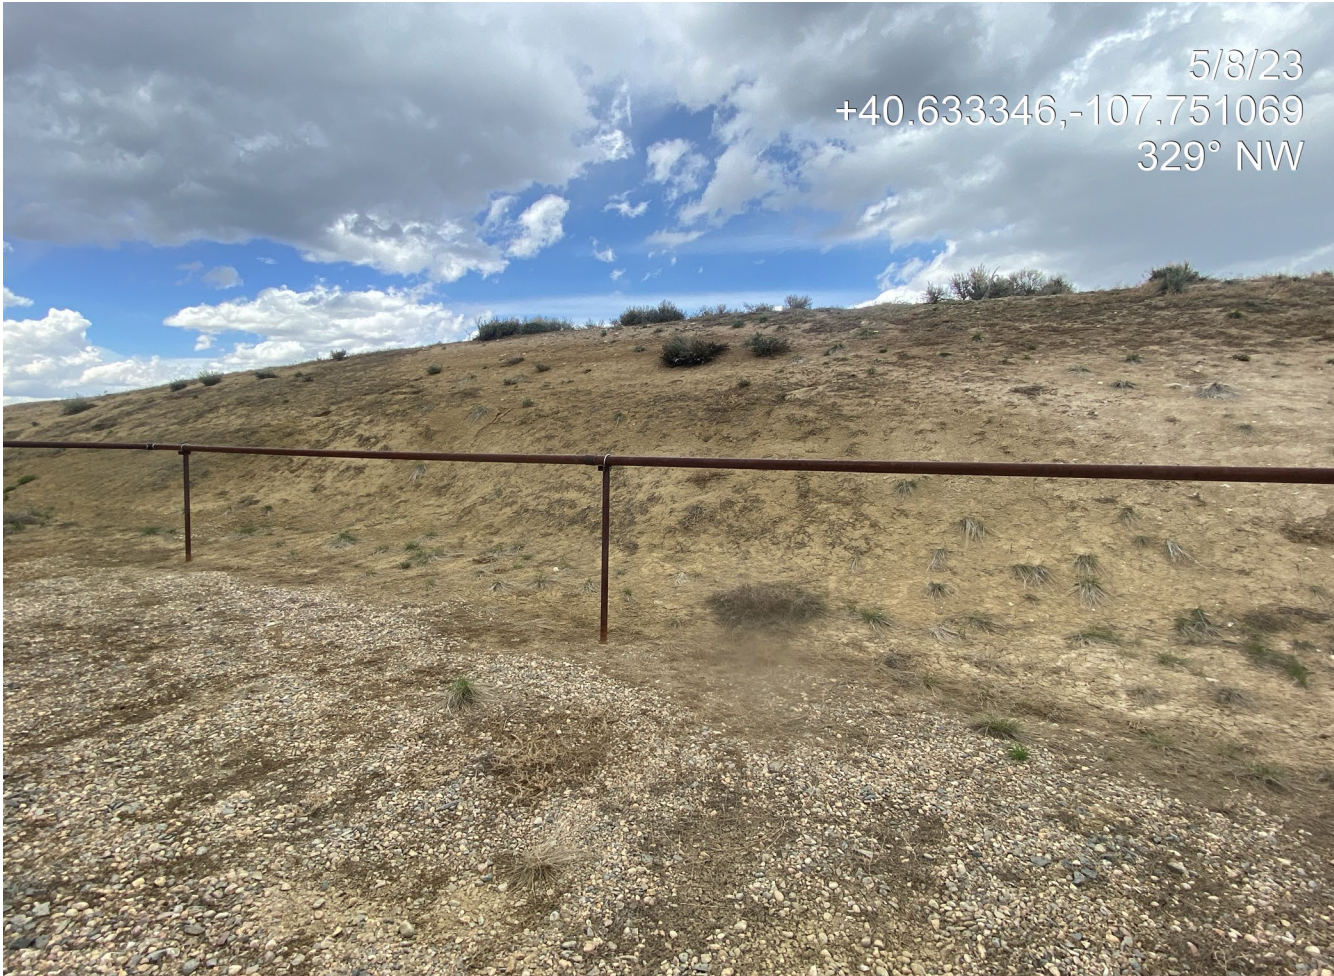
**Photo 12.** Photo taken at the north of the Location shows rill erosion occurring on the unstabilized and unprotected cut slope.

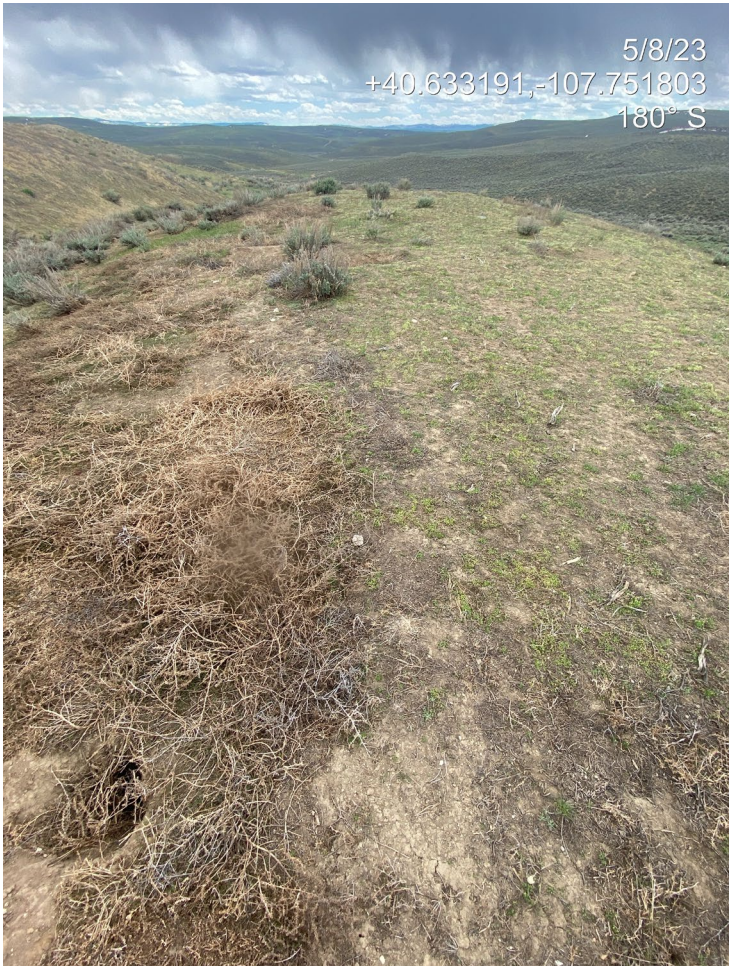
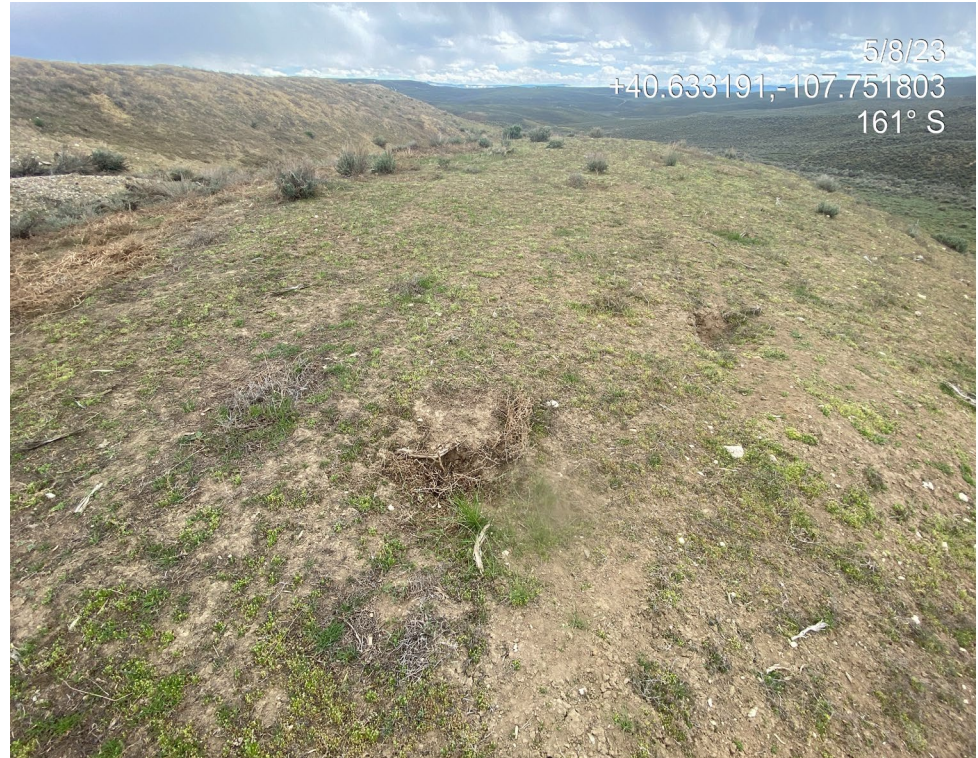
**Photo 13.** Photos show the topsoil stockpile at the west of the location. Pile is colonized by noxious weeds and undesirable plant species. Desirable and or perennial vegetation establishment is sparse.

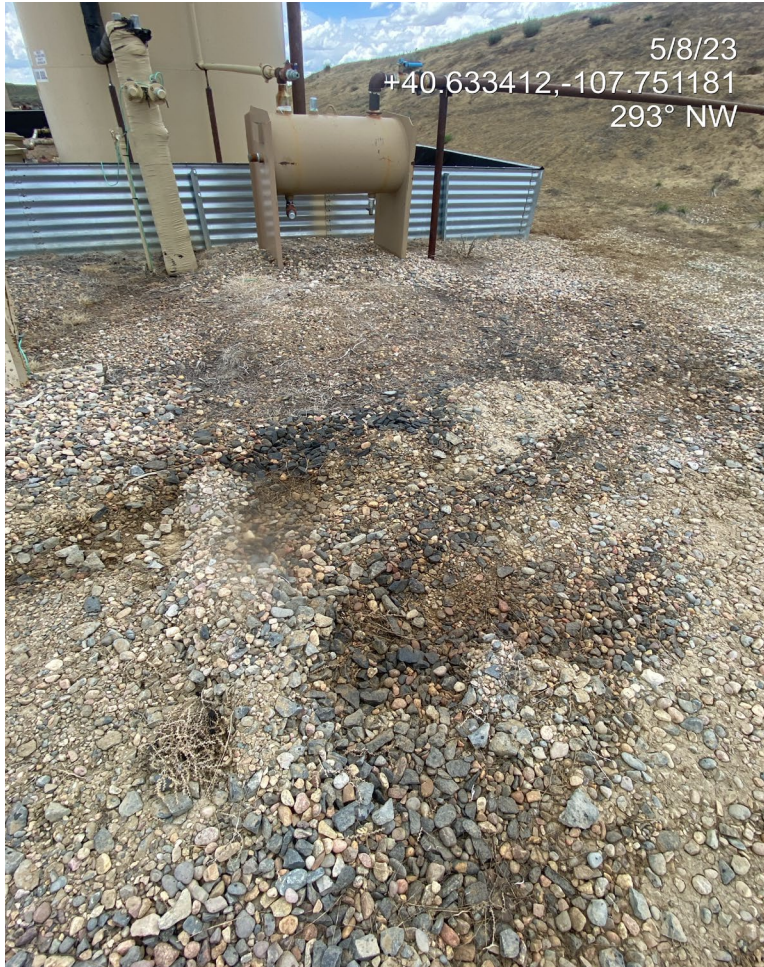
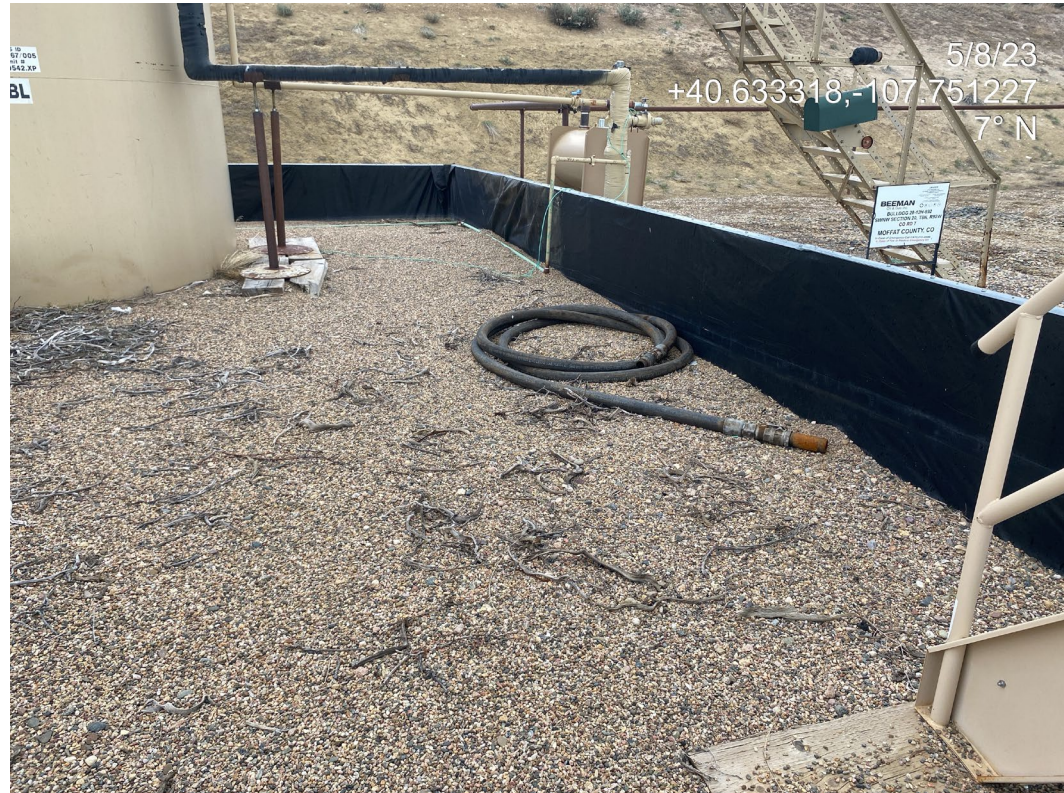
**Photo 14.** Photos show stained soils east of the tank battery (left) and unused hose equipment within the tank battery secondary containment berm (right).

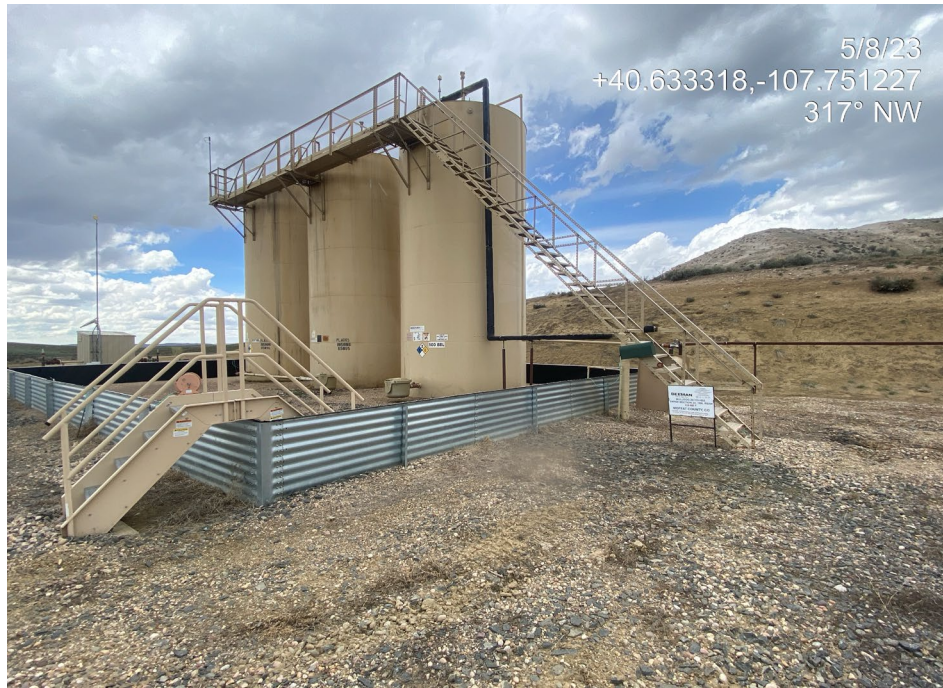
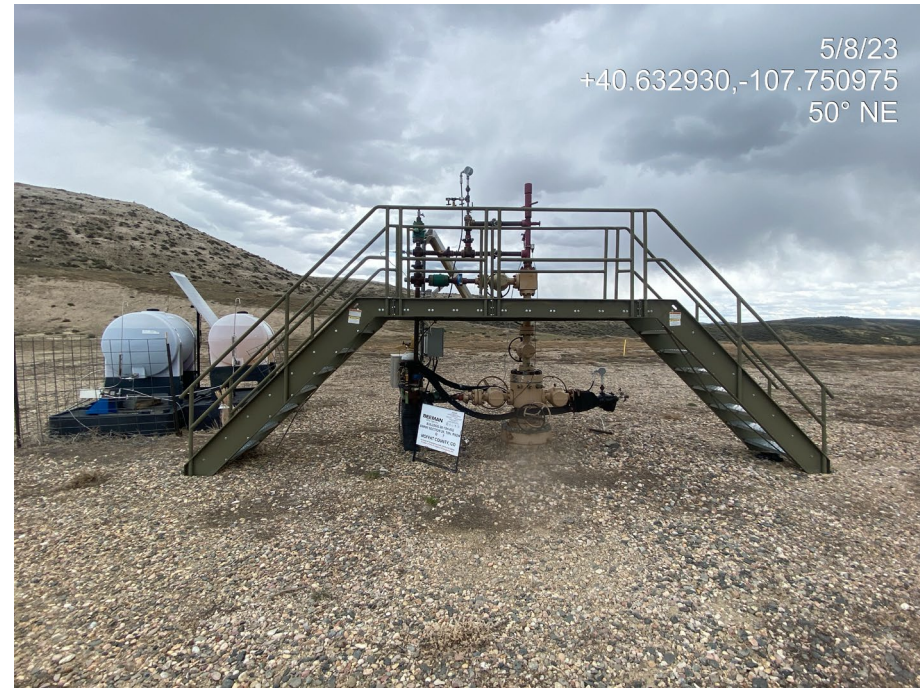
**Photo 15.** Photos show production areas. The battery sign does not comply with Rule 605.e (left). The wellhead sign does not comply with Rule 605.d (right).

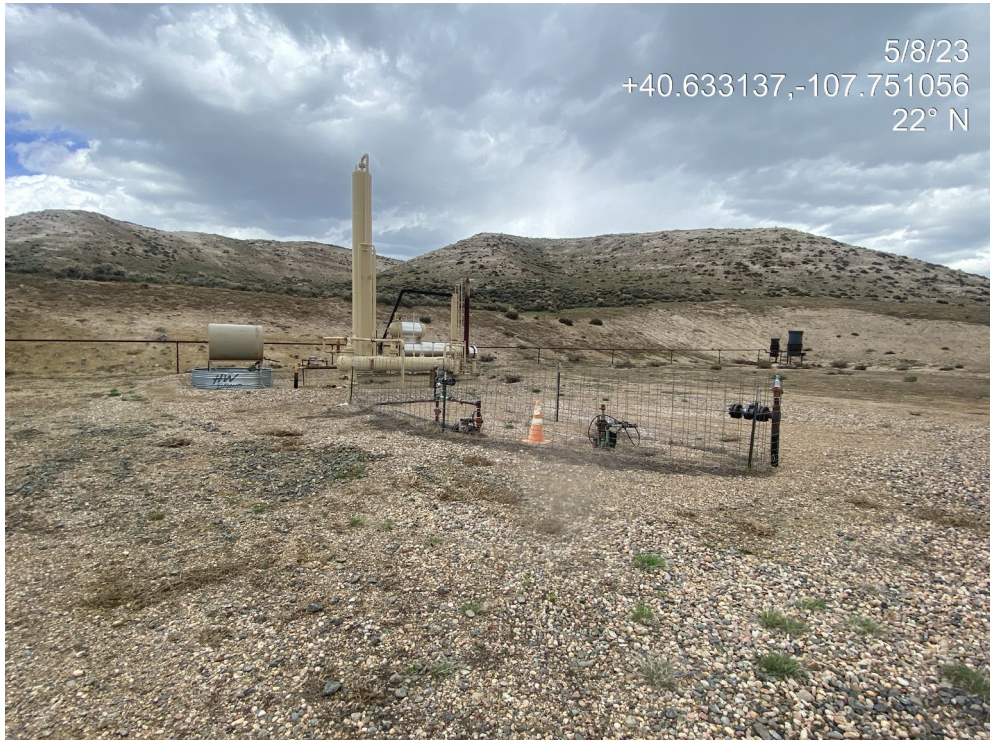
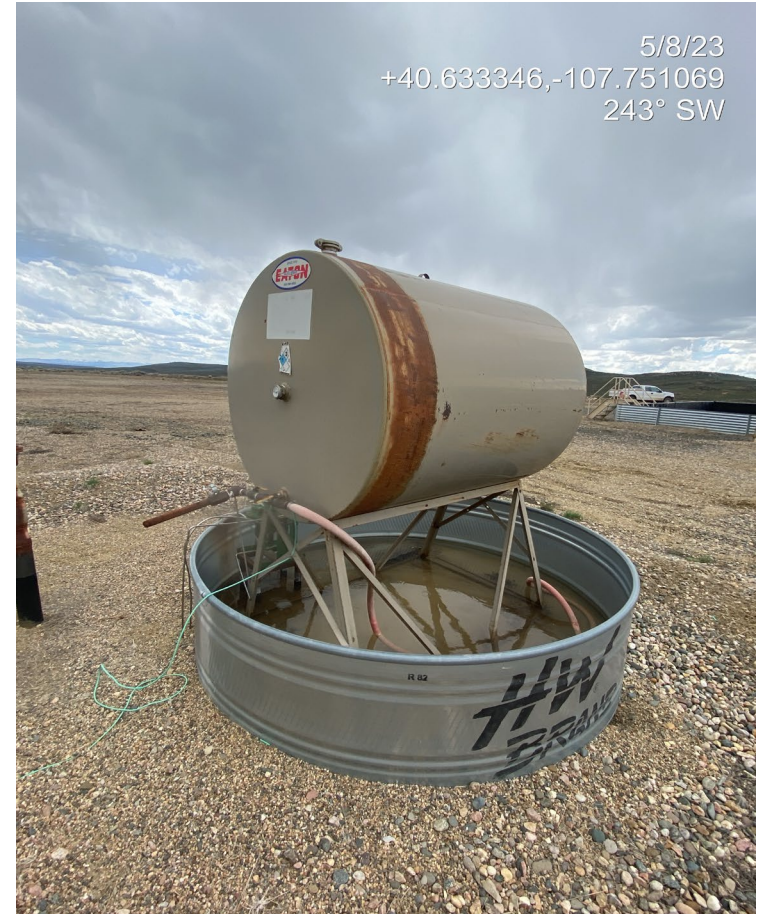
**Photo 16.** Photos show production areas to the north. Wildlife protection BMPs are missing/insufficient on the methanol tank secondary containment stock tank. The tank label is peeling and faded. Safety and identifying information is not legible.

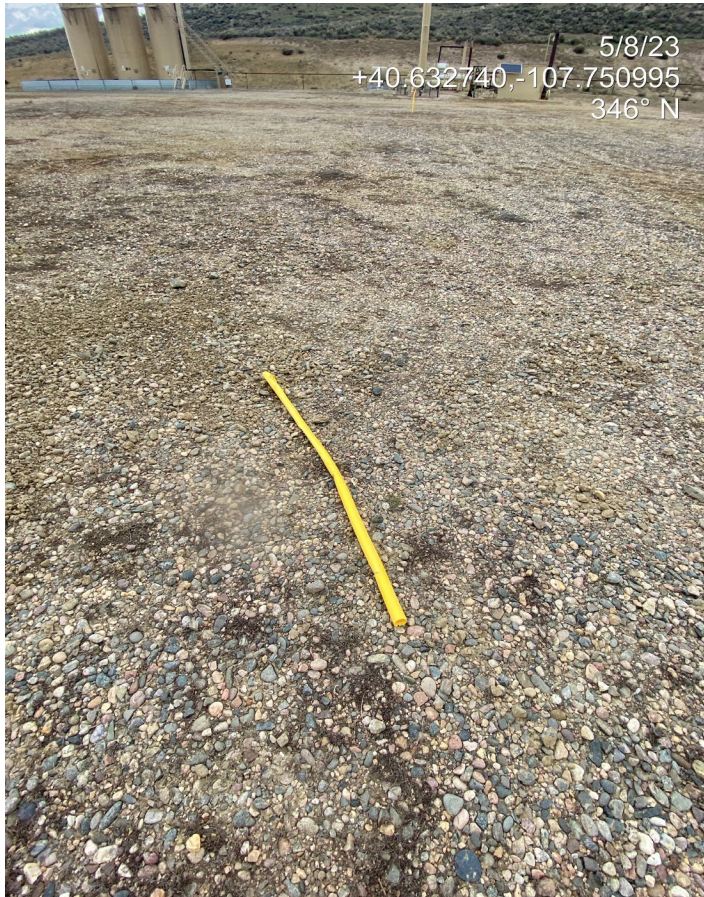
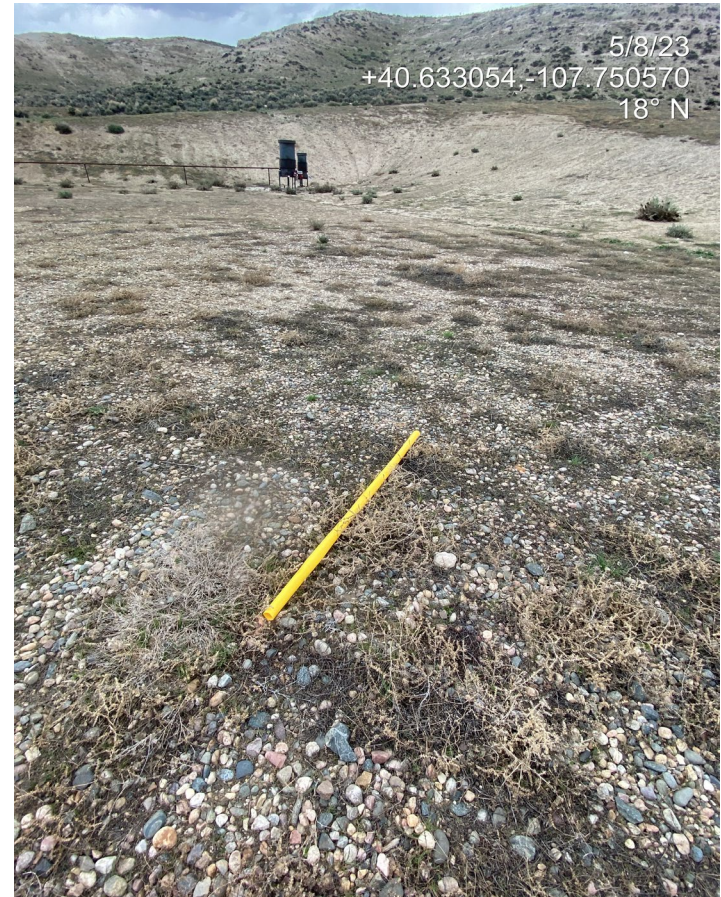
**Photo 17.** Photos show trash/debris.

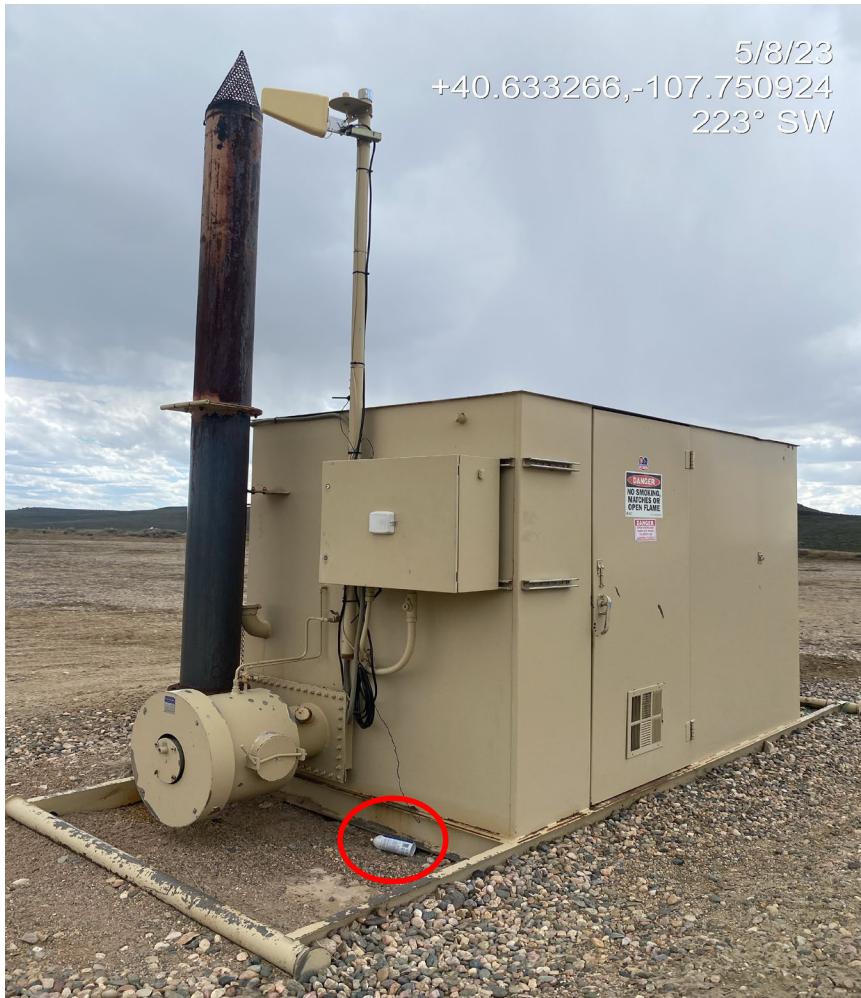
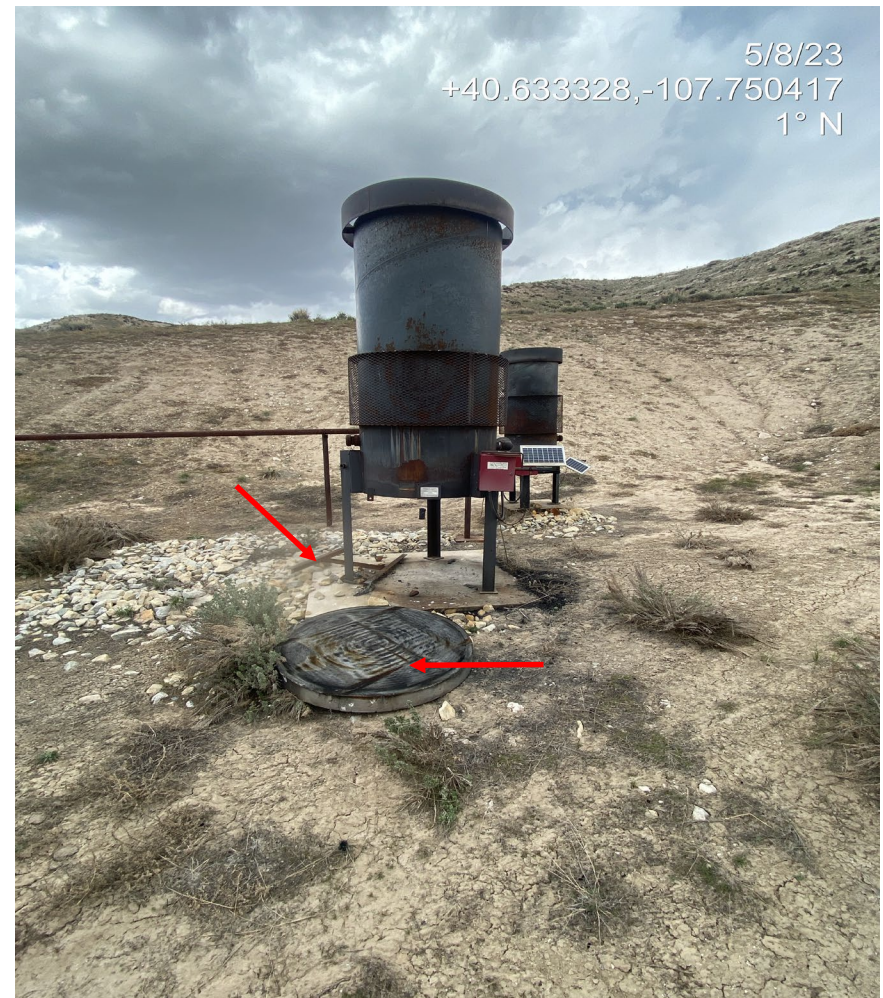
**Photo 18.** Photos show trash/debris.
