Inspection Photos
Location Name: CAERUS PICEANCE LLC A17E Pad
Location ID: 334953

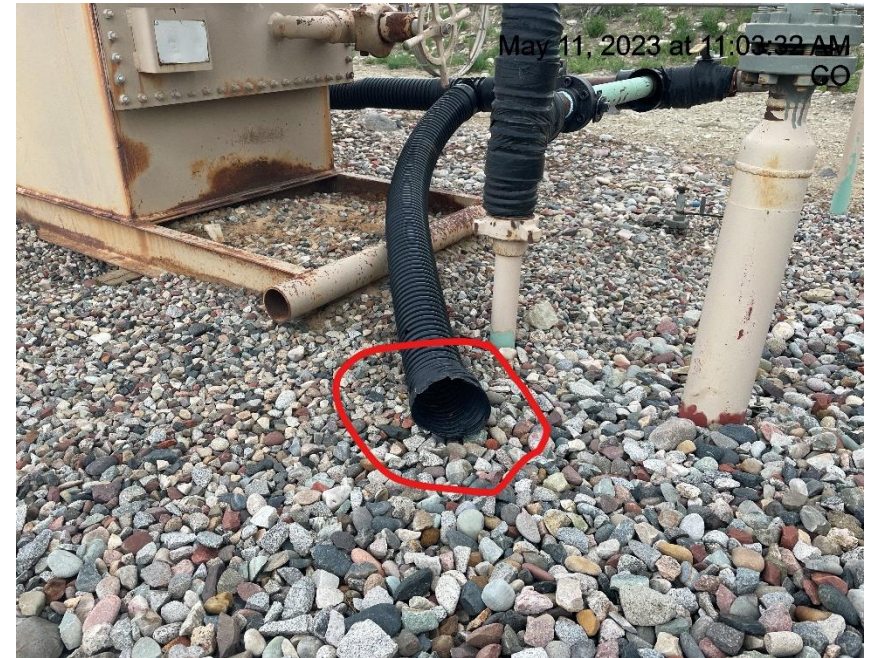
Photo # 7536 Flowline heating insulation open ended

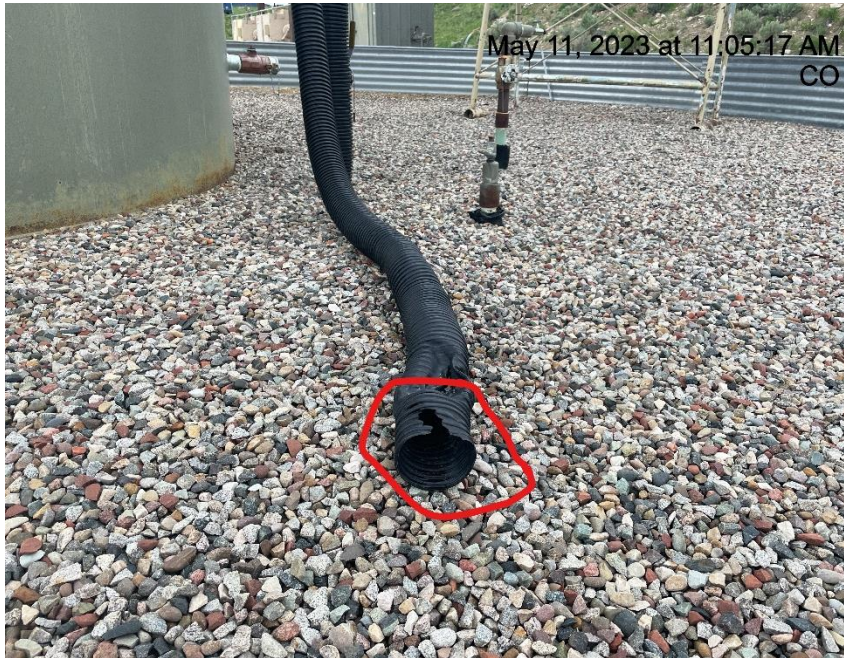
Photo # 7537 Flowline heating insulation open ended

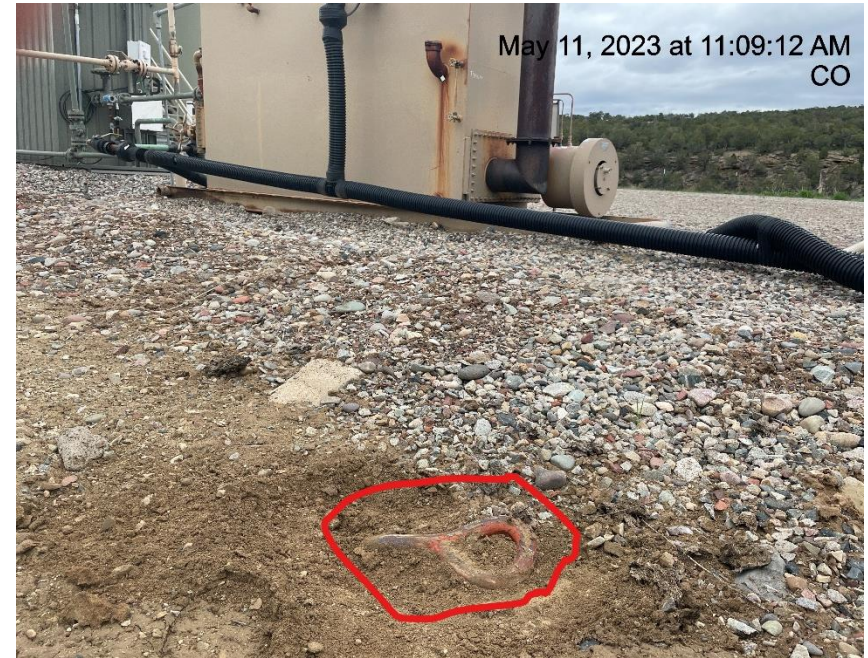
Photo # 7550 Unmarked deadman
